ANN ARBOR HISTORIC DISTRICT COMMISSION

Staff Report

ADDRESS: 1310 Hill Street, Application Number HDC15-227

DISTRICT: Washtenaw Hill Historic District

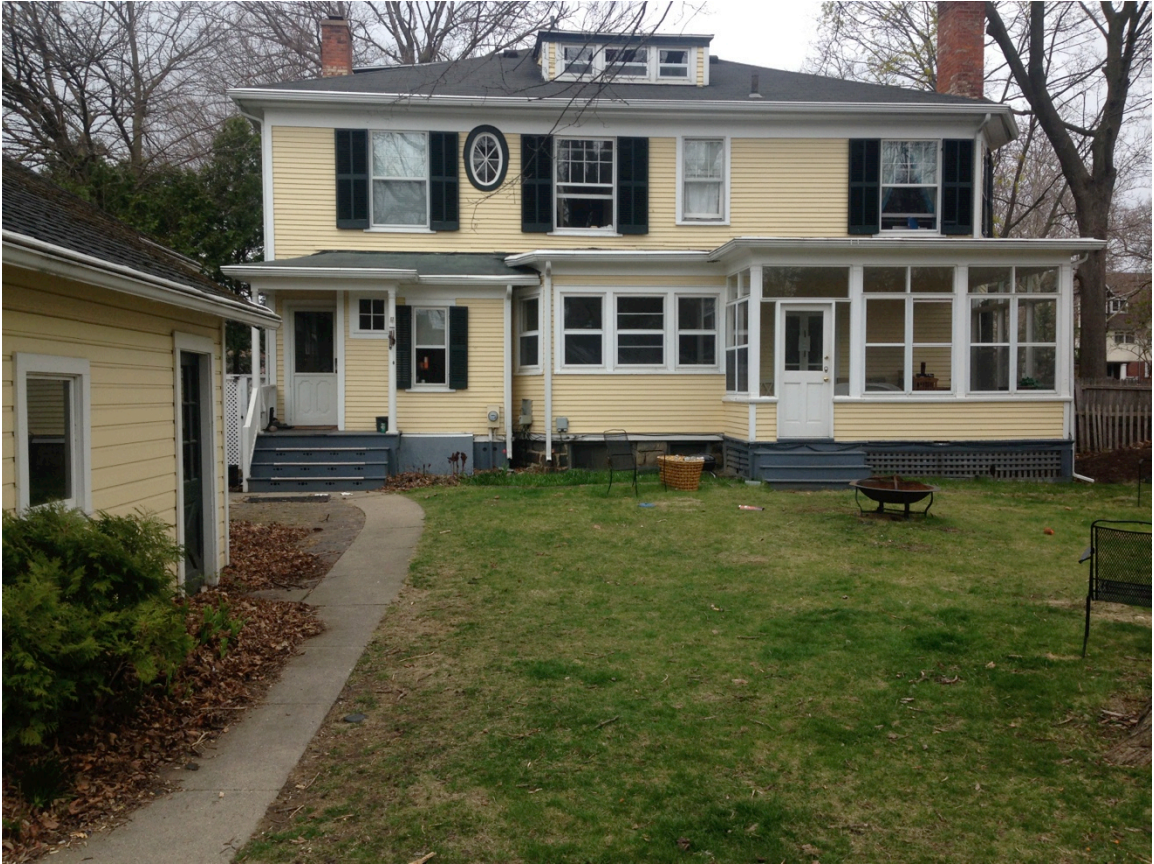
View of the rear of the house prior to the basement construction.

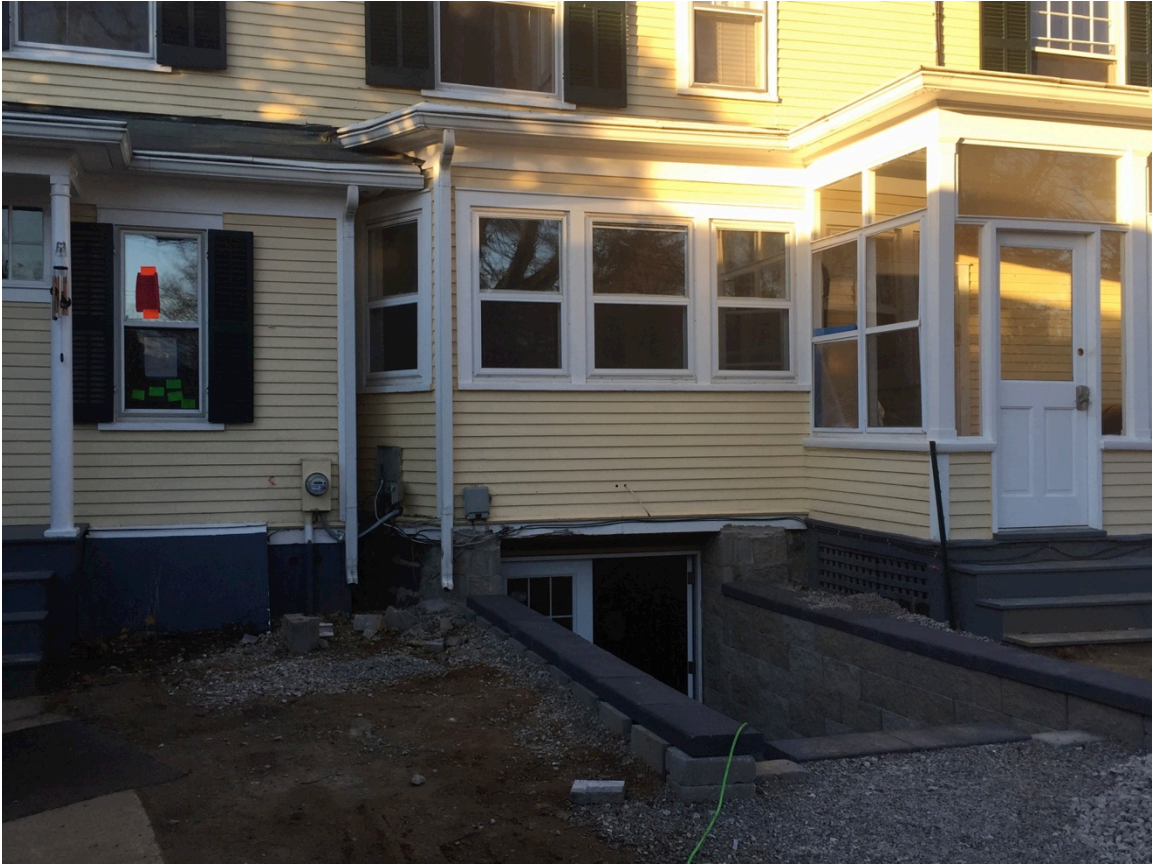
3. Standard 5 says that “Distinctive features, finishes, and construction techniques or examples of craftsmanship that characterize a property shall be preserved.” The cut stone basement walls are a distinctive feature of the house, as were the three wood, multi-paned basement windows that were removed to allow the doors to be installed.

The south entrance to the basement under development.

7. Staff recommends denial of the application and recommends that the HDC order the exterior work to be reversed. The owner may apply to appear on a future HDC agenda for a window that meets code requirements for egress for the basement that he made habitable.

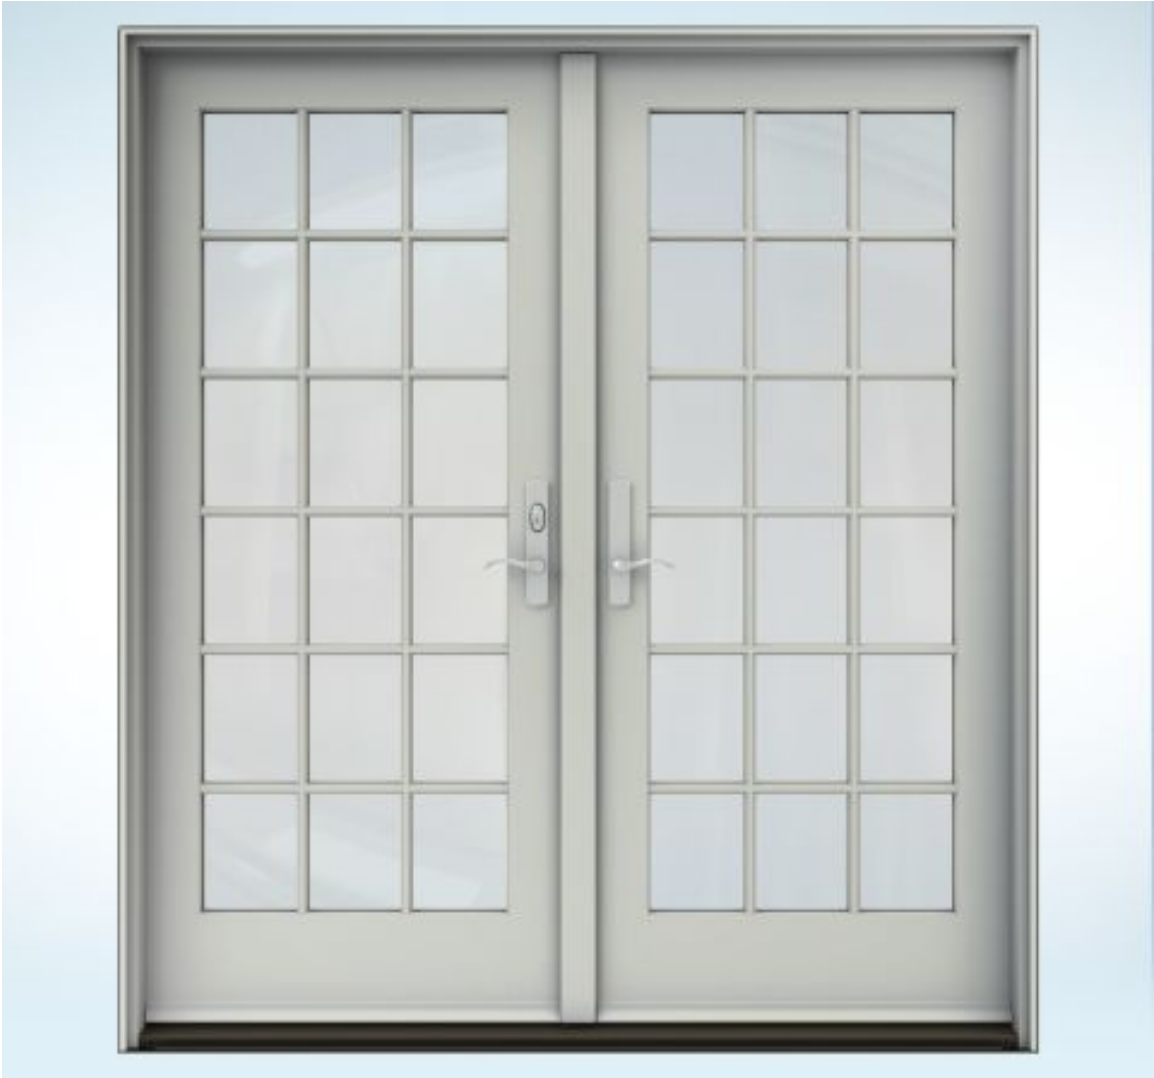
A white, Jeld-Wen swinging patio door was installed as the entry door of the south basement entrance.

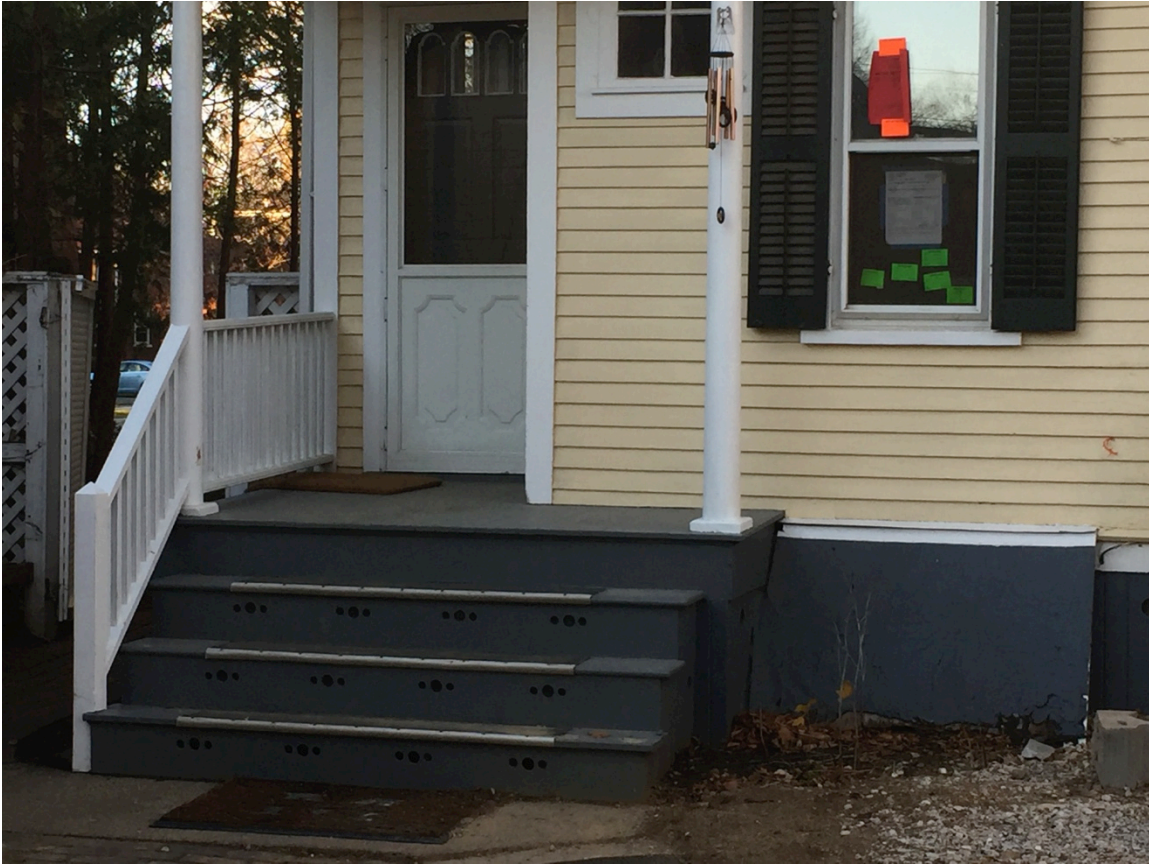
The exterior cellar door has been built over by the rear porch steps and kitchen addition. It has been covered over with plywood (to the right of the steps).

A handrail will be required for the steps leading down to both entrances. We will use a handrail similar to the existing handrail on the back steps as shown in the picture above.

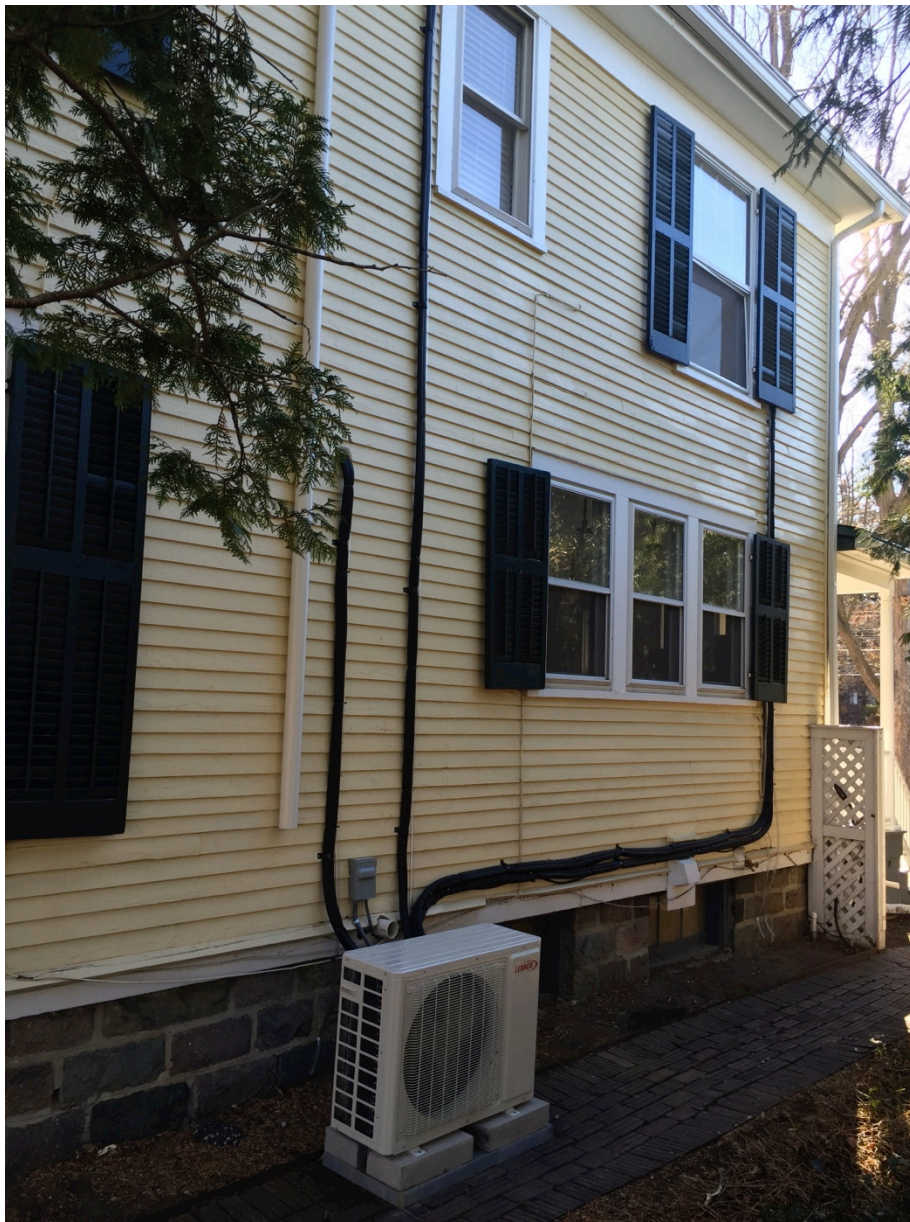
6. The mini-splits and line-sets are visually and physically damaging to the historic structure and setting and are inappropriate. The radon exhaust system is only partially installed, and it has not been demonstrated that it could not be located less conspicuously. The owner should work with staff to find appropriate locations and methods of installation for the air conditioning and radon mitigation units.

Mini-split compressor, line set configuration, and radon exhaust located on west side of house.

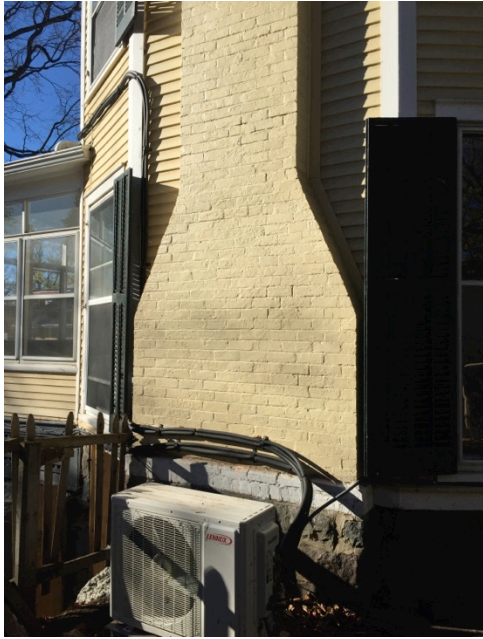
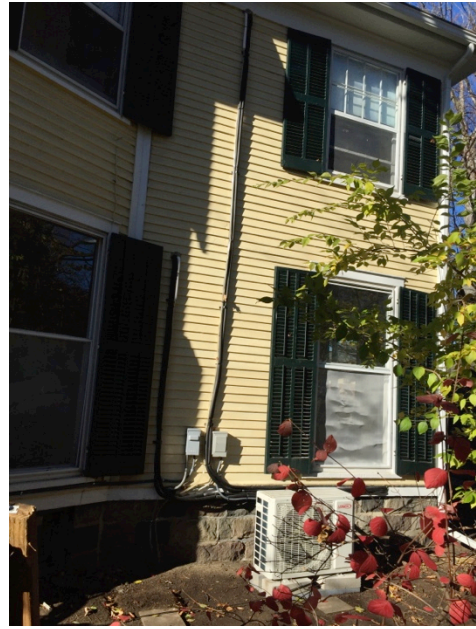
Mini-split compressors and line-sets on the east side of the house.

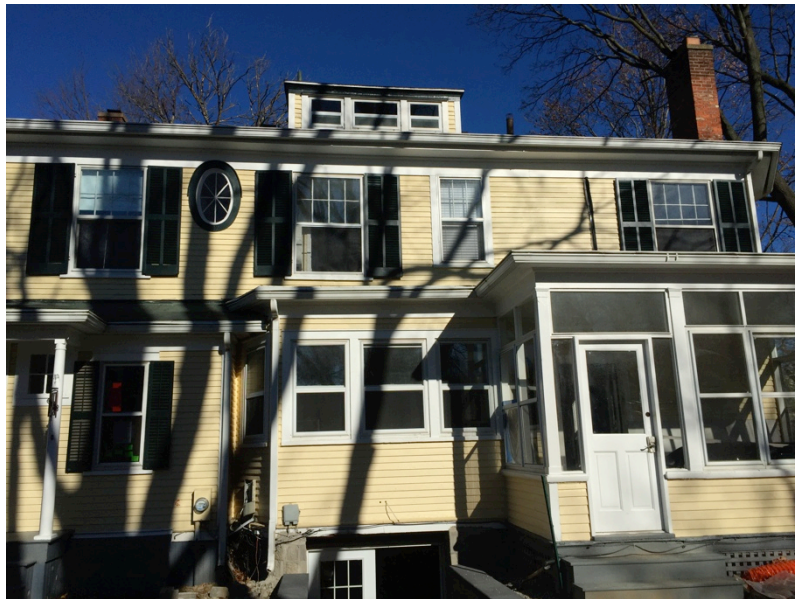
Mini-split line-set above the back porch.

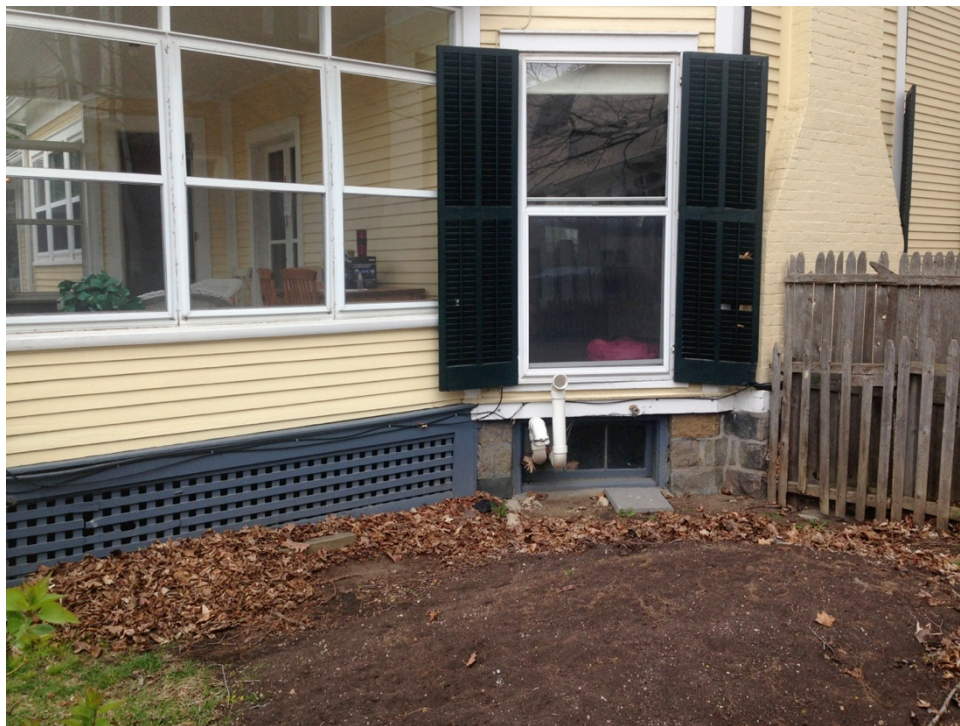
Close-up view of the southeast side of the house. The basement window that was being used for the existing furnace's exhaust and intake air ducts was removed. The dirt around this window was removed so that equipment could be brought into the basement. This is now the location of the east entrance.

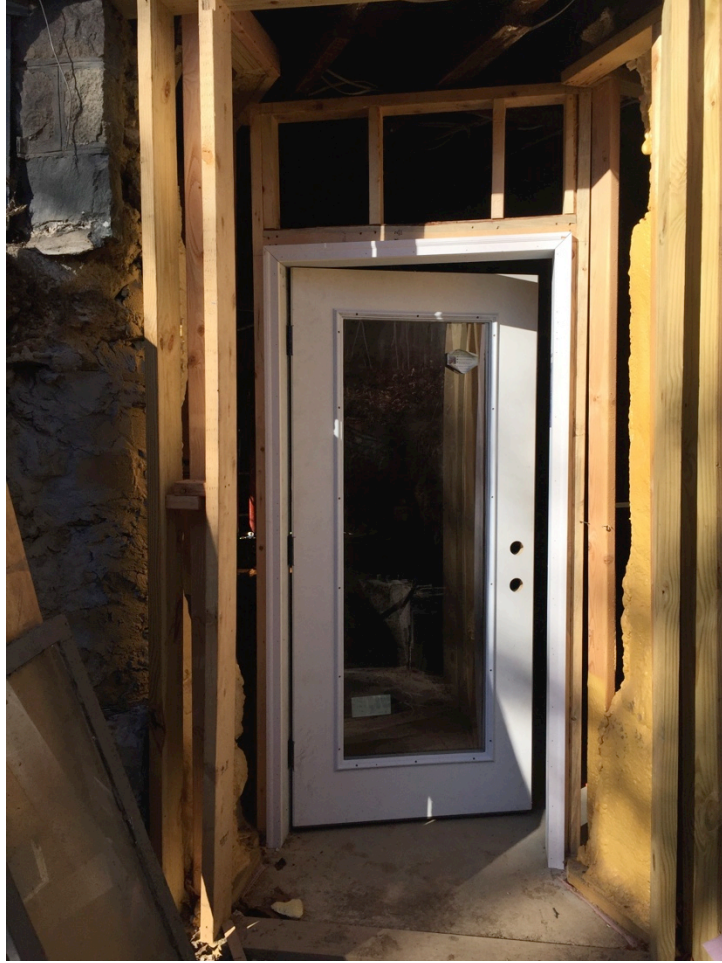
A Jeld-Wen full light door is being installed at the east entrance.

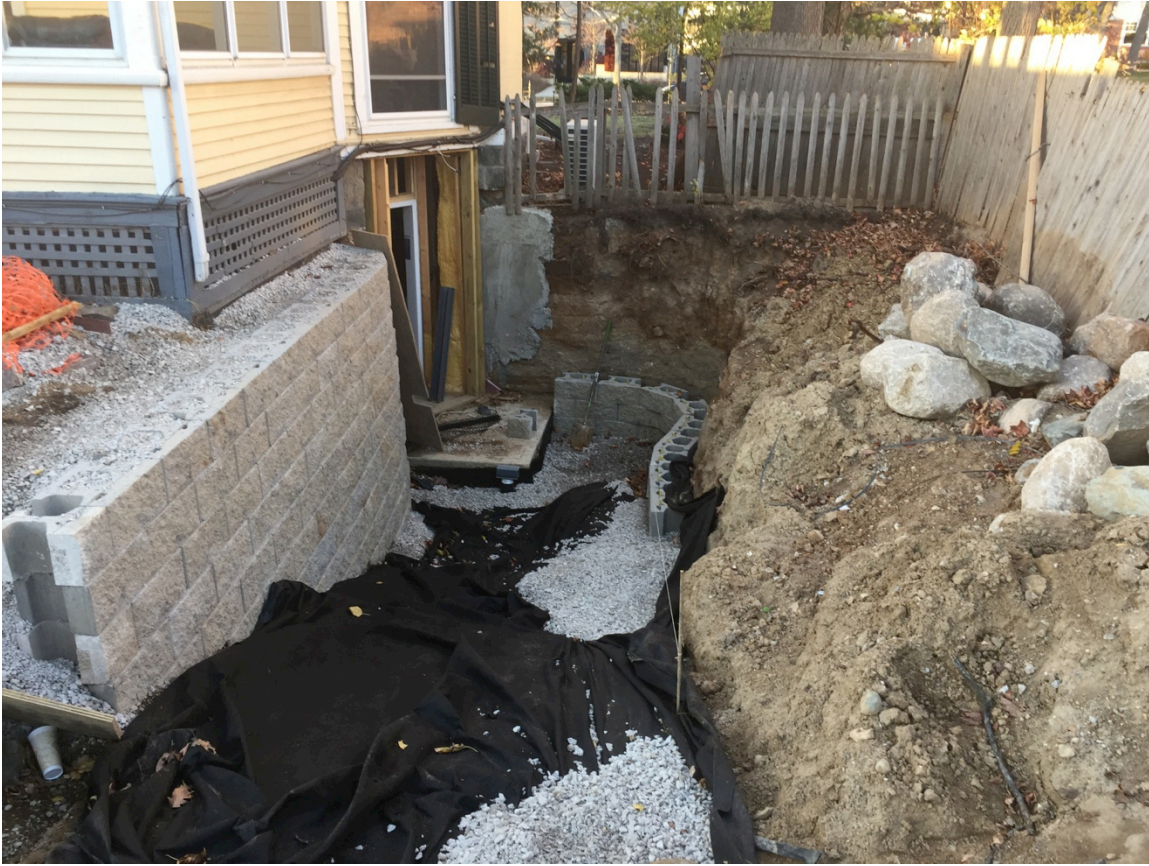
The east entrance is currently under development. The east side of this entrance will have a lower level Keystone wall along with a boulder retaining wall and landscaping.

We have retained the Head Gardener of the Historic Cranbrook Gardens in Bloomfield Hills to landscape the terraced area of this east entrance after it is completed. <http://housegardens.cranbrook.edu/>
