## City of Ann Arbor MRF Audit

The following report is a maintenance and operations evaluation of the CP Equipment at the City of Ann Arbor Materials Recovery Facility. The information gathered in this report was collected by John Kemp (CP Field Technician), and Brian Pressley (CP Customer Service Assistant Manager). This information was gathered over a 2-day period.

Company/Dept.: CP MFG / Customer Service		Title: System Audit		Document Number: Audit-002

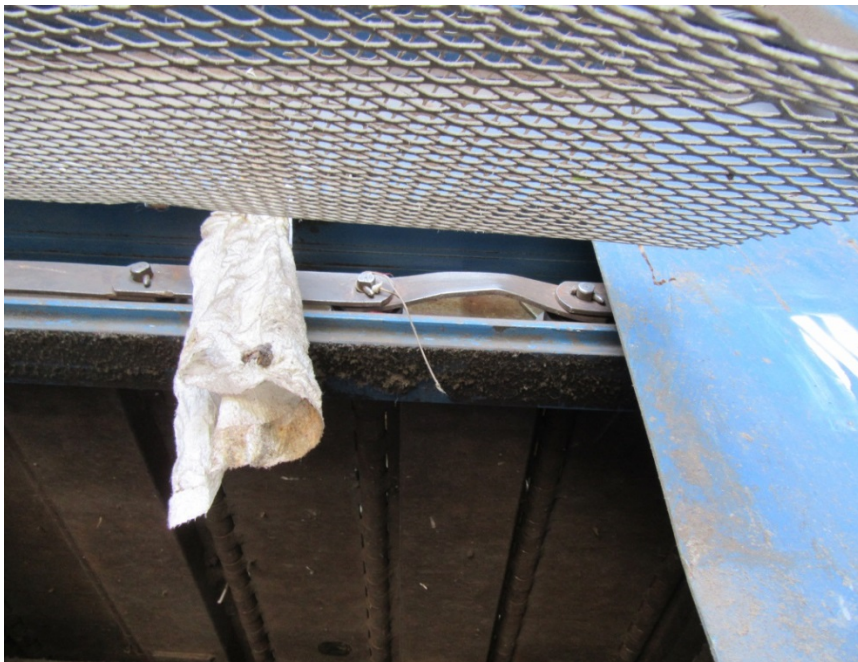
Photo A shows the damaged link in the belting. We recommend fixing the damaged links to prevent further damage to the belt.

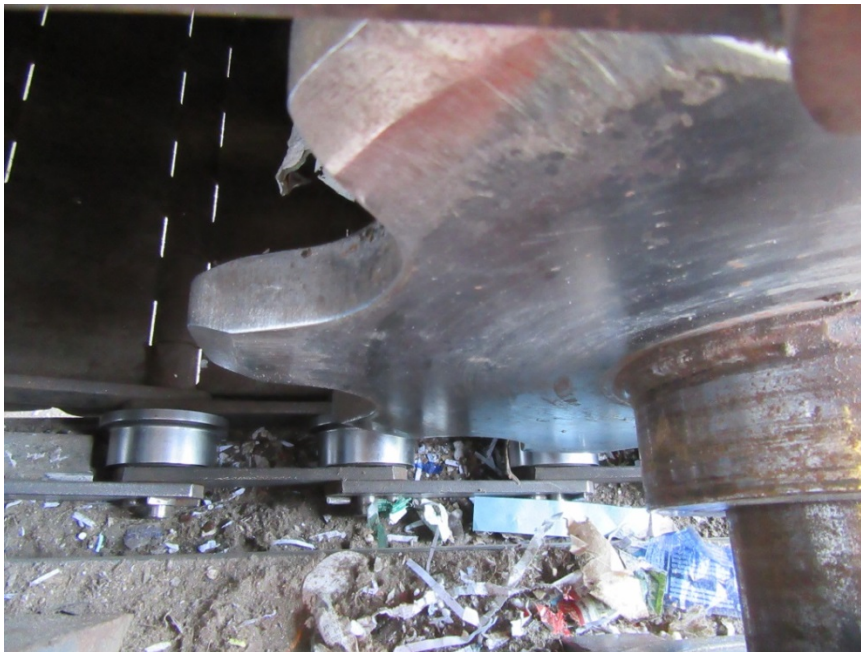
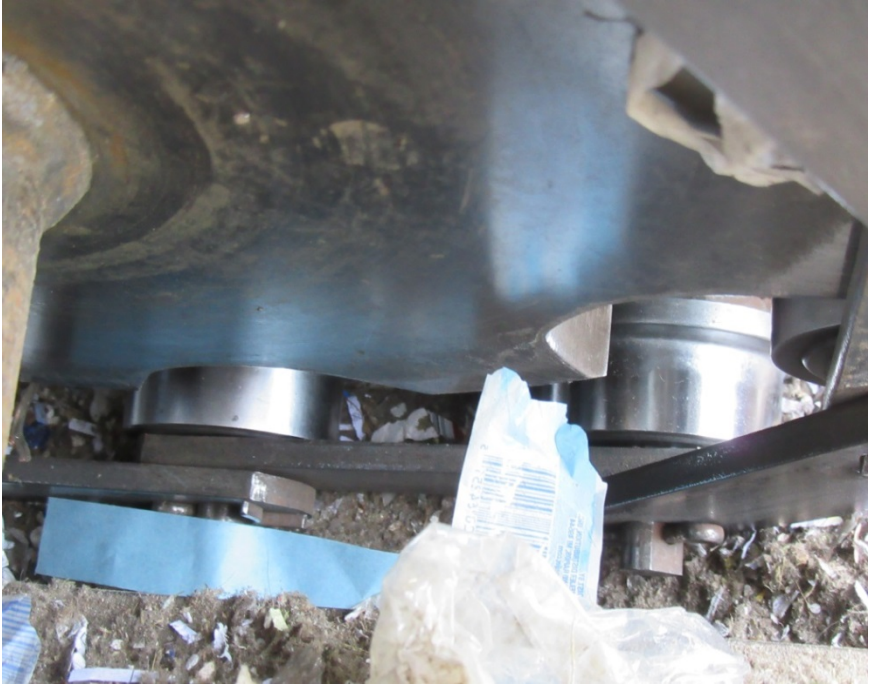
Photos A & B show the lack of tensioning on the belt. We recommend tensioning the belting on a regular basis to prevent premature wear of the belting and sprockets.

3. Steel Belt Conveyors are running with too much slack. The steel belt conveyor for the Incline Conveyor C-2 is in need of tensioning to prevent costly belt and sprocket damage.

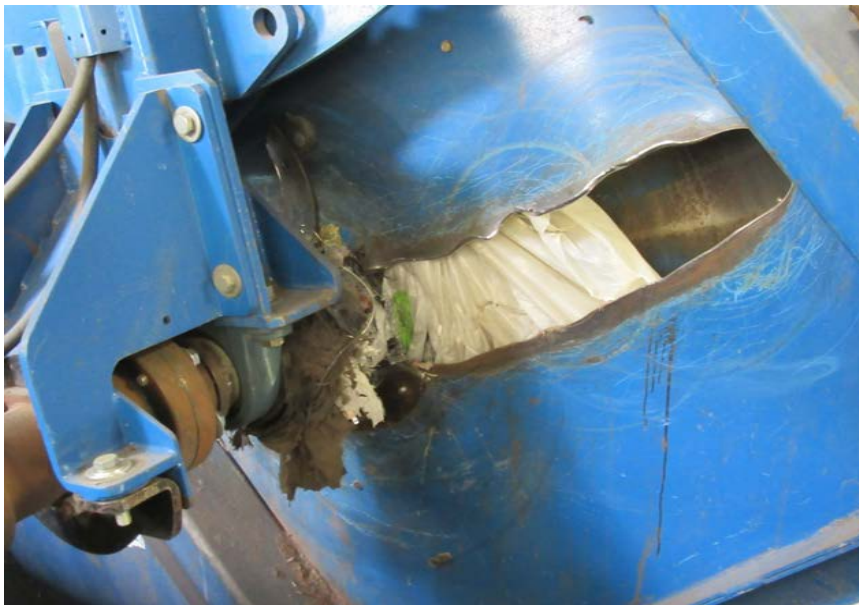
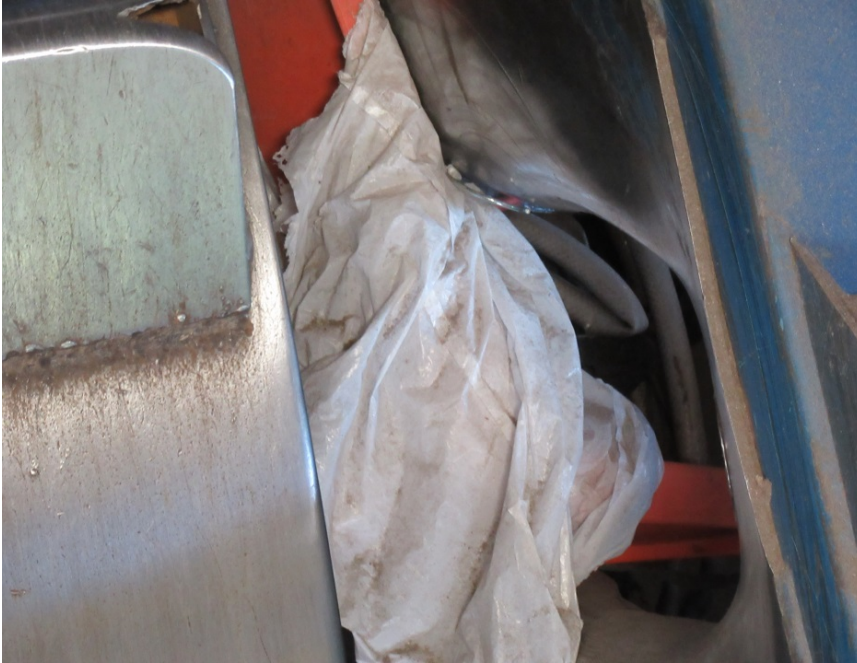
Photos A & B show the excessive wrapping around the Metering Drum shafts. We recommend removing these wrappings on a regular basis to prevent damage to the drum or to the support walls.

5. The Metering Drum needs some maintenance attention. The shaft wrappings that were seen during our inspection are causing damage to the sidewalls of the Metering Drum.

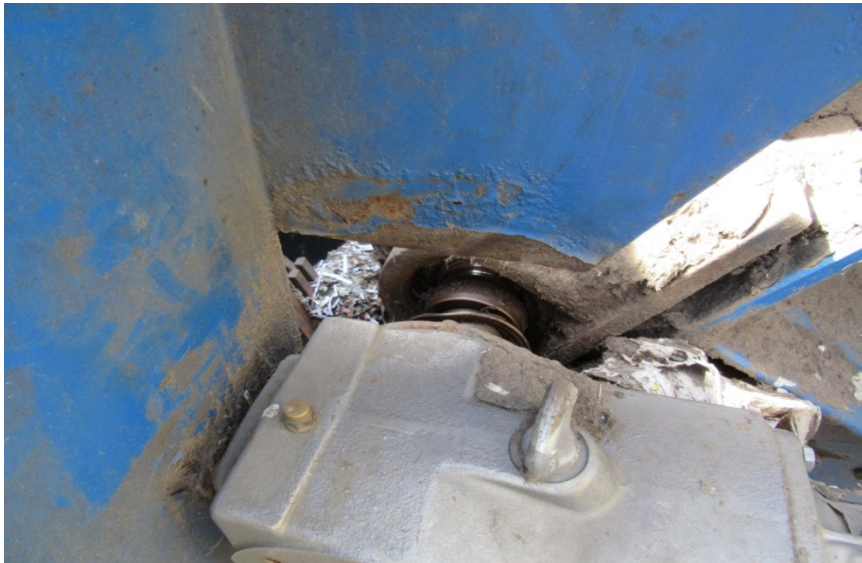
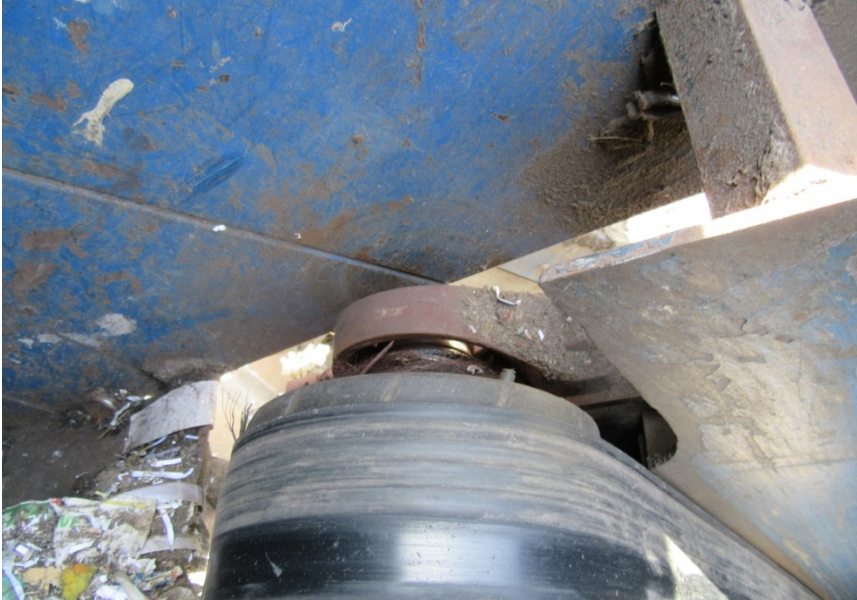
Photos A & B show the condition of the bearings. We recommend that both head shaft bearings are replaced as soon as possible.

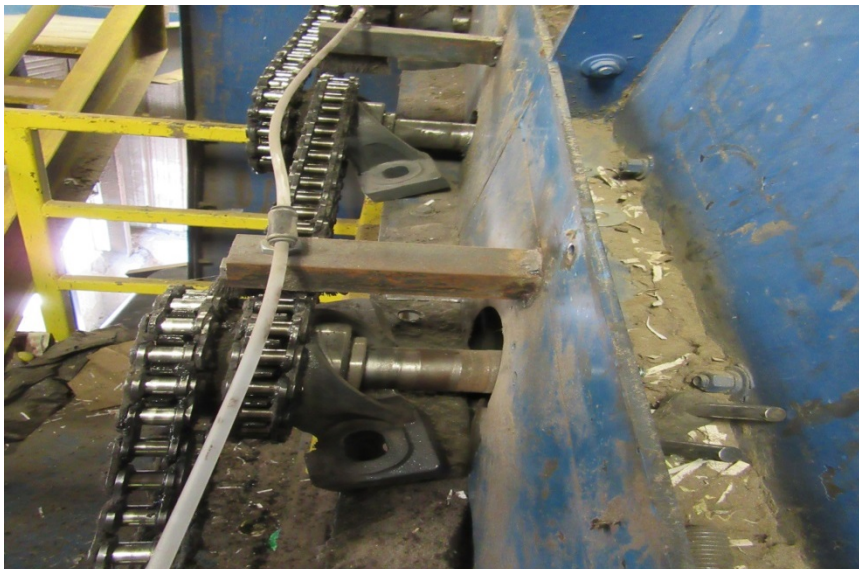
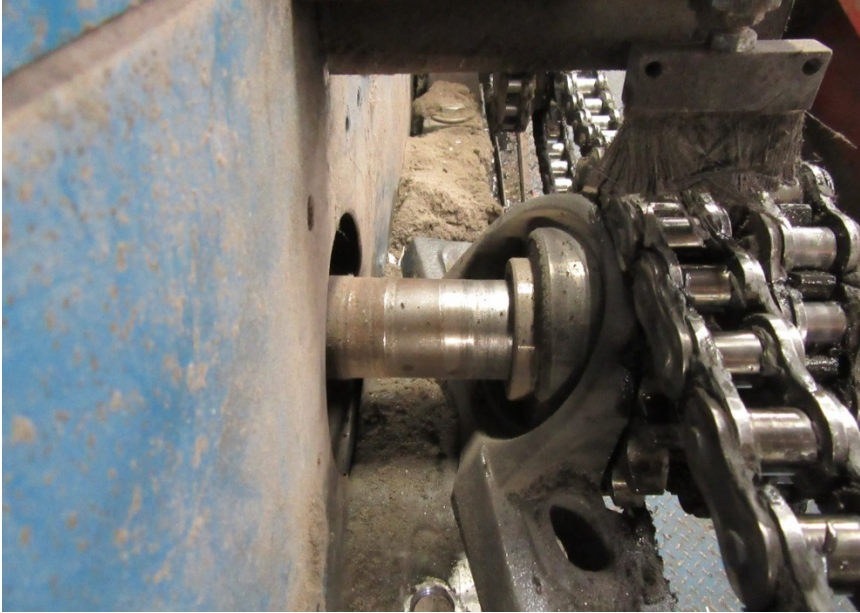
Photos A & B show damage to the bearings. These damaged bearings are a result of the misaligned rotors. Out of time rotors can cause material jams, damaging the bearings as shown. We recommend that the rotors are properly clocked on a regular basis to prevent this problem.

1. The OCC Screen requires some maintenance attention as soon as possible. There are multiple bearings that require replacement immediately. We recommend that these shafts are clocked accordingly as soon as possible.

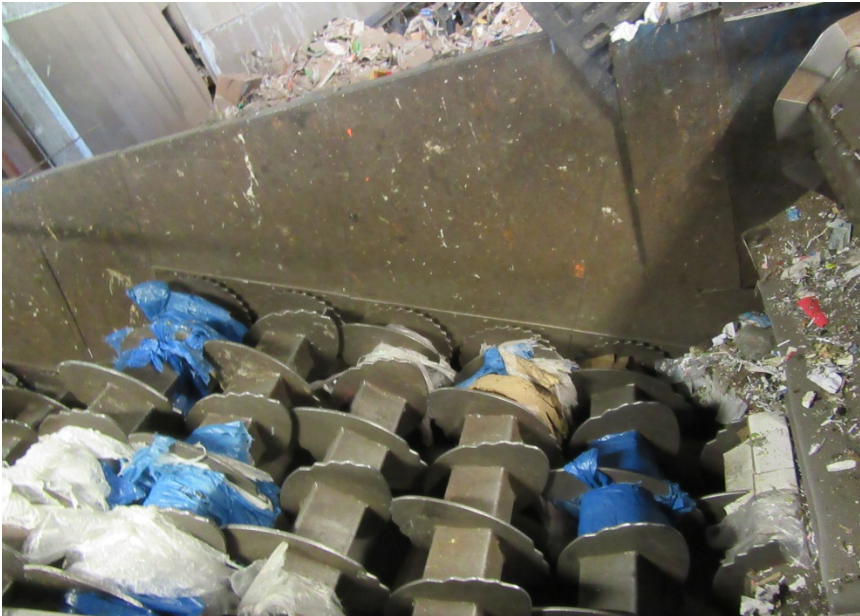
Photo C shows the misalignment of the rotors. This photo also shows the wrappings on the rotors. These wrappings can also lead to material jams resulting in damage to the shafts and bearings. We recommend removing all wrappings on a regular basis.

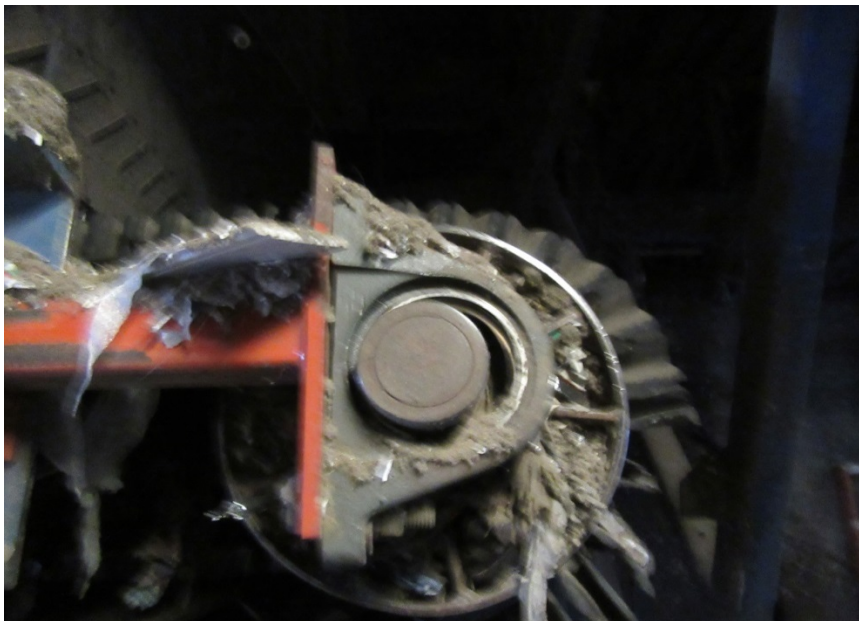
Photo A shows a bad tail pulley bearing. We recommend replacing this bearing to prevent damage to the shaft.

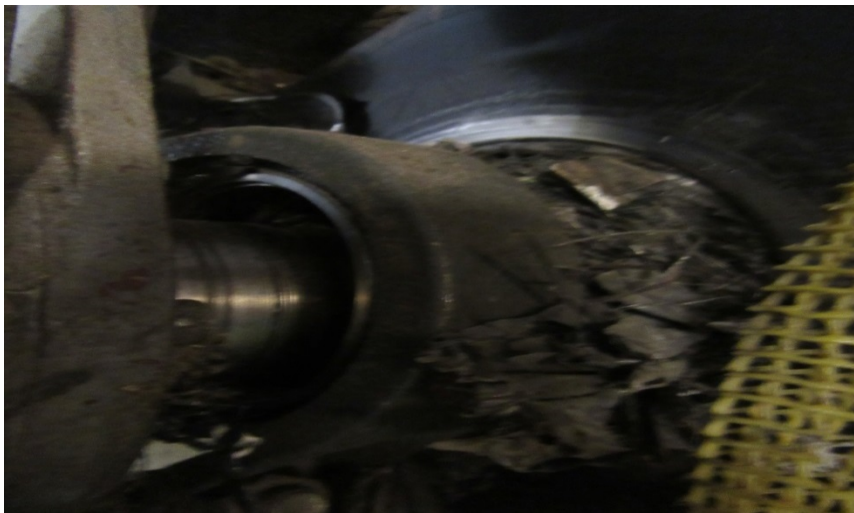
Photo A shows the bad bearing on the head pulley. We recommend replacing this bearing when possible to prevent shaft damage.

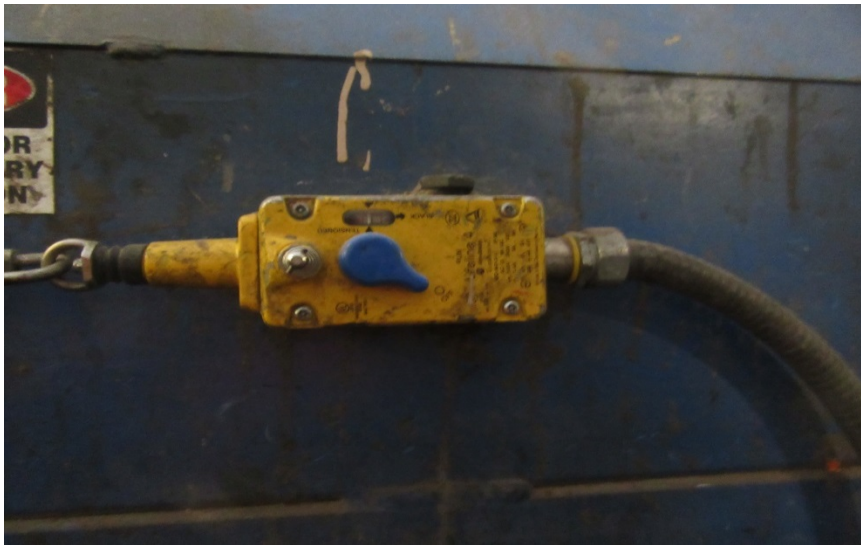
Photo A shows the missing Estop button for this conveyor. We recommend replacing the Estop button as soon as possible.

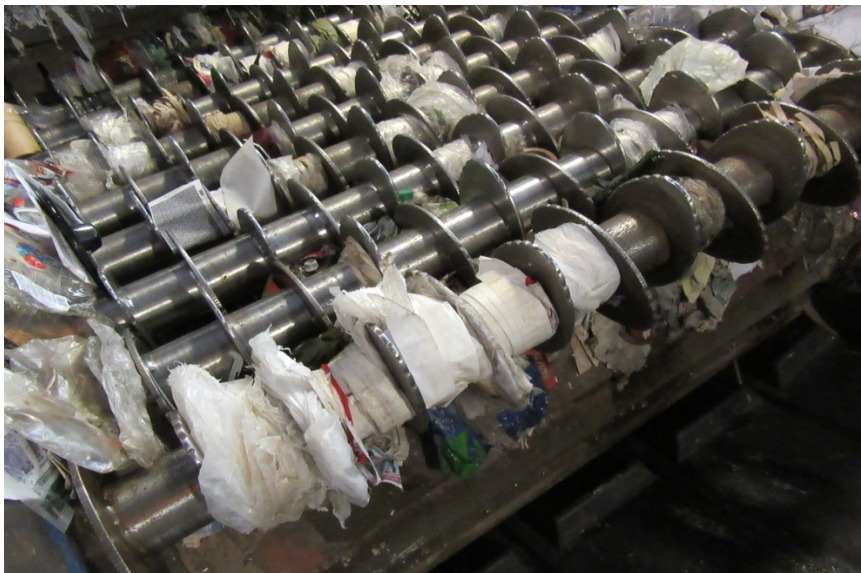
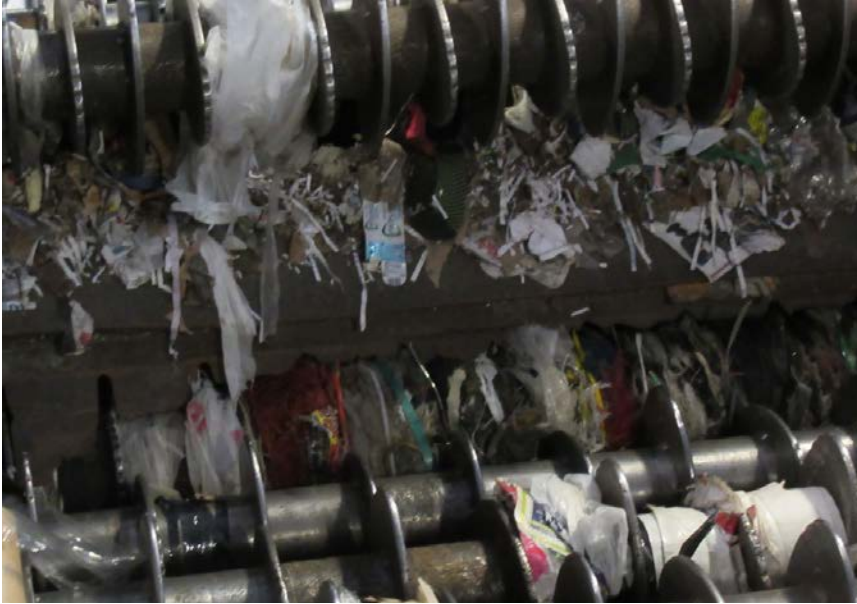
Photos A & B show the worn condition of the rotors. We recommend replacing these rotors to increase the separation performance of this screen. We also recommend removing the wrappings from the rotors on a regular basis to insure maximum separation performance and to prevent material jams.

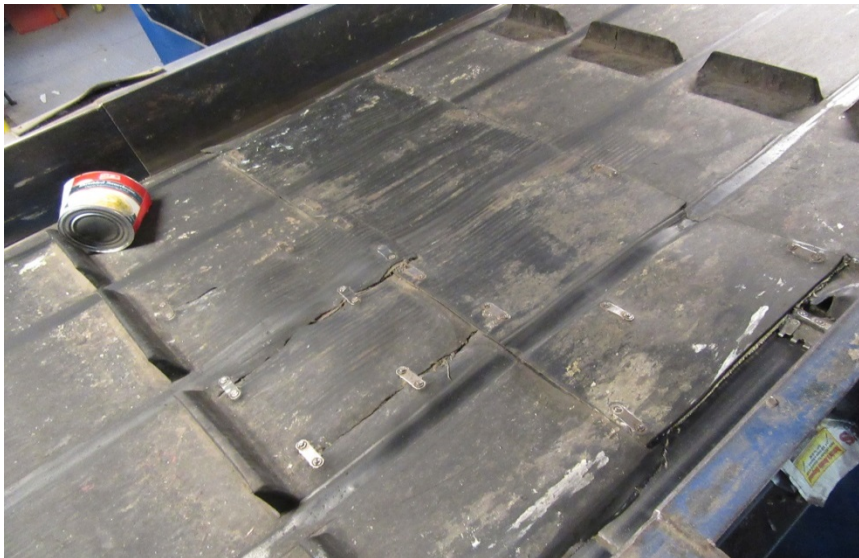
Photo A shows the worn condition of the belt. Some sections of belting are missing and other areas are patched. We recommend replacing this belt when possible to prevent material loss.

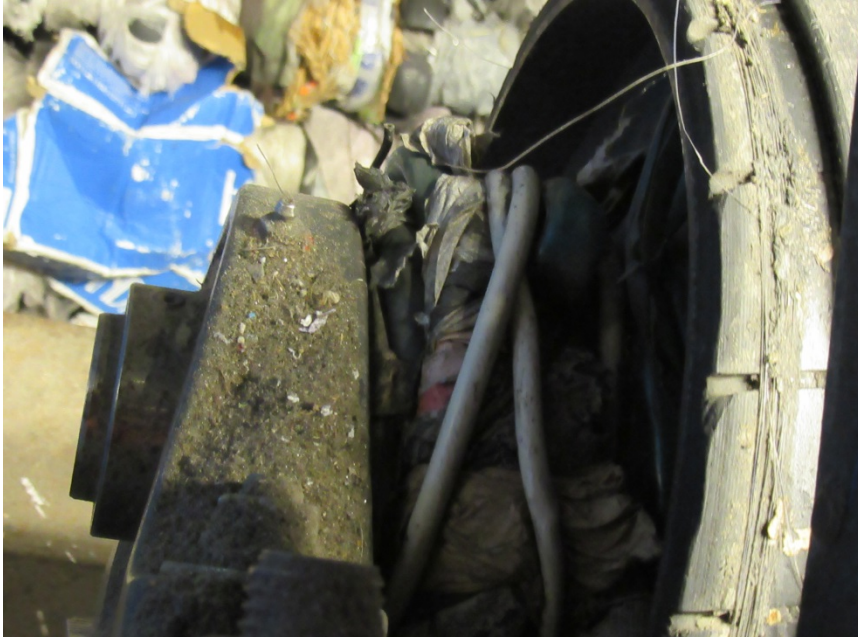
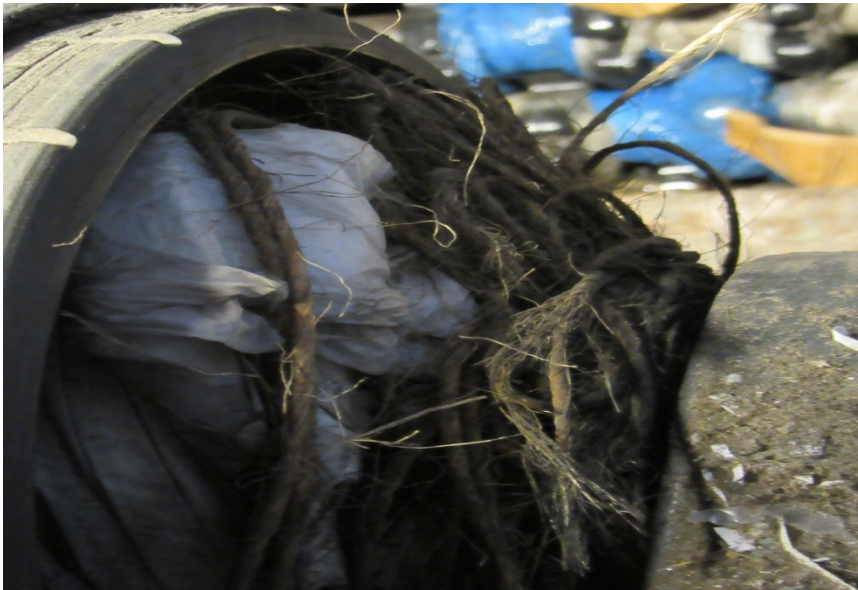
Photos B&C show the head pulley wrappings on both sides of the pulley. We recommend removing these wrappings on a regular basis to prevent damage to the bearings.

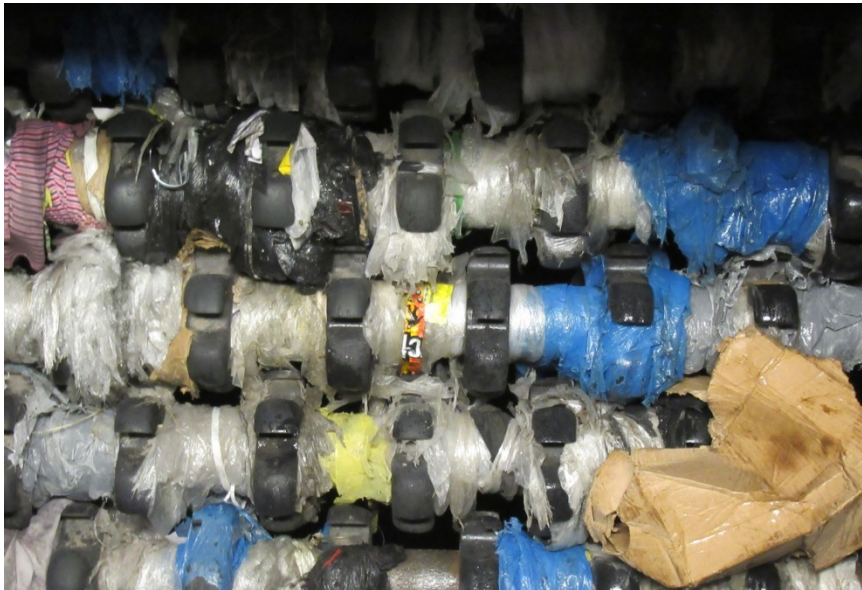
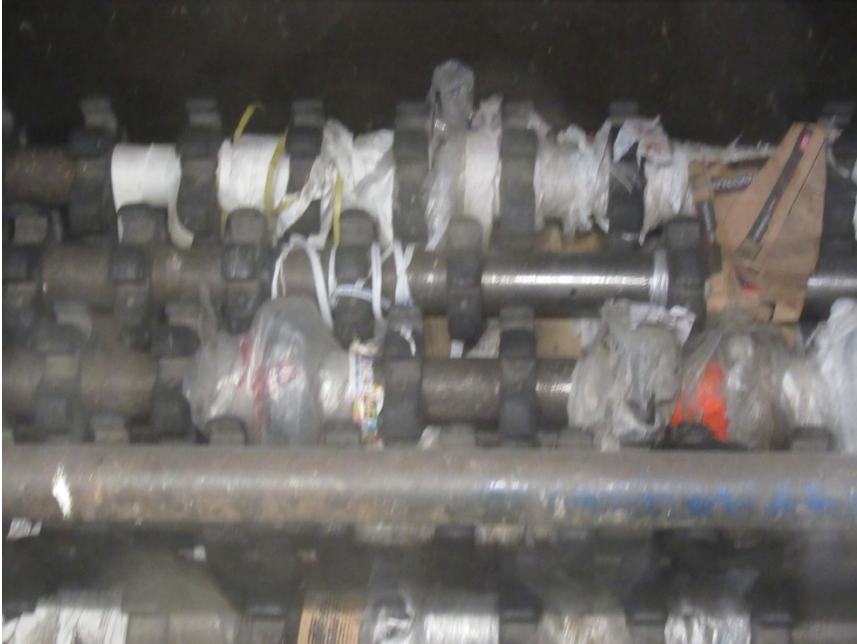
Photos A & B show the worn and missing finger discs. These discs are crucial to maximizing the material separation for this screen. We recommend replacing all of the finger discs on this screen. Also, the photos show the excessive amount of wrappings on the rotors. We recommend removing the wrappings on a regular basis to help maximize material separation.

2. The Newscreen should have all of the rubber finger discs replaced as soon as possible to maximize material separation. These discs are crucial in optimizing the screens performance.

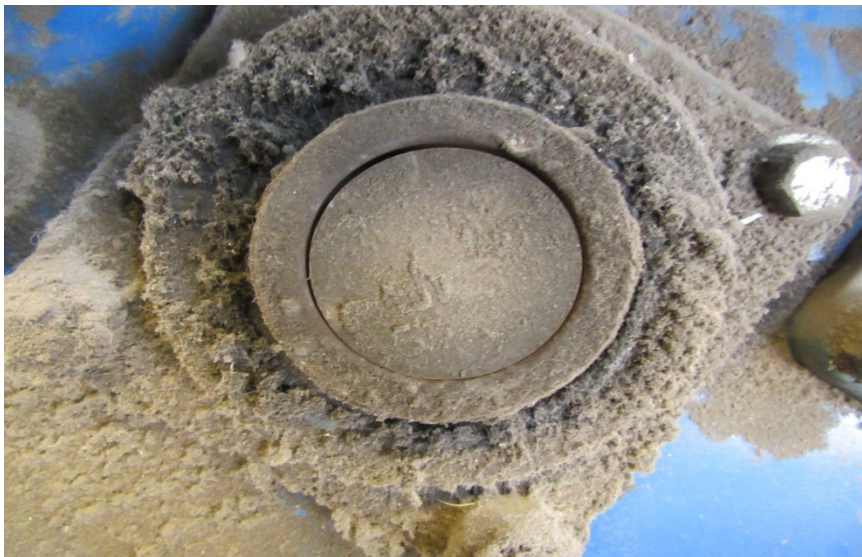
Photo A shows one of the many bad bearings on this screen. We recommend replacing all damaged bearings on this screen to prevent damage to the rotors.

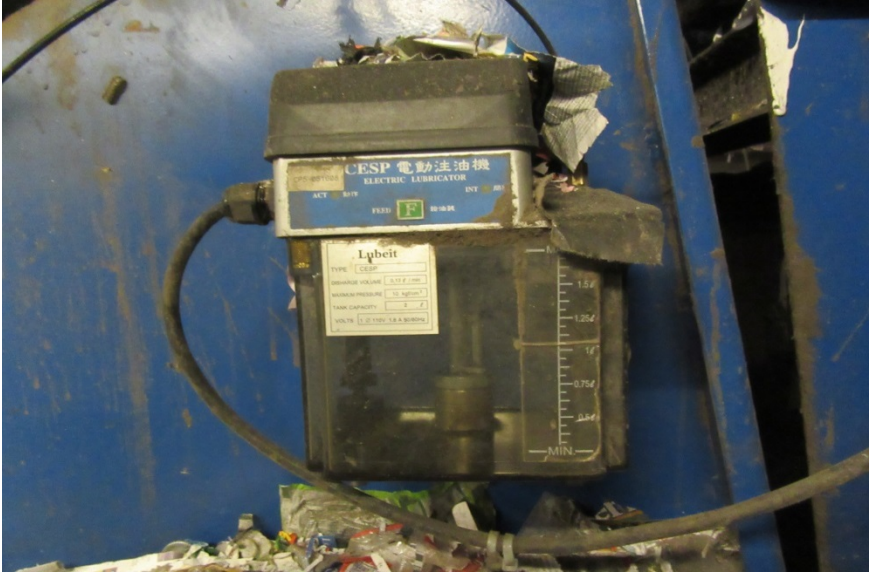
Photo B shows the empty oiler. We recommend that the oiler is filled and put back into use.

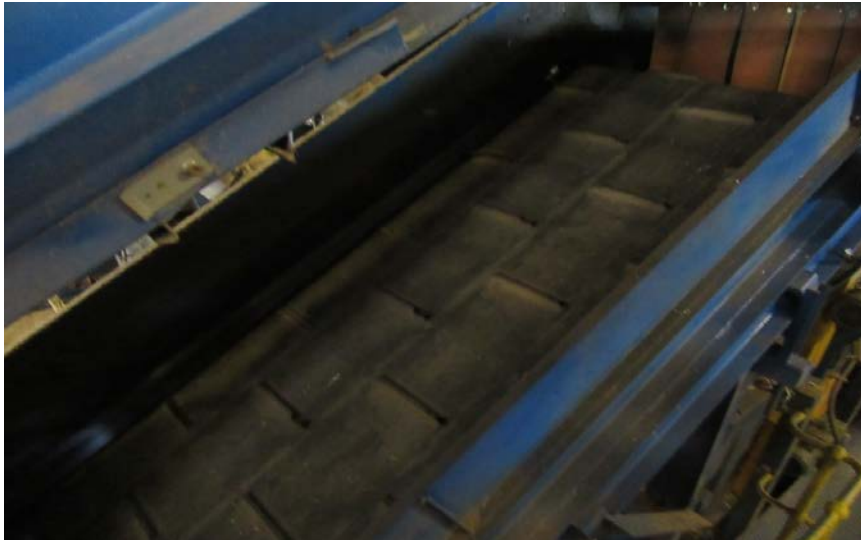
Photo A shows the worn condition of the belting. We recommend replacing this belt when possible.

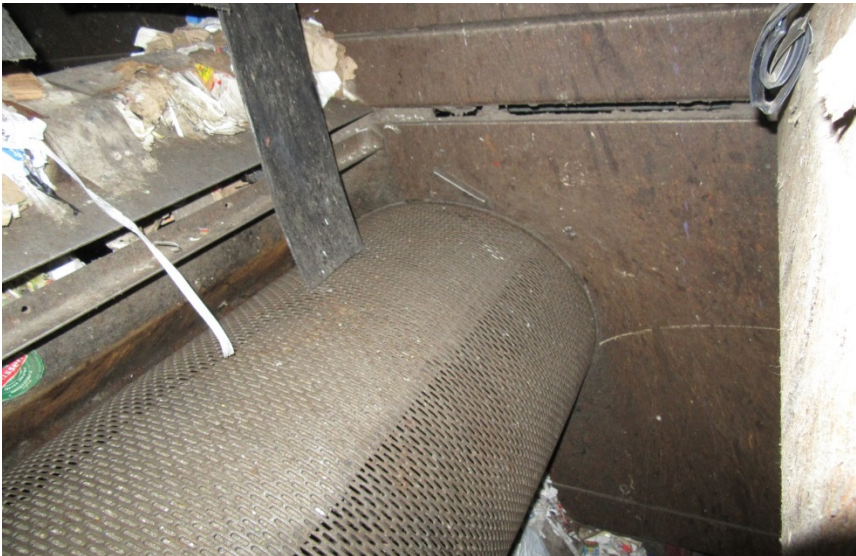
Photo A

ADS guide plate is missing. We recommend that the guide plate is replaced to increase performance.

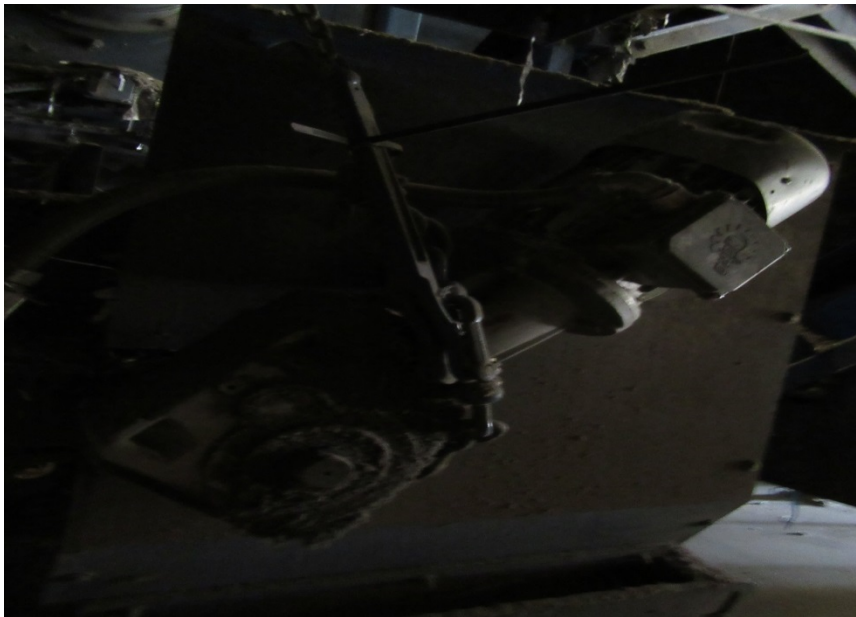
Photo A shows the gear motor supported by a chain. We recommend replacing the torque arm bracket and mounting the gear motor properly to prevent damage to the pulley or gear motor.

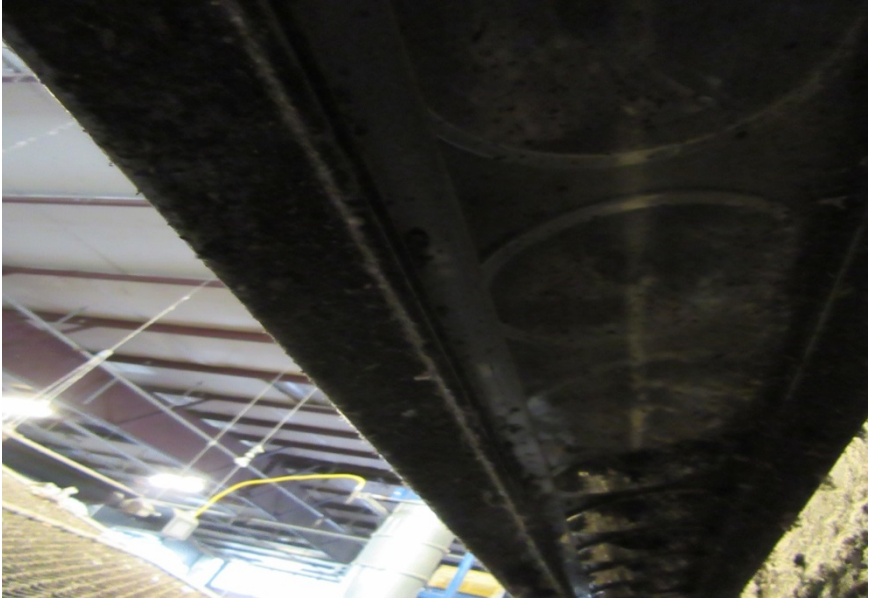
Photo A shows the missing glass on the light bar. One was on order at time of audit.

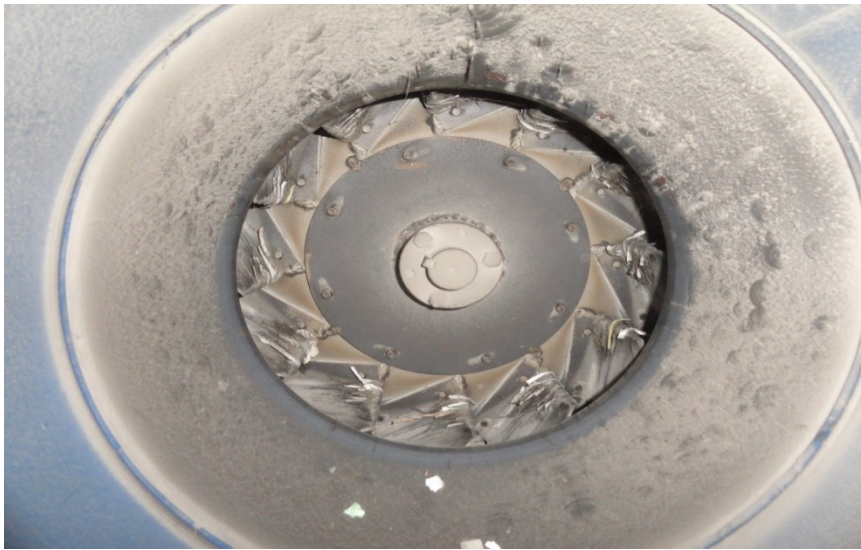
Photo A shows some debris that has built up on the impellor. We recommend that the impellor be cleaned on a regular basis. The silo blower overall is in good condition.

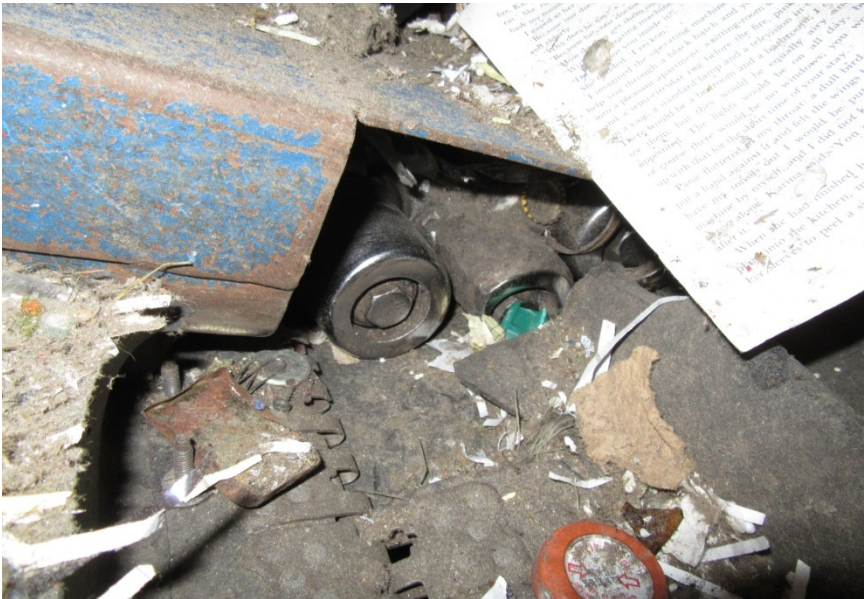
Photo A shows the jammed up- turn roller. We recommend replacing these rollers when possible. Also, the lacing is damaged and in need of repair to prevent material loss.

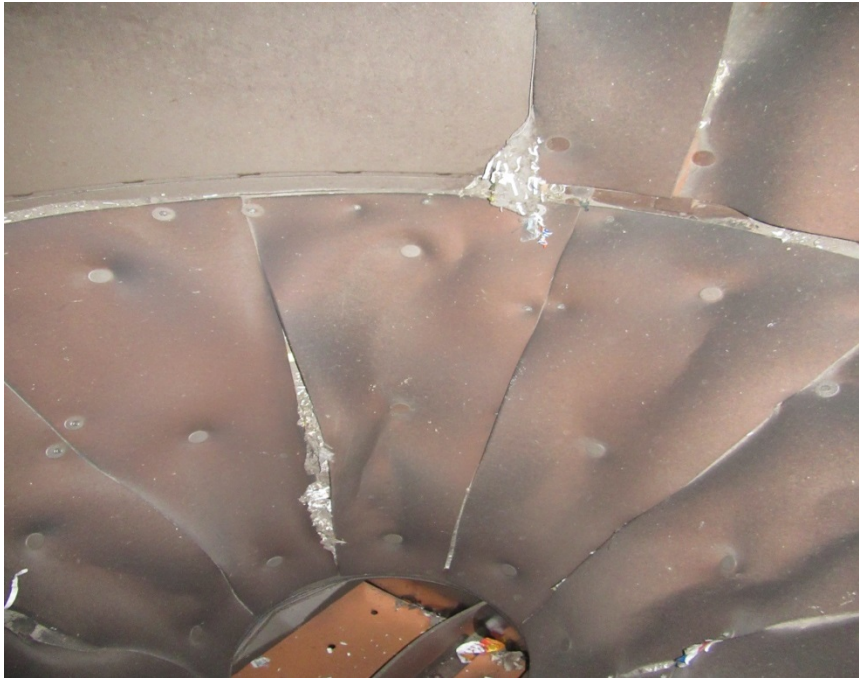
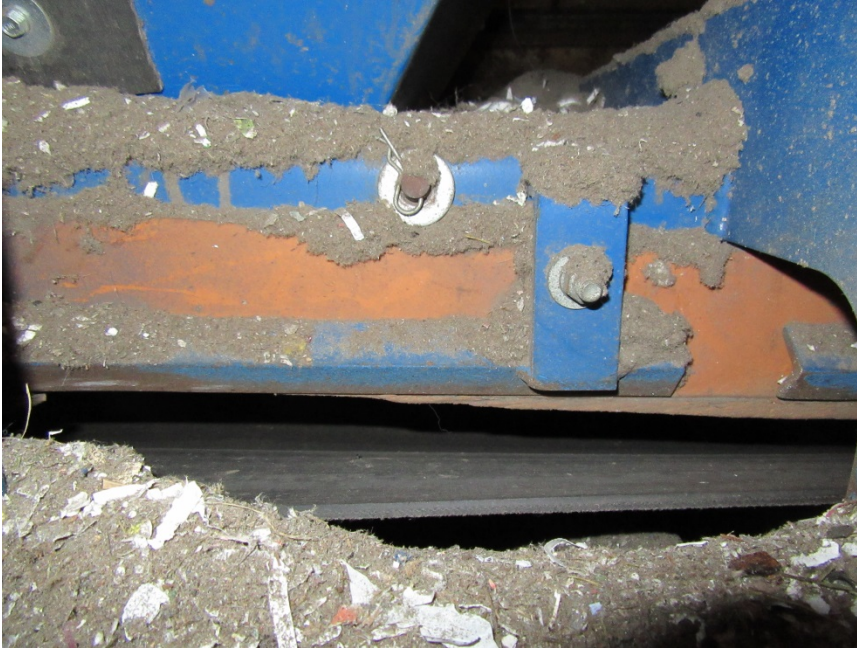
Photos A & B show the worn condition of the urethane liners in the cyclone. We recommend replacing these liners to help maximize the glass cleanup's efficiency. We also recommend that the seals be adjusted so that they meet the conveyor belt. This will help with the separation quality.

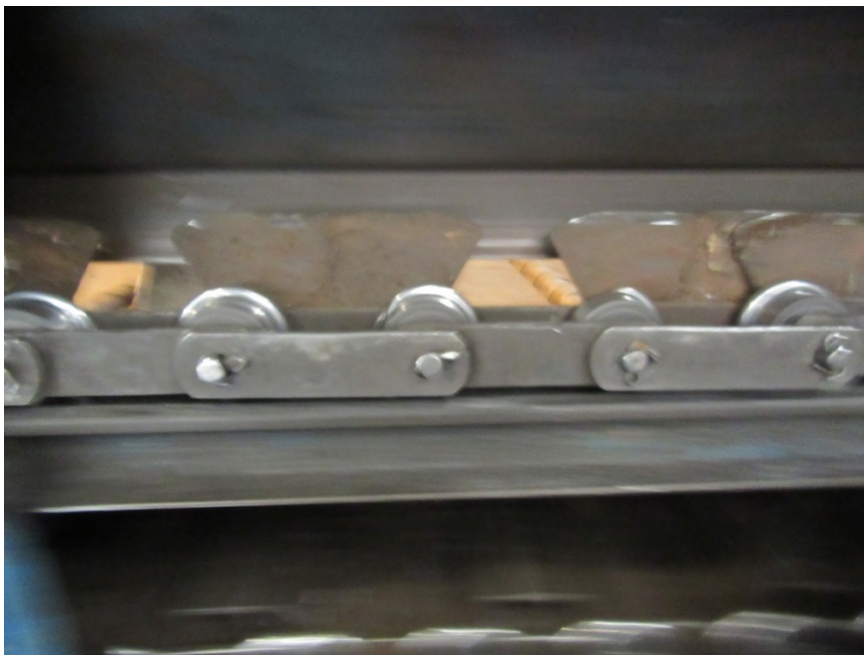
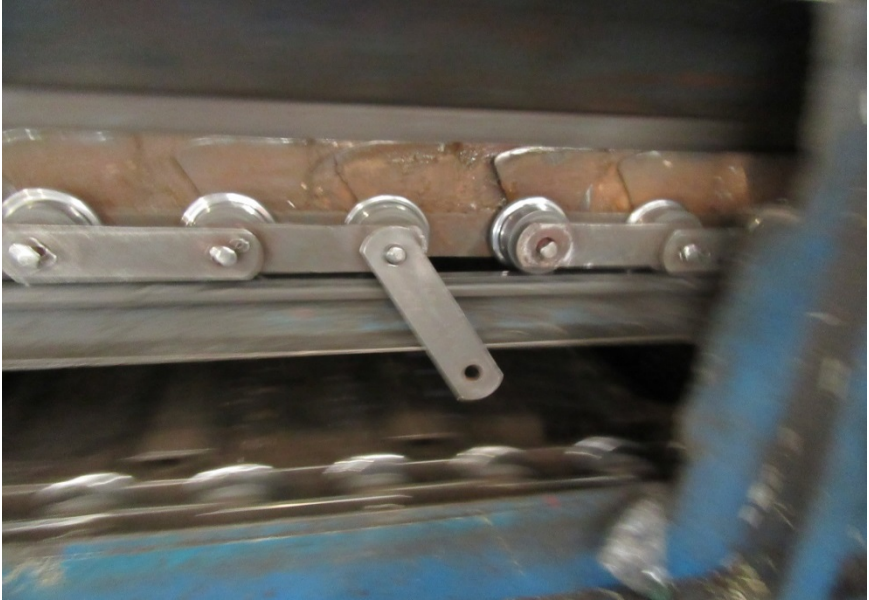
Photos A & B show the missing or damaged belting sections. We recommend replacing this belt when possible.

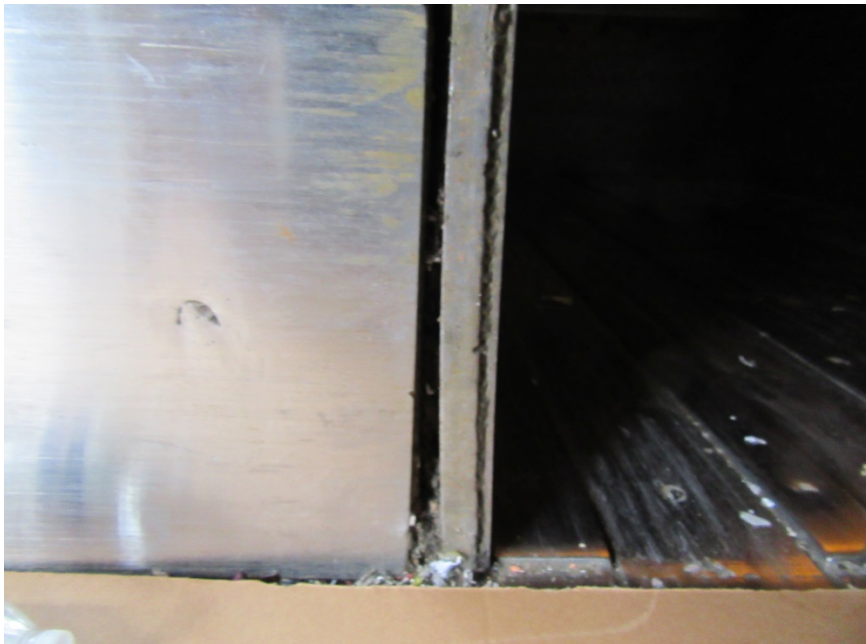
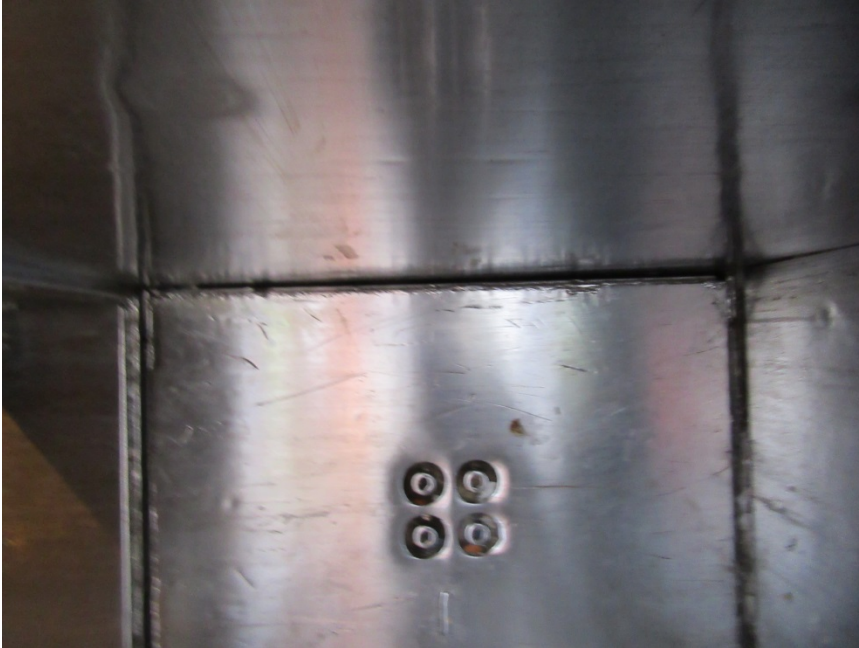
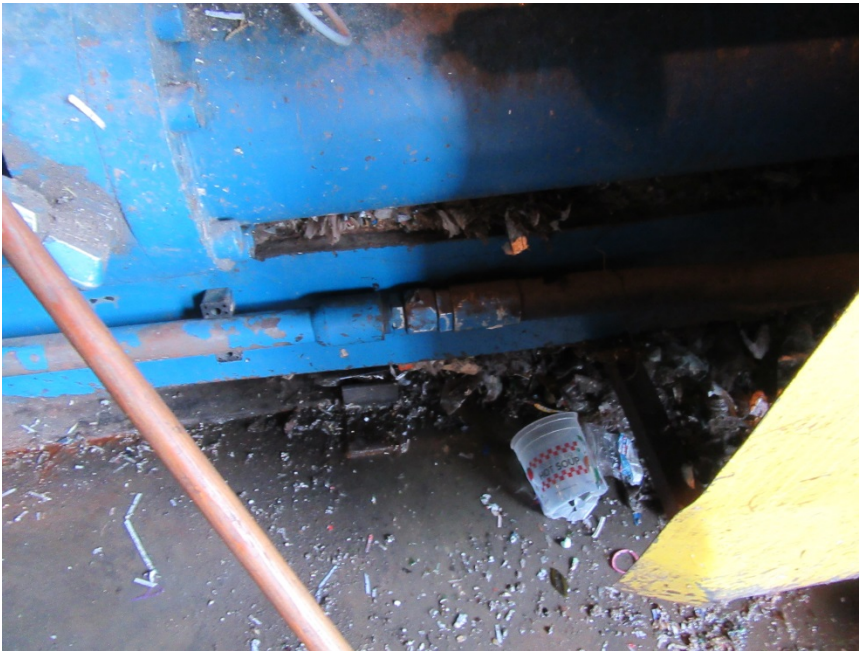
The overall condition of the baler is good. There is a ¼” knife gap that should be monitored. We also recommend flipping the blades. Shim and adjustment is also recommended. The door ram area needs to be cleaned and there is a radiator leak that was being repaired while we were on site.
