**CITY OF ANN ARBOR, MICHIGAN**

**LOCAL BRIDGE PROGRAM FUNDING APPLICATION  
FOR  
PREVENTATIVE MAINTENANCE  
FOR THE  
E. MEDICAL CENTER DRIVE BRIDGE OVER THE  
WOLVERINE LINE**

### LOCAL BRIDGE PROGRAM FUNDING APPLICATION E. MEDICAL CENTER DRIVE BRIDGE OVER THE WOLVERINE LINE

FEDERAL STRUCTURE ID. NO. 814021200000R01      MDOT STRUCTURE NO. 11065

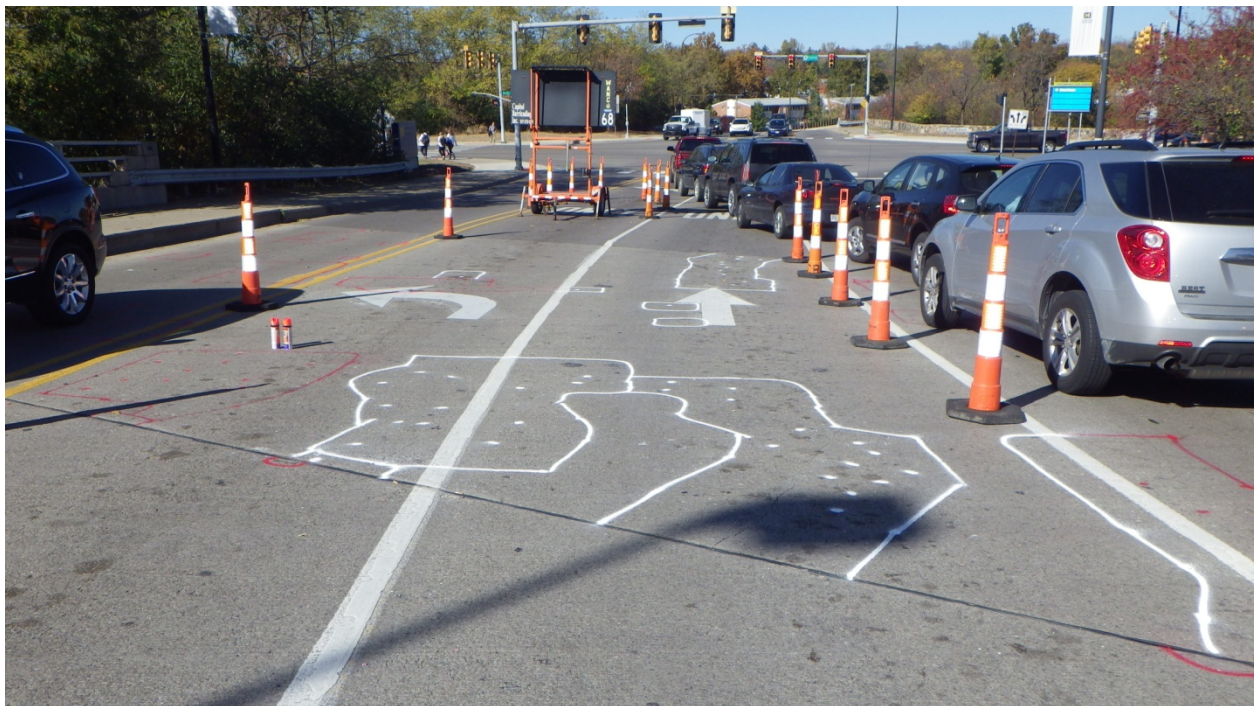
This structure is generally in fair condition. There are approximately 1,107 ft<sup>2</sup> (≈ 9.8% of the deck area) of delaminated and spalled areas. The north span has the largest concentration of spalled areas with approximately 29.4% of the north span being spalled and delaminated. The bottom side of the bridge deck has approximately 5% of the total area consisting of spalls (some with exposed reinforcement), delaminations, cracks with moisture and efflorescence, and rust stains. In order to better determine the amount of delaminated areas, we utilized infra-red thermal scanning technology in 2013 and again hand-sounded the deck in 2015 to locate and define the extent of delaminated areas.

**Figure 1 Deck Delaminations in North Span (looking north)**

concrete wearing surface is planned to be removed and replaced (shallow overlay.) The guardrails will be upgraded to meet current standards and overgrown brush will be removed from around the perimeter of the bridge. The current barrier and railing configuration on the outside edges of the bridge does not meet current NCHRP 350 crash requirements, however we do not have any crash history on this bridge that suggests their removal and replacement is warranted. Consequently, we will remove the railing elements and have them re-galvanized and painted as were the recently rehabilitated railings on the nearby Fuller Road and Maiden Lane bridges.

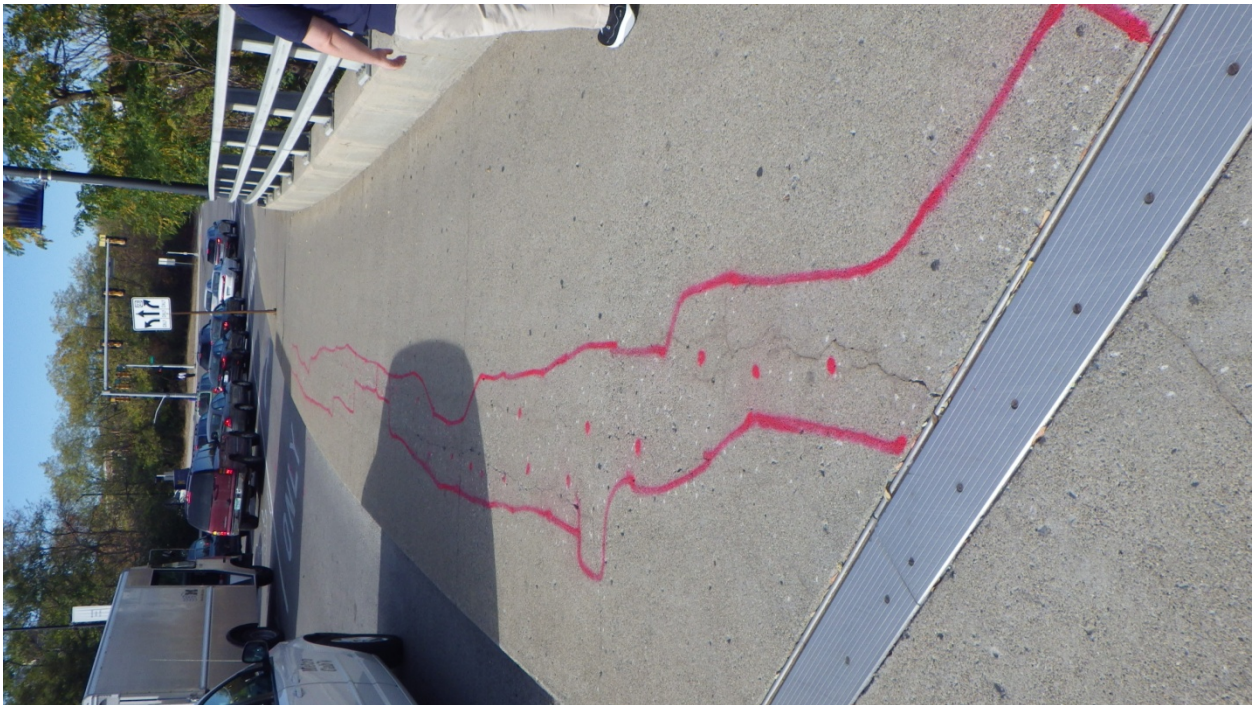
**Figure 4 Sidewalk Delaminations on east sidewalk**

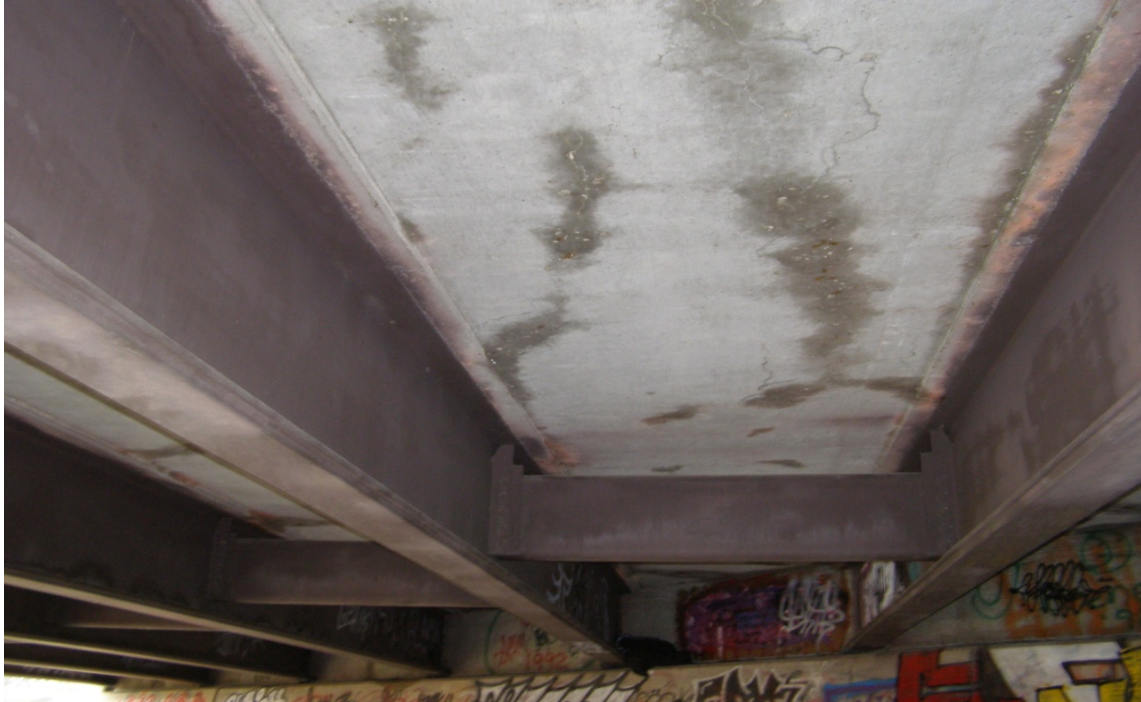
**Figure 5 Moisture and Cracking in Bottom of Deck, Span 3**

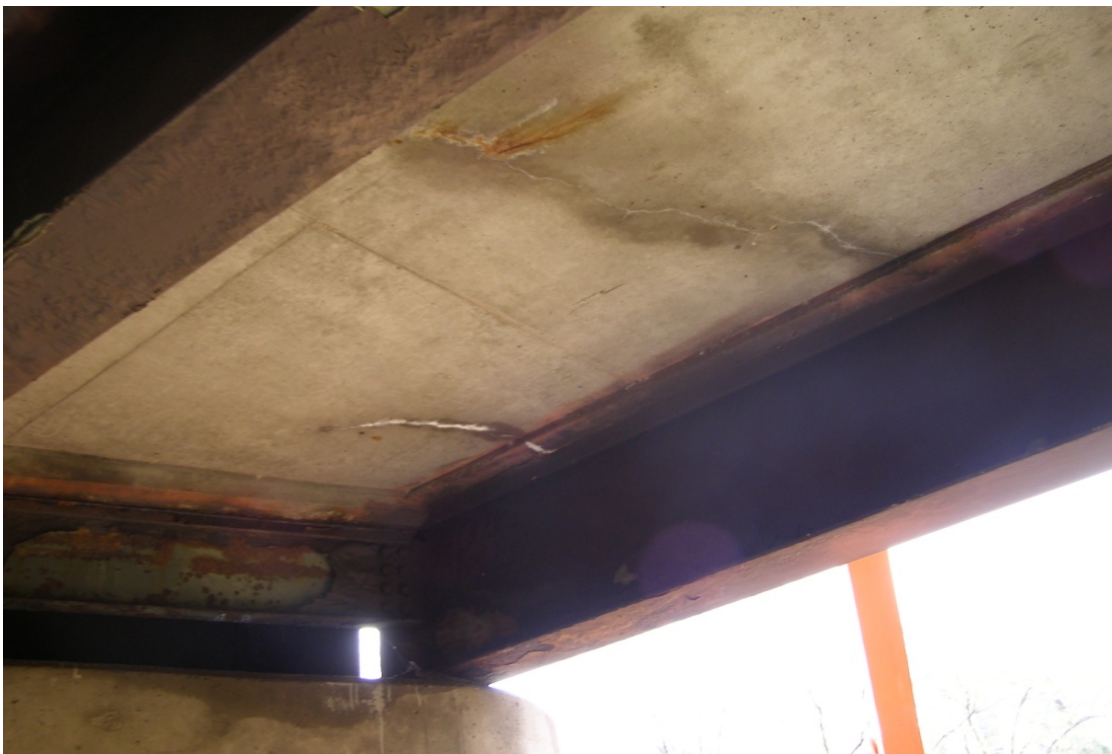
**Figure 6 Full Depth Cracks with Moisture, Leaching, and Rust Stains**

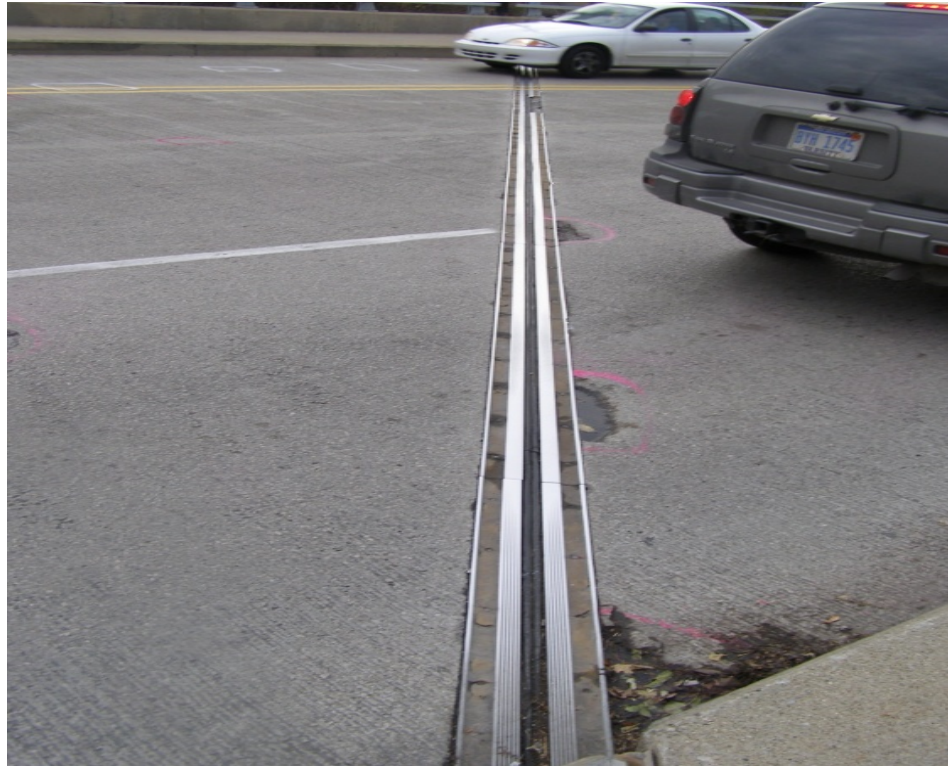
The paint system has failed. The expansion joints located over the piers are in poor condition. The glands in the expansion joints are torn and debris-filled. The joints leak causing corrosion at the beam ends and ponding water on the pier caps. The beam ends at the expansion joints are corroding, but there is no measurable section loss. The end diaphragms under the expansion joints also have corrosion without measurable section loss.

**Figure 7 Spalling along South Expansion Joint (looking west)**

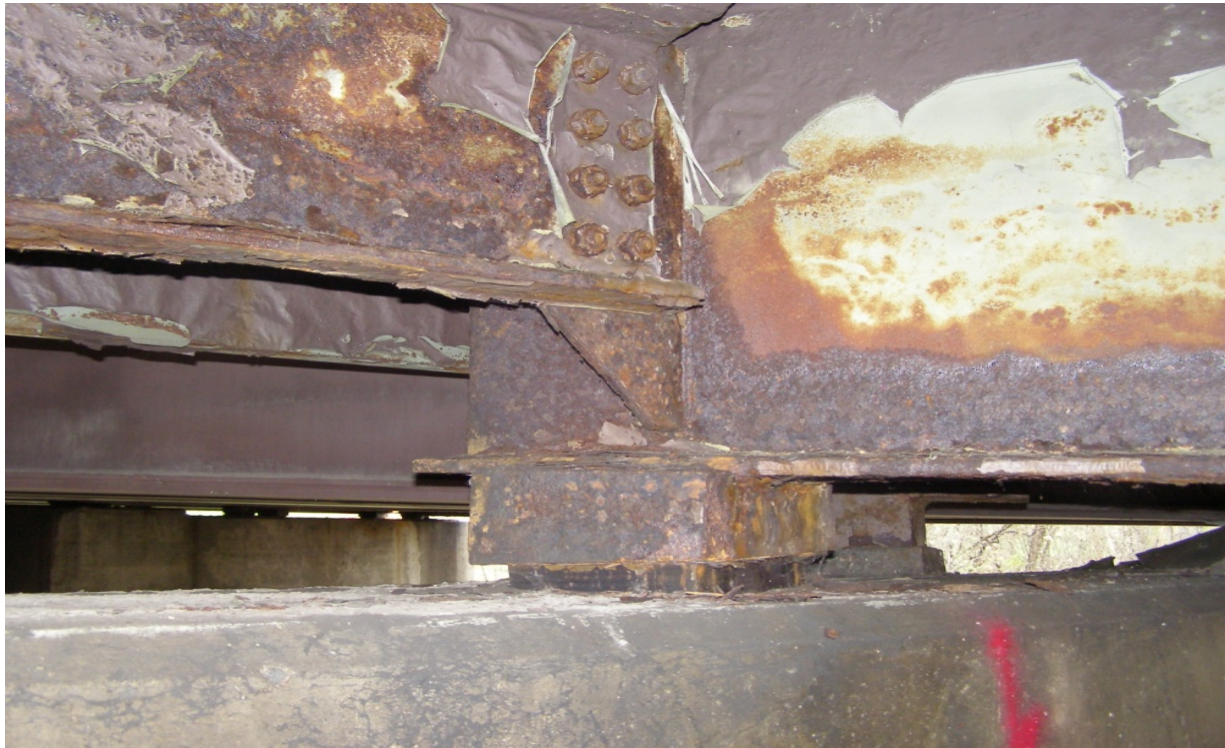
**Figure 10 End Diaphragm and Beam End Surface Rusting and Paint Failure, Pier 2**

The bridge is planned to have all steel beams, diaphragms, and cross braces cleaned and re-coated. The northerly pier cap is proposed to be removed and replaced. The expansion joints will be removed and replaced. At this time it is not believed that any of the beams ends will require significant steel repairs, however, some diaphragms under the expansion joints may need to be replaced depending upon their condition upon further inspection. The latex modified

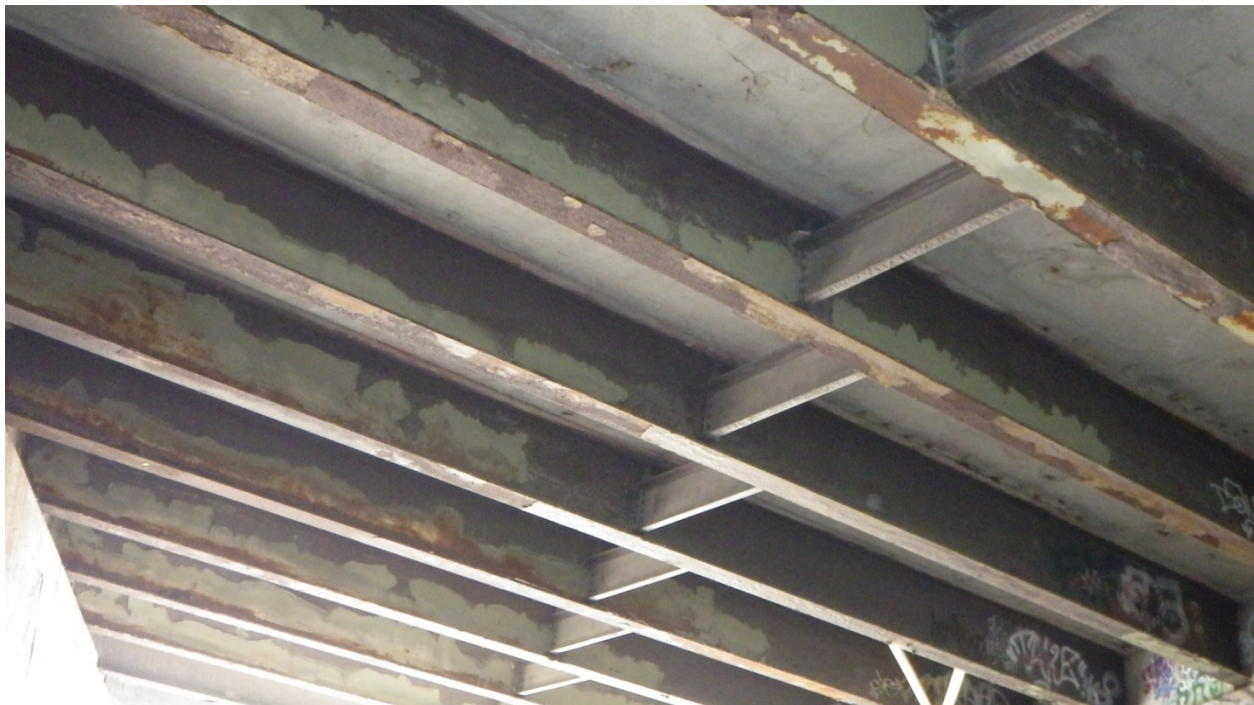
**Figure 11 Typical Paint Failure**

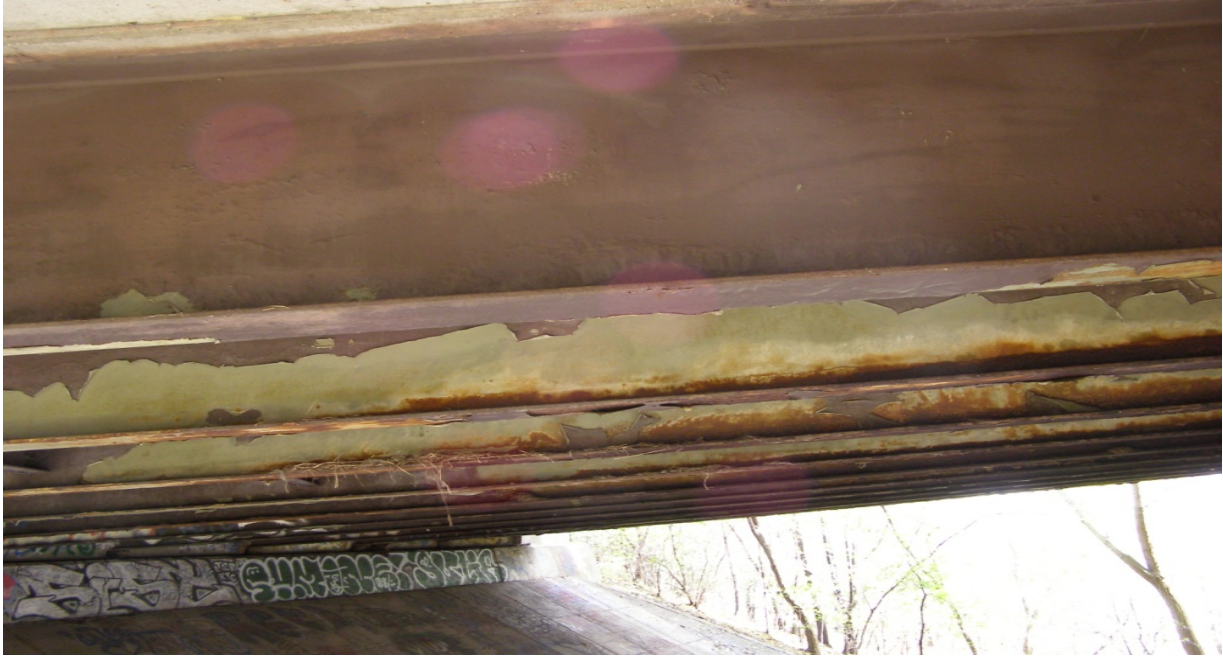
**Figure 12 Paint Failures at bottom flange of beams**

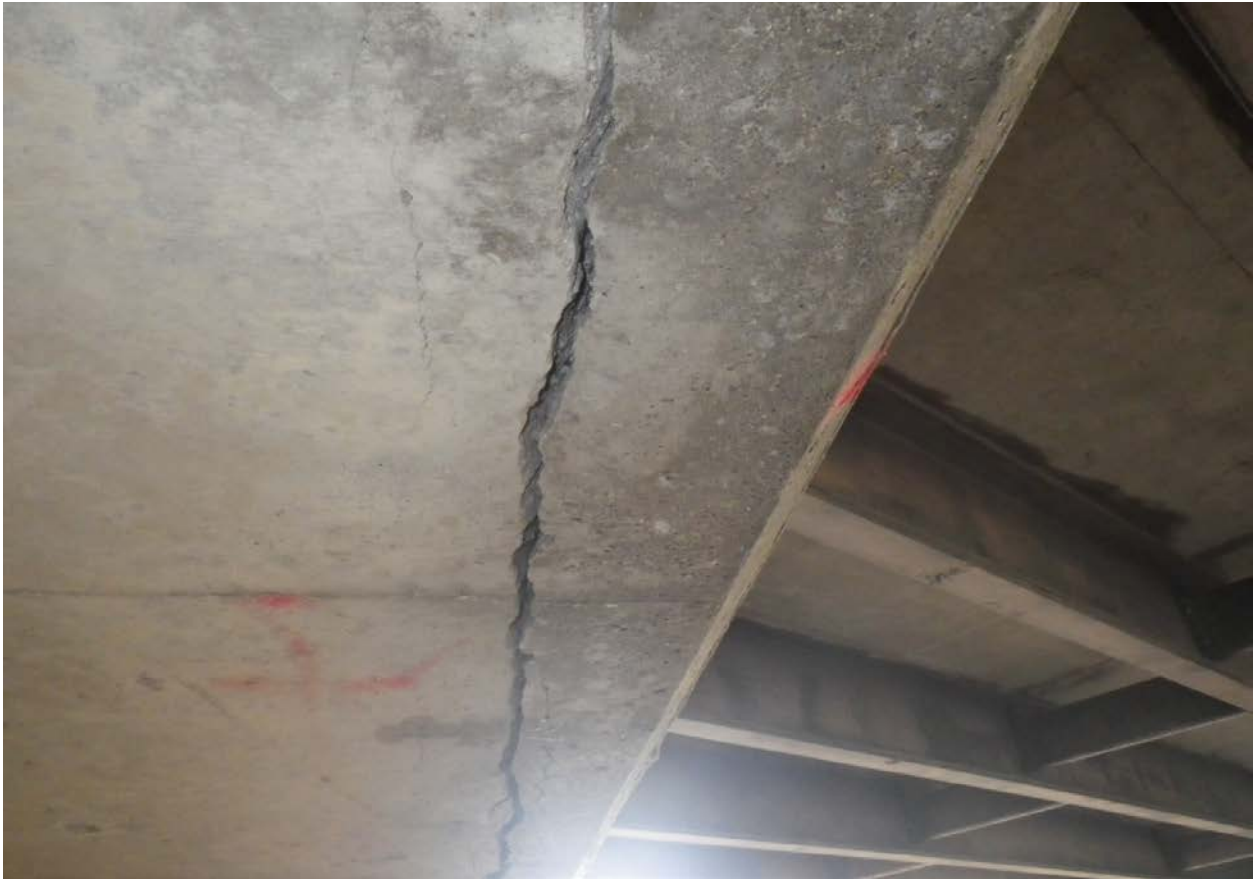
The piers are in fair condition. The south pier has a total of 18 areas of delaminations totaling 262 ft<sup>2</sup>; the north pier has 12 areas of delaminations totaling 283 ft<sup>2</sup>. The lower half of the piers are covered in graffiti. It appears that the northerly pier's cap must be replaced.

**Figure 13 Cracked Pier Cap (North Pier (Pier 2))**

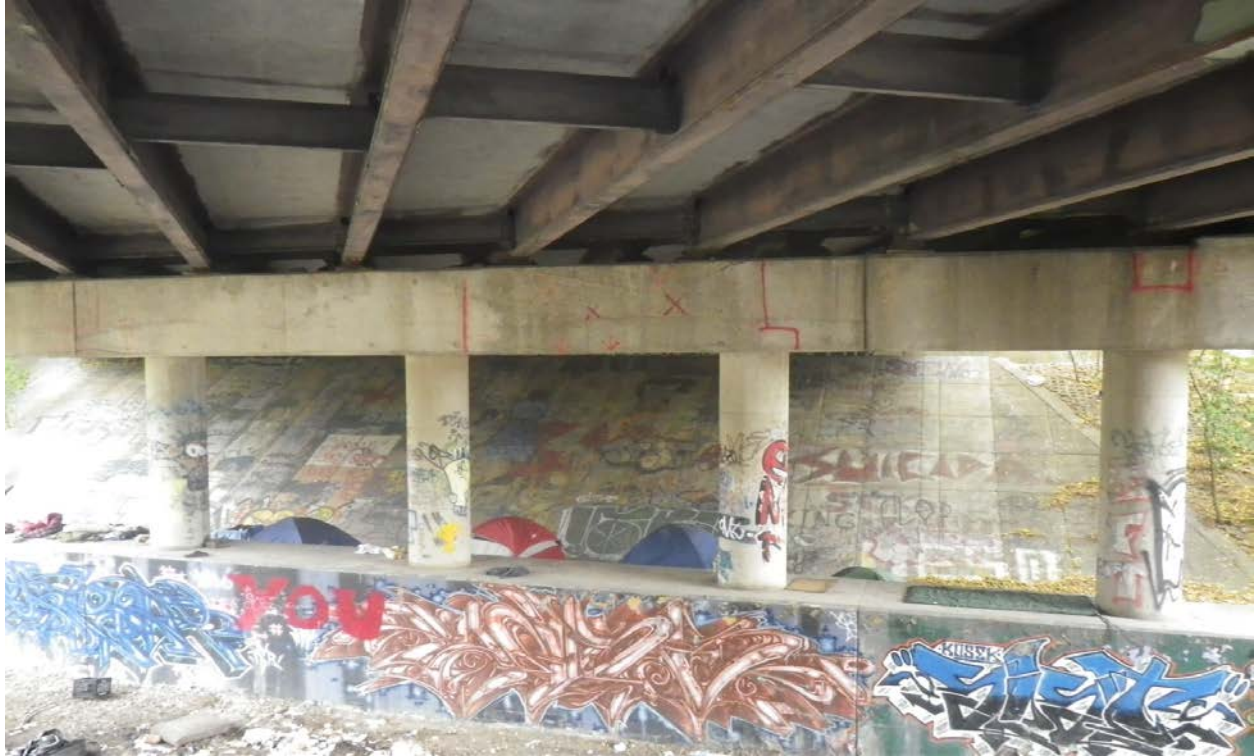
**Figure 14 Delamination on South Side of South Pier (Pier 1)**

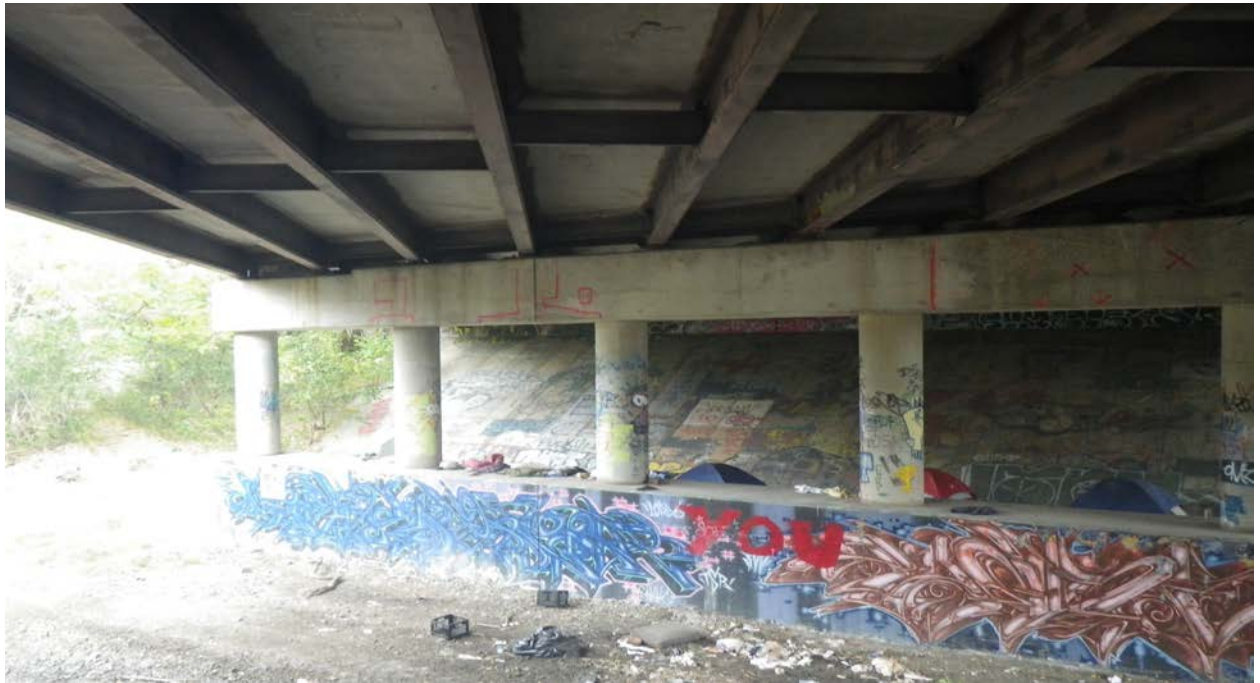
**Figure 15 Delaminations on South Side of North Pier (Pier 2)**

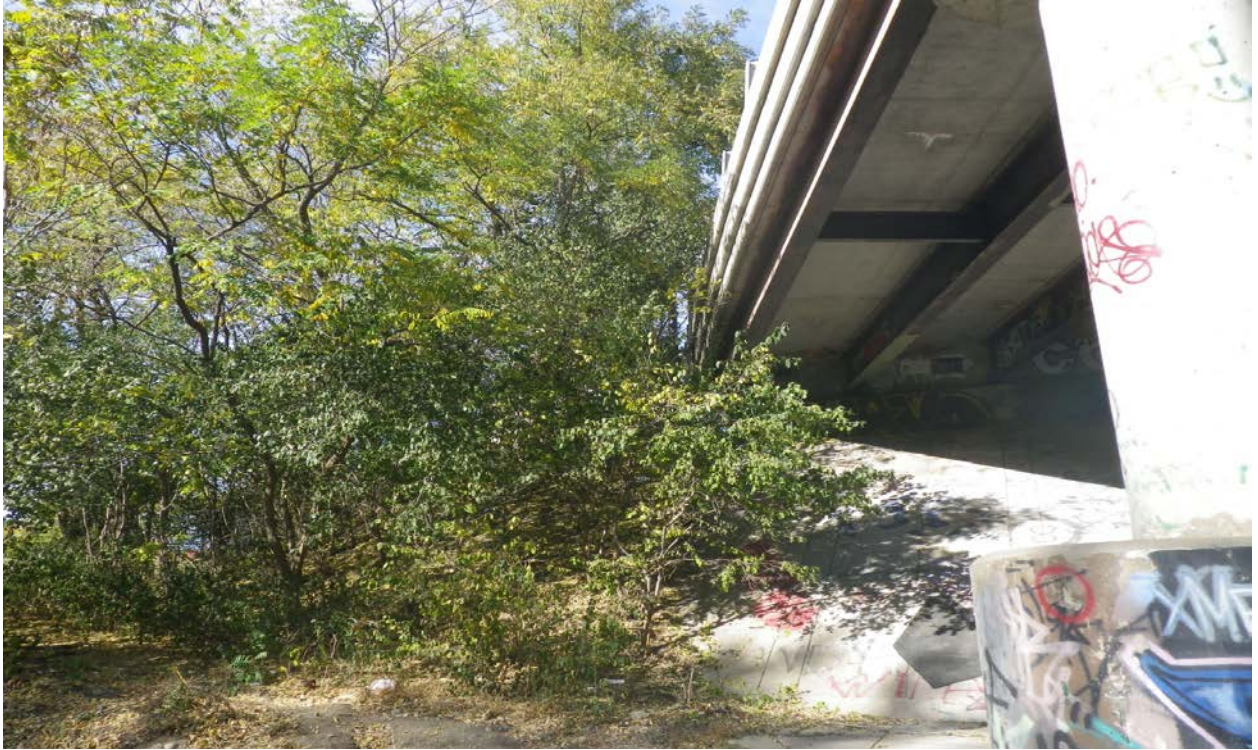
**Figure 16 Typical heavy vegetation surrounding bridge**
