City of Ann Arbor MRF Audit

Company/Dept.: CP MFG / Customer Service		Title: System Audit		Document Number: Audit

Author: M. Augustyn-Morales	Date: 2/9/2017	Rev 1

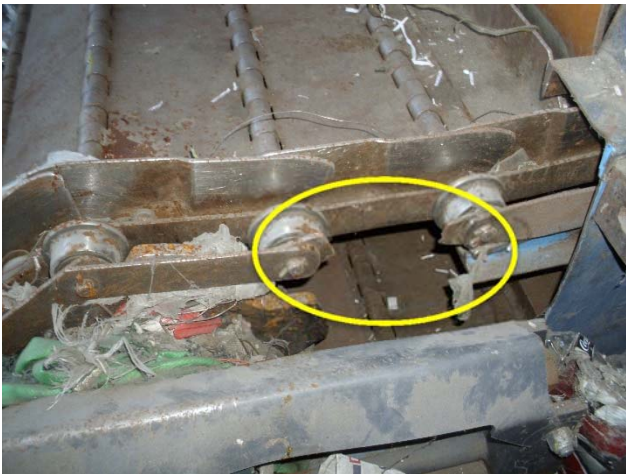
Take up is bent. Shaft is wrapped.

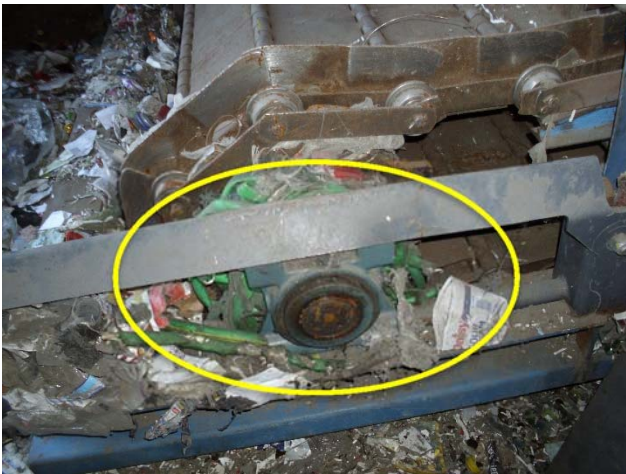
D hole bars are missing/broken.

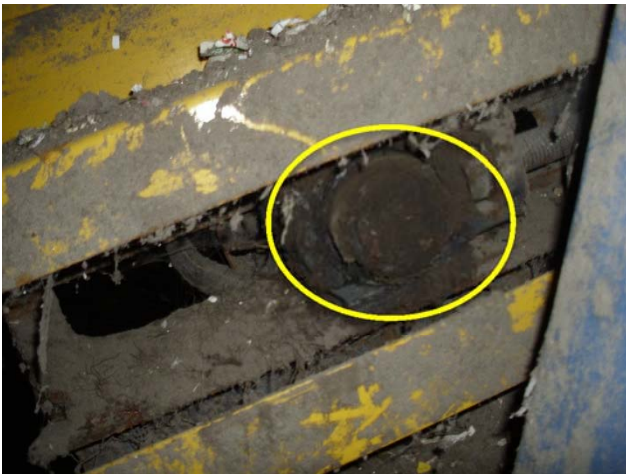
Bearings need to be replaced.

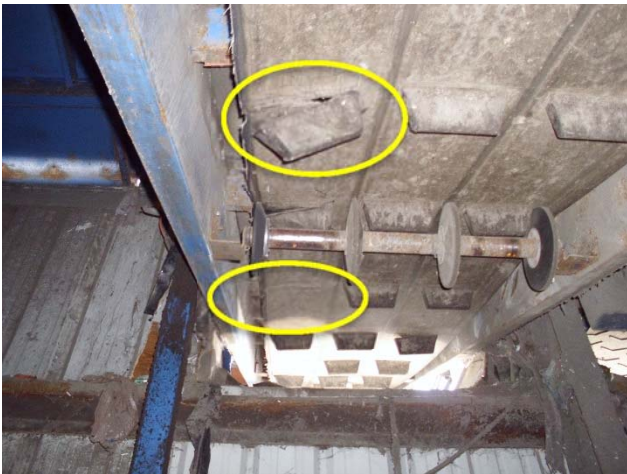
Belt need to be replaced. Cleats are torn/missing.

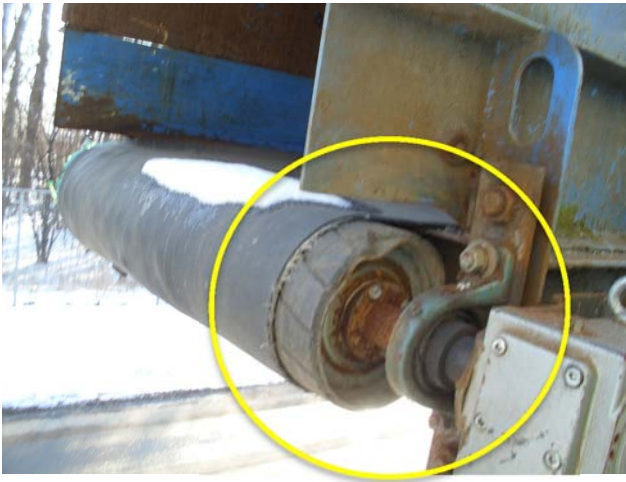
Pulley is damaged and needs to be replaced. Belt tracking is pulling to the left.

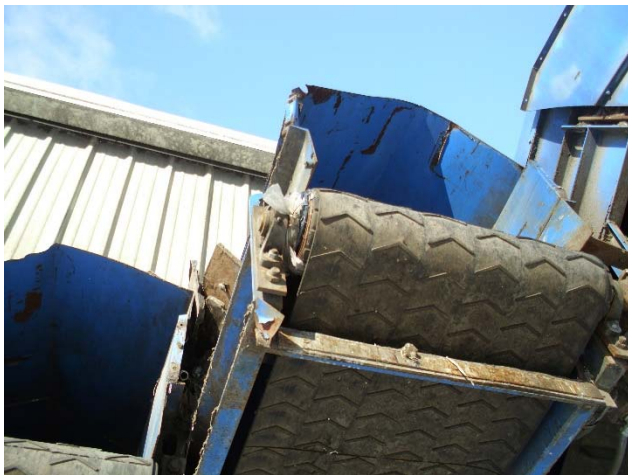
Overall condition of conveyor looks to be in working condition. Belt still has wear life before replacement is needed. Tracking is good.

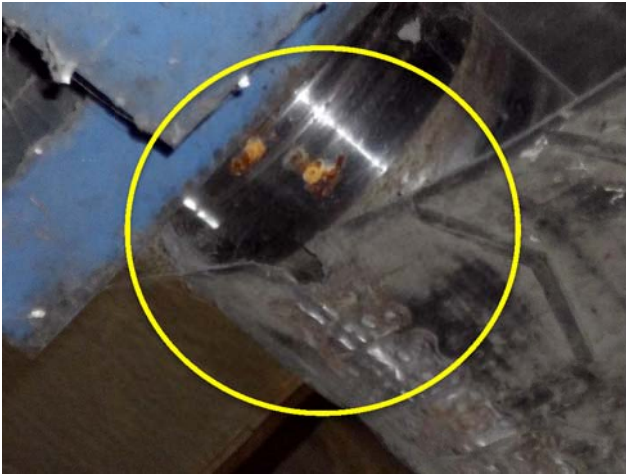
Pulley needs to be replaced. Belt is not tracked properly. Lacing is damaged and caused belt to tear.

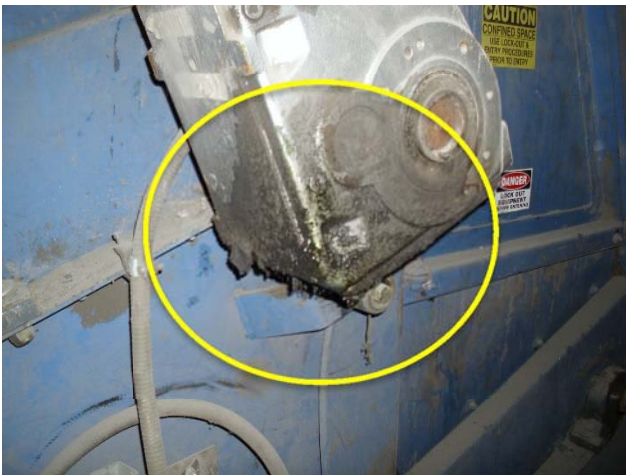
Gearbox is leaking, seal needs to be replaced.

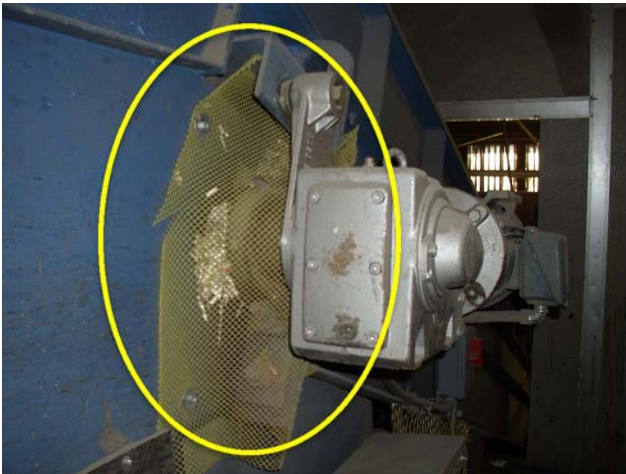
Guarding needs to be replaced.

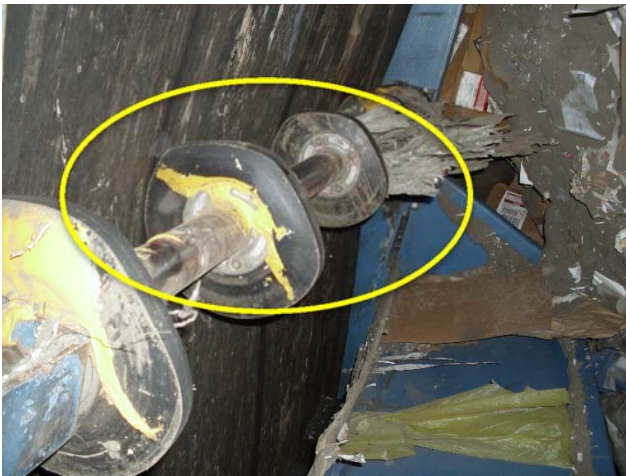
Return rollers are worn and needs to be replaced.

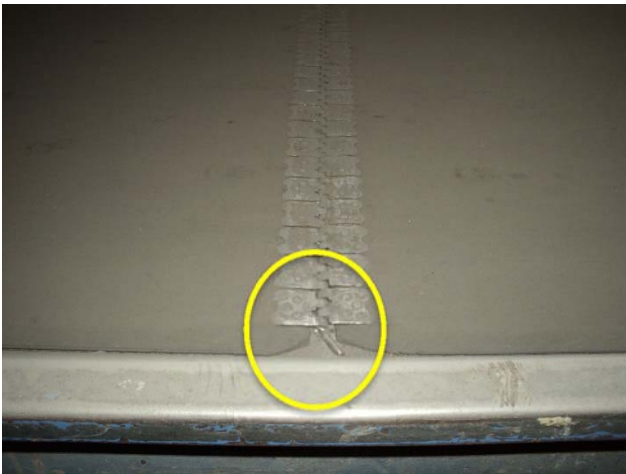
Belt is worn but serviceable.

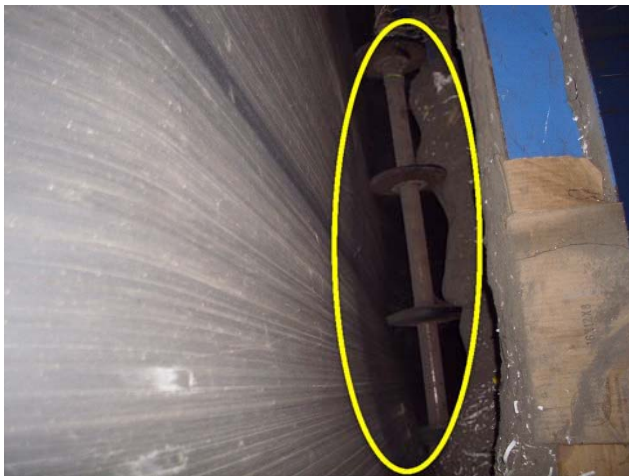
Return Rollers show signs of wear and should be replaced. Head and Tail Pulley needs to be replaced. Overall condition of conveyor is fair, cleaning required for optimal work.

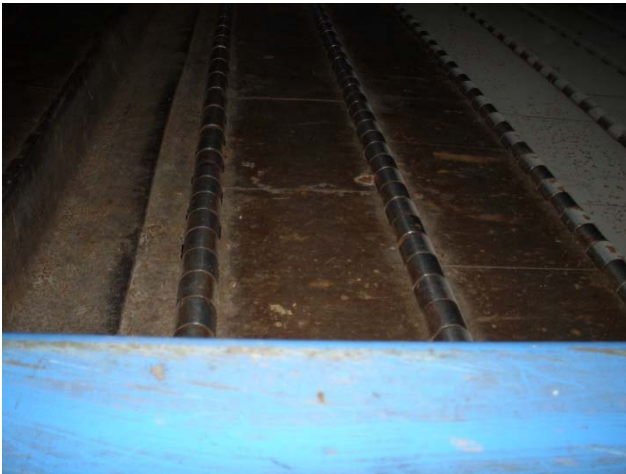
Conveyor is in good condition. Cleaning required for optimal use.

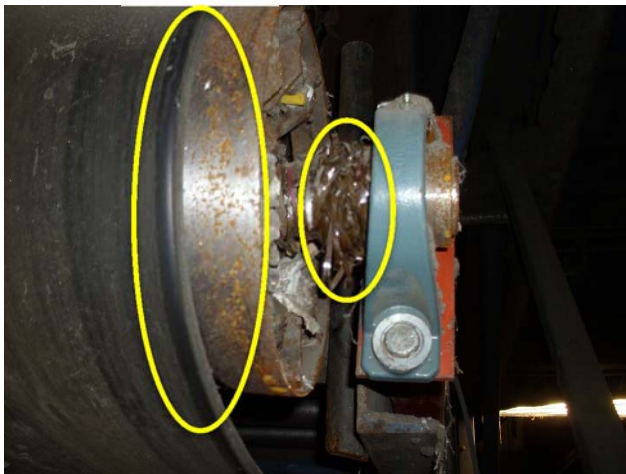
Above picture shows the condition of the belt tracking. It also indicates the condition of the pulley and the shaft being wrapped.

Return rollers are in good condition. Recommendation is to replace both pulleys, belt, gearmotor and bearings.

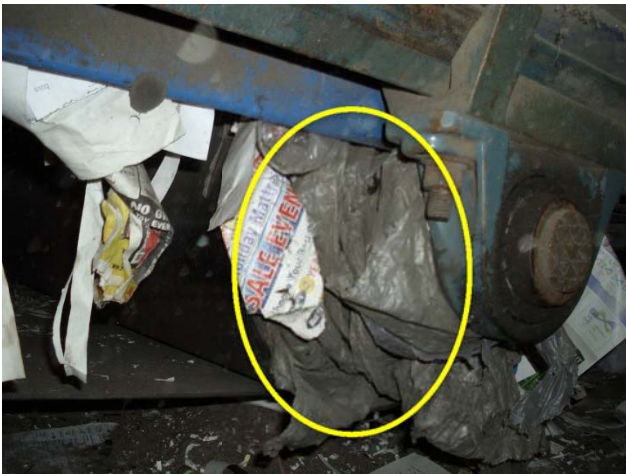
Shafts are wrapped and needs to be cleaned.

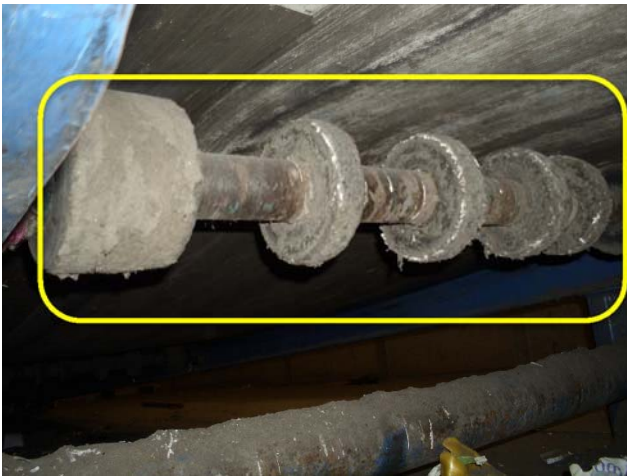
Return rollers need to be cleaned.

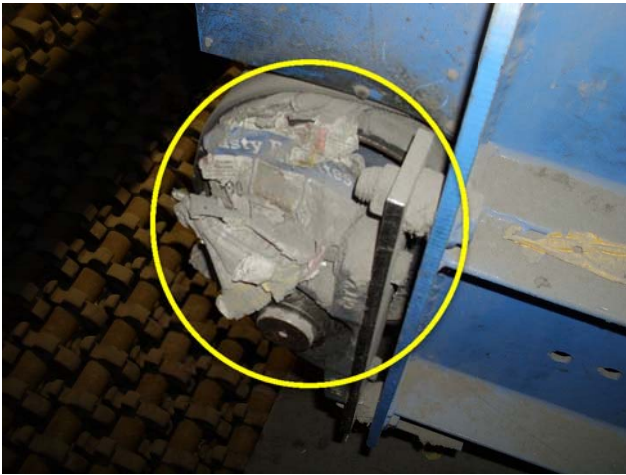
Shafts need to be cleaned off.

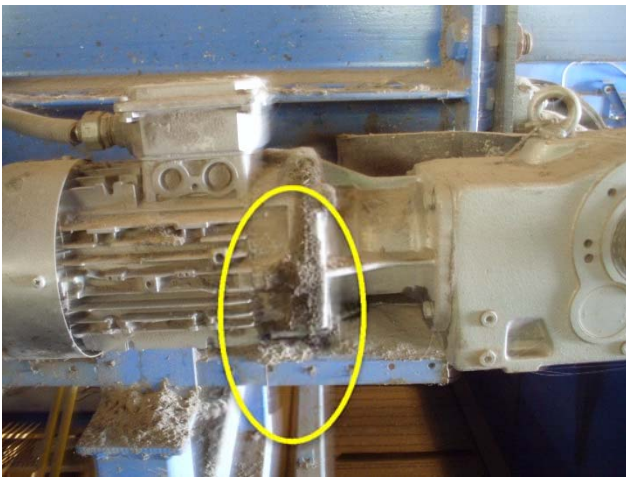
Gearmotor is leaking.

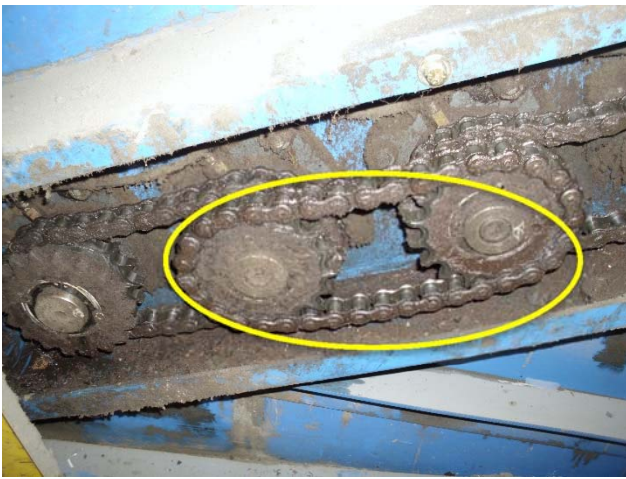
Chains are stretched/worn, full replacement needed. Sprockets are worn, replacement needed.

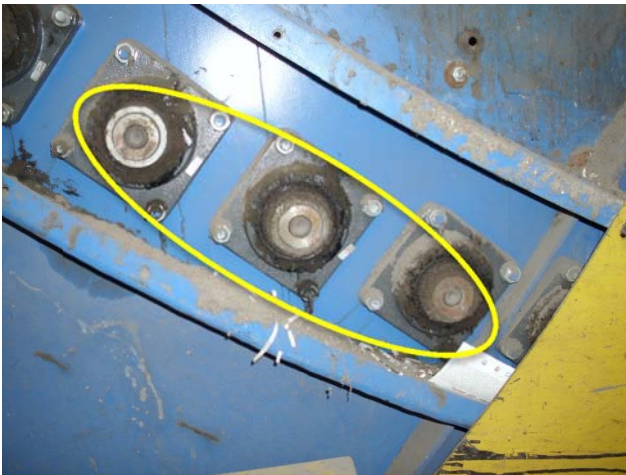
Bearings are worn and need to be replaced.

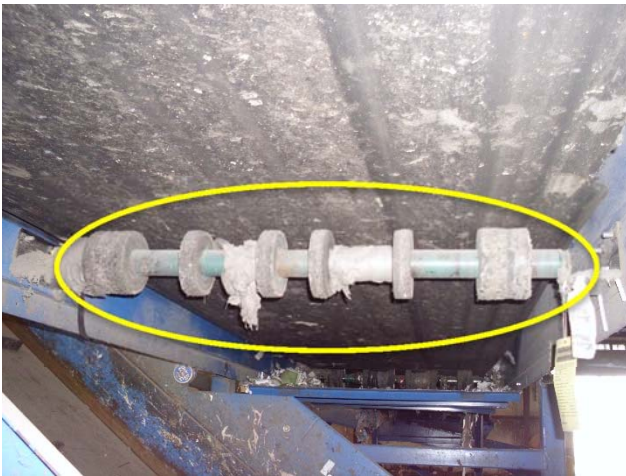
Return rollers are worn and need replacement.

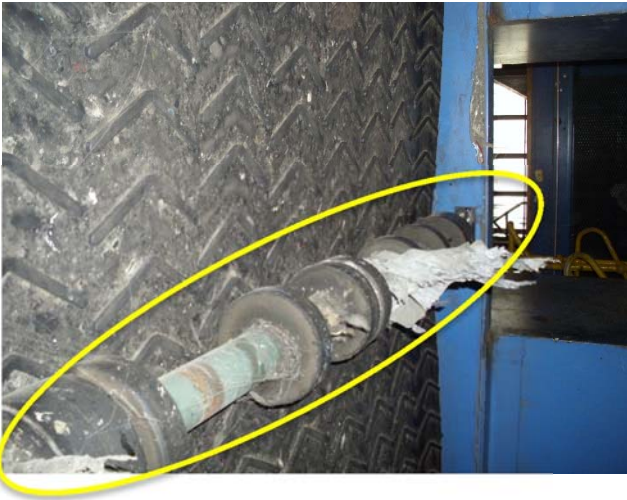
Return rollers are worn and wrapped, replacement required.

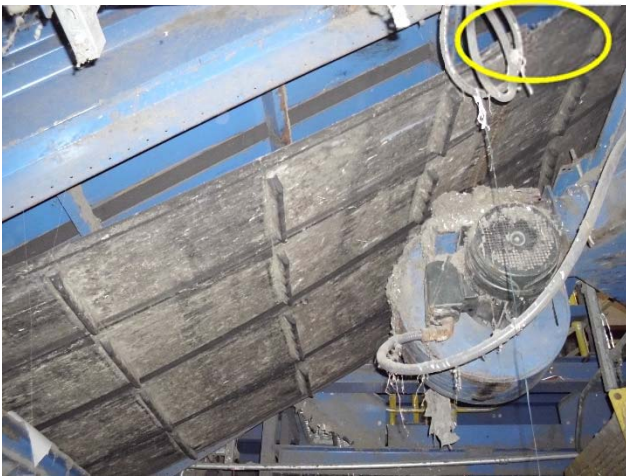
Belt is torn and needs to be replaced. Tensioning is lacking.

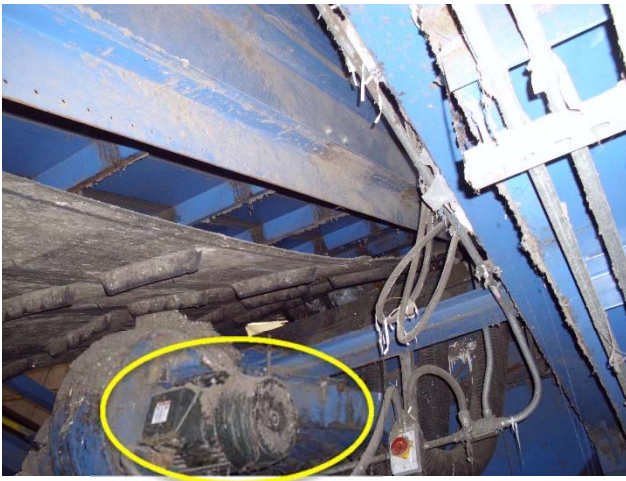
Gearmotor is leaking and needs to be replaced.

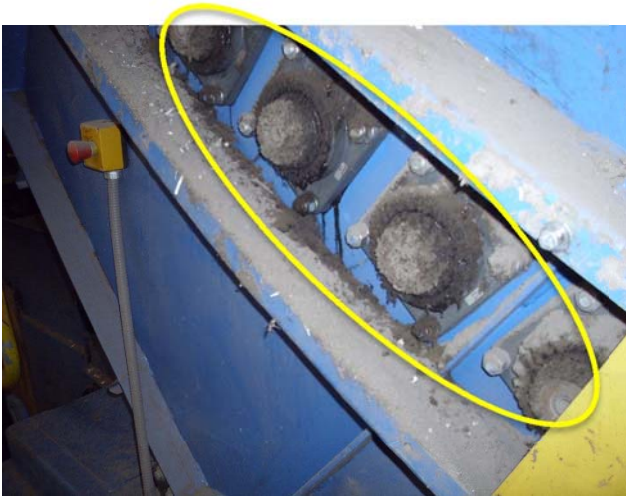
All bearings are worn and need to be replaced.

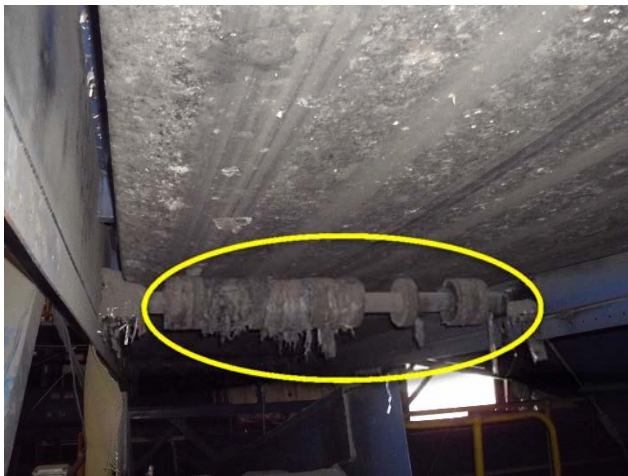
Return rollers are wrapped and worn, replacement required.

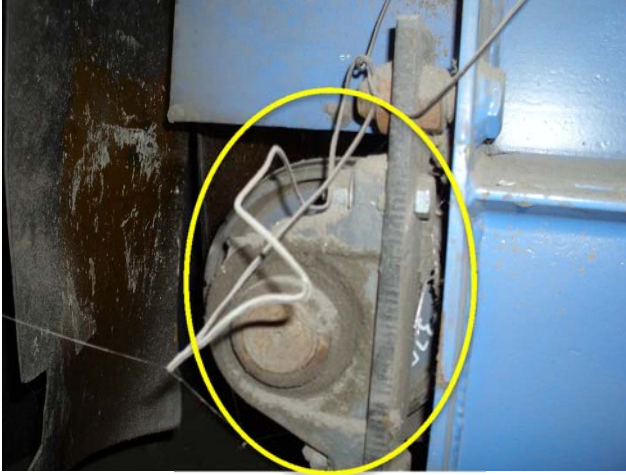
Bearing is worn, tracking of belt veers to the right, replacement required.

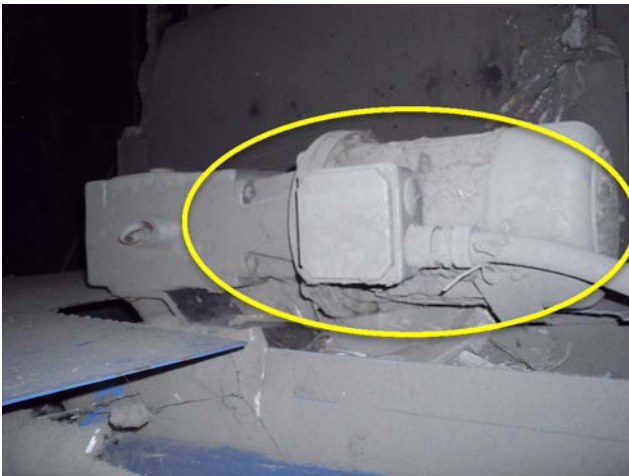
Motor is filled dust and surrounded by debris, replacement required.

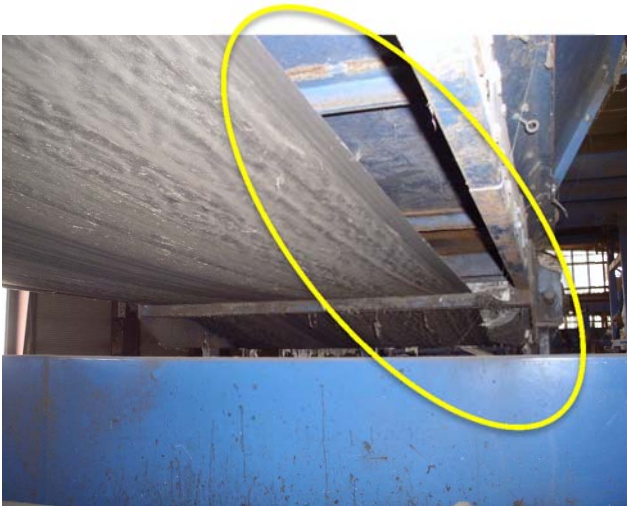
Return rollers are missing and wrapped where in place. Pictures also indicate the tracking to the left.
 Replacement required.

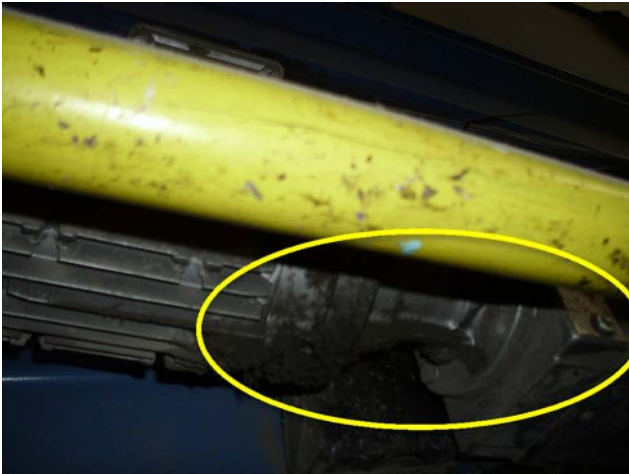
Gearmotor is leaking, replacement required.

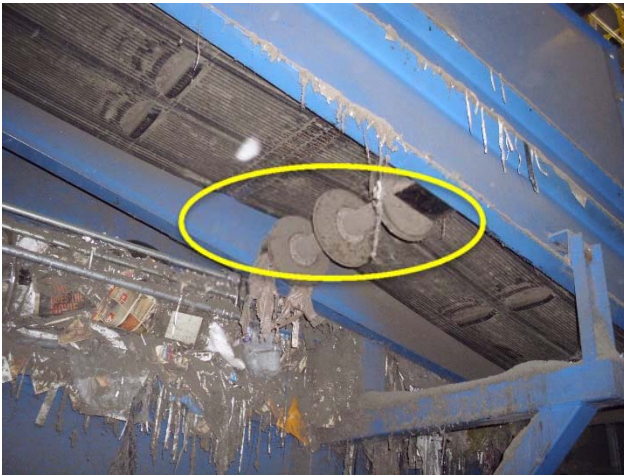
Return rollers are worn and need to be replaced.

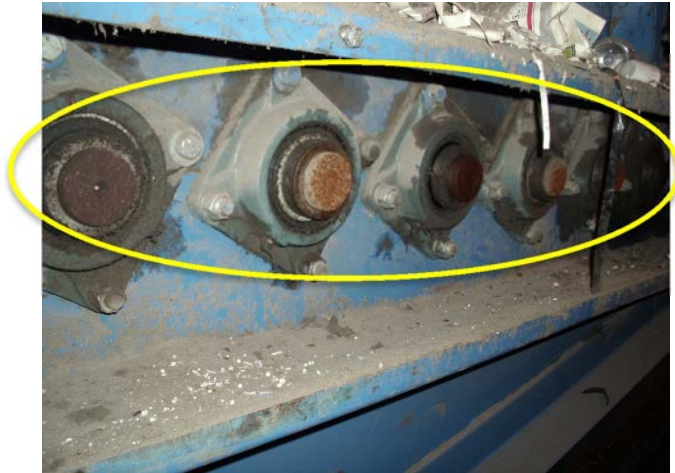
All bearings are worn, replacement required.

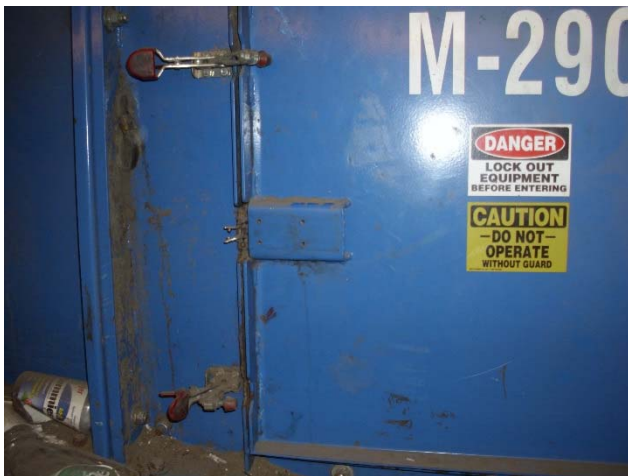
Safety device has been removed.

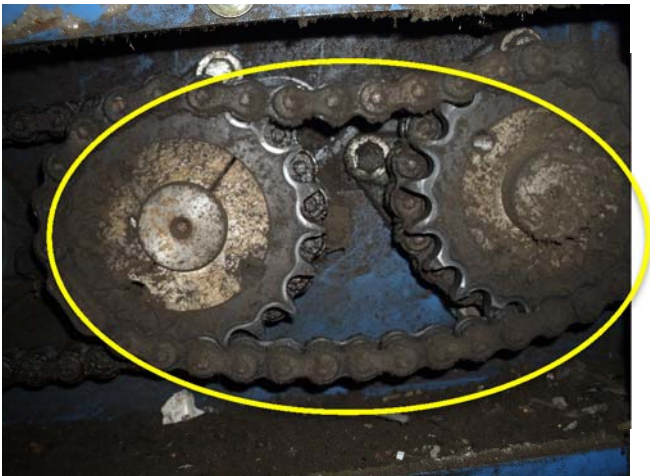
The above pictures show the excessive grease/oil from bearings that are worn, chains are stretched and worn, sprockets are worn, replacement of all components required.

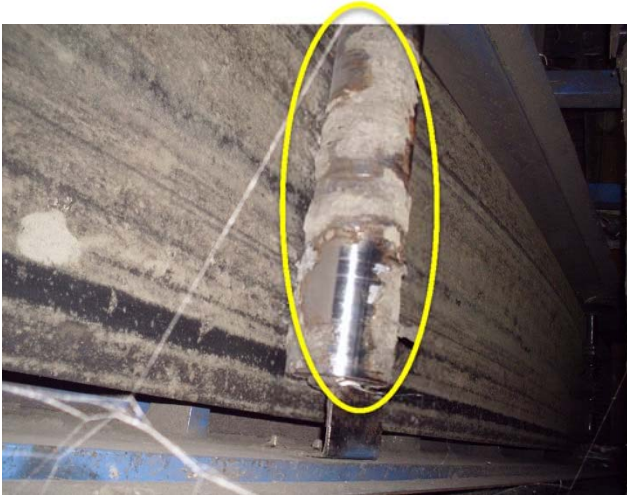
Return rollers are worn, replacement required.

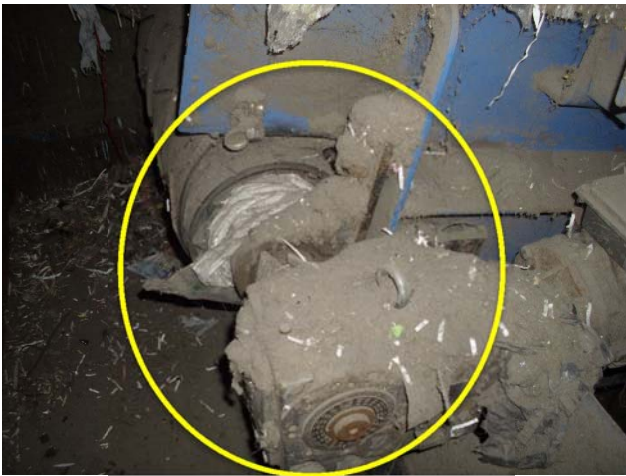
Severely wrapped head shaft, belt tracking is off, gearmotor is leaking. Replace all components.

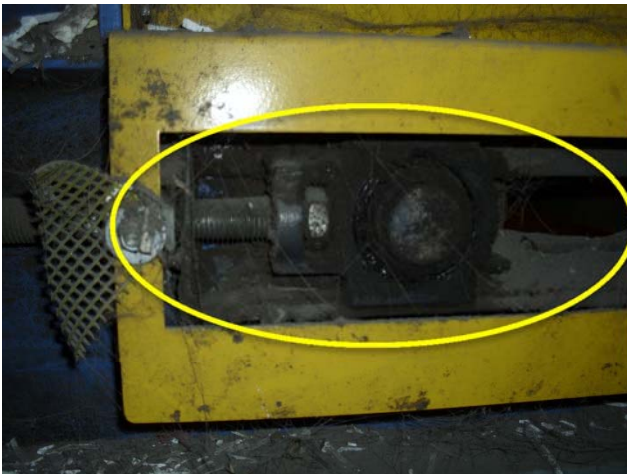
Bearing is worn, guarding is omitted, replacement required.

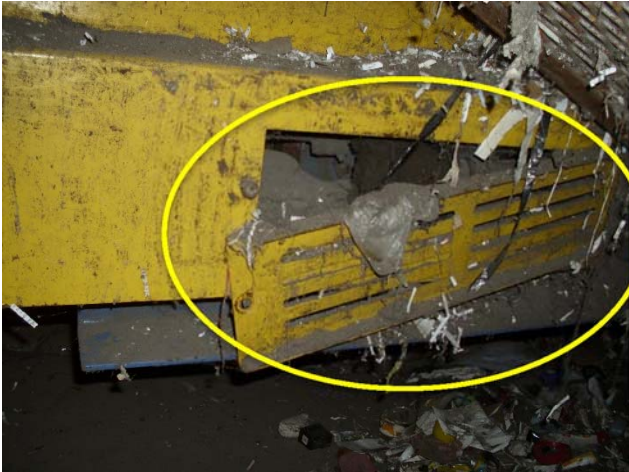
Guarding has been removed and left open. Pulleys are exposed, shows signs of severe wear, replacement required.

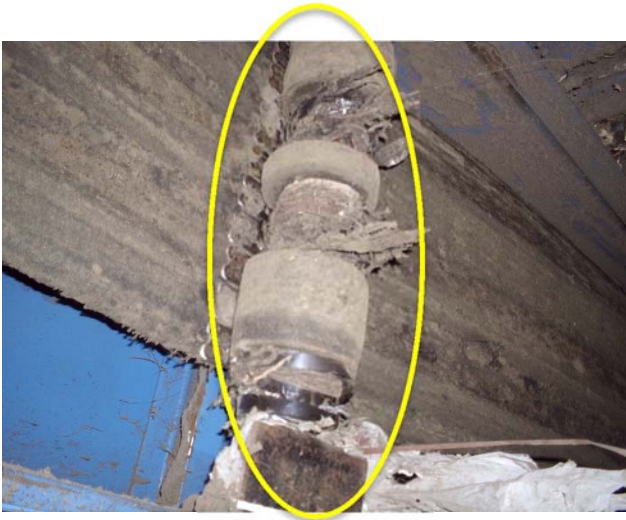
Return rollers are worn and need to be replaced. Picture also indicates a torn and severely worn belt, replacement required.

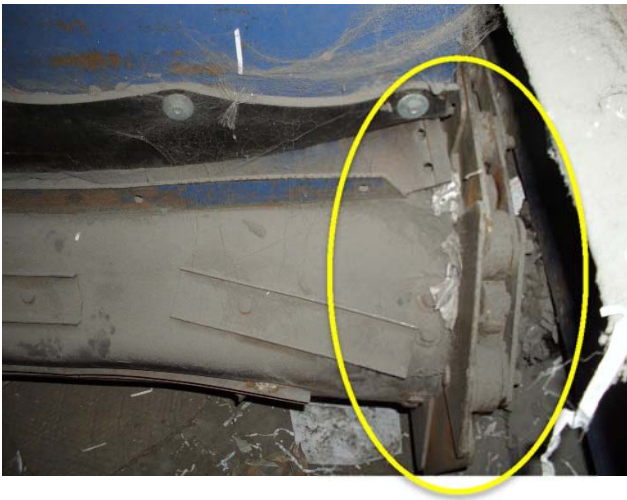
Belt is torn/worn, replacement required.

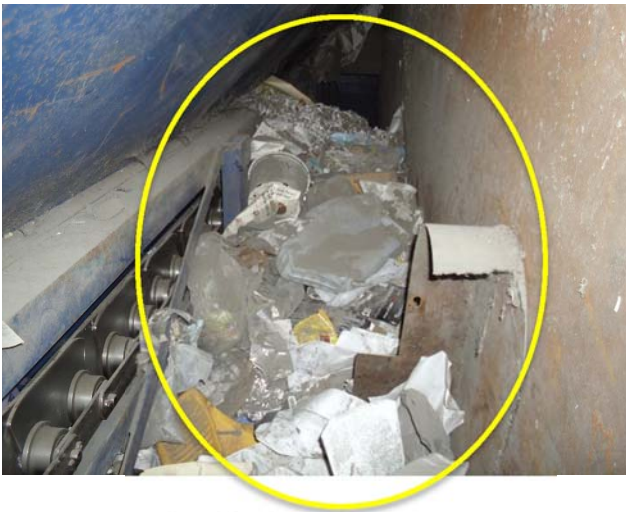
Conveyor needs to be cleaned.

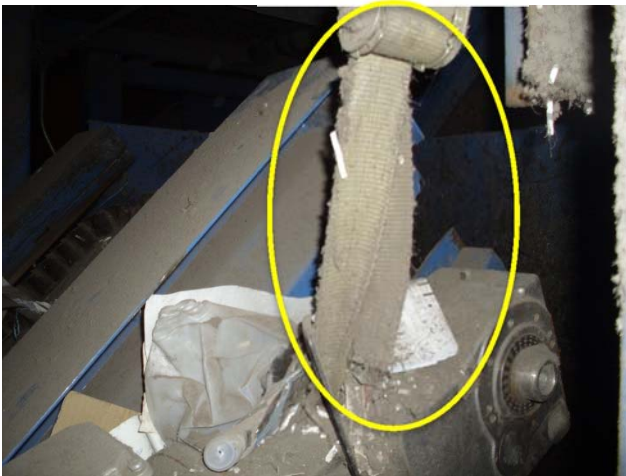
Gearmotor is leaking. Torque arm needs to be replaced as motor is held up by a tie down.

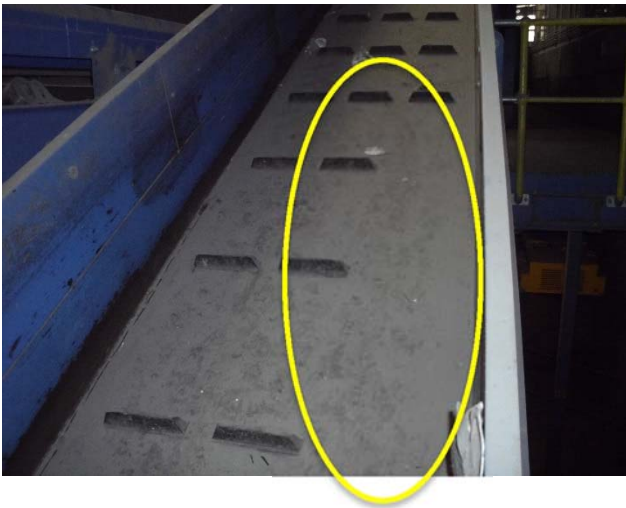
Belt is worn and need to be replaced. Missing cleats.

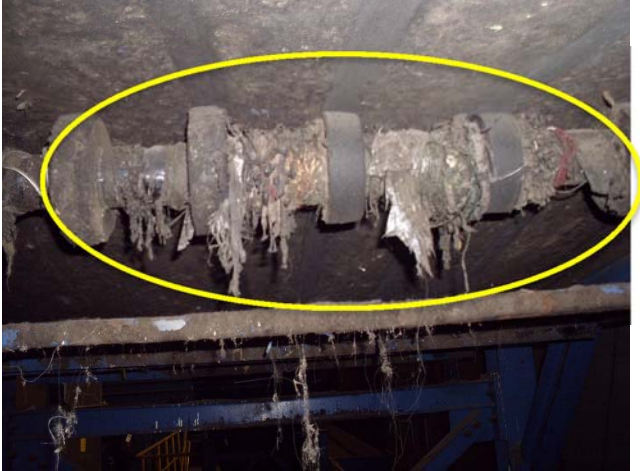
Return rollers are worn, replacement required.

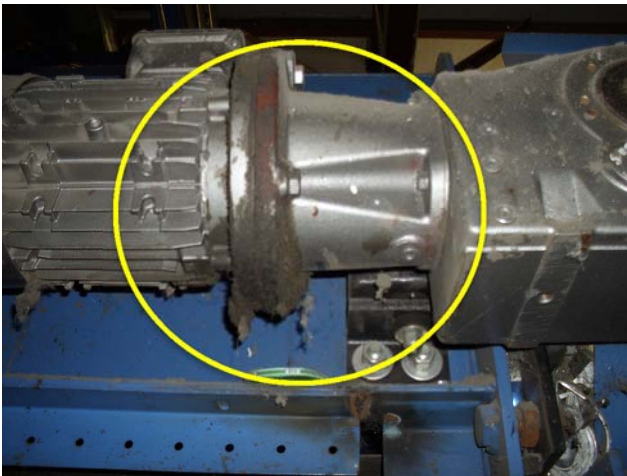
Gearmotor is leaking, replacement required.

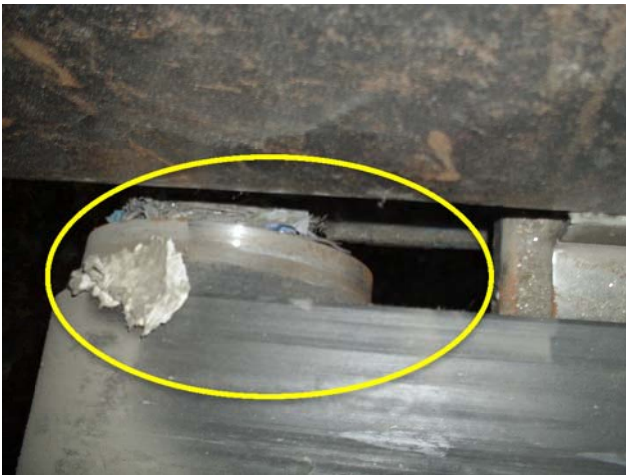
All components on this conveyor need replacement. Both pulleys, bearings, belt, gearmotor, return rollers. Replacement of conveyor recommended.

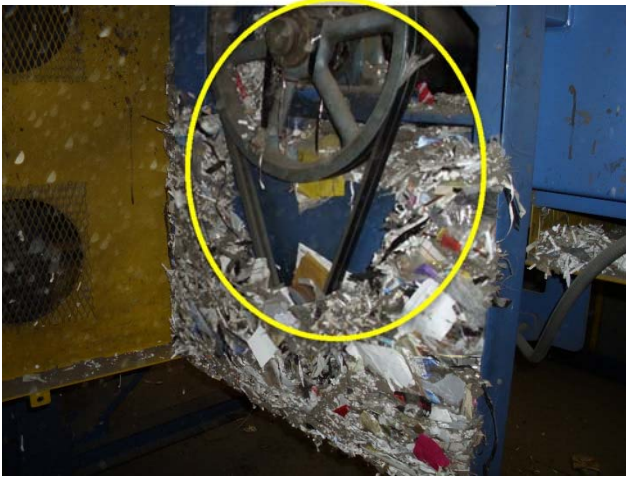
V-Belts need to be replaced.

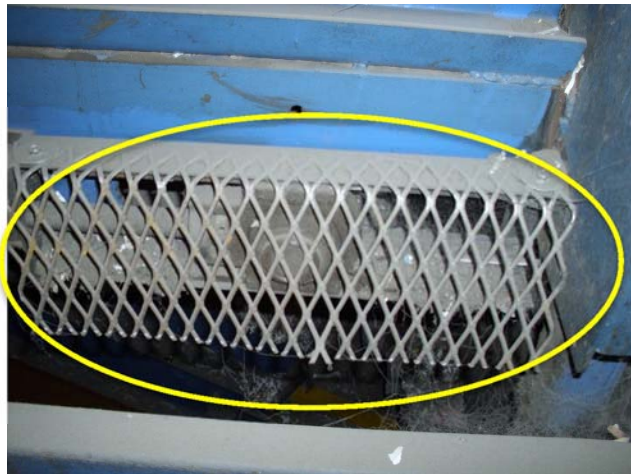
Guarding has been removed. Replacement required.

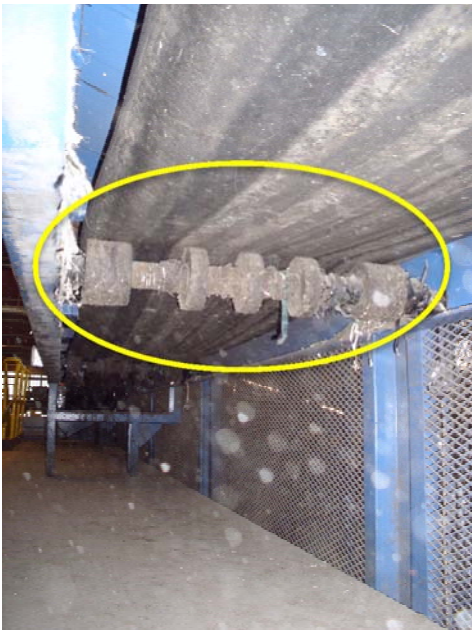
Return rollers are worn, replacement required.

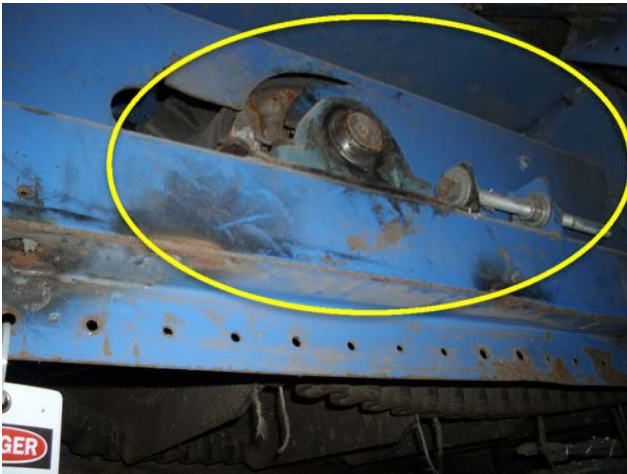
Pulleys, bearings and guarding is damaged. Replacement of all components required.

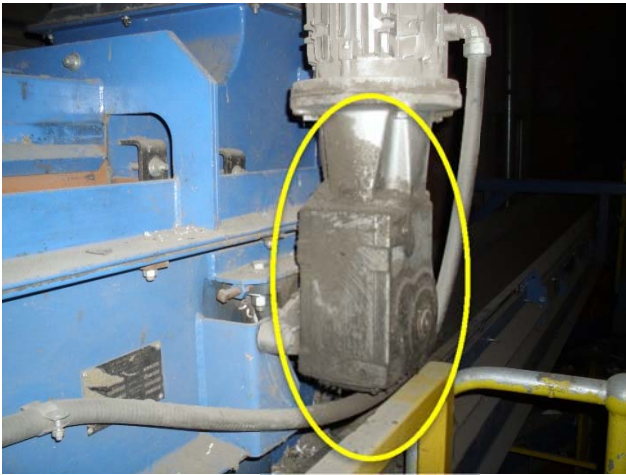
Gearmotor is leaking, replacement required.

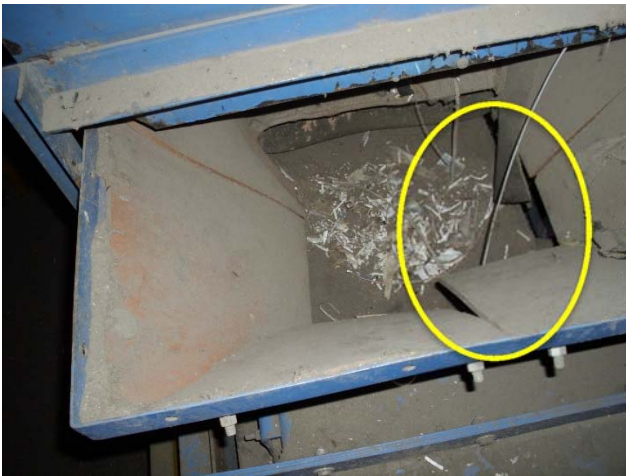
Liners need to be replaced.

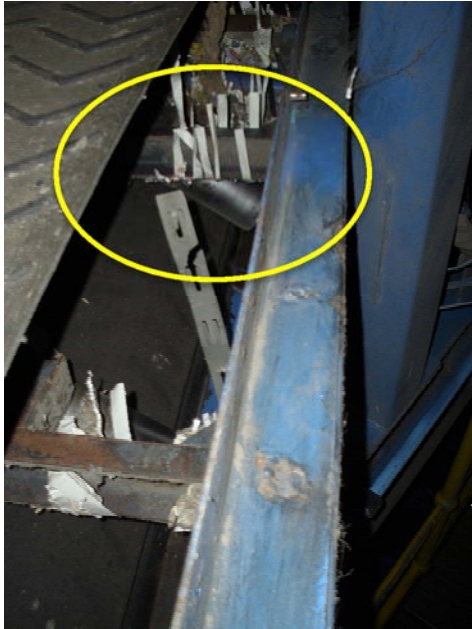
Belt tracking is pulling to the left, pulleys are both damaged beyond repair, replacement of belt, pulleys and bearings recommended.

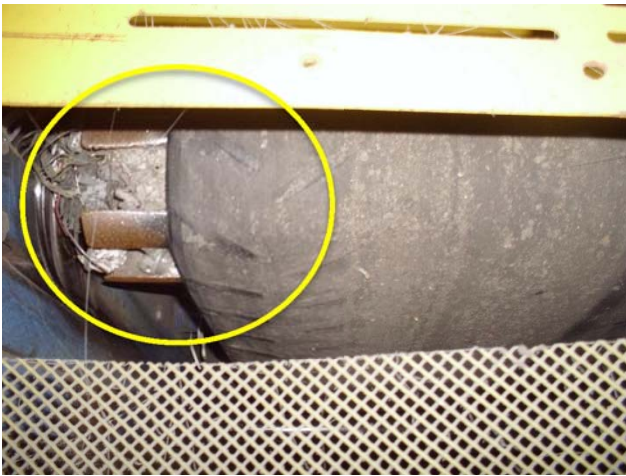
Pulleys are damaged, replacement of pulleys and bearings recommended. Belt tracking is to the right.

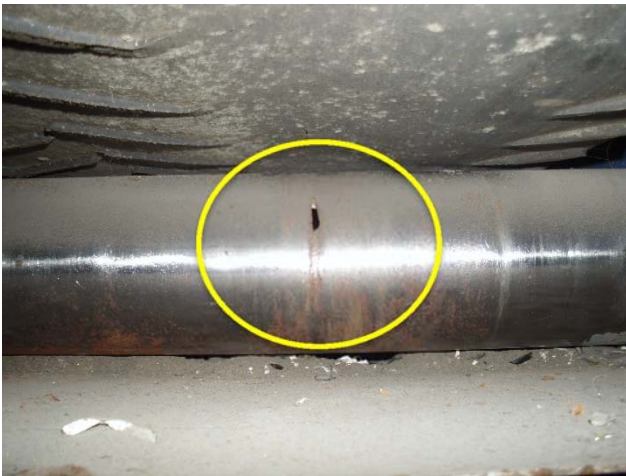
Return rollers are damaged. Replacement required.

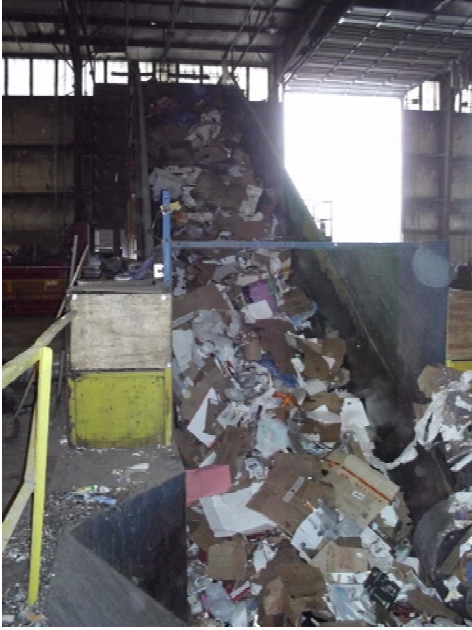
Amount of debris pile up has made it impossible for technician to properly inspect all aspects of the conveyor. It is said that the rails/tracks are worn, head shaft is bent and belt is in bad condition. Replacement of these components would optimize use of conveyor.
