STRUCTURAL EVALUATION REPORT

Chimney at 415 W. Washington Ann Arbor, Michigan

DNCE Project No. : 18-1339

Date Submitted: November 20, 2018

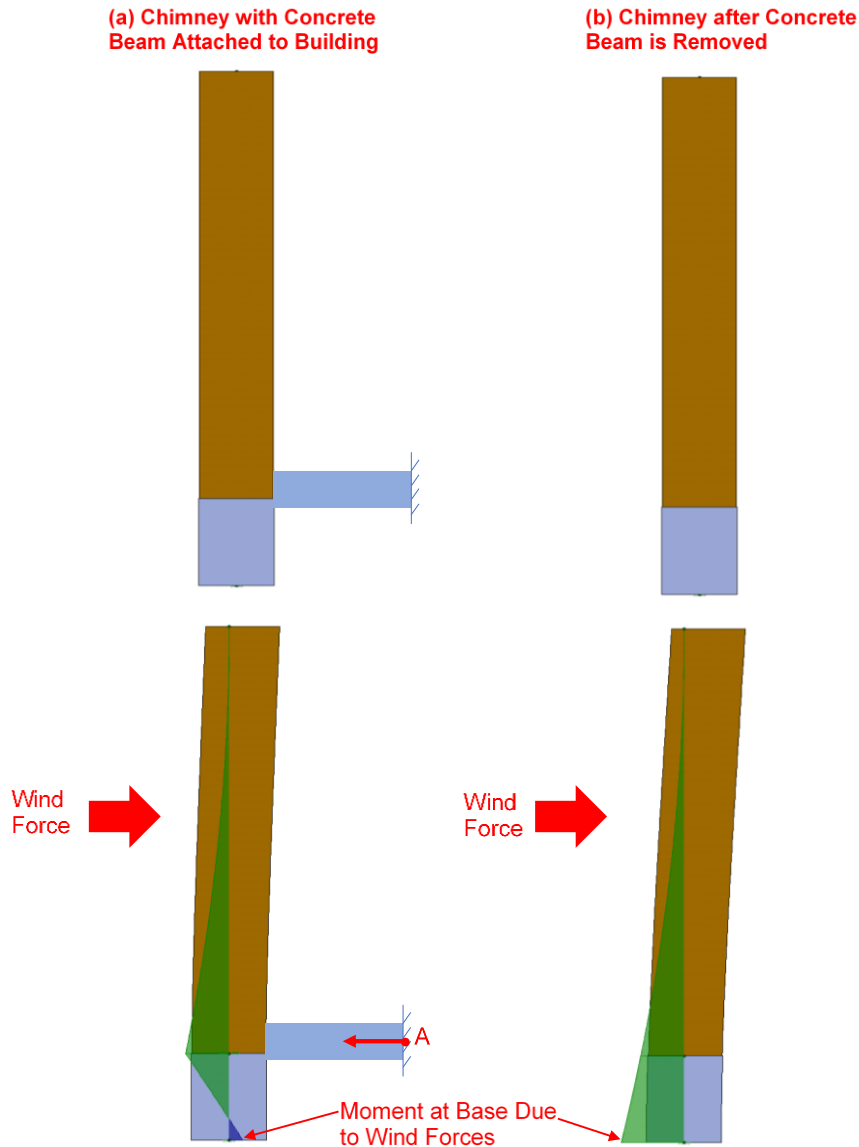
Figure 2. Concrete beam attachment to chimney and the adjacent building.

In order to examine the effect of removing the existing concrete beam (flue) connecting the chimney to the adjacent building, two models for the chimney structure have been analyzed (Figure 2). In both models, distributed lateral wind forces along the entire height of the chimney structure were applied in the north-south direction. The first model (a) is based on the existing conditions, while the second model (b) is based on the scenario where the beam is completely removed and the chimney is acting as a “stand-alone” structure. As shown in Figure 2, the resulted flexural moment at the base of the chimney after removing the beam (case b) became much larger, compared to the case where the beam is connected to the chimney, by approximately 4 times. However, this difference in the moment at the bottom is based on the assumption that the connecting beam is supporting the chimney in the horizontal direction, 8 ft above ground, and transferring lateral forces from the chimney to the existing building frame (presented by the reaction at point A).

Furthermore, the analysis results showed significant lateral forces at point A, and thus for such large lateral force to be supported at that point, the beam must be connected to the building frame. This connection to the building frame was not visible from the inside of the building as shown in Photoset 5 where the beam is mainly passing through and supported by the existing wall, but not attached to the frame above.

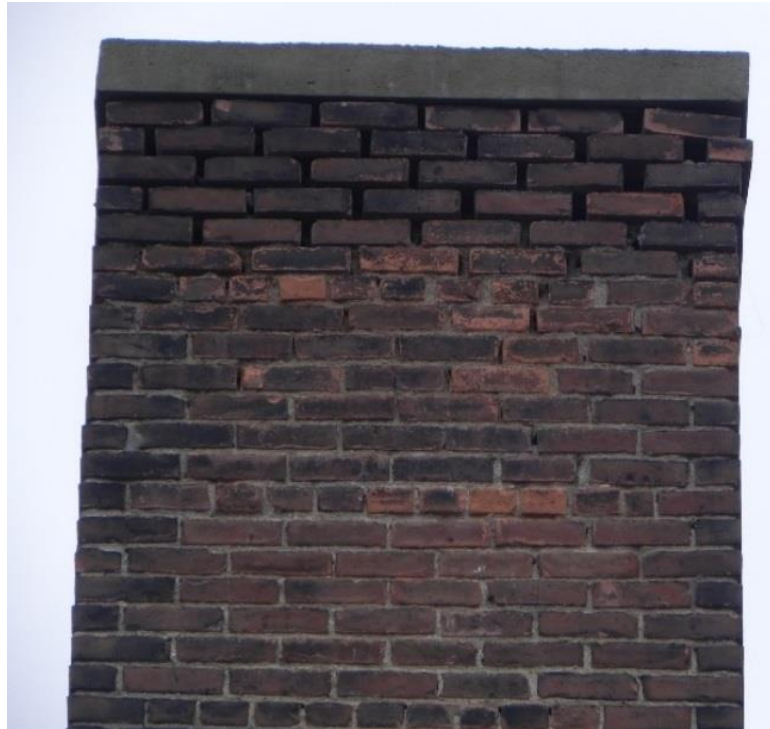
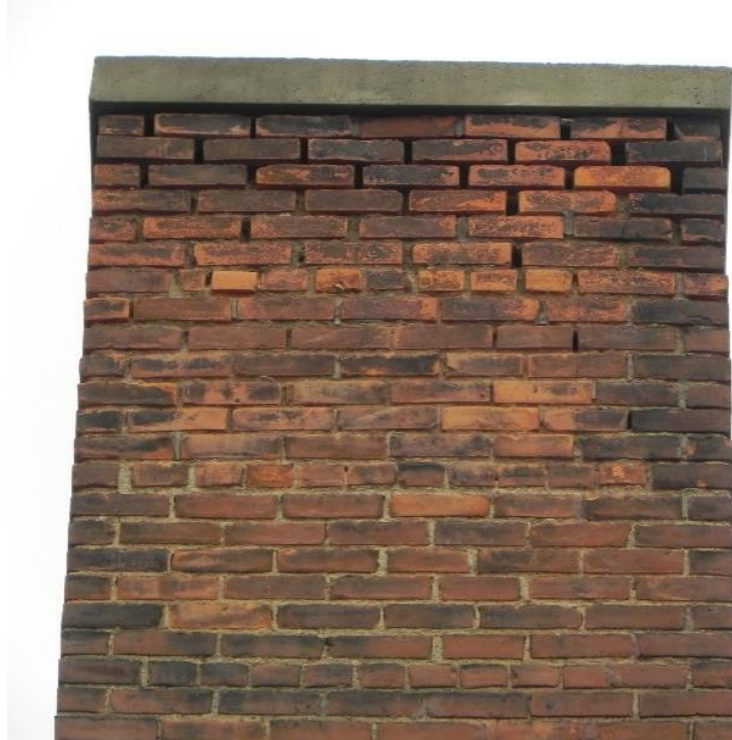
Chimney Top

- Loose bricks and lack of mortar between bricks at top of chimney (Photoset 1).
- The concrete base of the chimney has vertical cracks at the south side, east and west sides (Photoset 2).
- Major crack in bricks extending from the west to the south side of the chimney, above the concrete base (Photoset 3).
- Cracks in the concrete beam (Photoset 4).
- Sever horizontal crack in the existing building concrete frame near the beam attachment point (Photoset 4).

Photoset 1: Loose bricks and lack of mortar joints at top of chimney.

In general, the chimney structure is in a fair to good condition. There are no signs of settlement of the existing chimney base, but a few areas of cracking and loose brick as listed above (section 4.0). However, it should be noted that these areas require major repairs to be made acceptable by current building code requirements. It is recommended to repoint loose brick with new mortar, especially at the top of the chimney, as soon as possible to avoid further deterioration that could potentially become severe and risk falling.

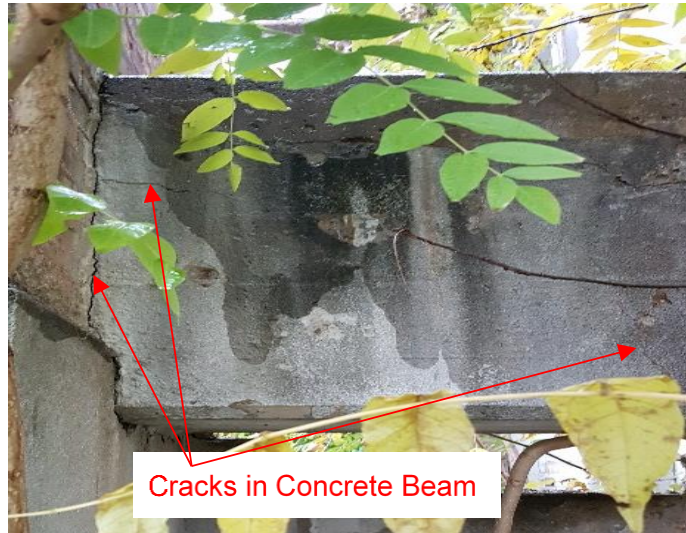
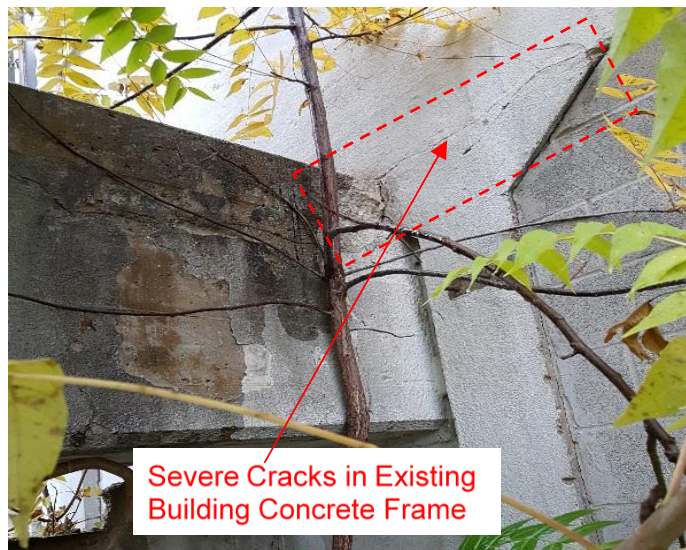
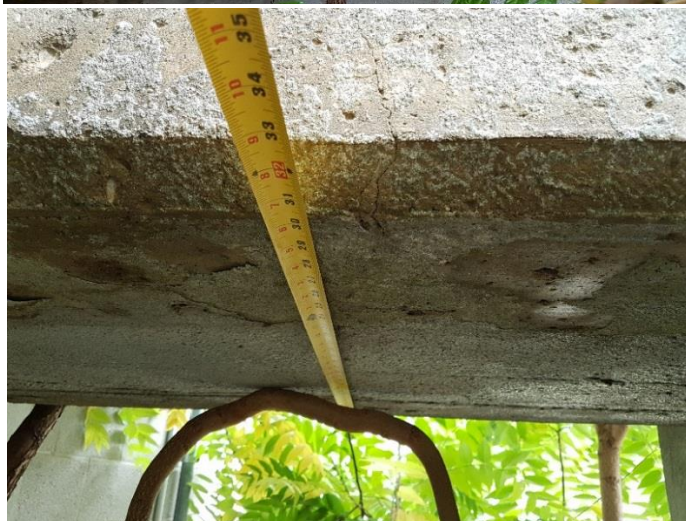
Connecting Concrete Beam

Photoset 4: Cracks in concrete beam and the adjacent building frame.

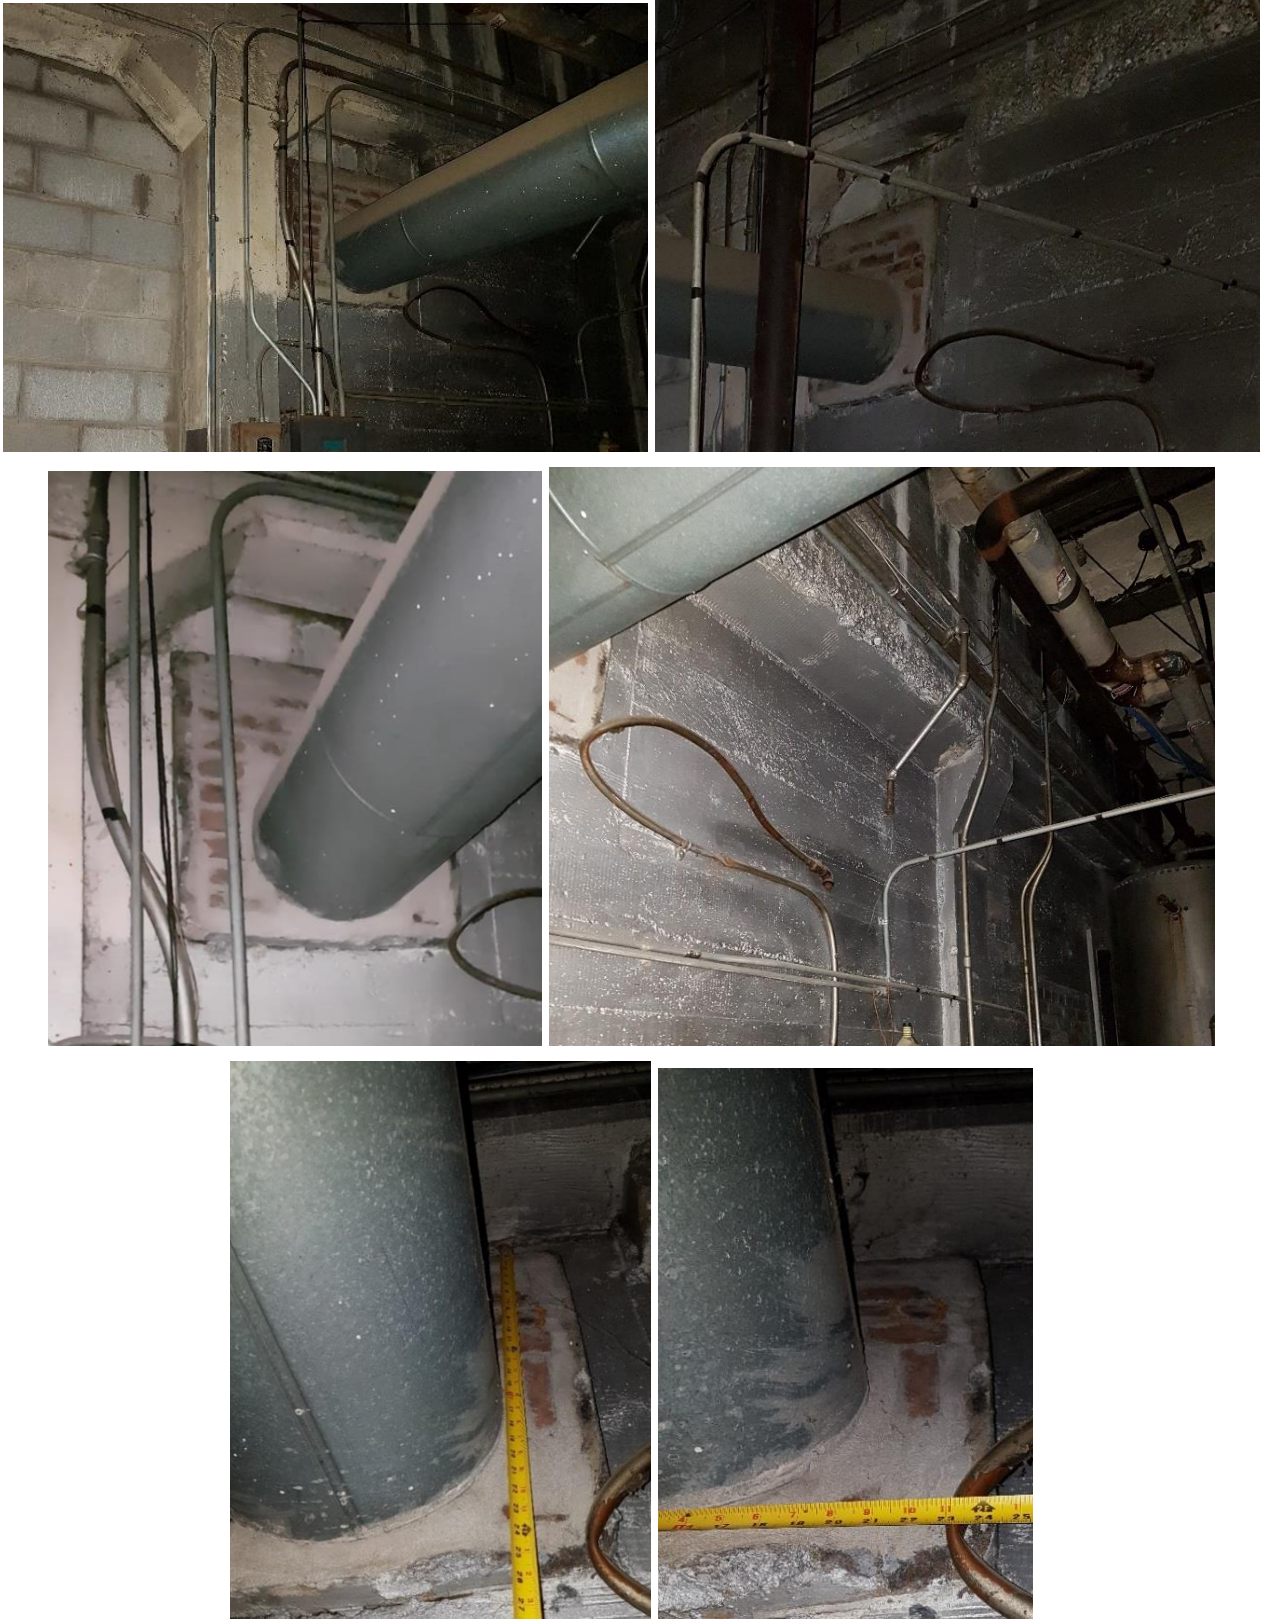
Photoset 5: Extension of the concrete beam end to the inside of the adjacent building.

Since no structural connection between the concrete beam and the existing building frame was visible, it is assumed that the beam was not designed as a main lateral support member to the chimney structure. Therefore, removing this beam should not affect the lateral stability of the chimney as a stand-alone structure, assuming that the chimney is supported on an isolated foundation. Thus, if the final decision is to keep the chimney, isolating the chimney foundation against vibration and soil movement during demolition and construction is highly recommended. Temporary shoring is advised during demolition of the adjacent building, and until the new construction is completed.
