ANN ARBOR HISTORIC DISTRICT COMMISSION

Staff Report

ADDRESS: 903 West Huron Street, Application Number HDC24-0089

DISTRICT: Old West Side Historic District

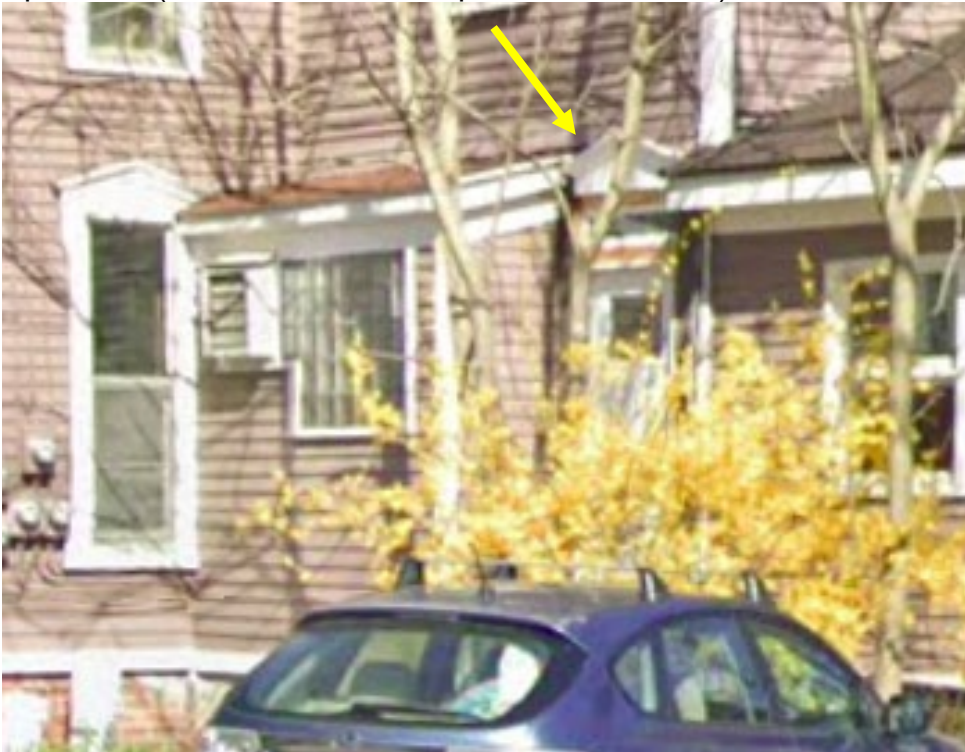
Google Street View Photos

3. On the south elevation of the house, visible from the public right-of-way, work was begun to replace a window with a door. The only historic material remaining after this work is the former window's pedimented crown. The trim that enframed the window on the sides has been removed. The window opening was made larger to accommodate a steel door and a narrow, disproportionate transom window. The door and transom are framed by underlayment or tar paper. The intended design or method to finish this trim is unknown.

April 2024 (Window has been replaced with a door)

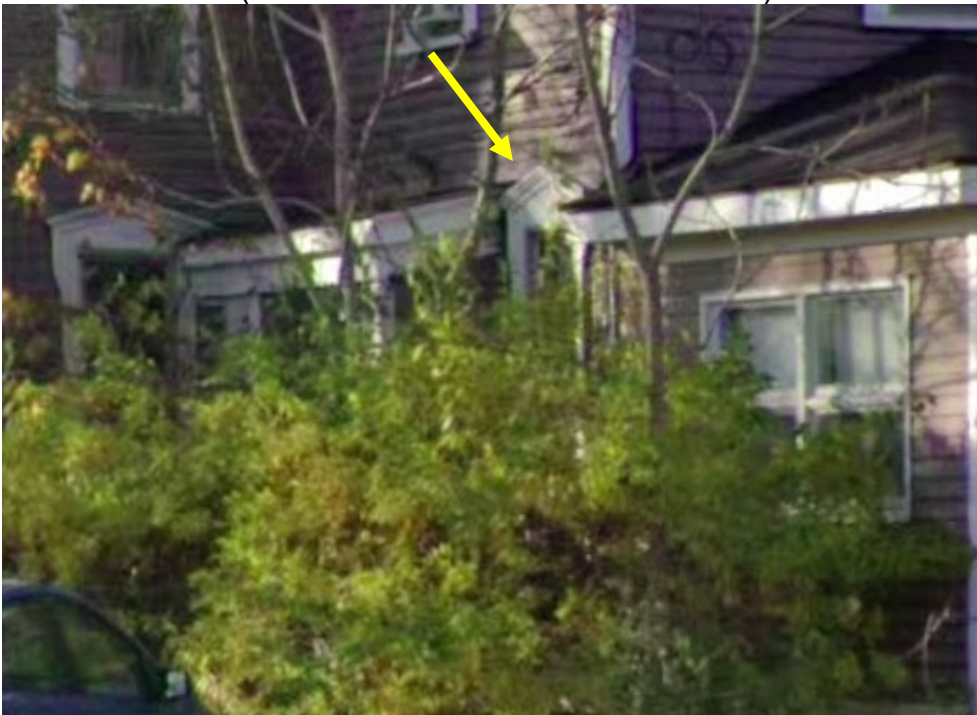
November 2020 (Window before conversion to a door)

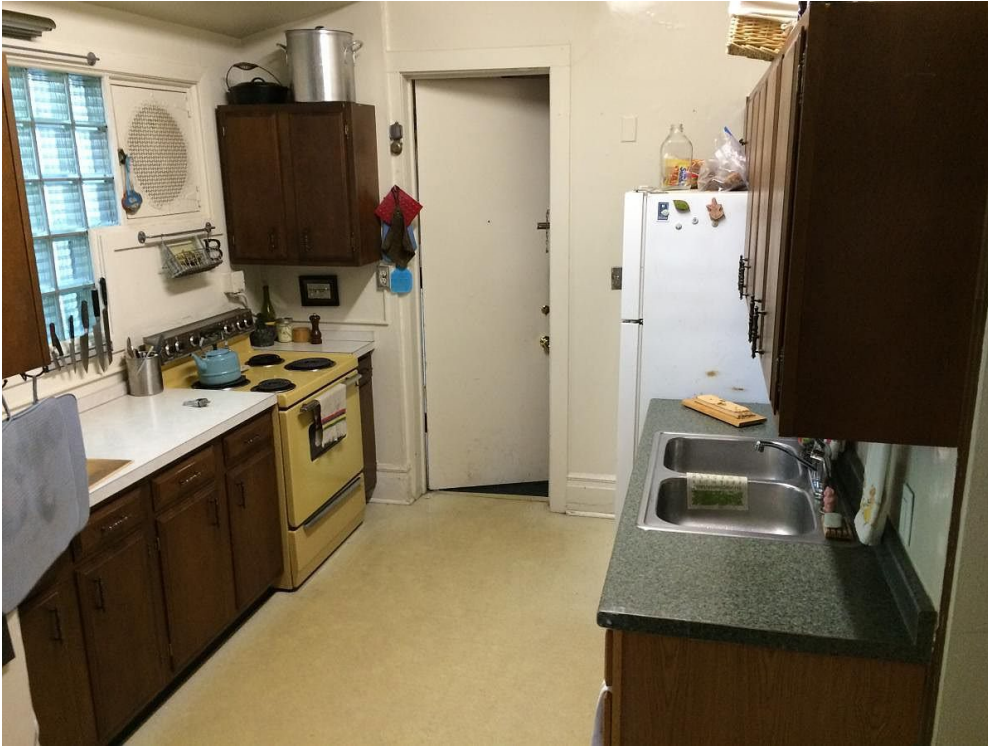
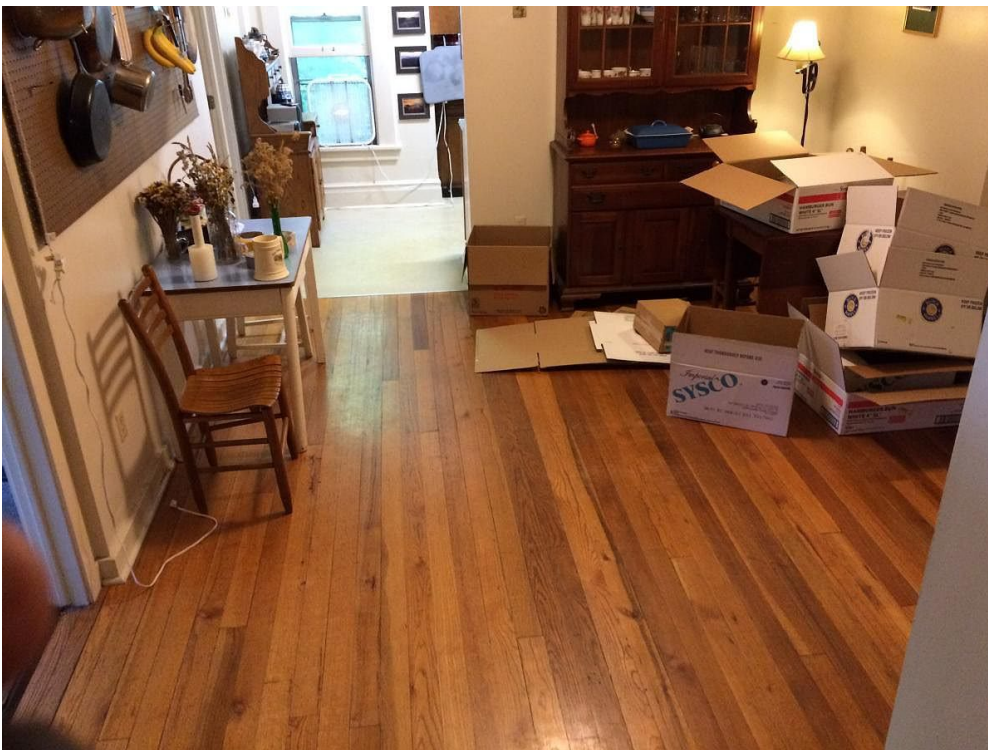
Undated interior photos from Zillow of 903 W Huron #1 (Note the glass block kitchen window that faces the rear parking lot, and the grey chair cushions (?) hanging from a cupboard in both photos. The window with the box fan is the one that was converted into a door.)

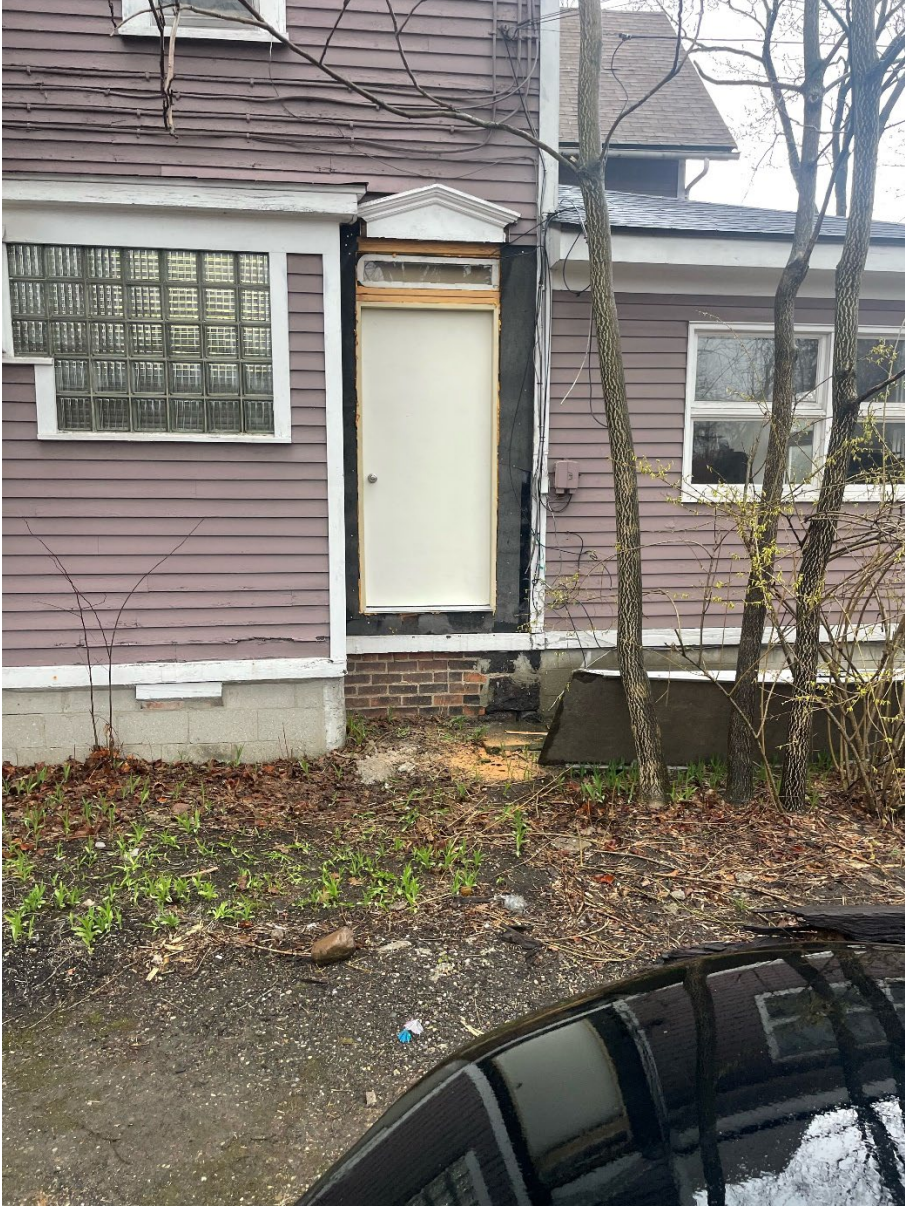
Owner's photograph of the door he replaced in the same opening, from 3/20/24 email
