City of Ann Arbor MRF Audit

The following report is a maintenance and operations evaluation of the CP Equipment at the City of Ann Arbor Materials Recovery Facility. The information gathered in this report was collected by John Kemp (CP Field Technician), and Brian Pressley (CP Customer Service Assistant Manager). This information was gathered over a 2-day period.

Company/Dept.: CP MFG / Customer Service		Title: System Audit		Document Number: Audit-002

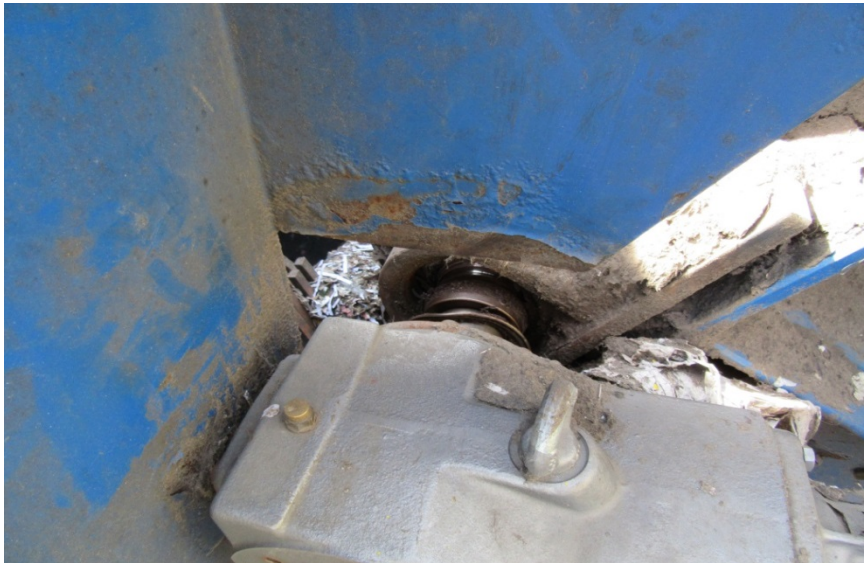
Photos A & B show the condition of the bearings. We recommend that both head shaft bearings are replaced as soon as possible.

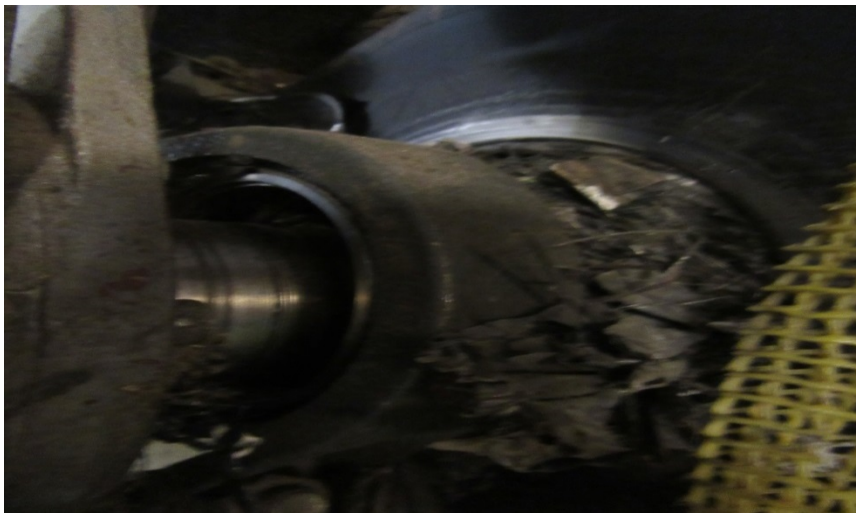
Photo A shows the bad bearing on the head pulley. We recommend replacing this bearing when possible to prevent shaft damage.

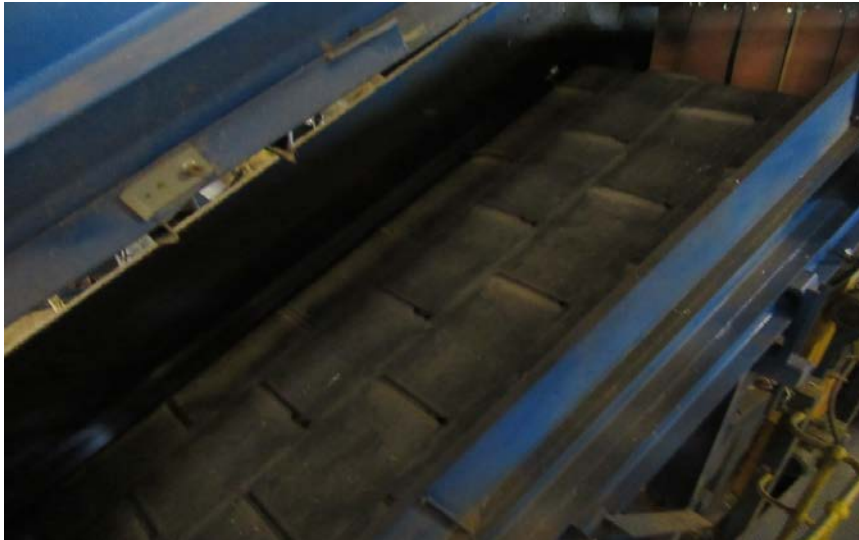
Photo A shows the worn condition of the belting. We recommend replacing this belt when possible.

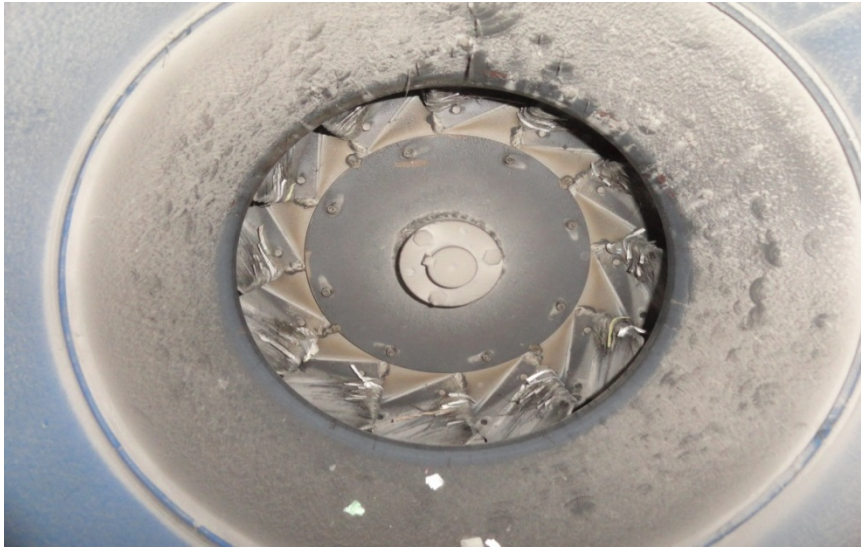
Photo A shows some debris that has built up on the impellor. We recommend that the impellor be cleaned on a regular basis. The silo blower overall is in good condition.

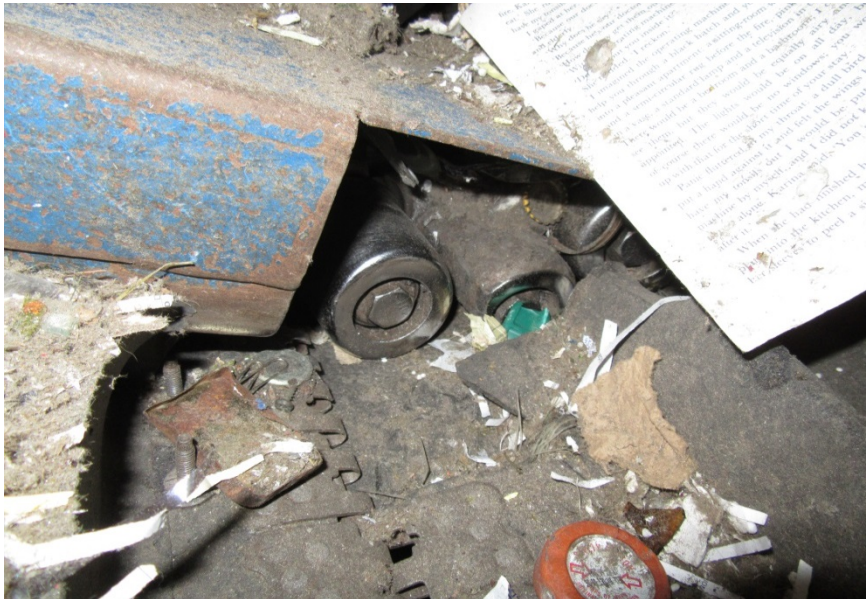
Photo A shows the jammed up- turn roller. We recommend replacing these rollers when possible. Also, the lacing is damaged and in need of repair to prevent material loss.
