City of Ann Arbor MRF Audit

The following report is a maintenance and operations evaluation of the equipment installed at the City of Ann Arbor Materials Recovery Facility by CP Manufacturing. The information gathered for this report was collected by Craig Frisch, Senior Field Project Manager. This information was gathered over a two day period.

Company/Dept.: CP MFG / Customer Service		Title: System Audit		Document Number: Audit

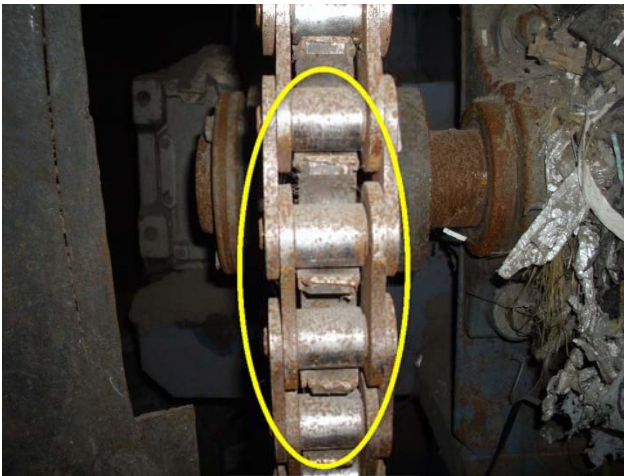
Shaft is wrapped inside of belt.

Head sprocket and Motor sprocket needs to be replaced. When sprockets are replaced, it is advised to change chain.

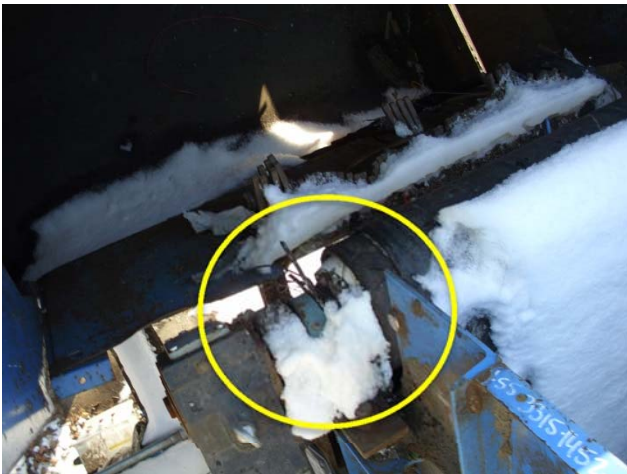
Belt need to be replaced. Cleats are torn/missing.

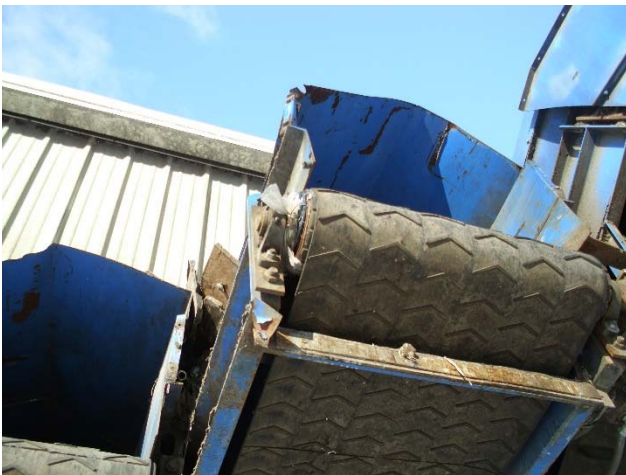
Overall condition of conveyor looks to be in working condition. Belt still has wear life before replacement is needed. Tracking is good.

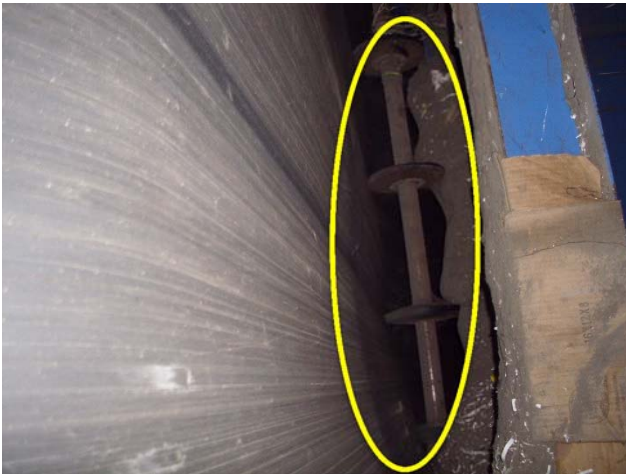
Return Rollers show signs of wear and should be replaced. Head and Tail Pulley needs to be replaced. Overall condition of conveyor is fair, cleaning required for optimal work.

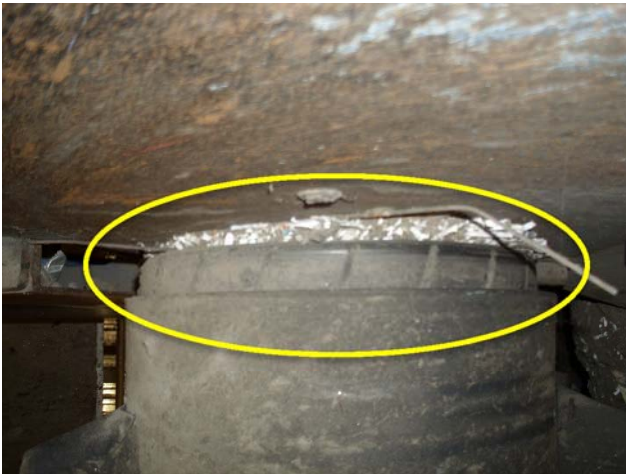
Picture shows belt tracking being off.

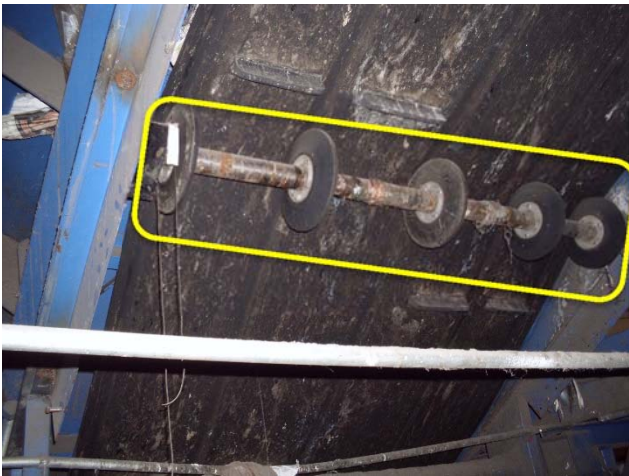
Return rollers are showing signs of wear, but are still serviceable.

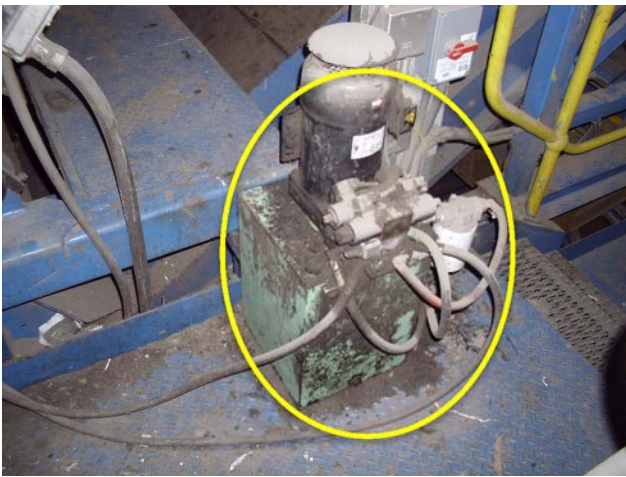
Hydraulics are leaking, replacement needed.

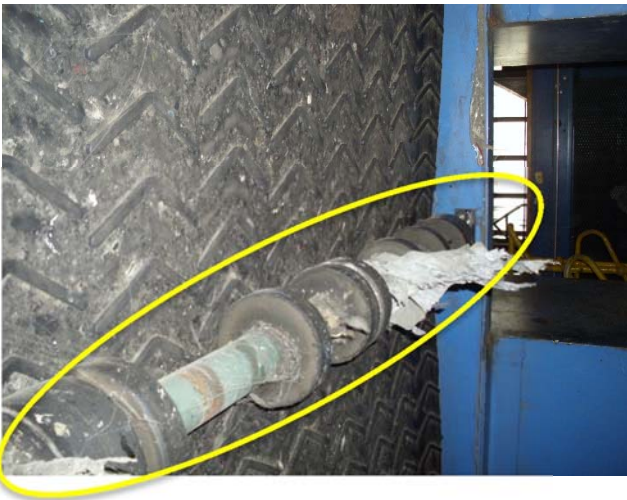
Return rollers are worn and wrapped, replacement required.

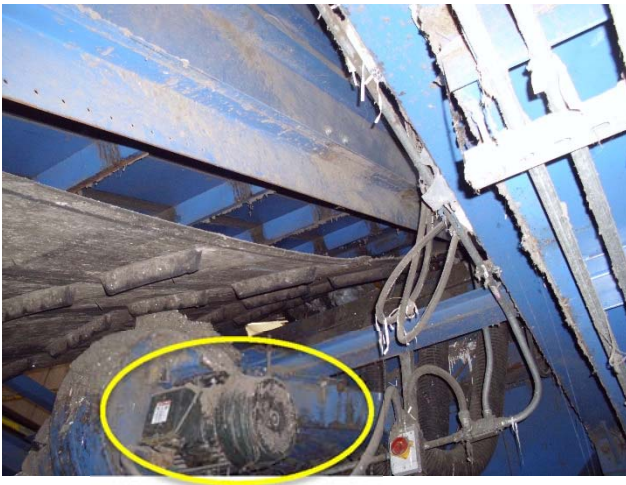
Gearmotor is leaking and needs to be replaced.

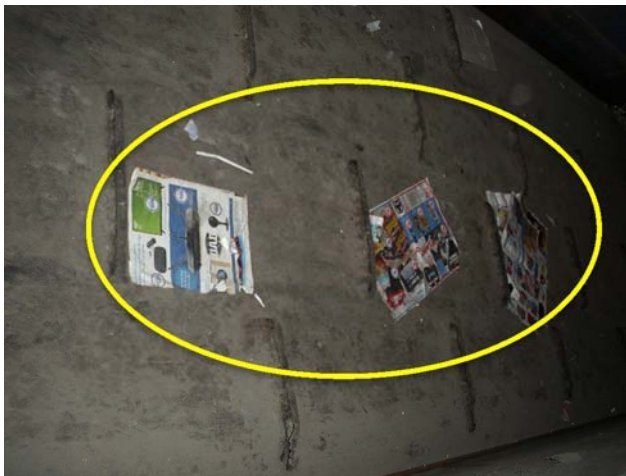
Belt is worn, cleats are barely visible, replacement required.

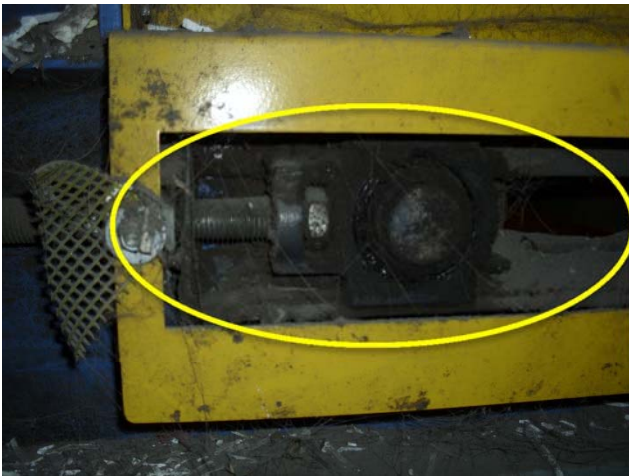
Bearing is worn, guarding is omitted, replacement required.

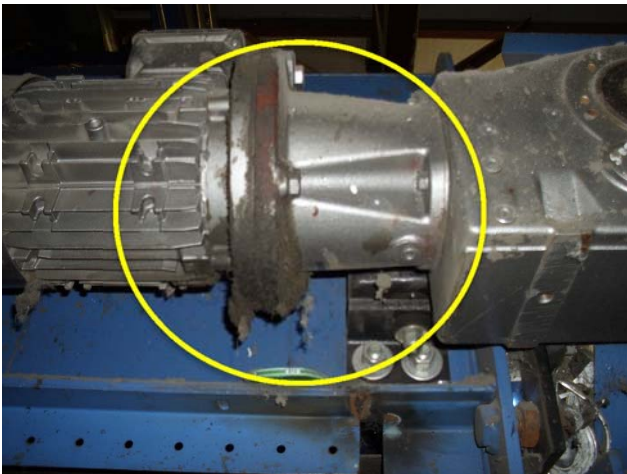
Gearmotor is leaking, replacement required.

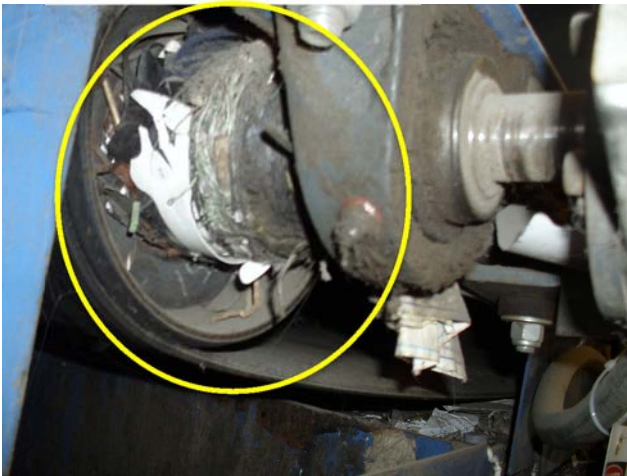
Pulley shafts are wrapped, bearings are worn, replacement of all required.

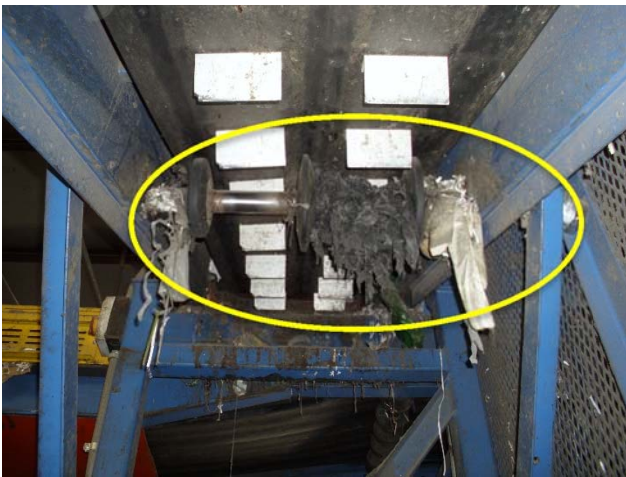
Return rollers are wrapped, cleaning required.

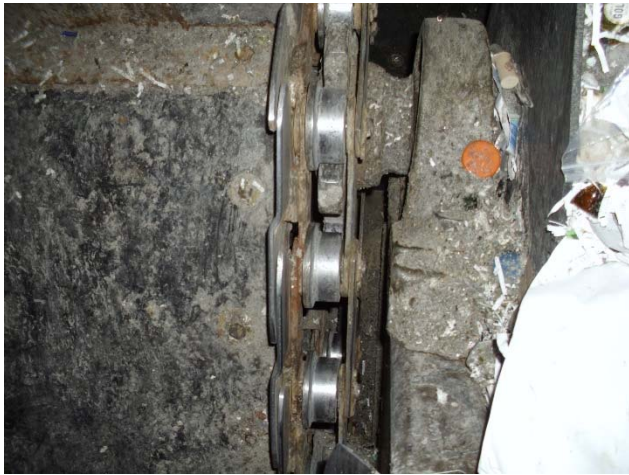
Belt is worn, immediate replacement required.
