## ANN ARBOR HISTORIC DISTRICT COMMISSION

### Staff Report

**ADDRESS:** 607-609 East William, Application Number HDC12-022

**APPLICATION:** The applicant seeks HDC approval to replace eleven double hung wood windows with new Andersen 400 series wood windows.

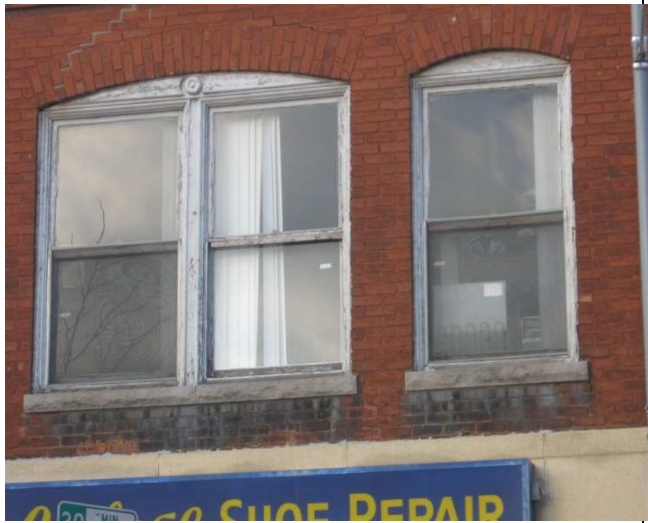
Window Numbers 1, 2 and 3

<b>Window Number</b>	<b>Description of problems with windows</b>	<b>Plan of Action</b>
<b>1</b>	Interior and exterior sash and sill are deteriorated. No lock	Remove and replace window
<b>2</b>	Exterior sill very soft. Sash cord missing	Remove and replace window
<b>3</b>	Sash pulling away in the corner. Sill is rotten	Remove and replace window
<b>4</b>	Interior sash separated in the corner. Sill rotten.	Remove and replace window
<b>5</b>	Broken lower pane. Sash area separated. No lock. Cord & Sash missing.	Remove and replace window
<b>6</b>	Upper pane is broken. Sash missing. Window boarded	Remove and replace window
<b>7</b>	Rotten sill, outside sash soft. No lock	Remove and replace window
<b>8</b>	Both sashes held with nails and screws. No lock. No cord sash.	Remove and replace window
<b>9</b>	Sash rotted from inside. Soft sill outside.	Remove and replace window
<b>10</b>	No lock. Window sash held together with screws	Remove and replace window

All windows show similar deterioration

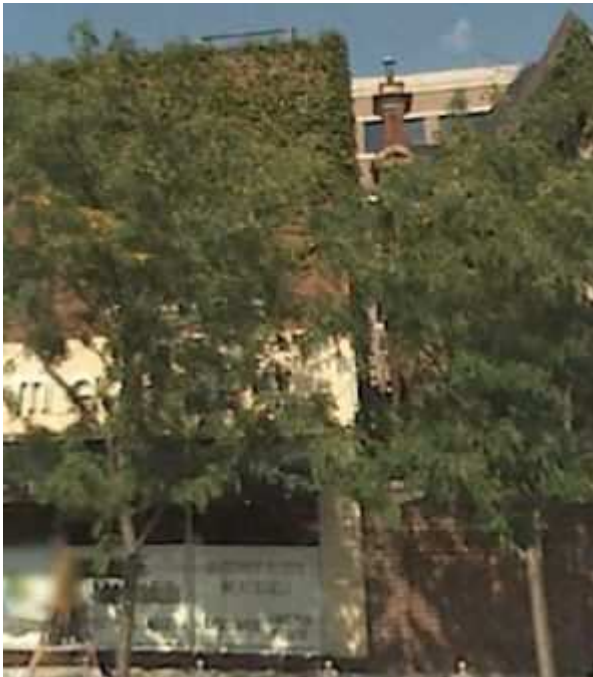
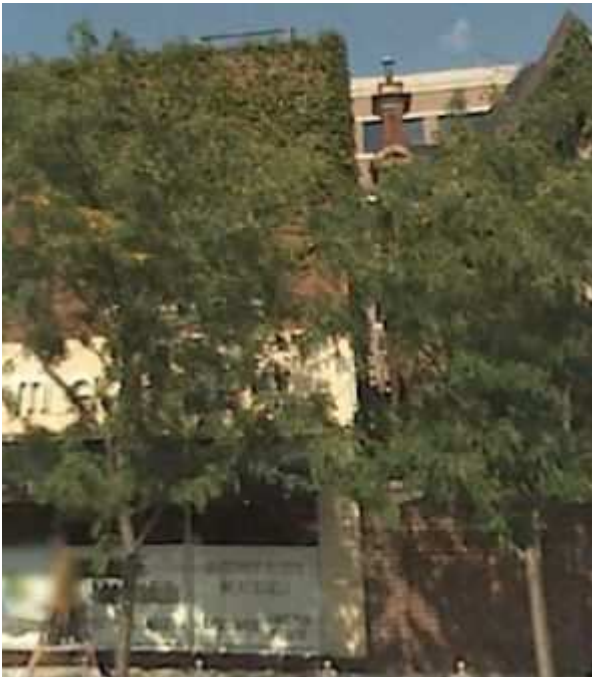
As the photos below illustrate, many of these windows are shaded. Additional windows not pictured are on the north side of the building, which receives very little sunlight.

We believe that both conditions have encouraged the rot and decay of the existing sills in this building, particularly because of its age. Fungal growth is also a problem with wood sills.

**Reasons for using Fibrex sills in this project rather than not wood.**
