STANDEN ENGINEERING SERVICES

RE: Structural Observations
Existing Pole Barn Building
2950 E. Ellsworth Rd.
Ann Arbor, MI 48108

City of Ann Arbor Public Services
Structural Observations of 2850 E. Ellsworth Rd, Ann Arbor, MI 48108
October 17, 2011

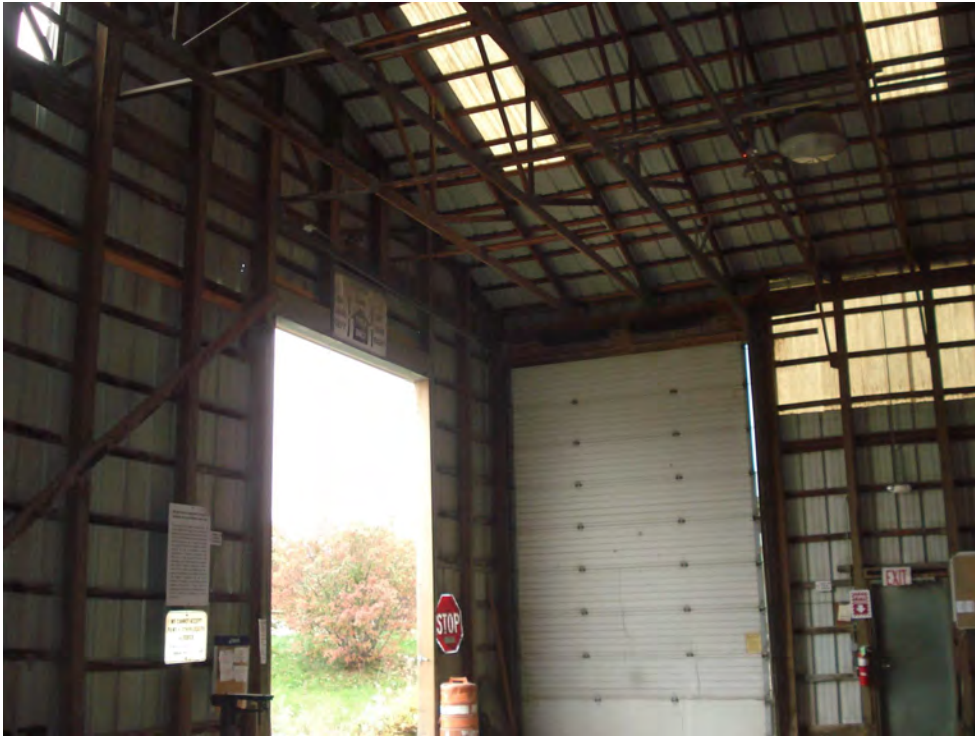
The soil conditions have resulted in differential settlement of the building foundations and floor slabs. The southeast corner of the building appears to have settled at least 12 inches (Photograph 5). The settlement has caused rain-water runoff to accumulate at the east end of the building. The original section of the building, at the west end, is relatively level. An elevation survey of the building has not been performed at this time. Because of the soil conditions, additional settlement is expected.

5. Southeast corner of the building has settled at least 12 inches.

- Water drainage should be improved at the east end of the building to minimize the amount of water that is percolating into the soil and contributing to the settlement.
- The sanitary sewer line for the bathroom located at the northeast corner of the building should be checked for settlement and flow constraints.

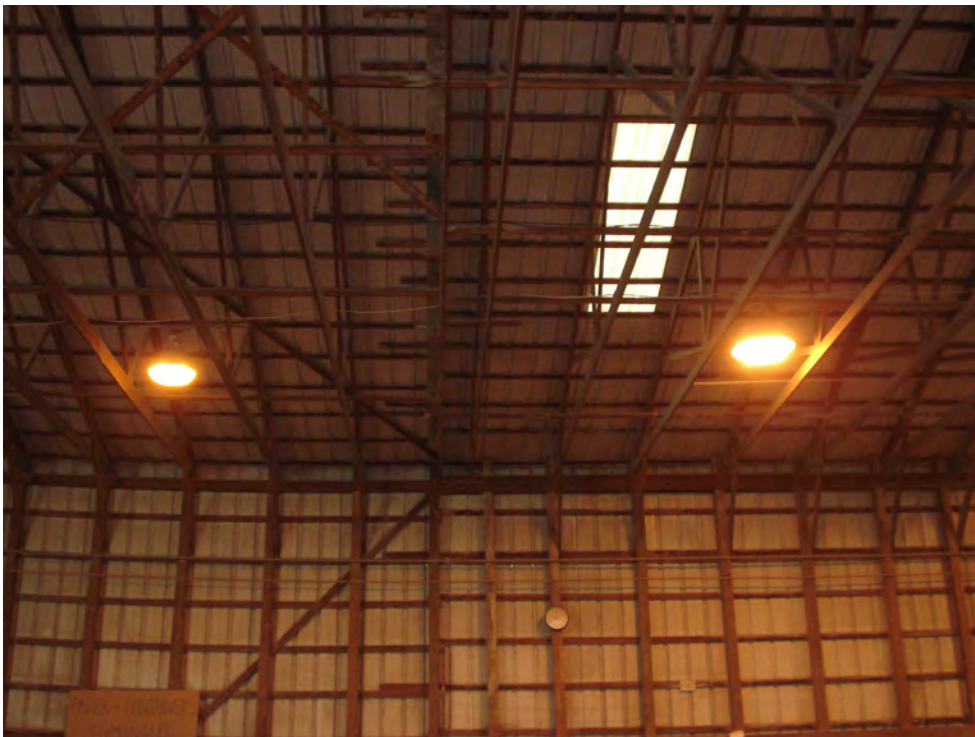
The post and beam construction and the wood trusses are fairly flexible and tolerant of differential settlement. The settlement of the wall posts has caused the trusses to slope down from the north wall to the south wall (Photograph 6). The gable-end trusses at the east and west ends of the east additions are stressed by the differential movement (Photographs 7 and 8). Several lateral braces have come loose and the steel connector plates are stressed. The movement of the trusses has also caused several of the angled stiffeners along the north wall to crack.

6. Trusses slope downward from the north to the south wall.

- The gaps in the metal siding and the roofing should be patched to minimize water intrusion into the building.
- The gable-end trusses at the east and west ends of the east additions should be attached to the adjacent trusses with diagonal bracing.
- The angle bracing at the north wall, between the posts and the bottom chords of the trusses, should be inspected and reattached as necessary.
- Additional 45° diagonal bracing should be installed between the center, vertical members of the trusses to add lateral support to the roof framing.

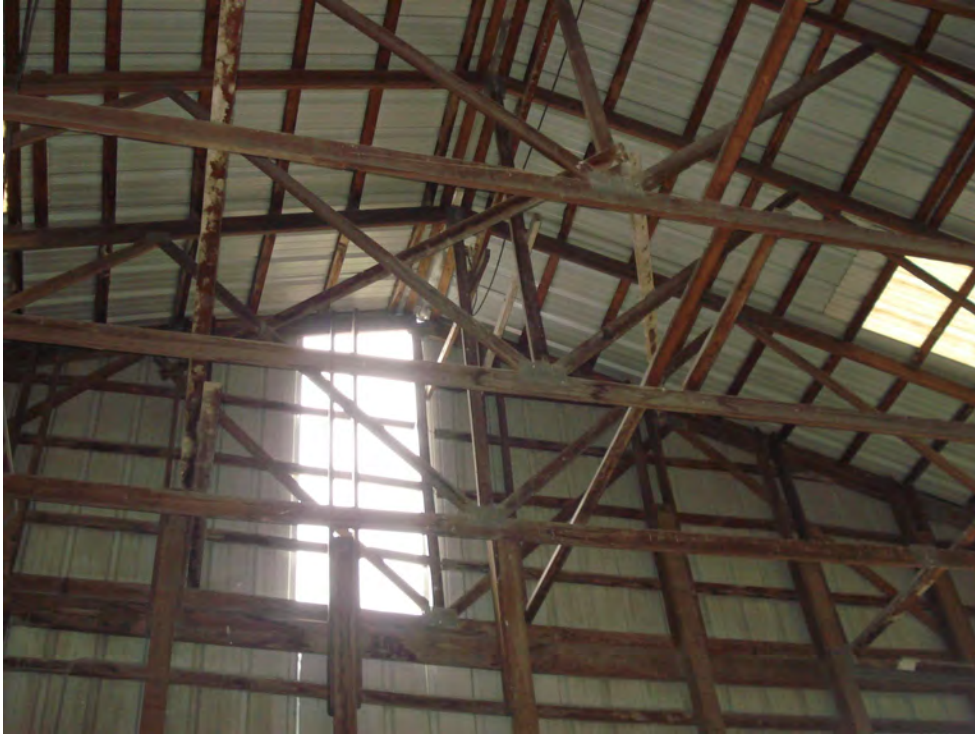
The settlement has also caused some displacement of the metal siding and roofing. This has made the siding and roof more susceptible to wind damage. Gaps in the metal siding and roofing is allowing rain water to enter the building and may cause long-term corrosion concerns at the nailed joints.

7. Siding gaps and truss movement at the east gable end of the roof.

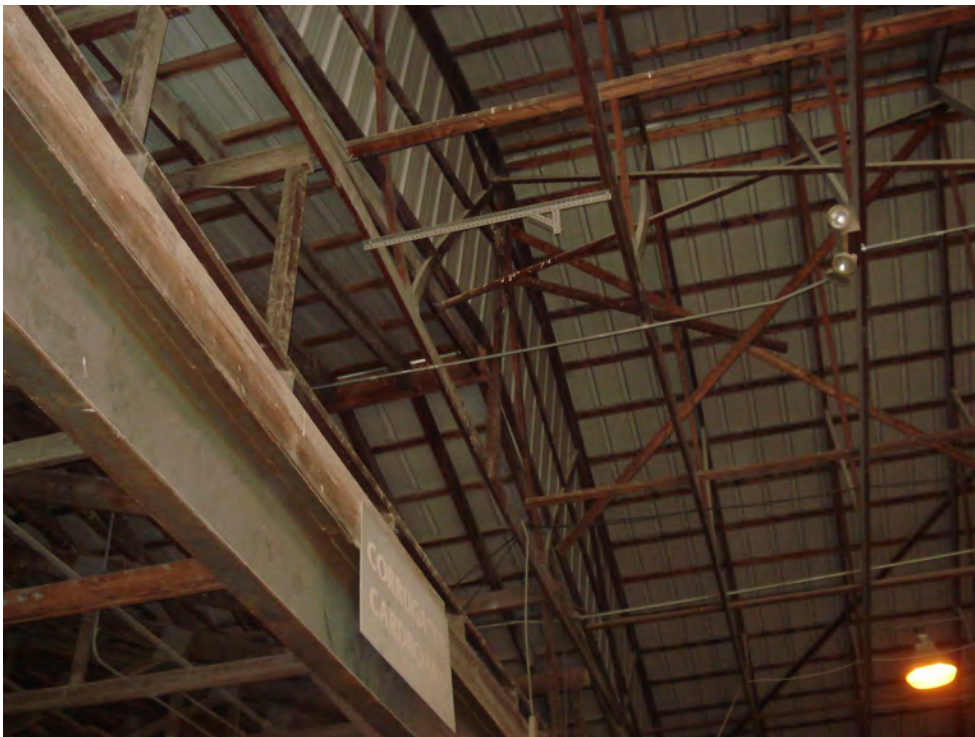
8. Loose bracing and stressed members at the west gable end.
