CITY OF ANN ARBOR
MATERIAL RECOVERY FACILITY
4150 Platt Road
Ann Arbor Michigan, 48108

PROCESS SYSTEM
INSPECTION REPORT

Ann Arbor – Inspection Report

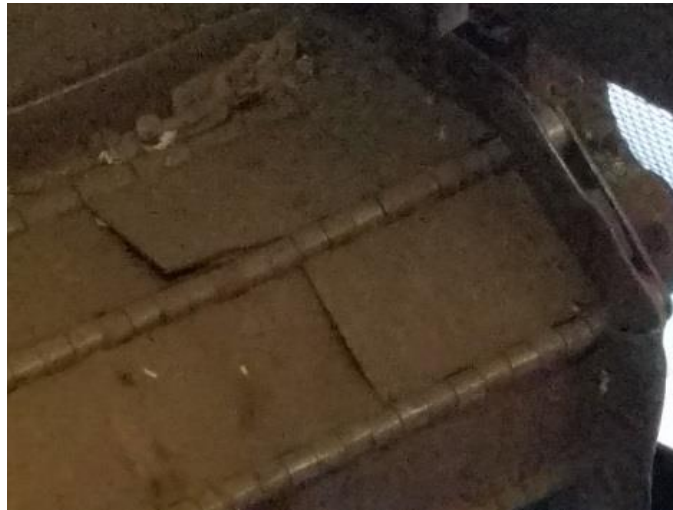
POS M-1 Infeed Conveyor

- Steel Belt Separating
- Guarding under head pulley missing
- Loose electrical wire on motor
- Wrappings on head pulley shaft

Ref A5

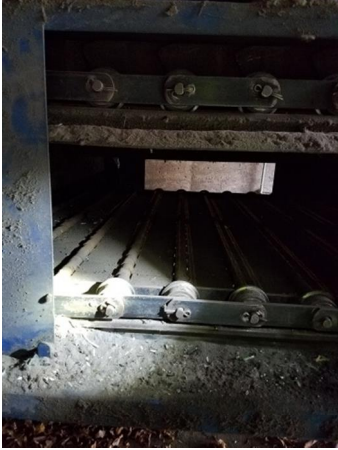
POS M-2 Incline/Presort Conveyor

- Guarding missing, open exposed chain accessible
- Missing link pin and worn roller wheels on chain
- Bent support, not lagged to floor
- Heavily worn sideboards at Metering Drum and below
- Belly pan under head pulley bulging apart from material buildup
- Bent cleats
- Tail Guard not secured

Ref A5, A8, A9

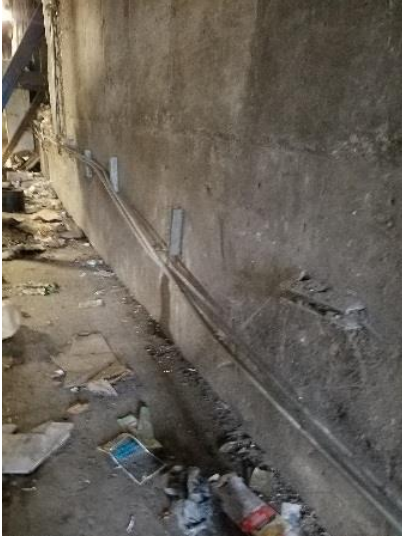
POS M-2 Surrounding Area

- Loose conduit hanging from wall
- Improper lighting support over Q.C. station
- Electrical Line crimped
- Chute(s) stuffed with material
- Floor deck lifting in areas
- Bottom step to presort bent

Ref A14

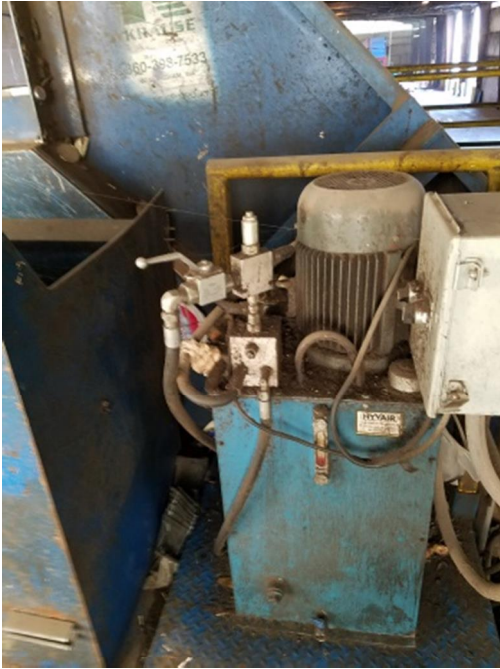
POS M-3 Metering Drum

- Loose hydraulic lines and leaking hydraulic power pack
- Worn drum and cleats
- Wrappings on drum shafts

Ref A4, A10

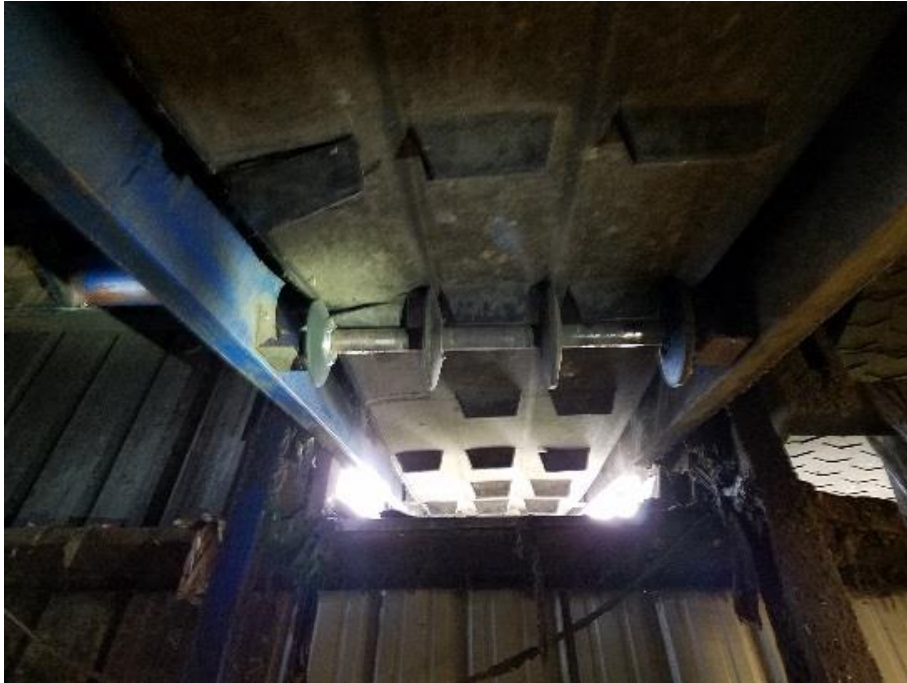
POS M-4A Transfer Conveyor

- Loose and missing cleats
- Wrappings on head pulley
- Worn and missing Return Rollers

Ref A2, A3, A5

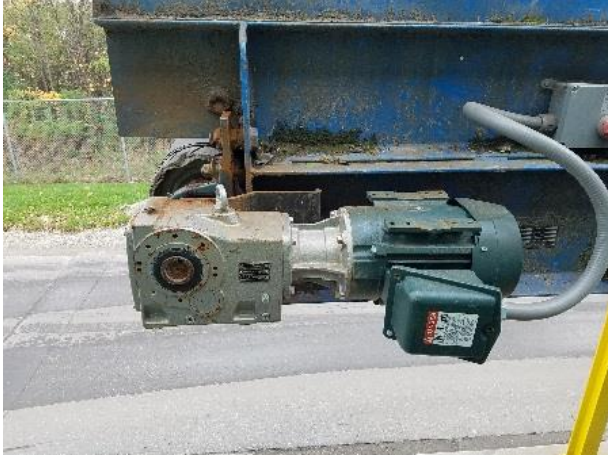
POS M-4B Transfer Conveyor

- Bent head pulley and wrapping on shaft
- Belt heavily worn and damaged lacing
- Return Rollers missing

Ref A3, A7, A10

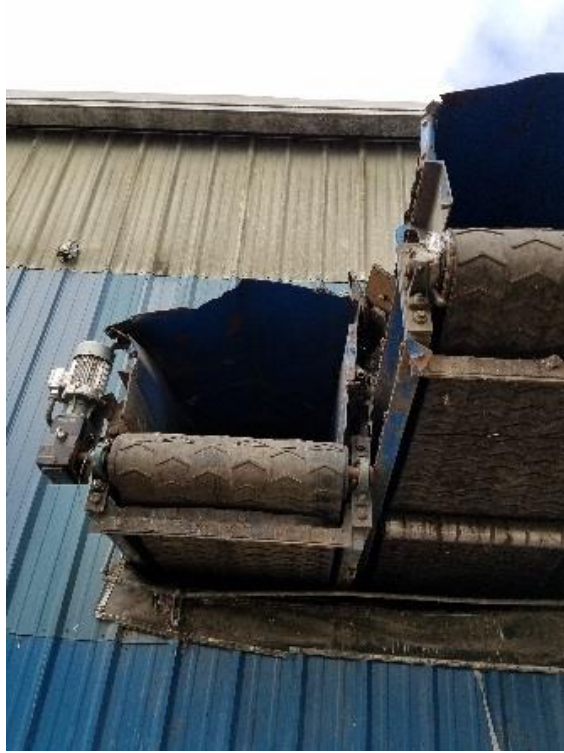
POS M-5 Trash Transfer Conveyor

- Wrapping on head pulley
- Gearbox possibly leaking
- Belt not tracked and cutting sideboard

Ref A3, A5, A6, A10

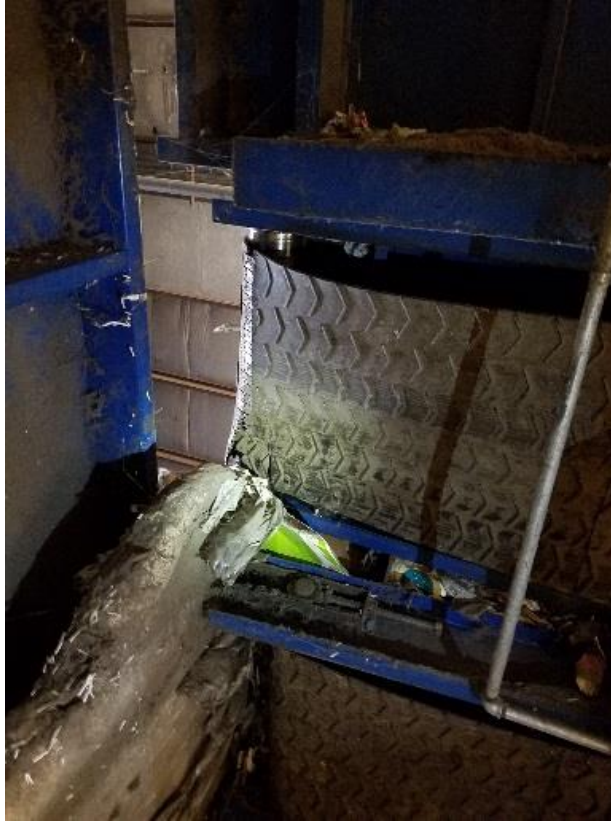
POS M-6 Large Plastic Transfer Conveyor

- Lacing torn & ripping
- Tracking off

Ref A5

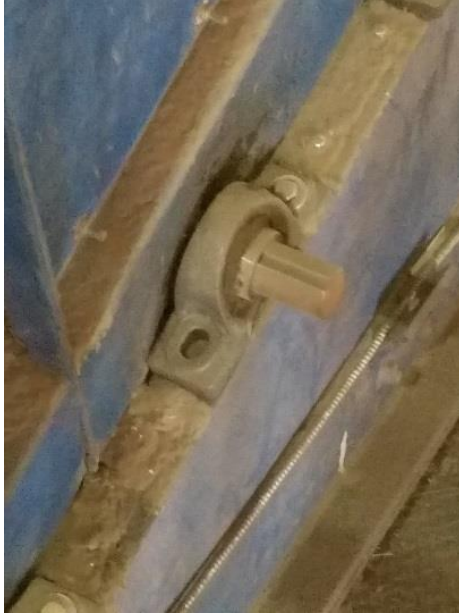
POS M-7 OCC Screen

- Bearing bolt missing
- Gearbox leaking
- Oil reservoir missing/broken
- Motor fan cover missing screw
- Motor seal-tight damaged
- Teeth on Discs heavily worn
- Transfer plate at Infeed worn thru
- Additional Fall Protection needed on right side ladder (overlooking Tip Area)

Ref A8, A9

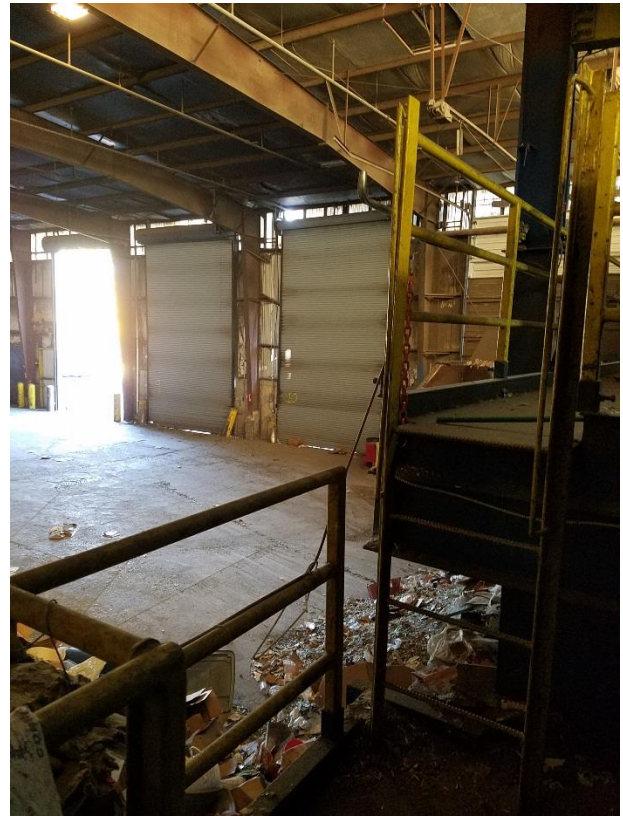
Ref A8

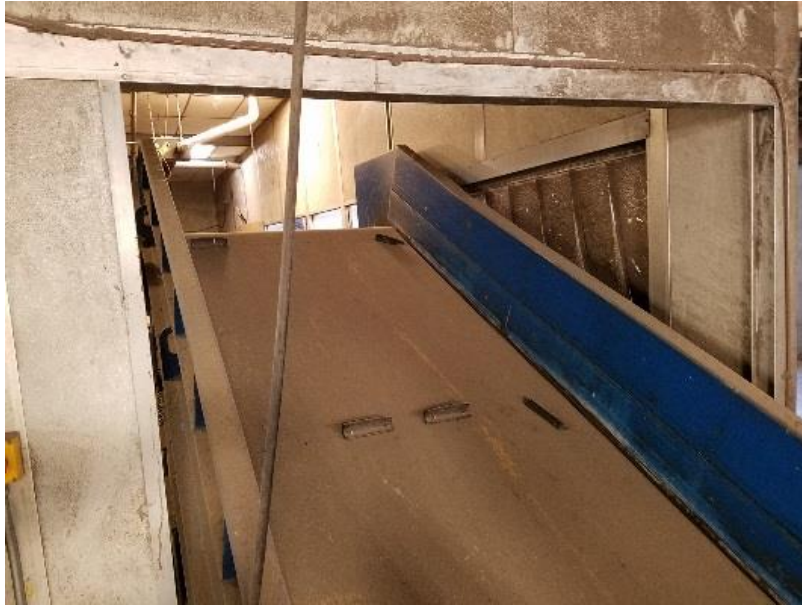
POS M-8 OCC Transfer Conveyor

- Belt Cleats missing and loose
- Threshold to Pos M-9A trip hazard

Ref A5

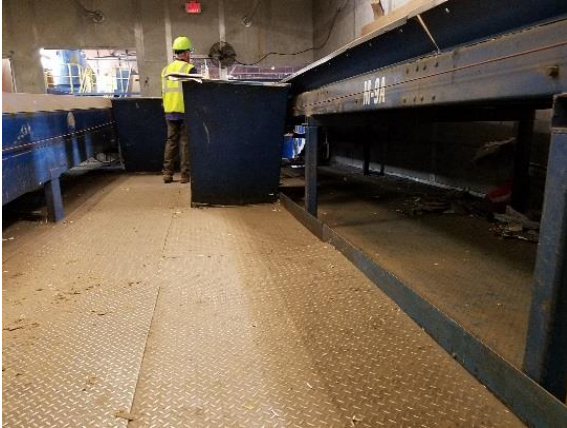
POS M-9A OCC Q.C. Conveyor

- Missing Belly Guard
- Open electrical box (no cover)
- Motor drive guard damaged
- Missing/Loose Sideboards
- Damaged Sort Chutes
- Deck lifting at Sort Station

Ref A11, A12

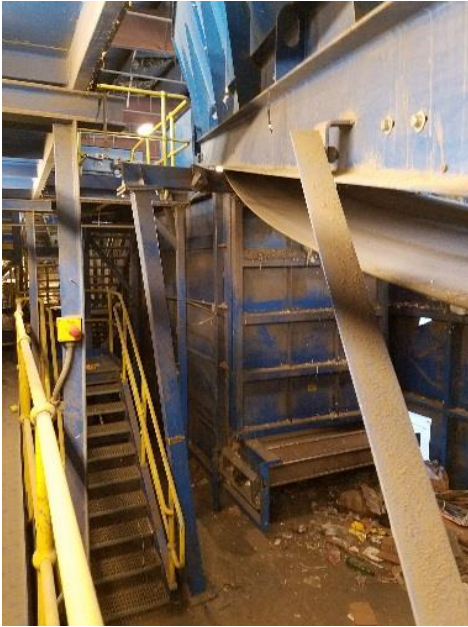
POS M-9B OCC Transfer Conveyor

- Bent/Leaning support
- Bolted connection incomplete
- Missing/Worn Return Rollers
- Add Right-side Transition Plate to Contain Material

Ref A2, A7

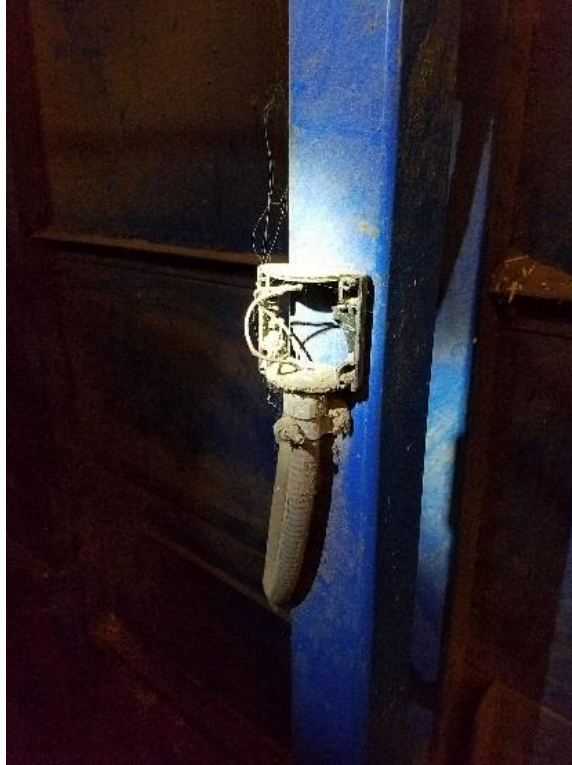
POS M-10A OCC Storage Conveyor

- Missing E-stop
- Missing Tail Guard

Ref A14

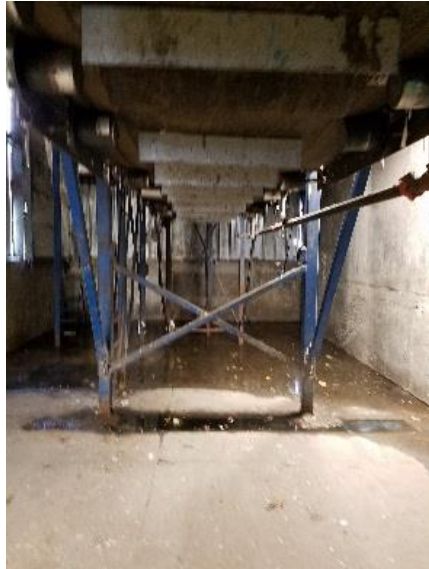
POS M-11 Screen Thrus Transfer Conveyor

- Belly Guards missing
- Self-cleaning Tail Pulley packed with material
- Windings on tail shaft
- Return Rollers worn
- Feed chute packed with material and worn
- Upturn Return Roller missing from radius

Ref A8

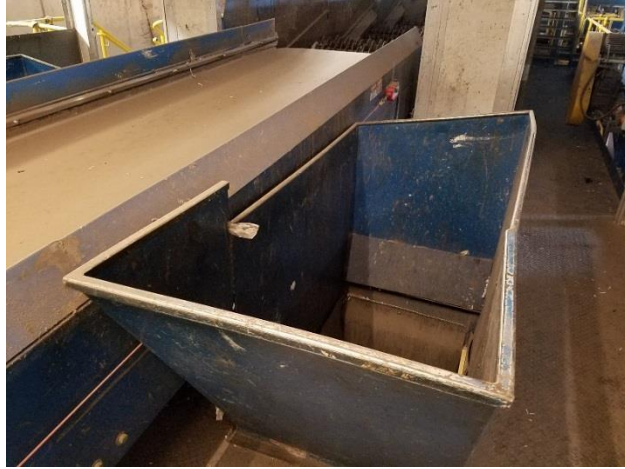
POS M-12 Mixed Transfer Conveyor

- Return Rollers missing
- Damaged Sorting Chutes with sharp edges
- E-Stop Pull Cord missing eye-loops along conveyor

Ref A6, A11, A12

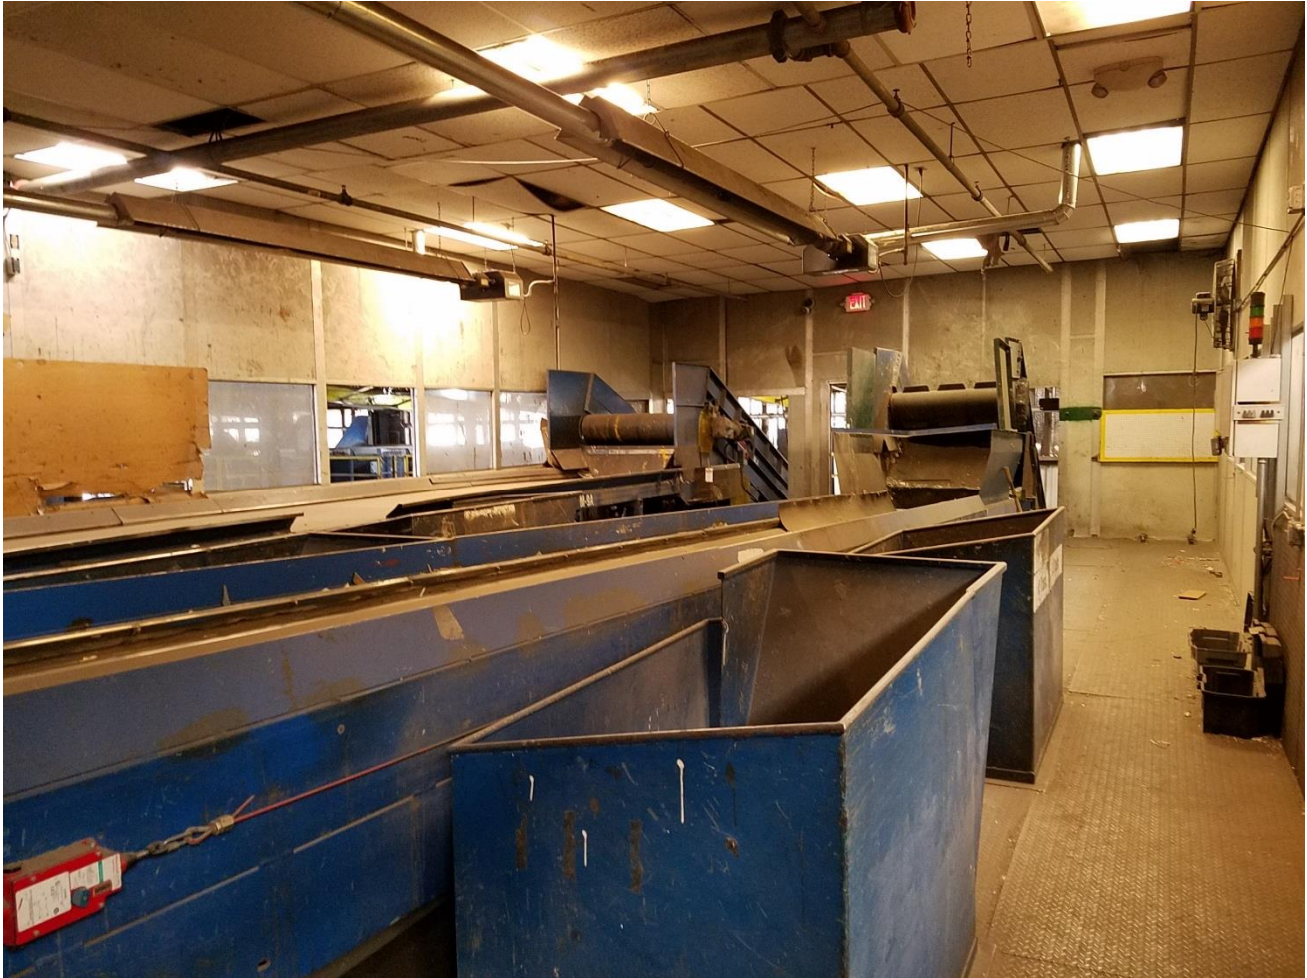
POS M-13 Scalping Screen Presort Conveyor & Surrounding Area

- No guarding to belt underside
- Open electrical box (no cover)
- Motor drive guard damaged
- Distorted chutes with sharp edges

Ref A6, A8, A12

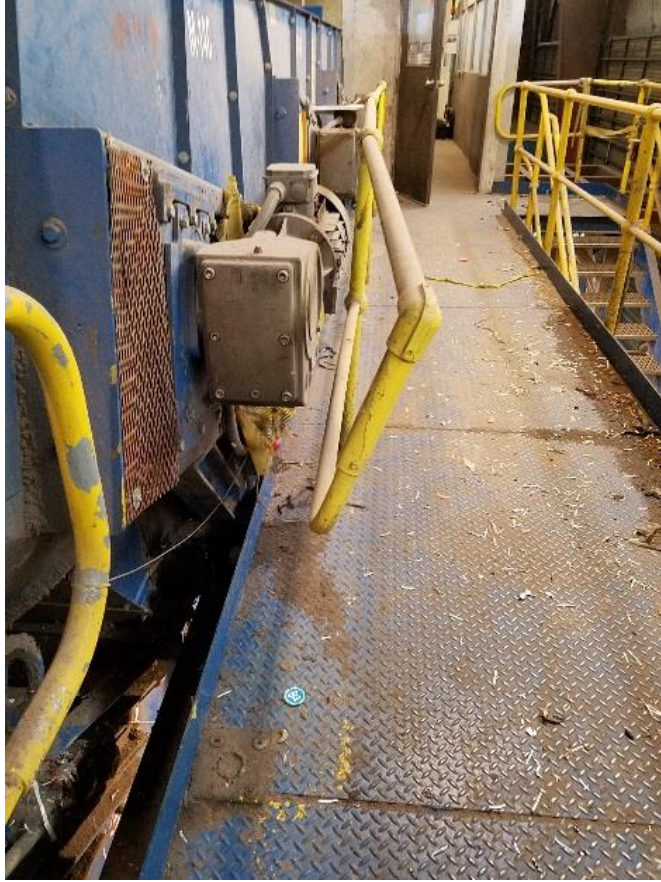
POS M-14 Scalping Screen

- Leaking Drive Motor
- Bent Handrail adjacent
- Heavily worn discs

Ref A1, A4, A7

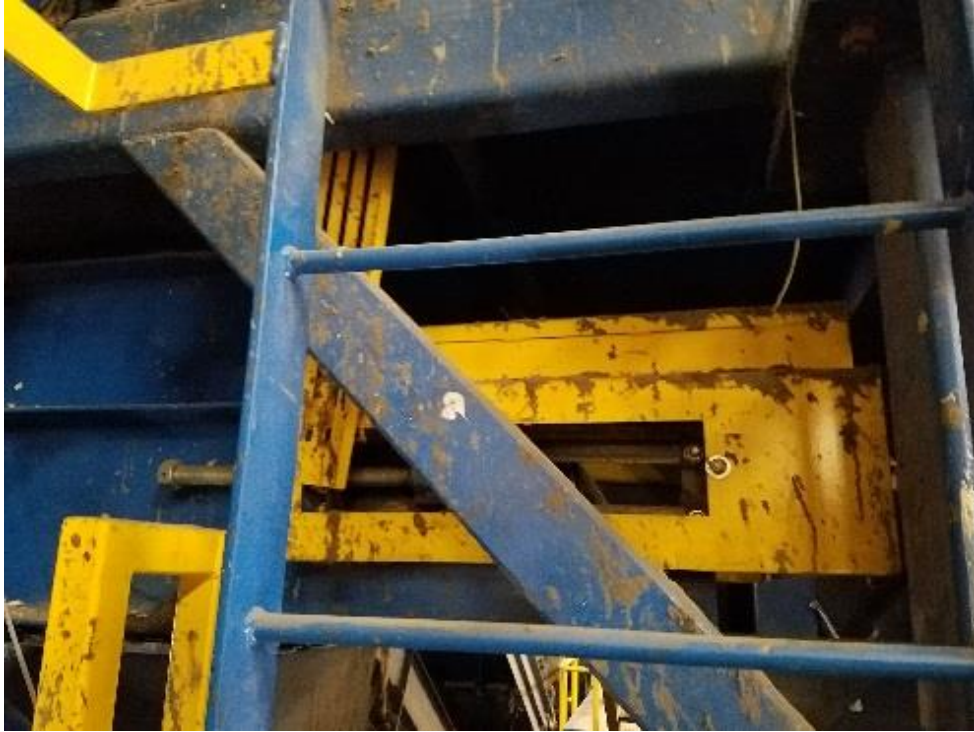
POS M-16A OCC Transfer Conveyor

- Tail Bearing Guard missing

Ref A8

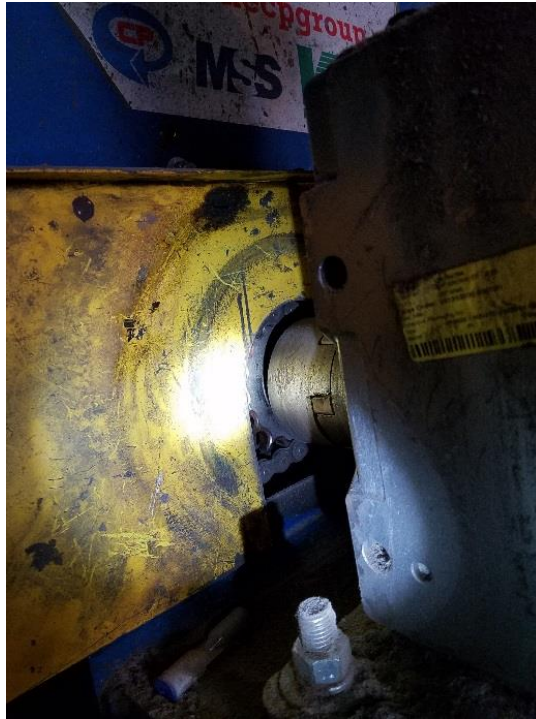
POS M-17 ONP Screen

- Worn Sprocket
- Hydraulic Power Pack Leaking

Ref A9

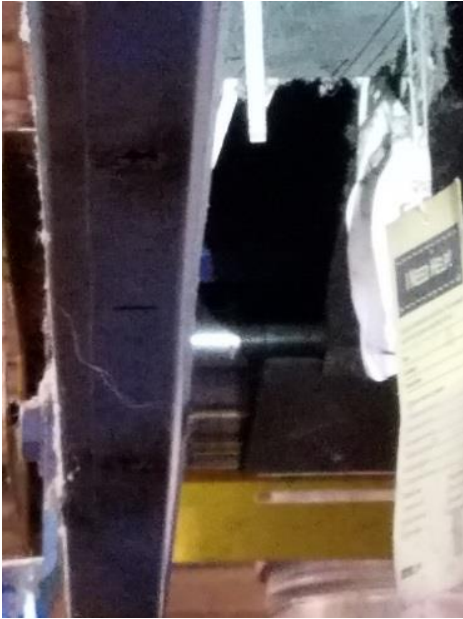
POS M-18 Fiber Transfer Conveyor

- Belt edge torn
- Wrapping on Return Roller
- Tail Bearing Guard missing
- Missing Belly Pan at Tail
- Bearings worn
- Tail Shaft worn

Ref A5

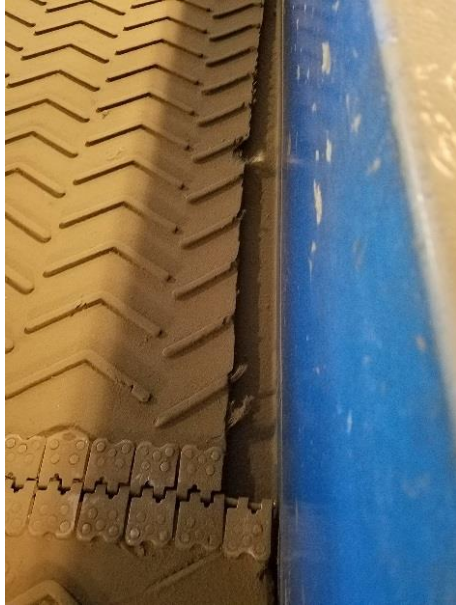
POS M-20 Fiber Sort Conveyor

- Belt torn along edge
- Wrappings on Head Pulley
- Missing Belly Guard

Ref A5

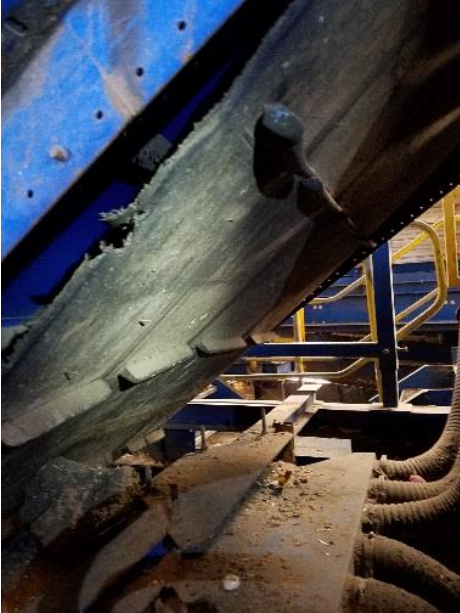
POS M-21 CP Screen Feed Conveyor

- Torn belt edge
- Missing cleats and return rollers
- Motor leaking
- Missing Dust Cover on oiler

Ref A2, A5

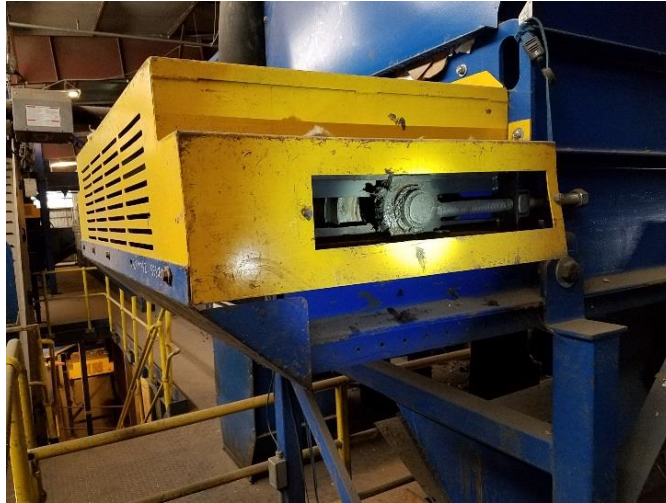
POS M-23 Mid Fiber transfer Conveyor

- Tail Bearing Guard missing
- Missing Tail Belly Pan
- Bearings worn
- Questionable OSHA compliant guarding

Ref A8, A10

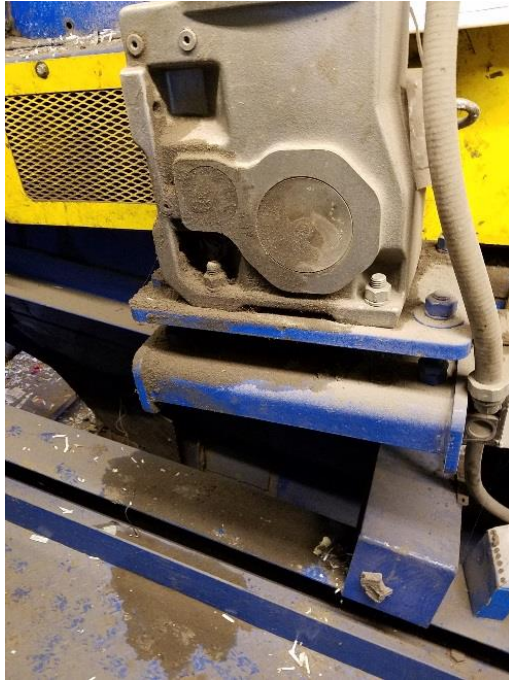
POS M-29 Glass Breaker

- Motor Drive Leaking
- Missing/Inoperative Disconnect Switches
- Empty Oil Reservoir

Ref A14

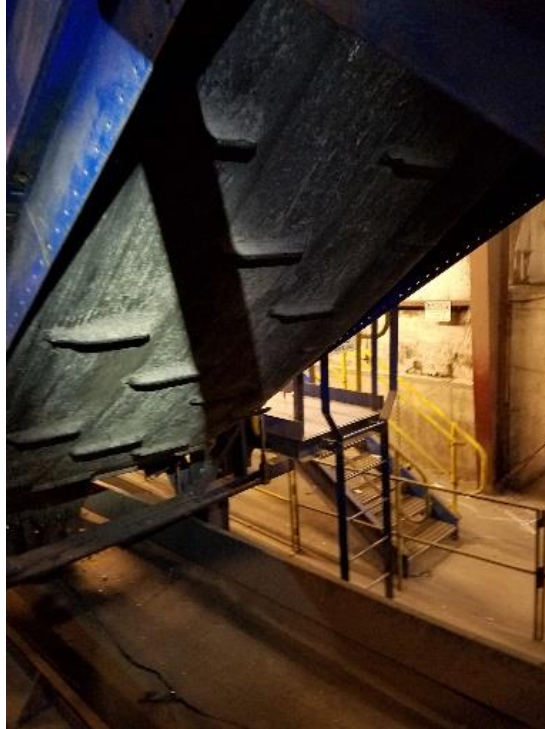
POS M-30 ADS Feed Conveyor

- Worn Cleats
- Missing/Damaged Return Rollers
- Missing Belly Guards

Ref A5, A8

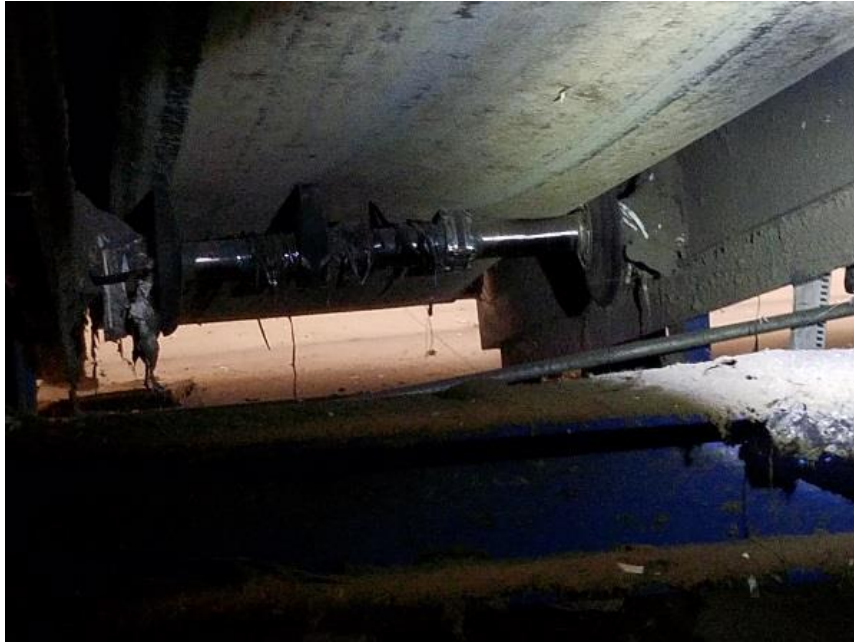
POS M-32 Fiber Transfer Conveyor

- Drive leaking
- Worn Return Rollers
- Broken electrical conduit

Ref A2, A3

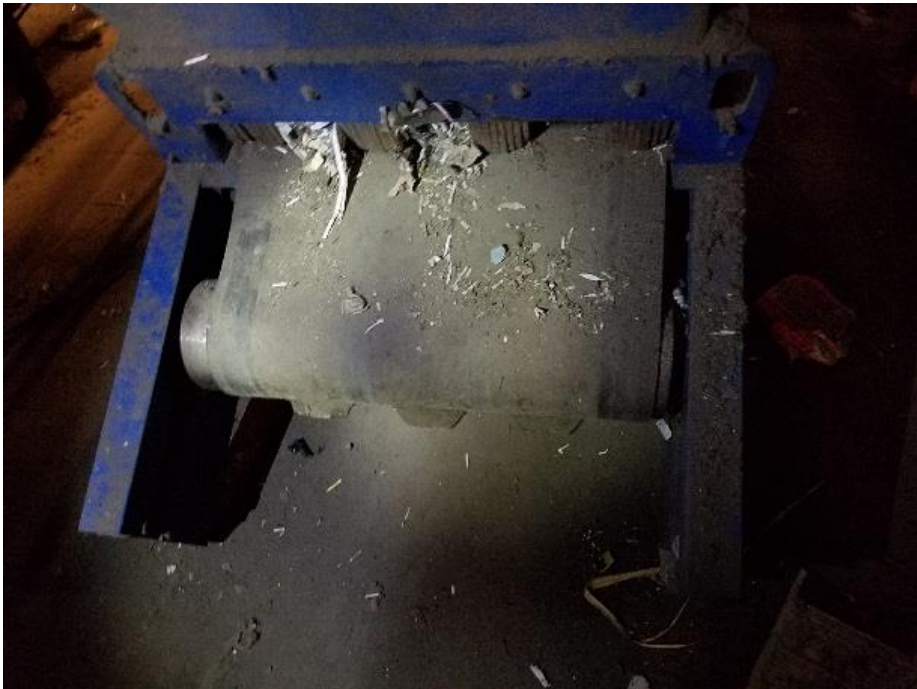
POS M-33 Fiber Transfer Conveyor

- Missing Tail Guard
- Loose/Worn/Patched Belting

Ref A8

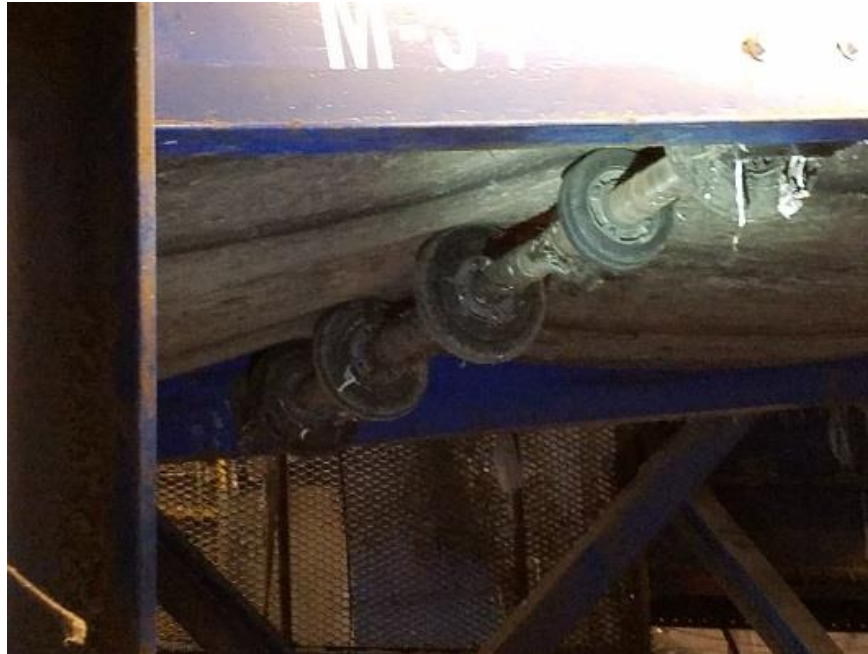
POS M-34 ADS Feed Conveyor

- Worn Return Rollers

Ref A2, A3

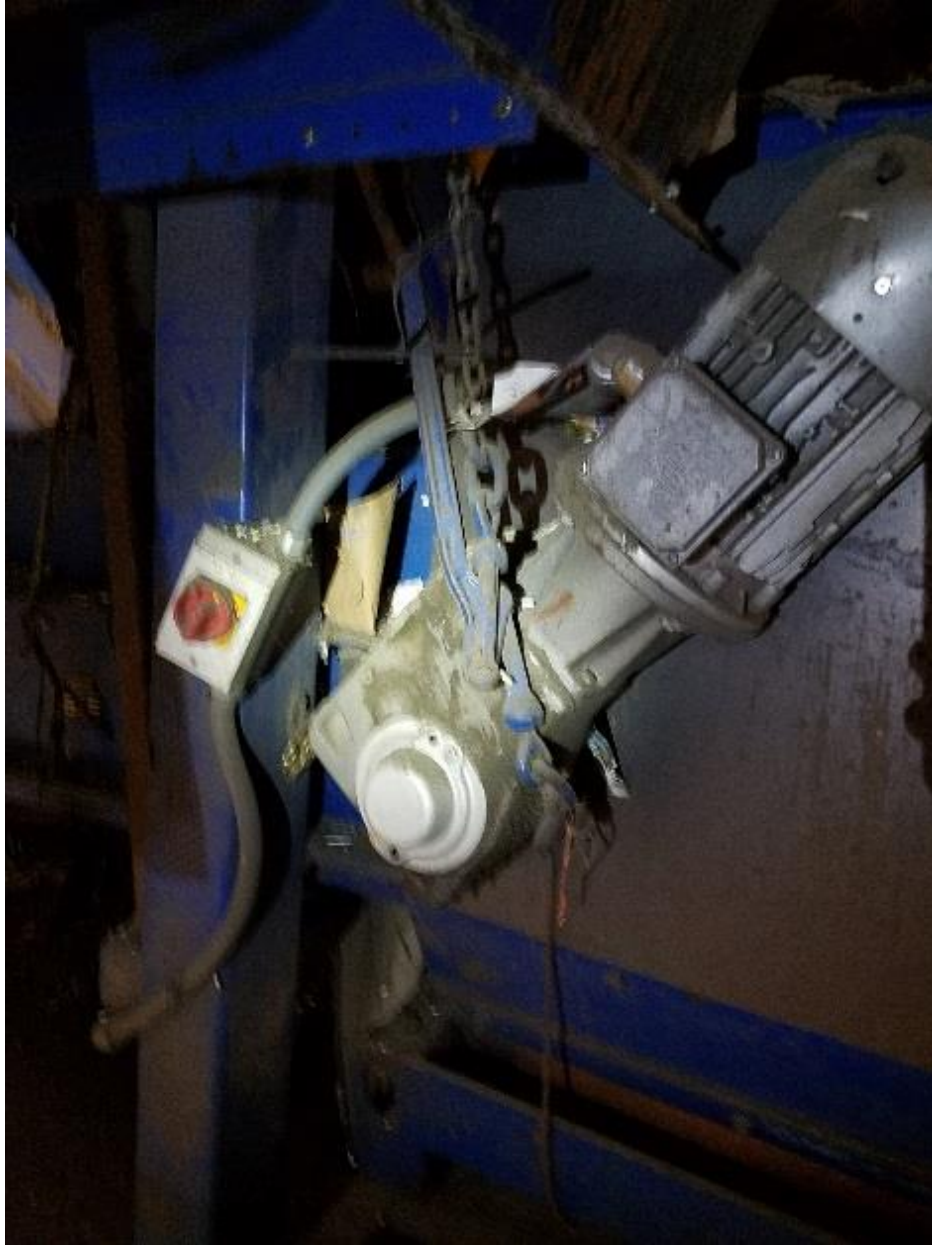
POS M-37 Fiber Transfer Conveyor

- Chain Binder used as motor support

Ref A15

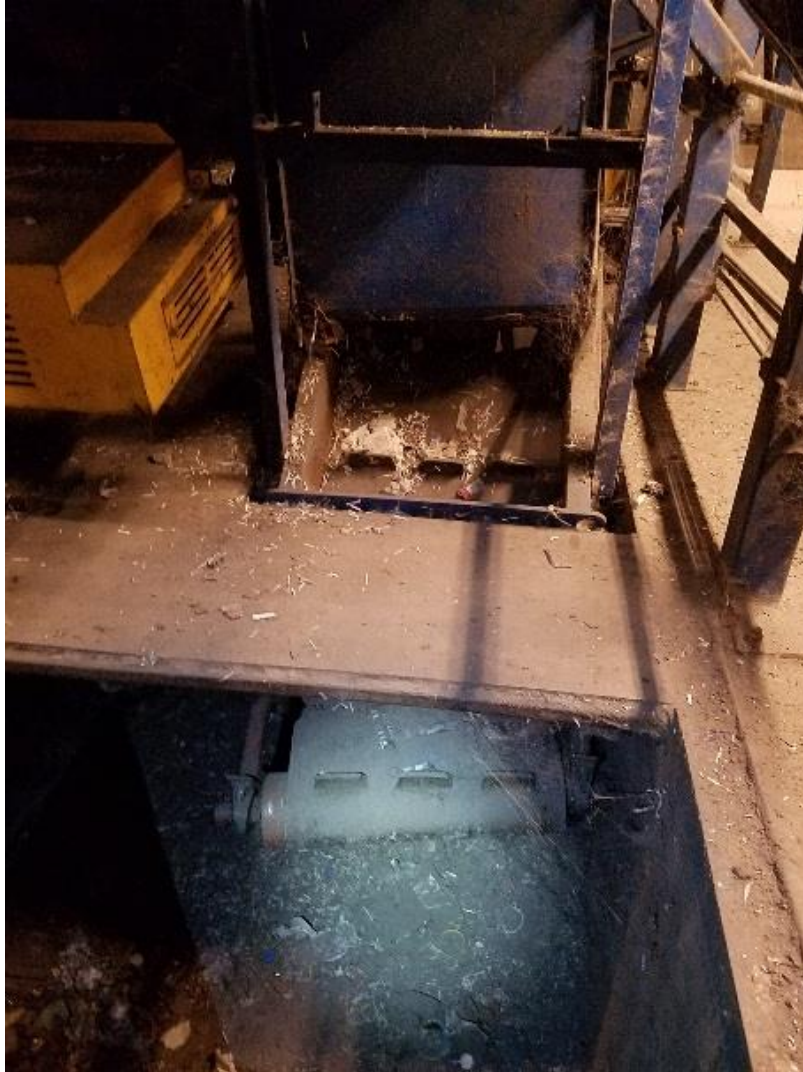
POS M-46A B&C Transfer Conveyor

- Offset Take-up, Belt not tracking

Ref A5

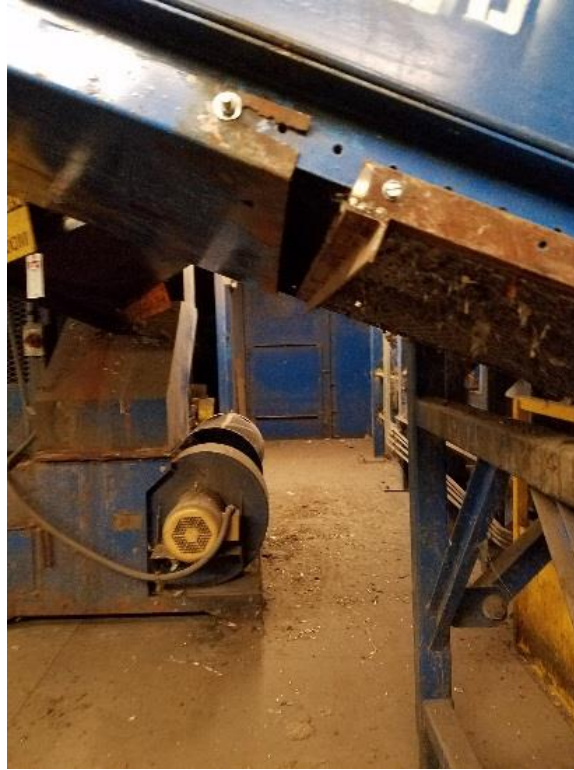
POS M-46B B&C Transfer Conveyor

- Belly Pan Spacing to be closed
- Worn Return Rollers and belting

Ref A6, A8

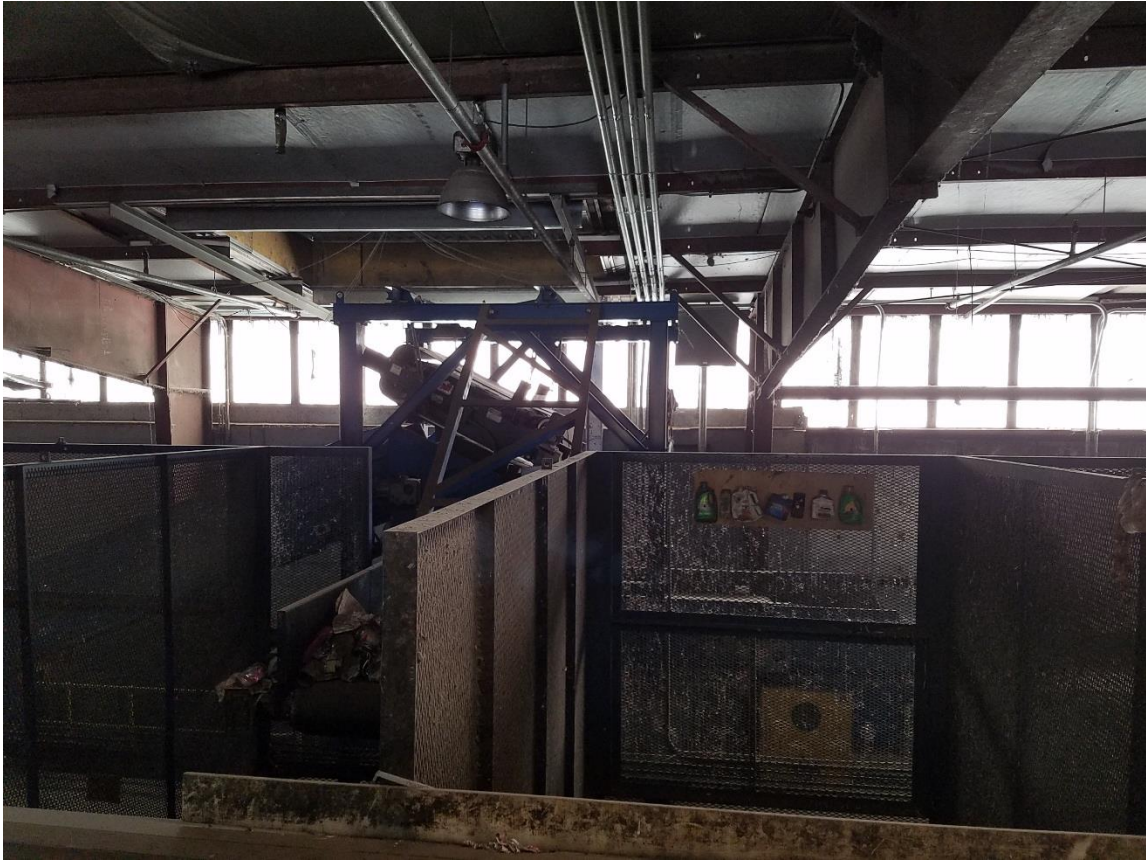
POS M-49 FE Transfer Conveyor

- Drive Leaks
- Missing Return Roller

Ref A2, A4

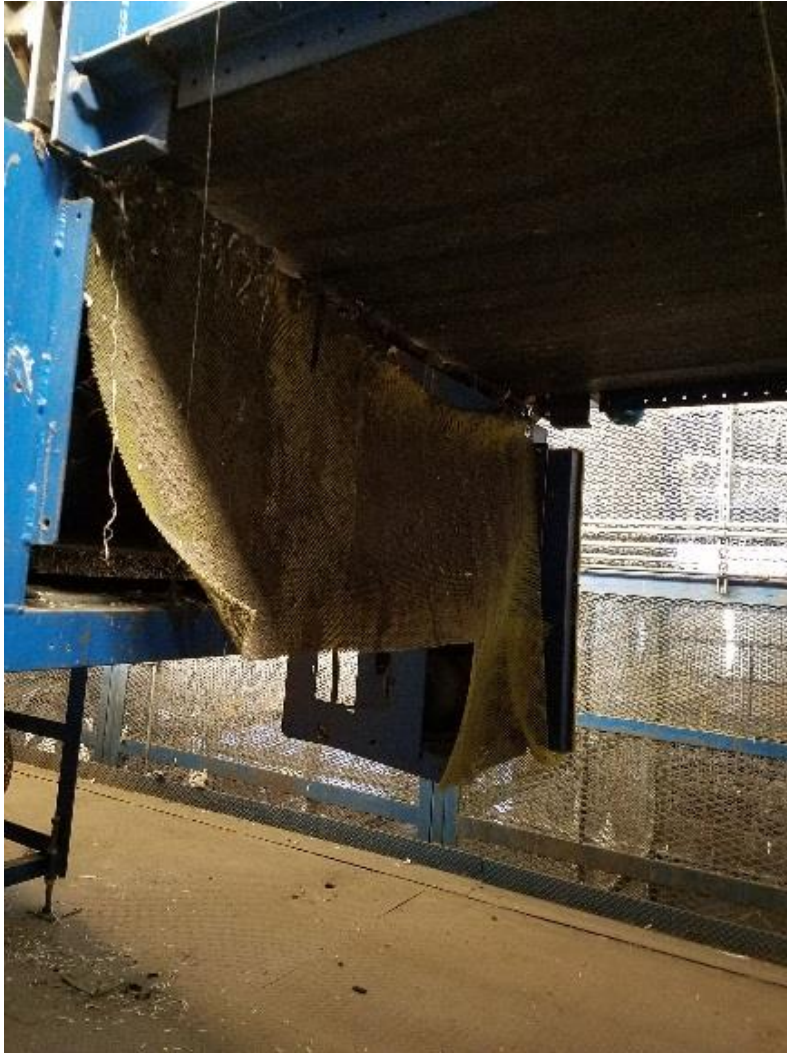
POS M-50A Accelerator Conveyor

- Missing Tail Guard
- Missing Belly Guard

Ref A6, A8

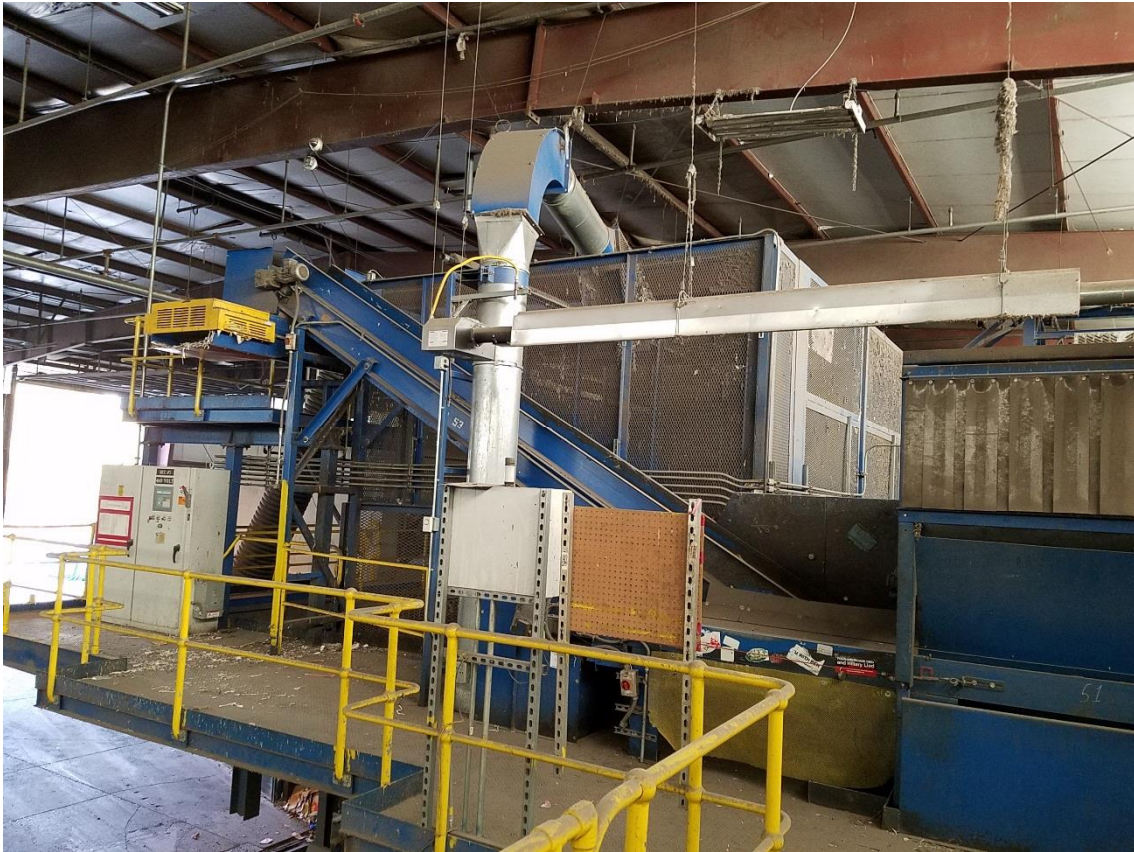
POS M-51 PET Q.C. Conveyor

- Insufficient Belly Guarding

Ref A8

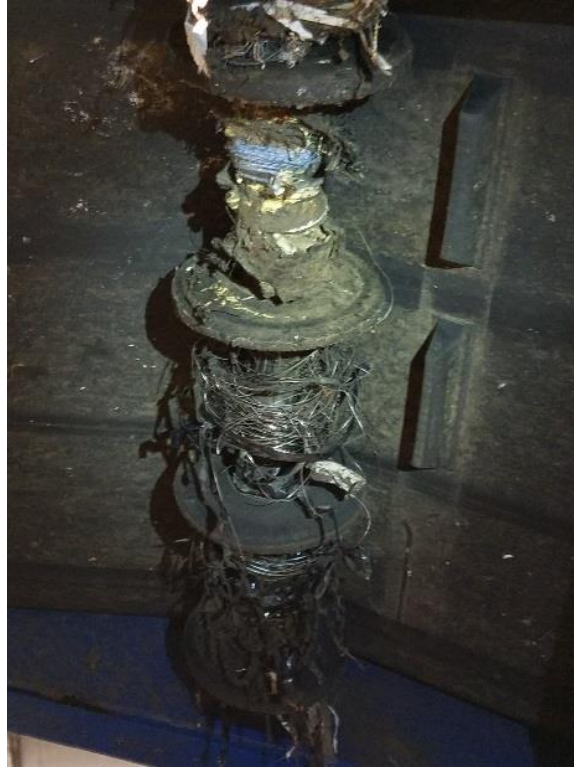
POS M-53 Pass Fraction Transfer Conveyor

- Heavily worn Return Roller
- Insufficient Guarding where conveyor comes thru platform

Ref A2, A3

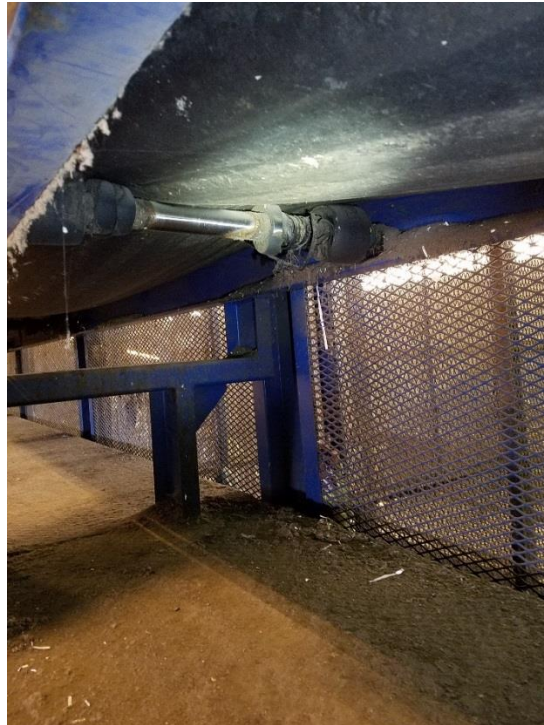
POS M-54 Container Sort Conveyor

- Missing Belly Guard
- Missing Return Roller, others ground flat
- Torn Belting at lace and shredded edge

Ref A3, A8

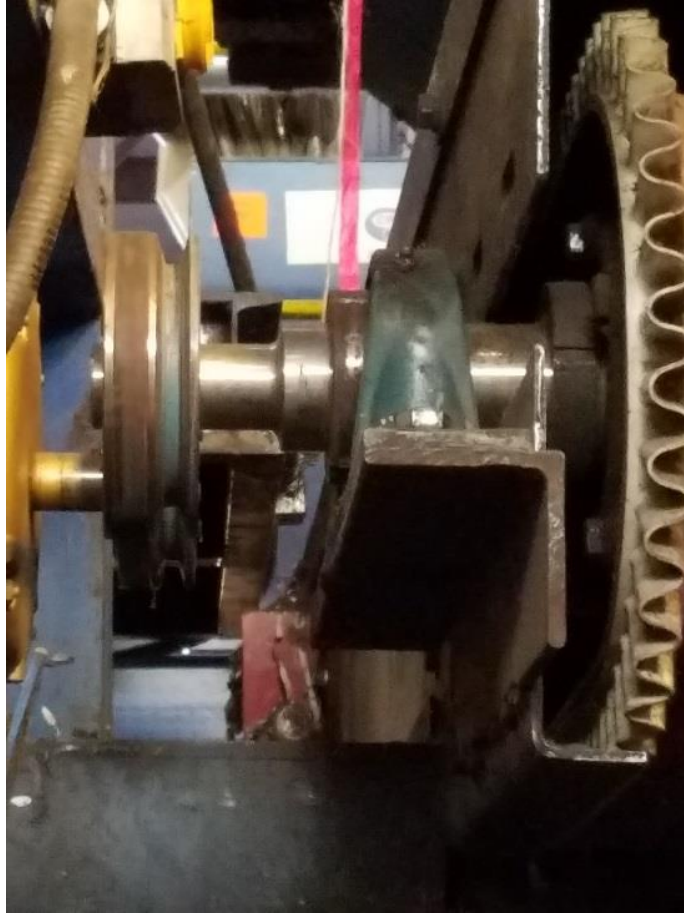
POS M-55 Eddy Current

- Missing one (1) Drive Belt
- Missing Bearing Cover

Ref A5, A8, A10

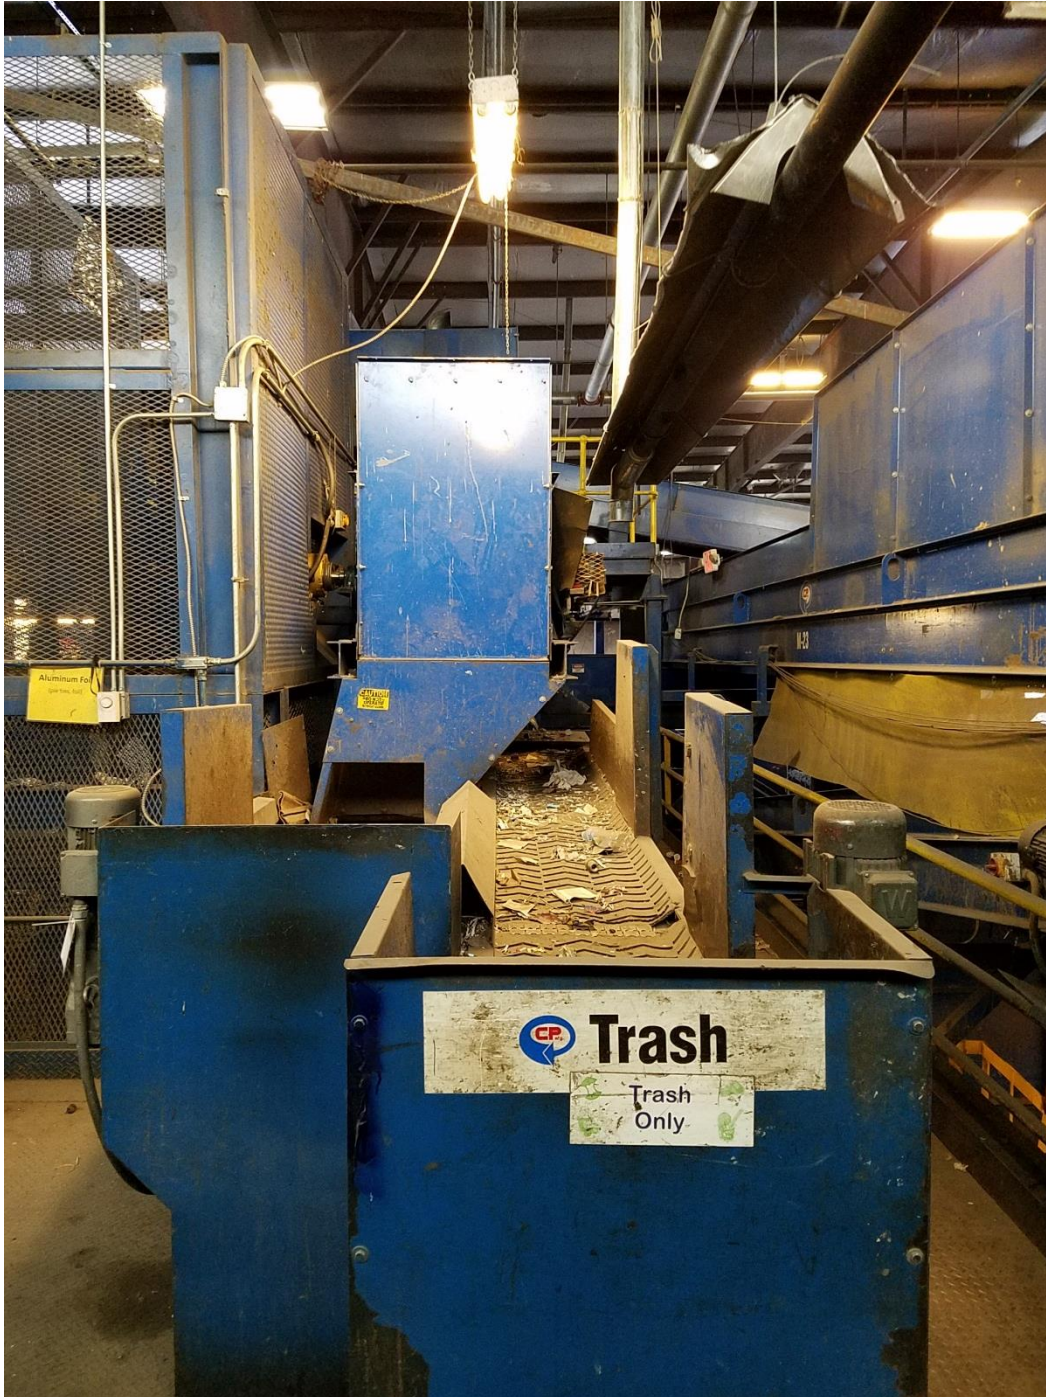
POS M-56 Alum Q.C. Conveyor

- Missing Belly Guard
- Drive leaks

Ref A4, A8

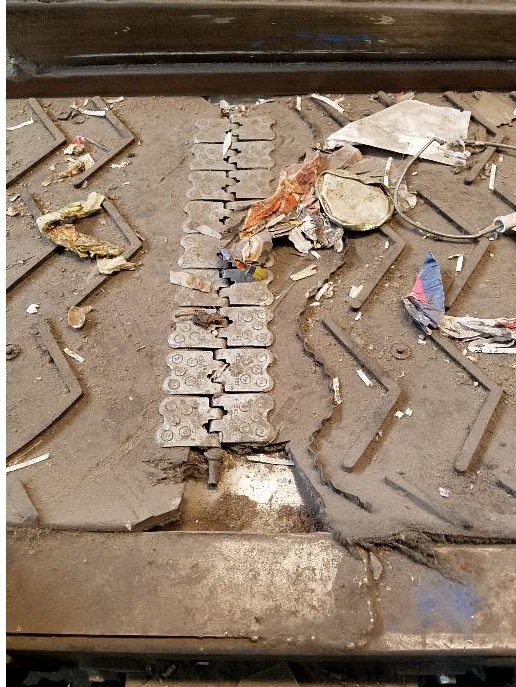
POS M-58 Pass Fraction Q.C. Conveyor

- Belt torn at lace
- Missing Return Rollers
- Missing Belly Guard
- No E-Stop at Sort Station

Ref A2

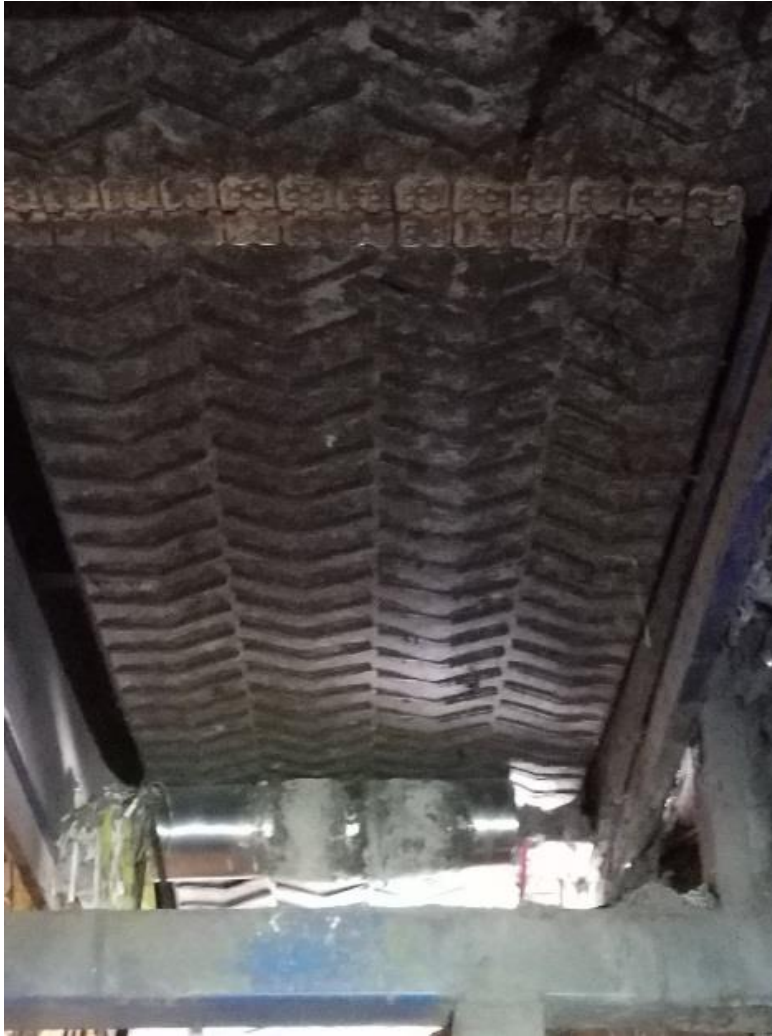
POS M-59 Trash Transfer Conveyor

- Return Roller Buildup
- Heavy Belt Wear

Ref A2, A3, A5
