CITY OF ANN ARBOR
MATERIAL RECOVERY FACILITY
4150 Platt Road
Ann Arbor Michigan, 48108

PROCESS SYSTEM
INSPECTION REPORT

Ann Arbor – Inspection Report

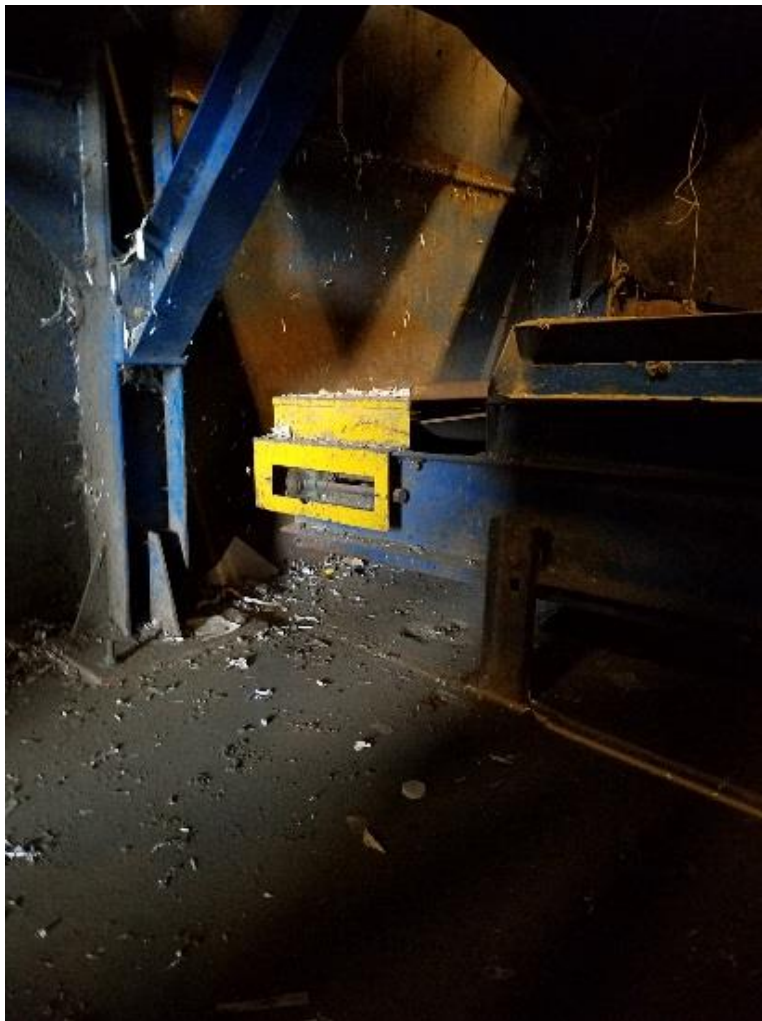
POS M-61 Glass Transfer Conveyor

- Missing Tail Guard over bearing
- Missing Return Rollers
- Drive leaking

Ref A2, A4, A8

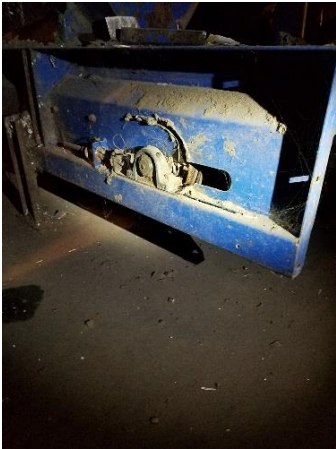
POS M-62 Glass Transfer Conveyor

- Tail Pulley wearing thru take-up
- Belt heavily worn
- Missing Tail Guard
- Belt Return Roller Jammed & Bypassed
- Wood used to hold up belting
- Broken electrical conduit

Ref A8, A10

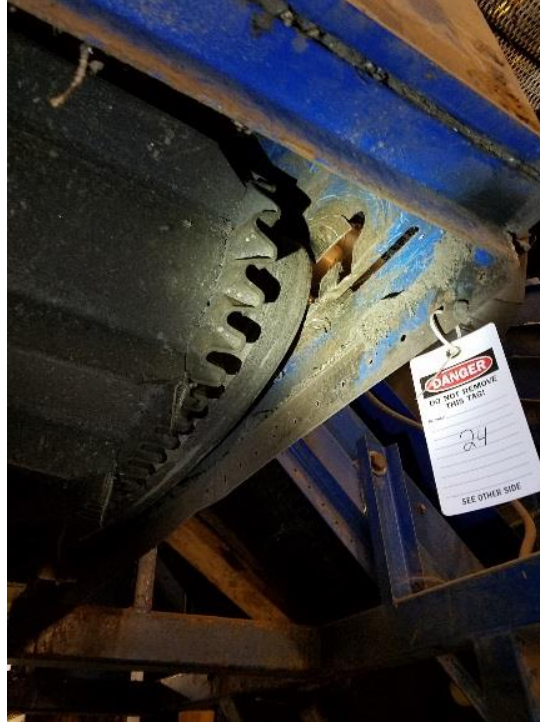
POS M-63A Glass Transfer Conveyor

- Tail Pulley worn thru Take-up
- Wood used as Return Guide
- Missing Belly guards
- Drive Leaks oil

Ref A6, A

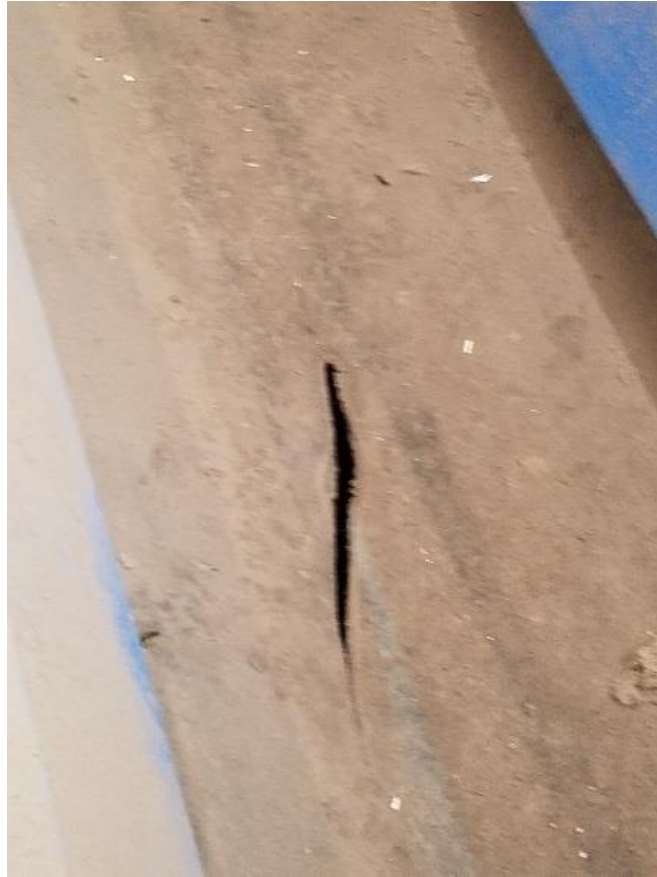
POS M-63B Glass Transfer Conveyor

- Torn Belting
- Missing Tail Guard
- Missing Idler guards

Ref A5

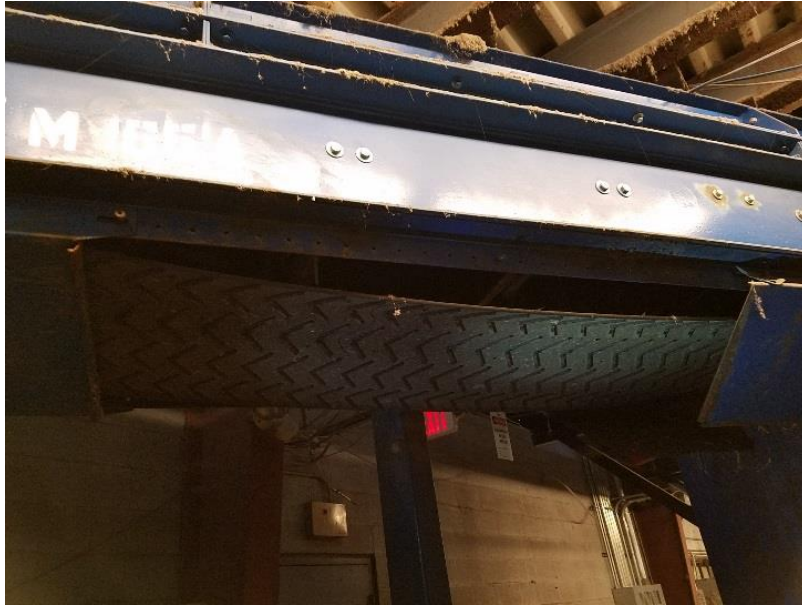
POS M-65A Glass Transfer Conveyor

- Missing Return Roller(s)
- Damaged Belt due to drag on chute
- Belt tracking right
- Tail Pulley heavily worn
- Drive leaks oil

Ref A2, A3, A5

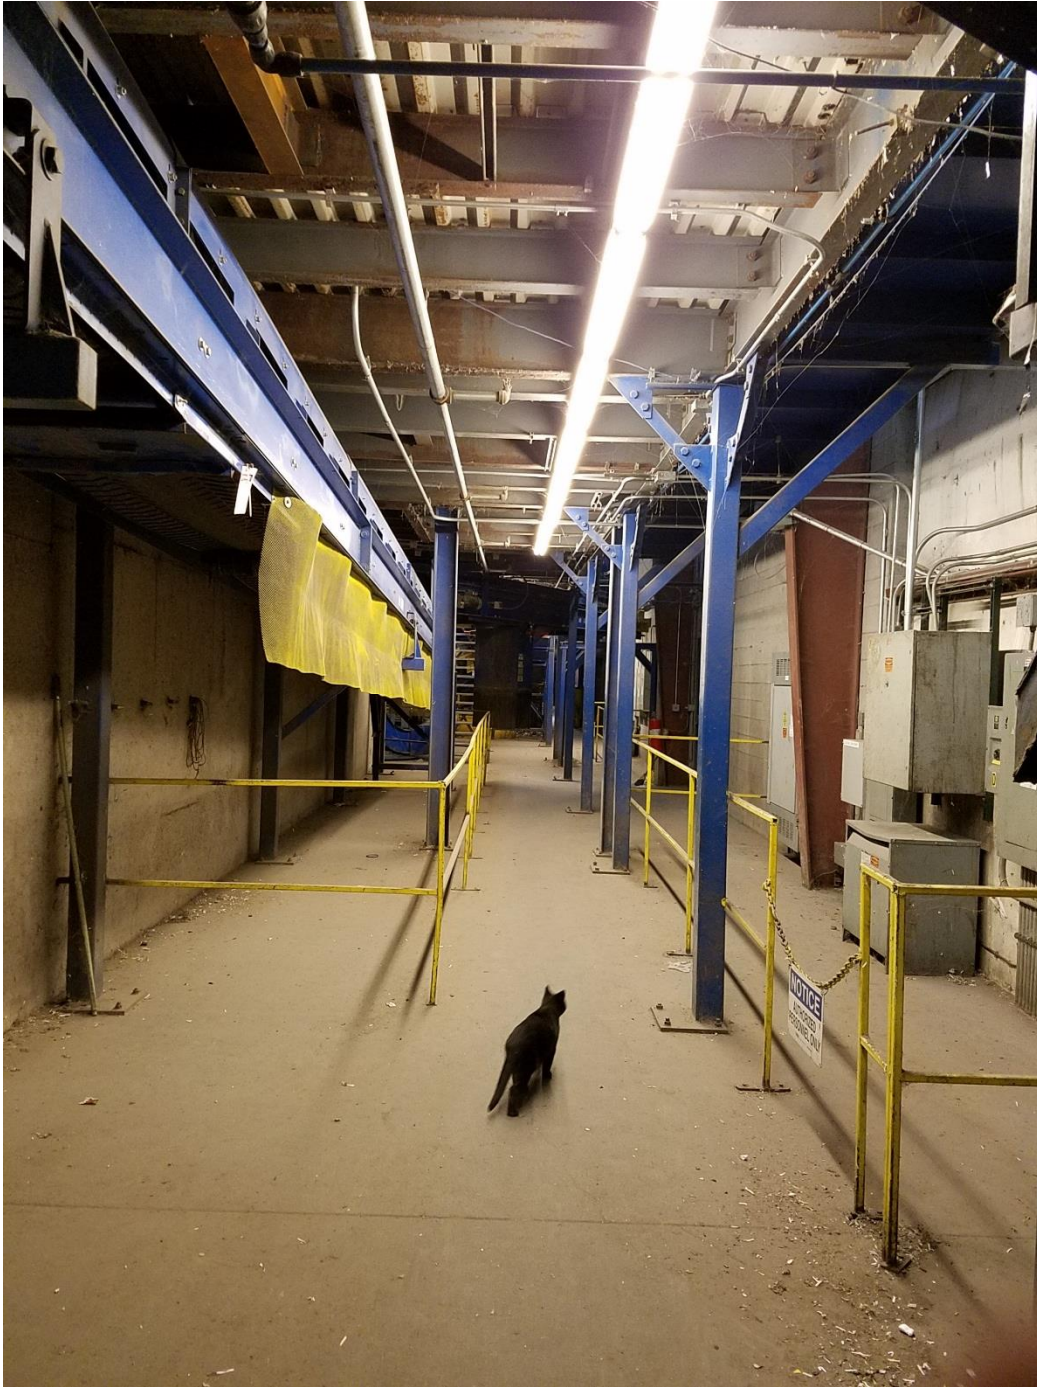
POS M-65B Glass Transfer Conveyor

- Heavy wear on belt
- Belt tracking right

Ref A5

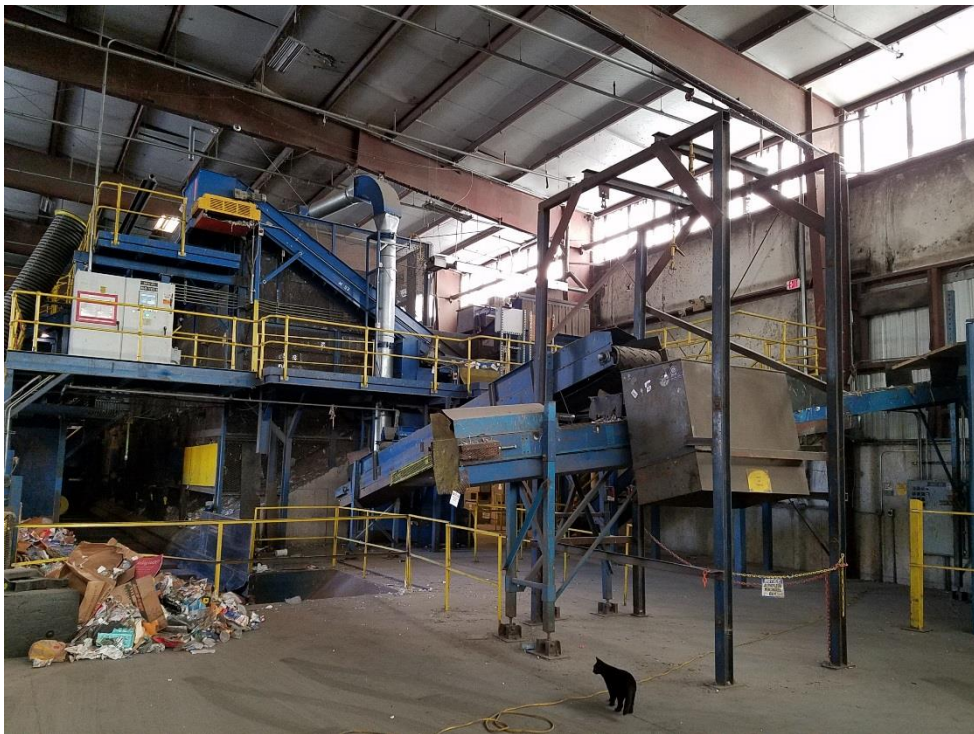
POS M-67 Glass Transfer Conveyor

- Buildup on Return Rollers

Ref A3

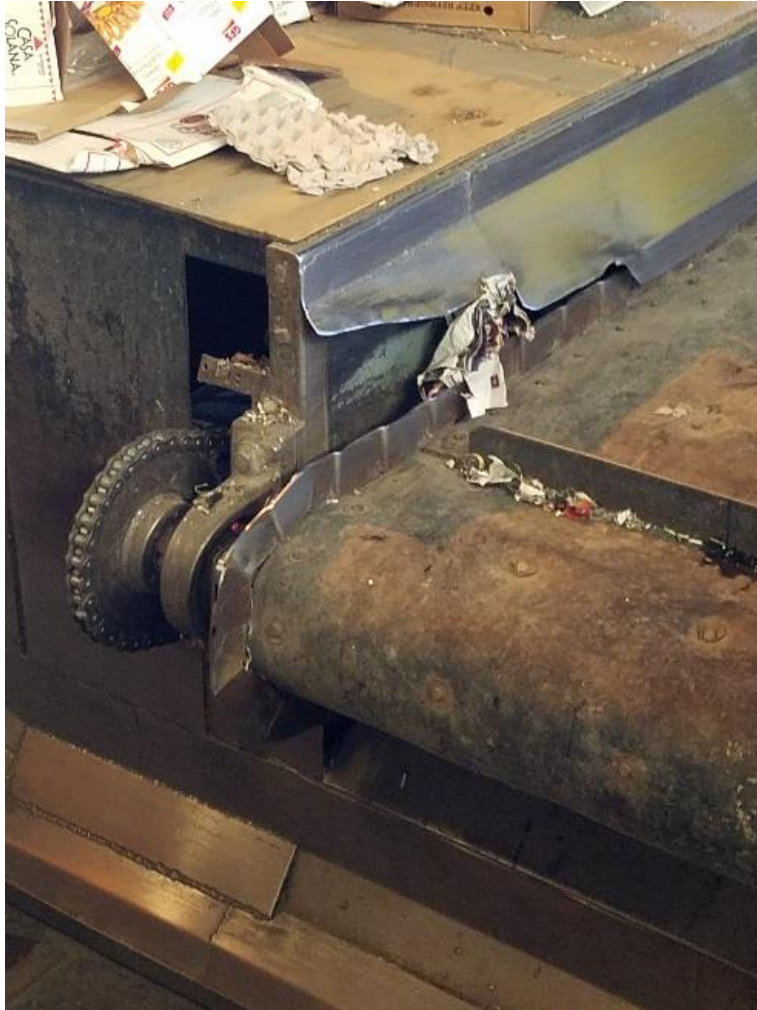
POS M-71 Silo & Bunker Upload Conveyor

- Sideboards worn thru at Head Pulley (both sides)

Ref A6

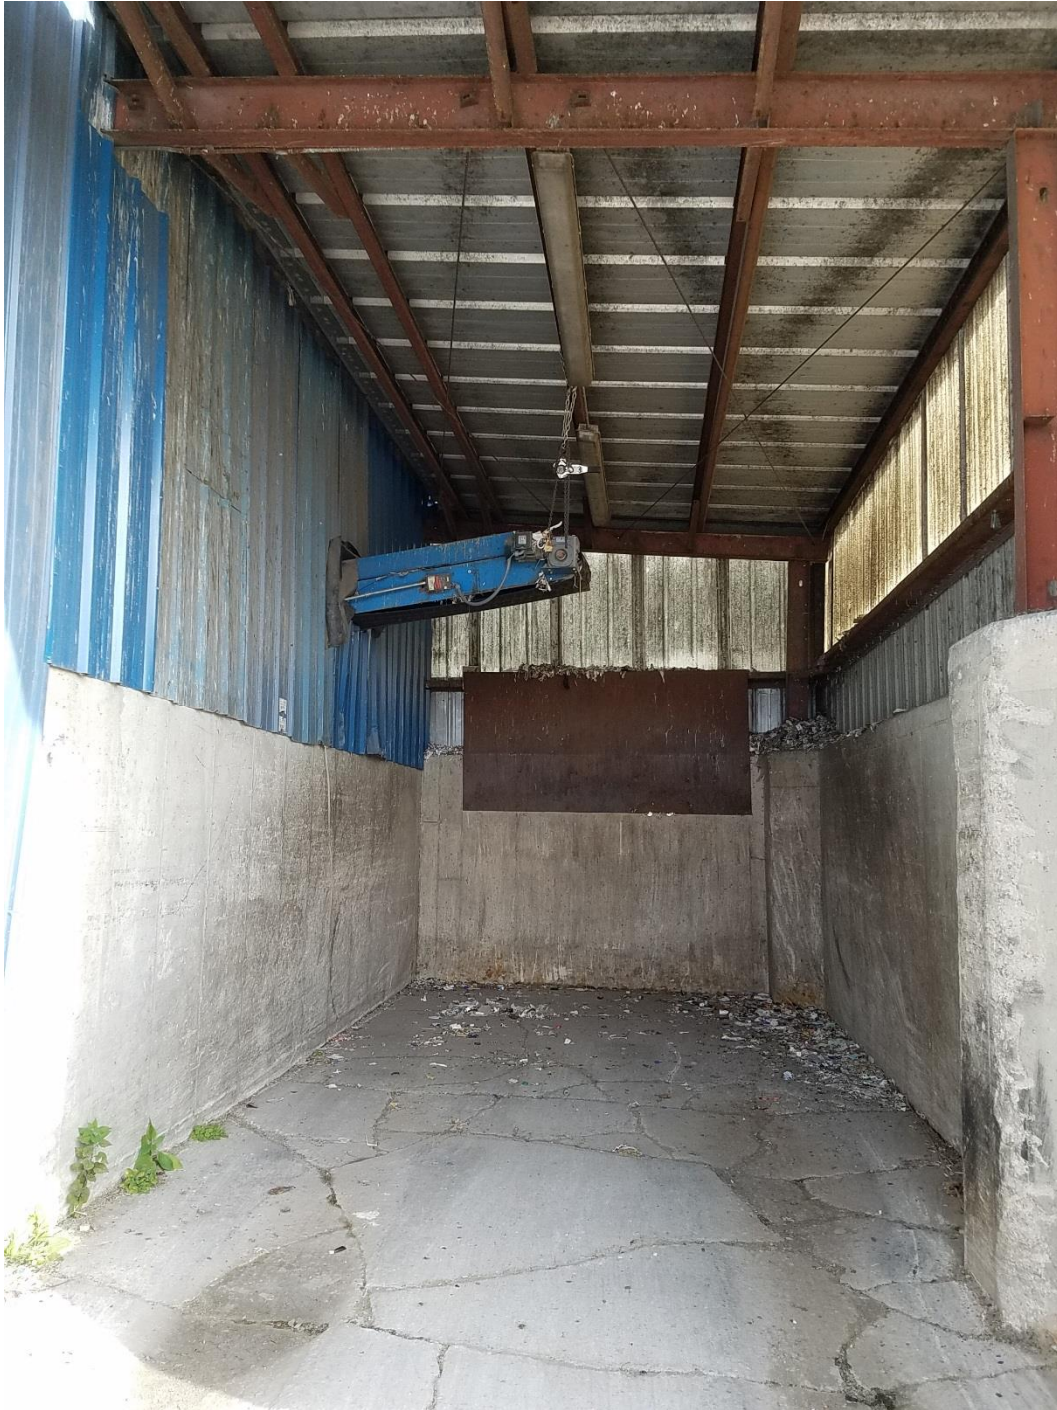
POS M-75 Glass Transfer Conveyor (to bunker)

- Head Pulley supported by chain-fall

Ref A15
