CITY OF ANN ARBOR
MATERIAL RECOVERY FACILITY
4150 Platt Road
Ann Arbor Michigan, 48108

PROCESS SYSTEM
INSPECTION REPORT

December 16, 2016

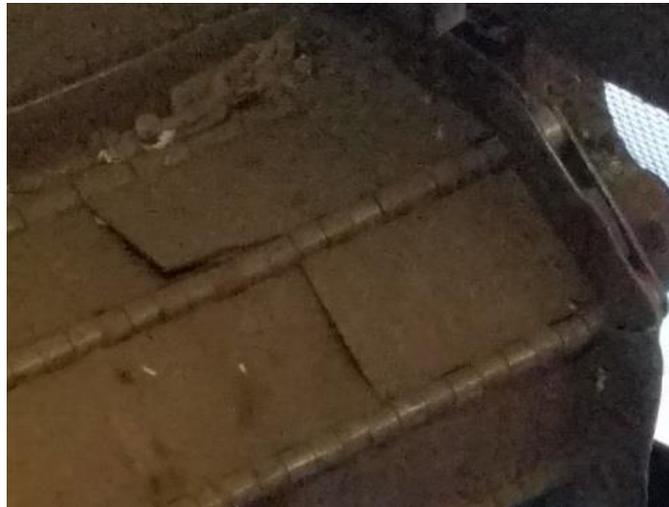
POS M-1 Infeed Conveyor

- Steel Belt Separating
- Guarding under head pulley missing
- Loose electrical wire on motor
- Wrappings on head pulley shaft

Ref A5

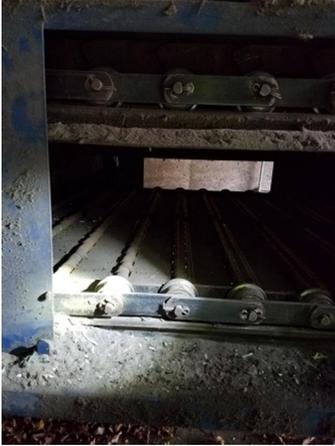
POS M-2 Incline/Presort Conveyor

- Guarding missing, open exposed chain accessible
- Missing link pin and worn roller wheels on chain
- Bent support, not lagged to floor
- Heavily worn sideboards at Metering Drum and below
- Belly pan under head pulley bulging apart from material buildup
- Bent cleats
- Tail Guard not secured

Ref A5, A8, A9

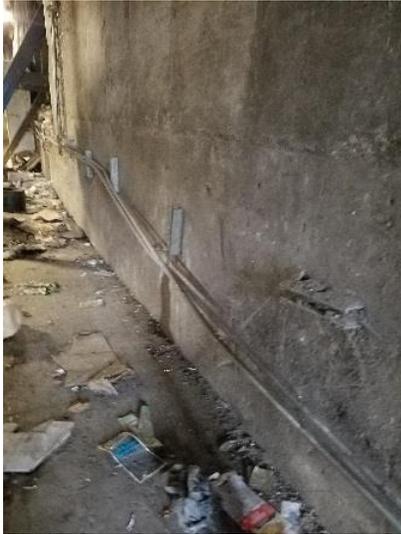
POS M-2 Surrounding Area

- Loose conduit hanging from wall
- Improper lighting support over Q.C. station
- Electrical Line crimped
- Chute(s) stuffed with material
- Floor deck lifting in areas
- Bottom step to presort bent

Ref A14

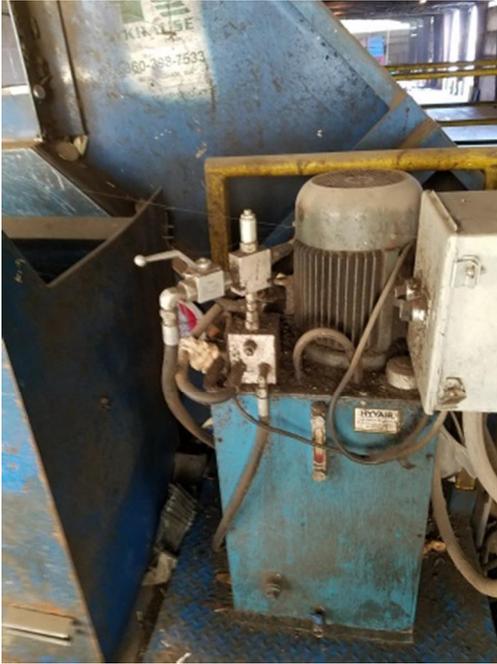
POS M-3 Metering Drum

- Loose hydraulic lines and leaking hydraulic power pack
- Worn drum and cleats
- Wrappings on drum shafts

Ref A4, A10

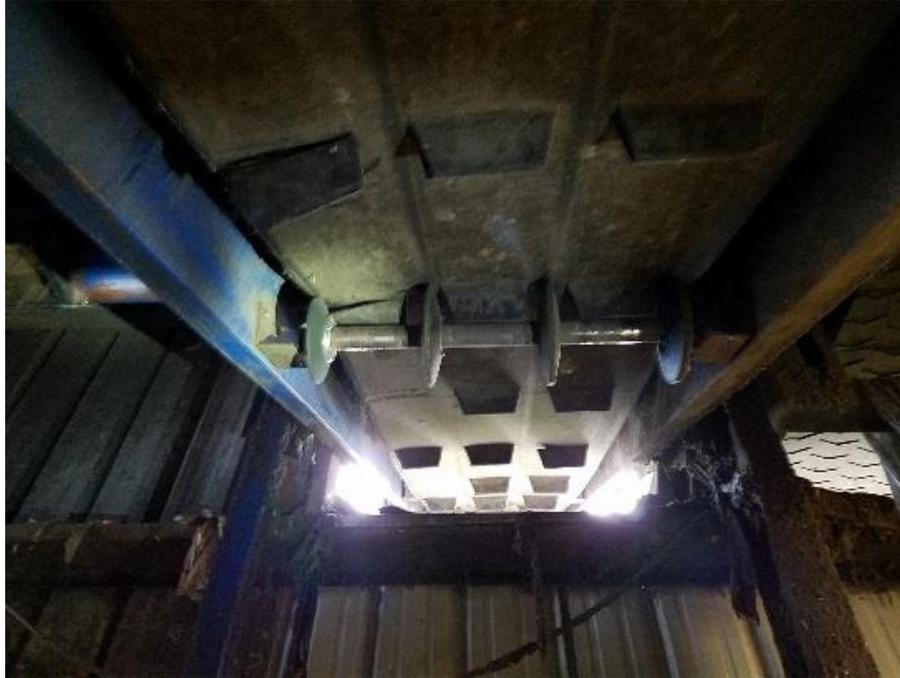
POS M-4A Transfer Conveyor

- Loose and missing cleats
- Wrappings on head pulley
- Worn and missing Return Rollers

Ref A2, A3, A5

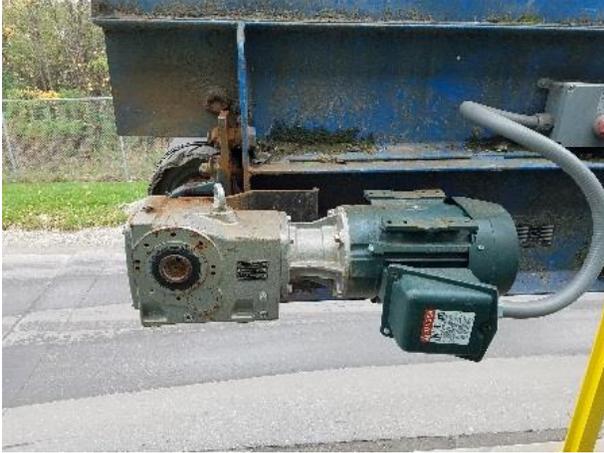
POS M-4B Transfer Conveyor

- Bent head pulley and wrapping on shaft
- Belt heavily worn and damaged lacing
- Return Rollers missing

Ref A3, A7, A10

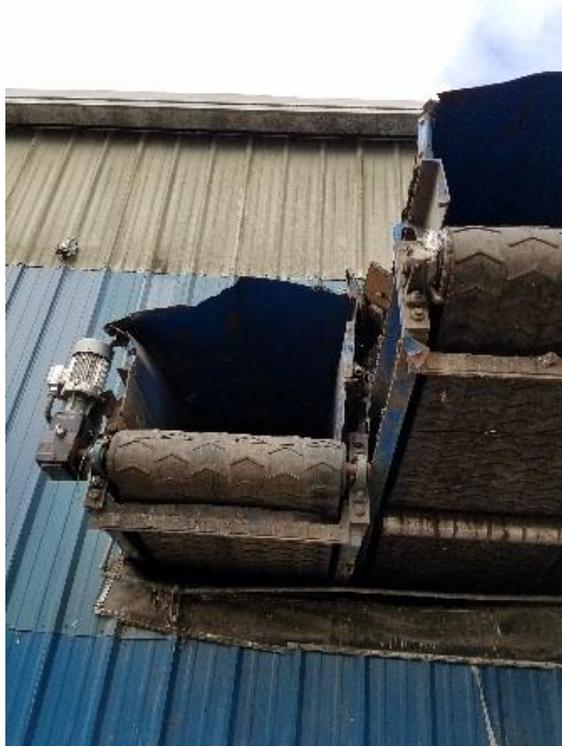
POS M-5 Trash Transfer Conveyor

- Wrapping on head pulley
- Gearbox possibly leaking
- Belt not tracked and cutting sideboard

Ref A3, A5, A6, A10

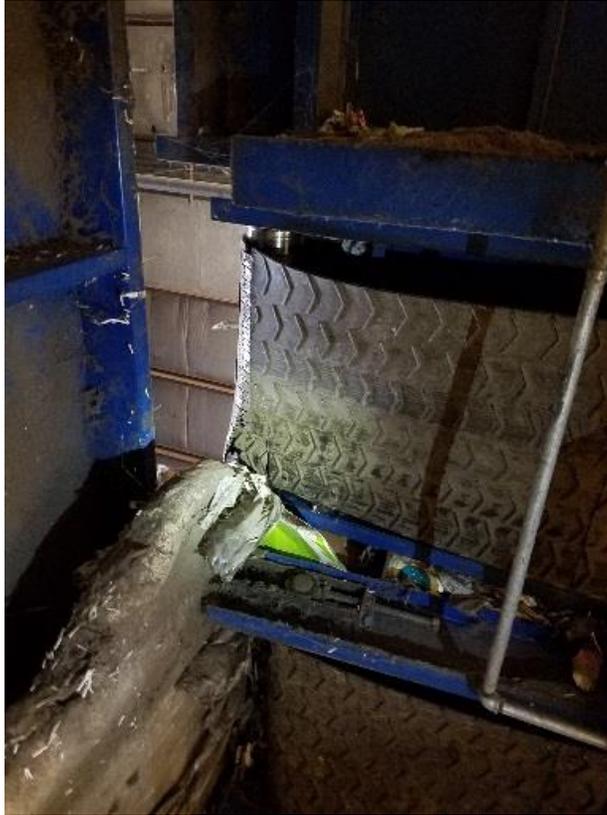
POS M-6 Large Plastic Transfer Conveyor

- Lacing torn & ripping
- Tracking off

Ref A5

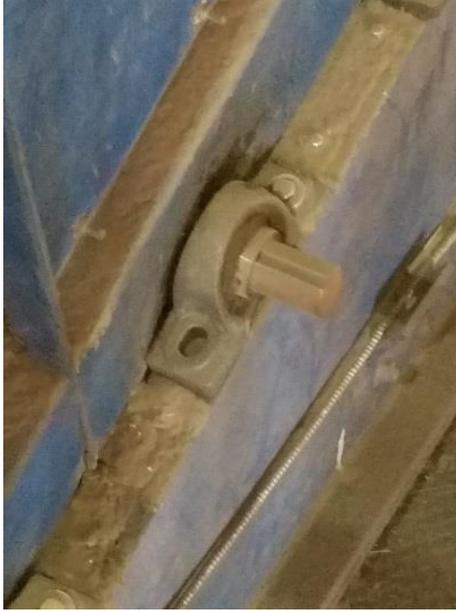
POS M-7 OCC Screen

- Bearing bolt missing
- Gearbox leaking
- Oil reservoir missing/broken
- Motor fan cover missing screw
- Motor seal-tight damaged
- Teeth on Discs heavily worn
- Transfer plate at Infeed worn thru
- Additional Fall Protection needed on right side ladder (overlooking Tip Area)

Ref A8, A9

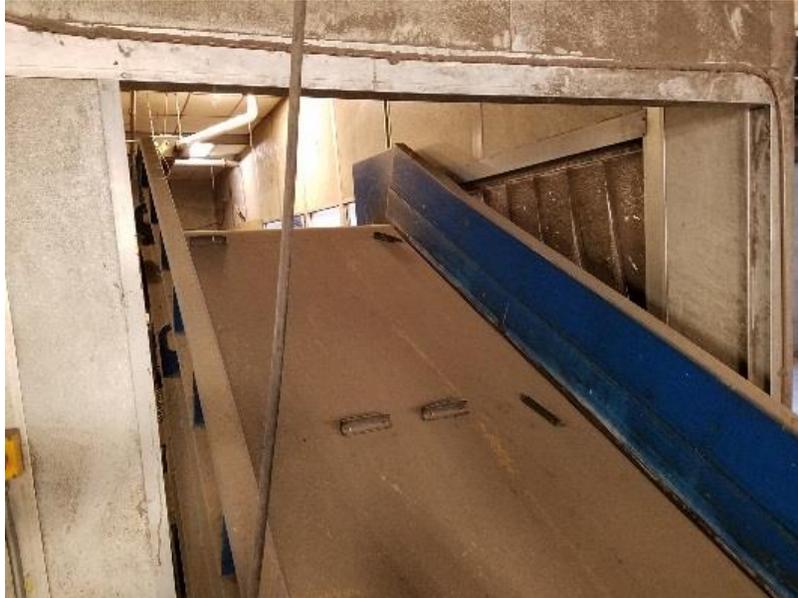
POS M-8 OCC Transfer Conveyor

- Belt Cleats missing and loose
- Threshold to Pos M-9A trip hazard

Ref A5

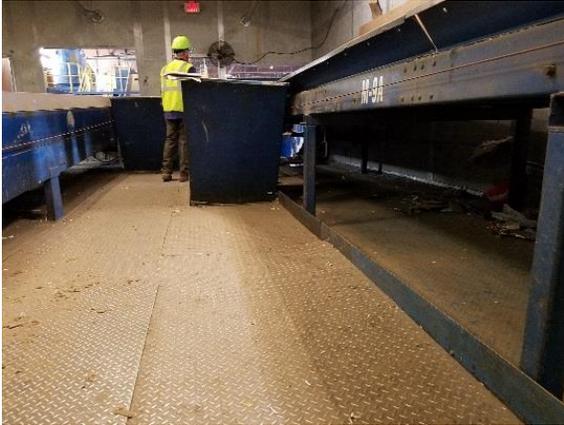
POS M-9A OCC Q.C. Conveyor

- Missing Belly Guard
- Open electrical box (no cover)
- Motor drive guard damaged
- Missing/Loose Sideboards
- Damaged Sort Chutes
- Deck lifting at Sort Station

Ref A11, A12

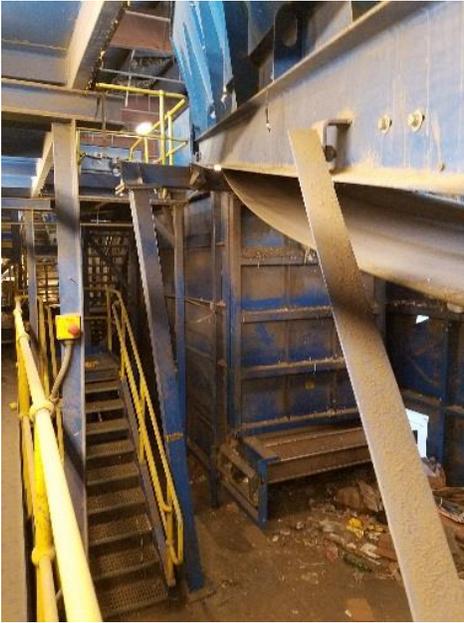
POS M-9B OCC Transfer Conveyor

- Bent/Leaning support
- Bolted connection incomplete
- Missing/Worn Return Rollers
- Add Right-side Transition Plate to Contain Material

Ref A2, A7

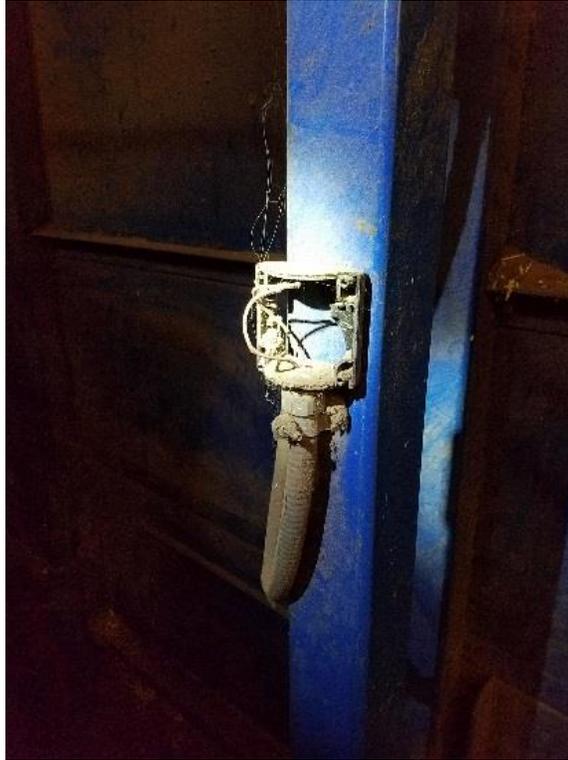
POS M-10A OCC Storage Conveyor

- Missing E-stop
- Missing Tail Guard

Ref A14

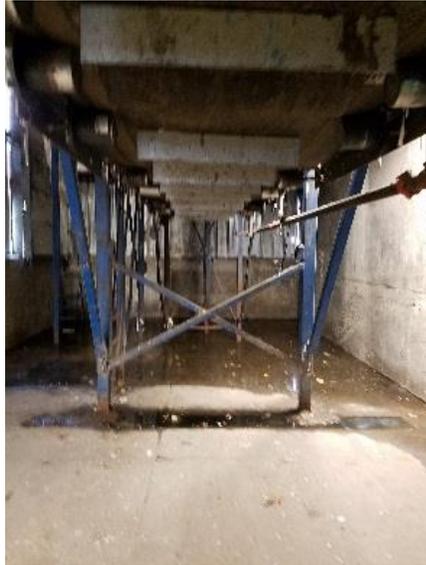
POS M-11 Screen Thrus Transfer Conveyor

- Belly Guards missing
- Self-cleaning Tail Pulley packed with material
- Windings on tail shaft
- Return Rollers worn
- Feed chute packed with material and worn
- Upturn Return Roller missing from radius

Ref A8

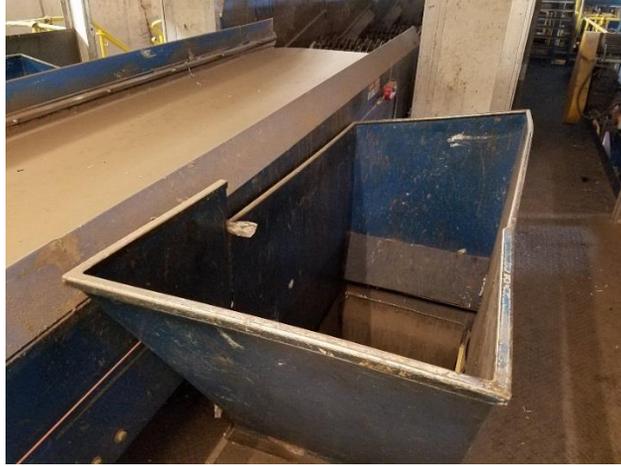
POS M-12 Mixed Transfer Conveyor

- Return Rollers missing
- Damaged Sorting Chutes with sharp edges
- E-Stop Pull Cord missing eye-loops along conveyor

Ref A6, A11, A12

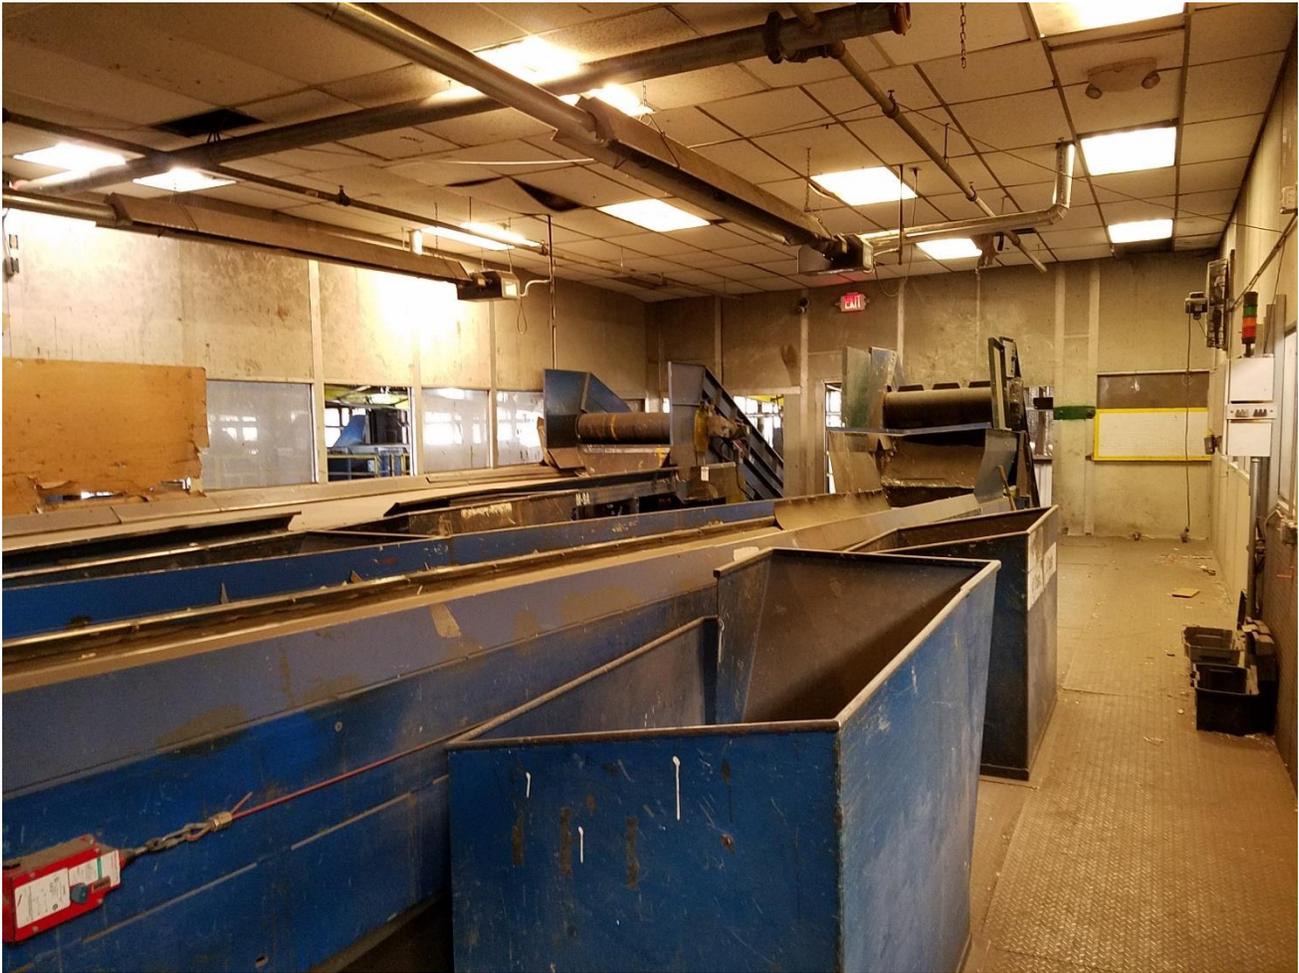
POS M-13 Scalping Screen Presort Conveyor & Surrounding Area

- No guarding to belt underside
- Open electrical box (no cover)
- Motor drive guard damaged
- Distorted chutes with sharp edges

Ref A6, A8, A12

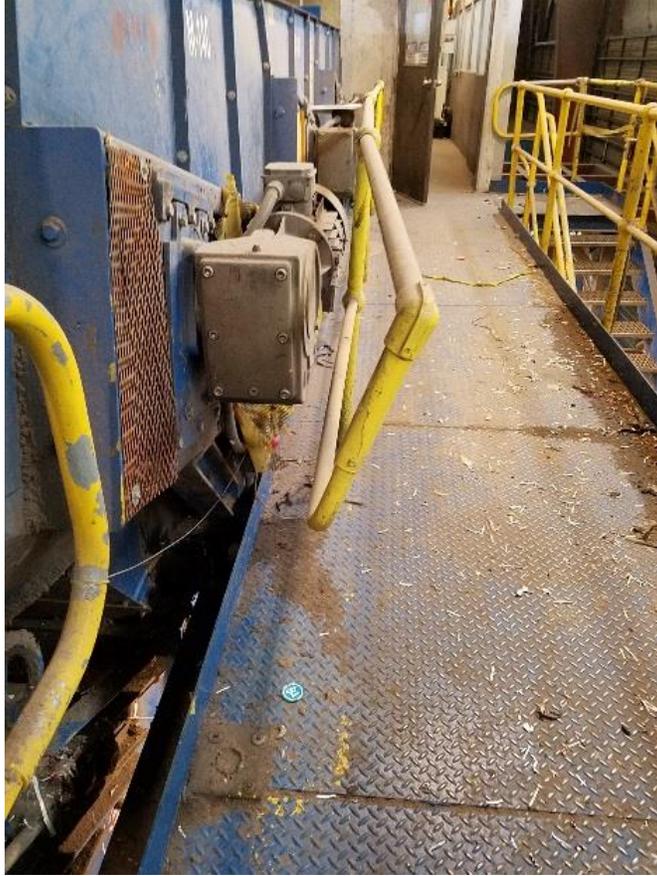
POS M-14 Scalping Screen

- Leaking Drive Motor
- Bent Handrail adjacent
- Heavily worn discs

Ref A1, A4, A7

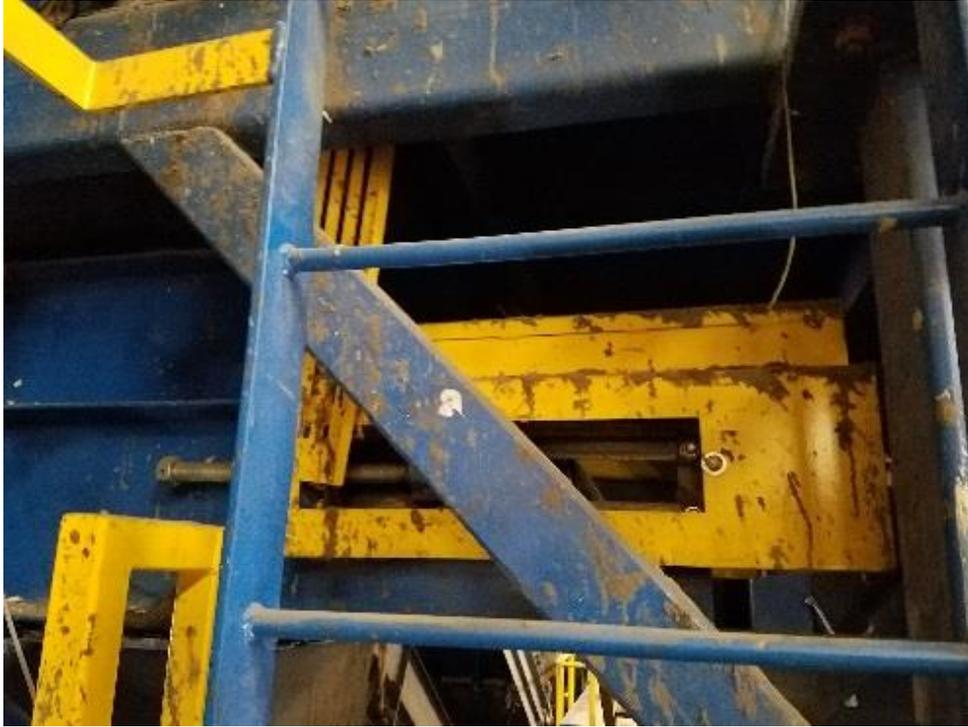
POS M-16A OCC Transfer Conveyor

- Tail Bearing Guard missing

Ref A8

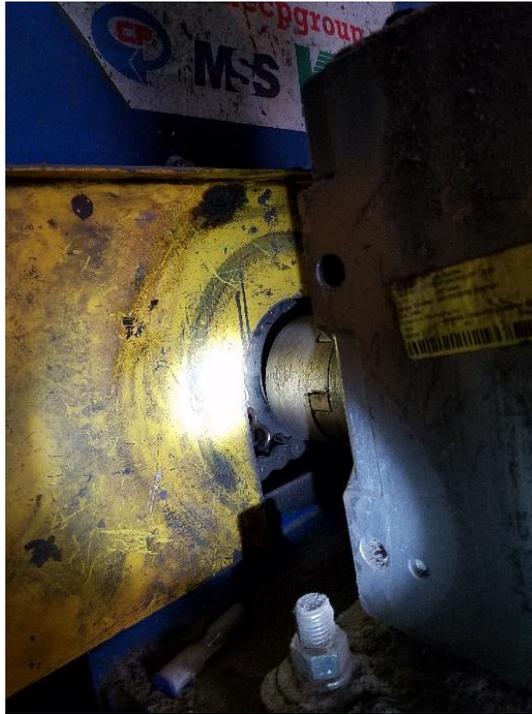
POS M-17 ONP Screen

- Worn Sprocket
- Hydraulic Power Pack Leaking

Ref A9

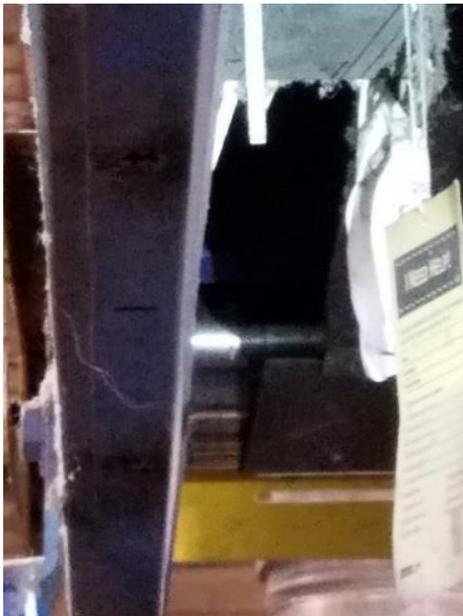
POS M-18 Fiber Transfer Conveyor

- Belt edge torn
- Wrapping on Return Roller
- Tail Bearing Guard missing
- Missing Belly Pan at Tail
- Bearings worn
- Tail Shaft worn

Ref A5

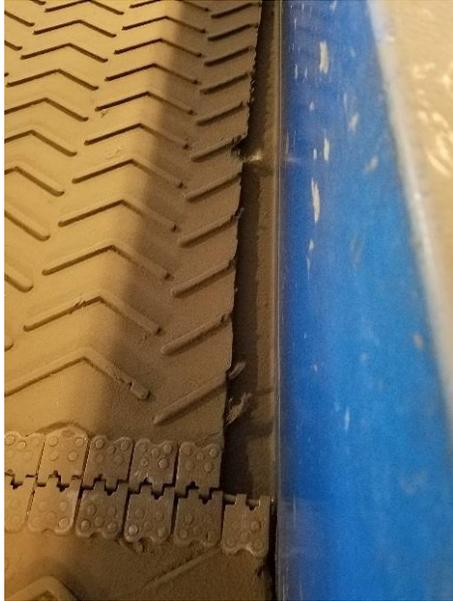
POS M-20 Fiber Sort Conveyor

- Belt torn along edge
- Wrappings on Head Pulley
- Missing Belly Guard

Ref A5

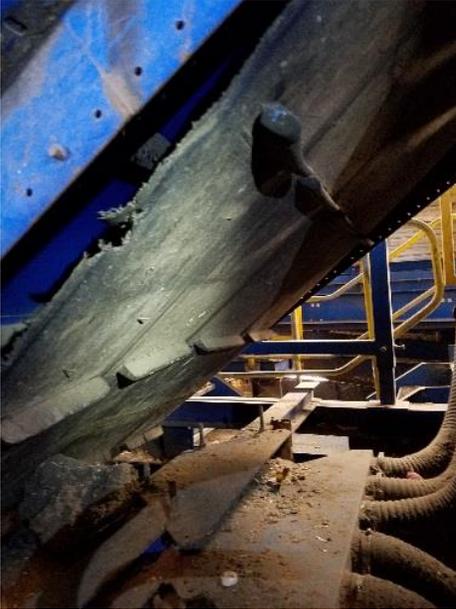
POS M-21 CP Screen Feed Conveyor

- Torn belt edge
- Missing cleats and return rollers
- Motor leaking
- Missing Dust Cover on oiler

Ref A2, A5

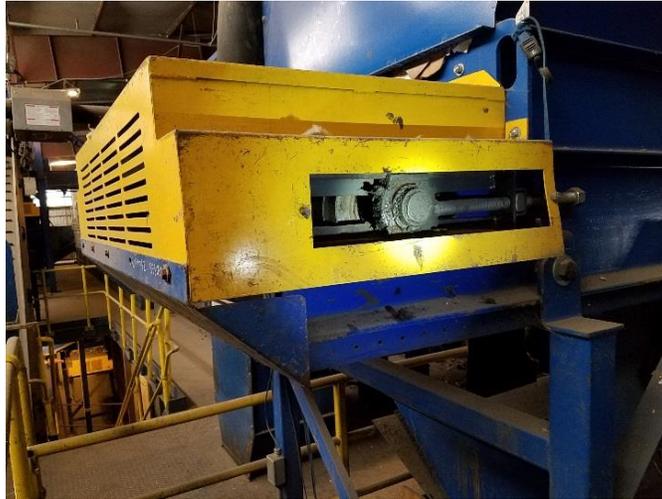
POS M-23 Mid Fiber transfer Conveyor

- Tail Bearing Guard missing
- Missing Tail Belly Pan
- Bearings worn
- Questionable OSHA compliant guarding

Ref A8, A10

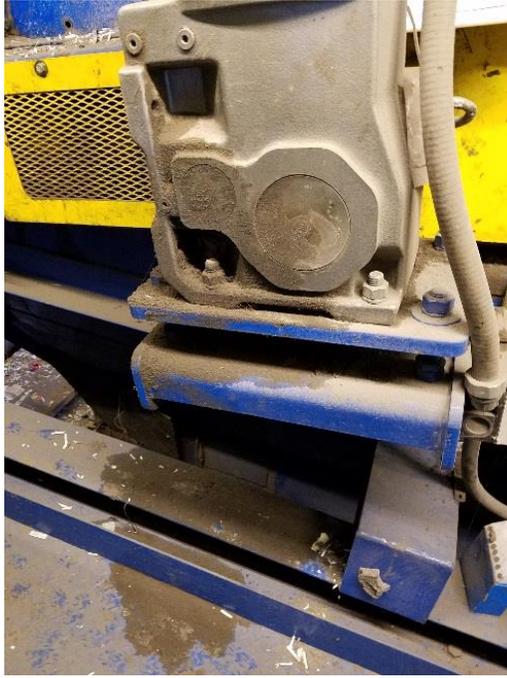
POS M-29 Glass Breaker

- Motor Drive Leaking
- Missing/Inoperative Disconnect Switches
- Empty Oil Reservoir

Ref A14

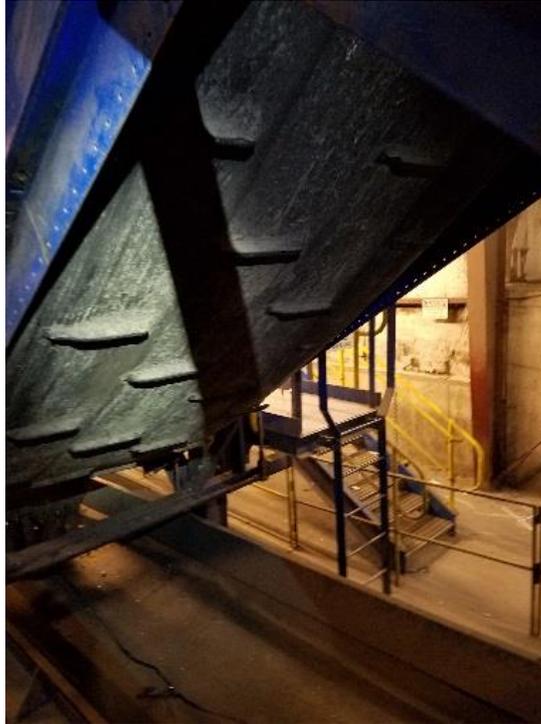
POS M-30 ADS Feed Conveyor

- Worn Cleats
- Missing/Damaged Return Rollers
- Missing Belly Guards

Ref A5, A8

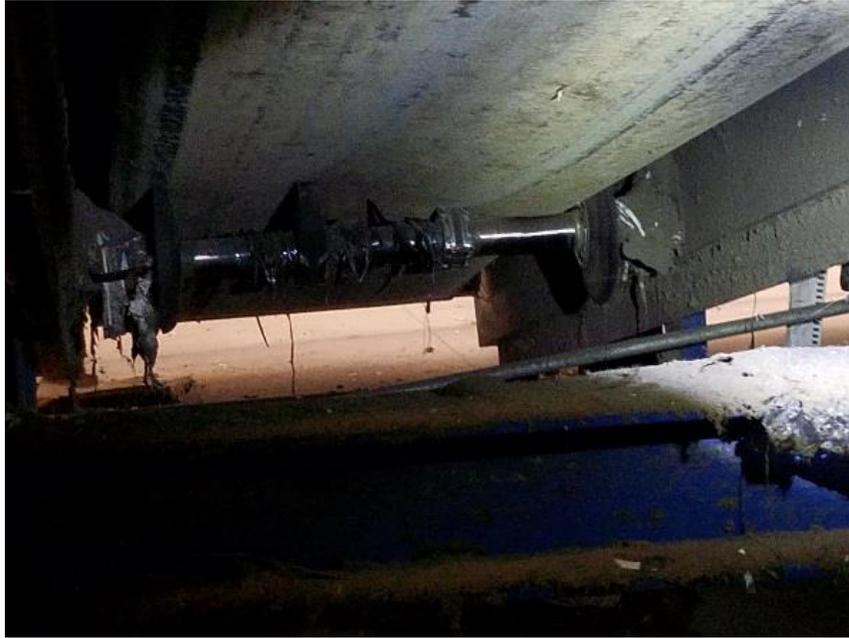
POS M-32 Fiber Transfer Conveyor

- Drive leaking
- Worn Return Rollers
- Broken electrical conduit

Ref A2, A3

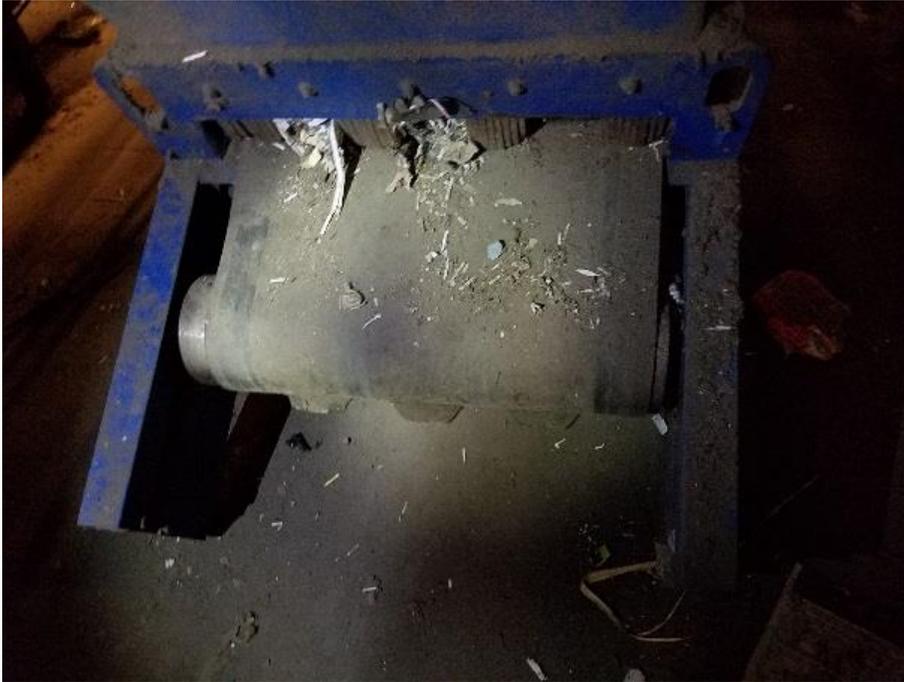
POS M-33 Fiber Transfer Conveyor

- Missing Tail Guard
- Loose/Worn/Patched Belting

Ref A8

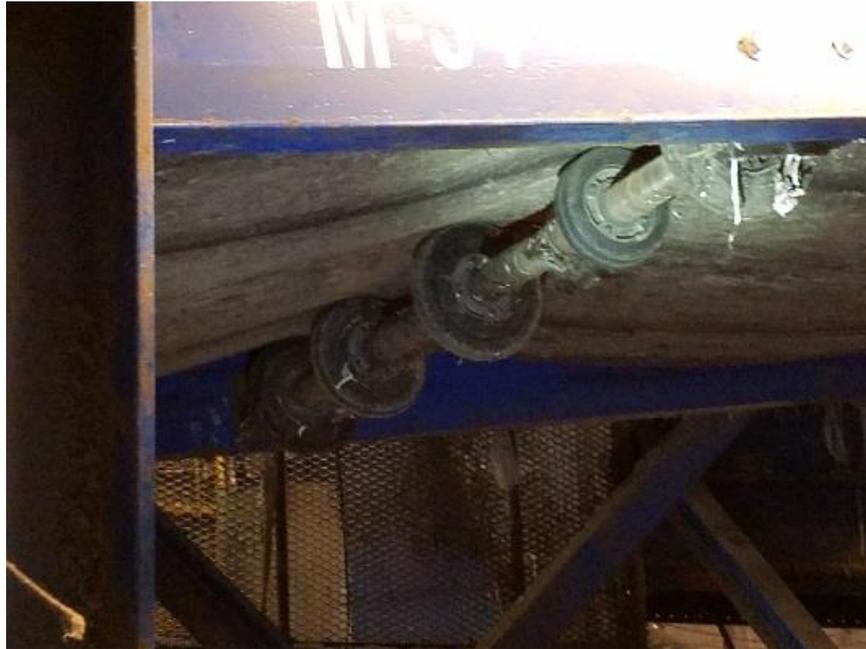
POS M-34 ADS Feed Conveyor

- Worn Return Rollers

Ref A2, A3

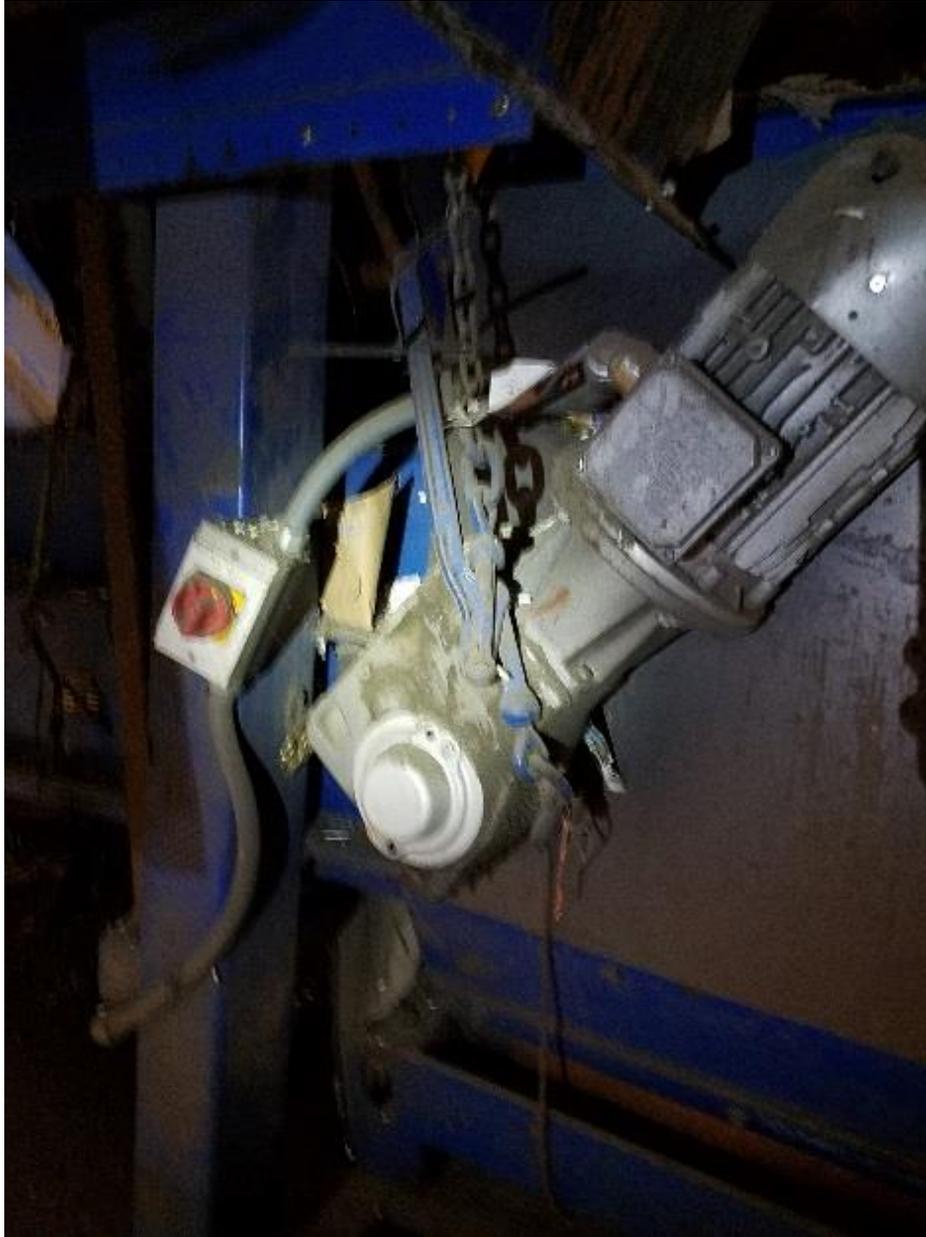
POS M-37 Fiber Transfer Conveyor

- Chain Binder used as motor support

Ref A15

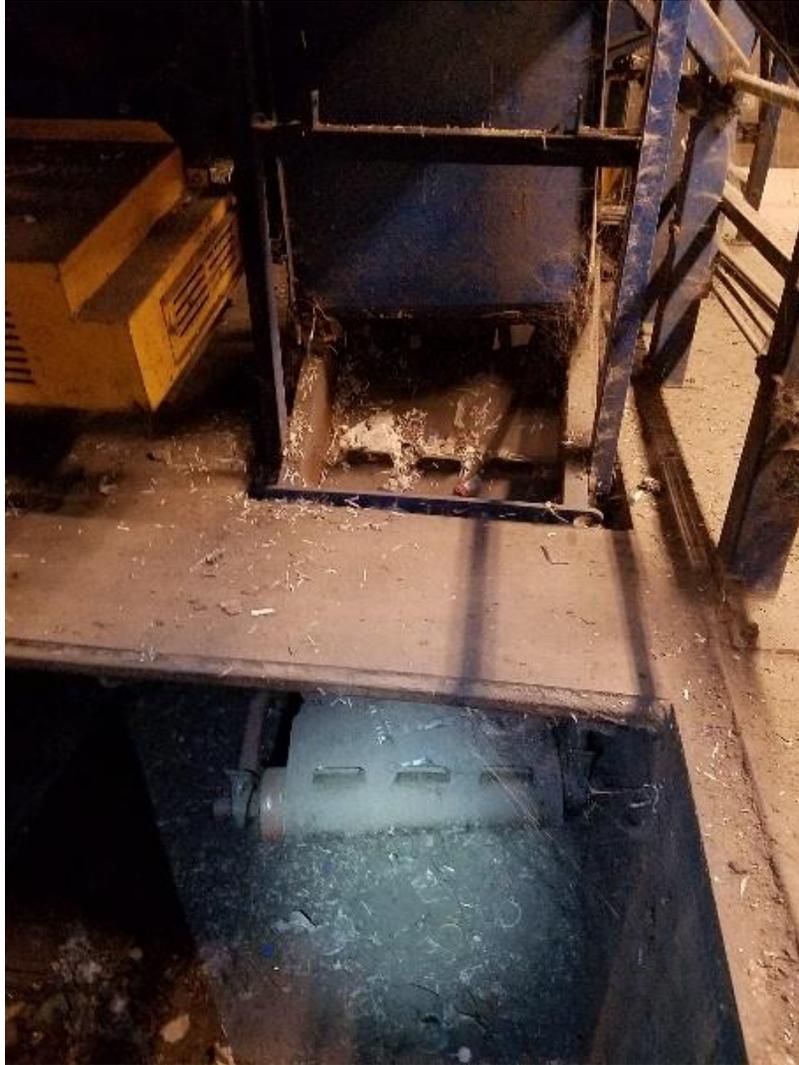
POS M-46A B&C Transfer Conveyor

- Offset Take-up, Belt not tracking

Ref A5

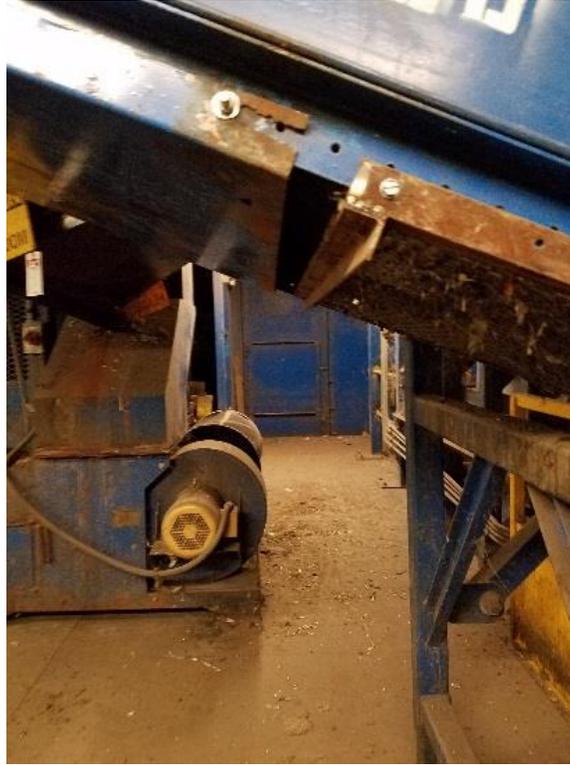
POS M-46B B&C Transfer Conveyor

- Belly Pan Spacing to be closed
- Worn Return Rollers and belting

Ref A6, A8

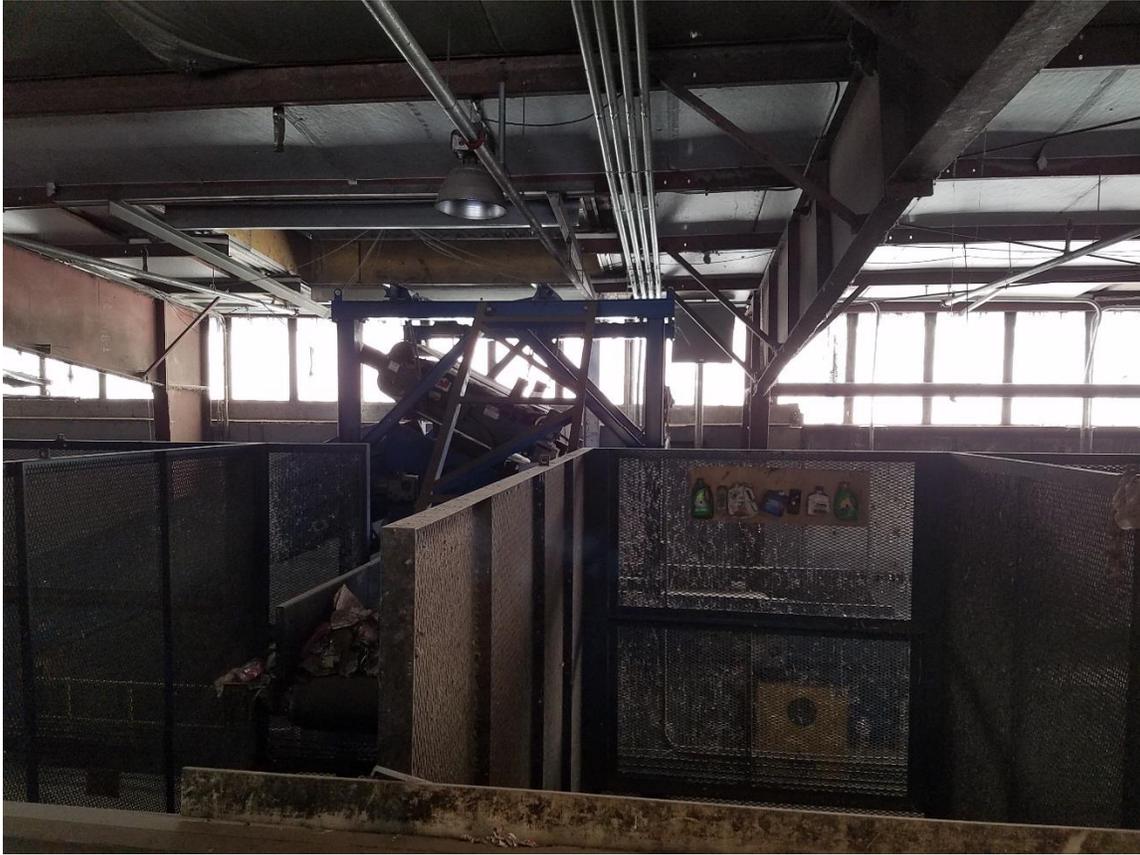
POS M-49 FE Transfer Conveyor

- Drive Leaks
- Missing Return Roller

Ref A2, A4

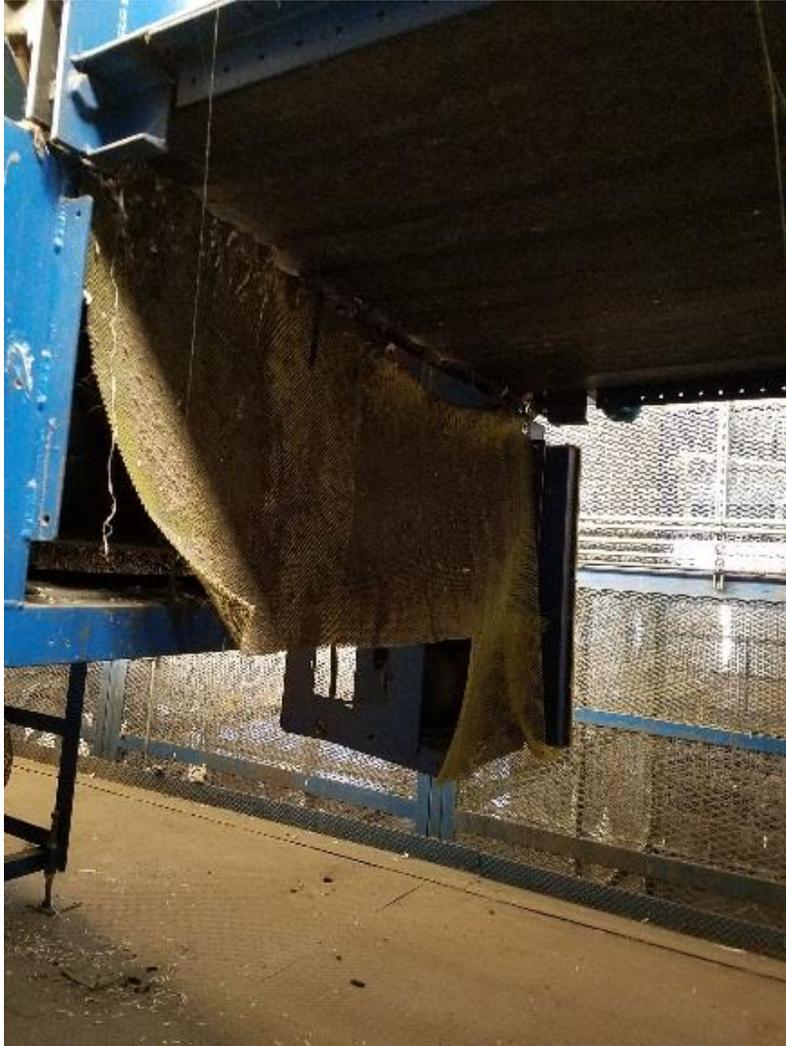
POS M-50A Accelerator Conveyor

- Missing Tail Guard
- Missing Belly Guard

Ref A6, A8

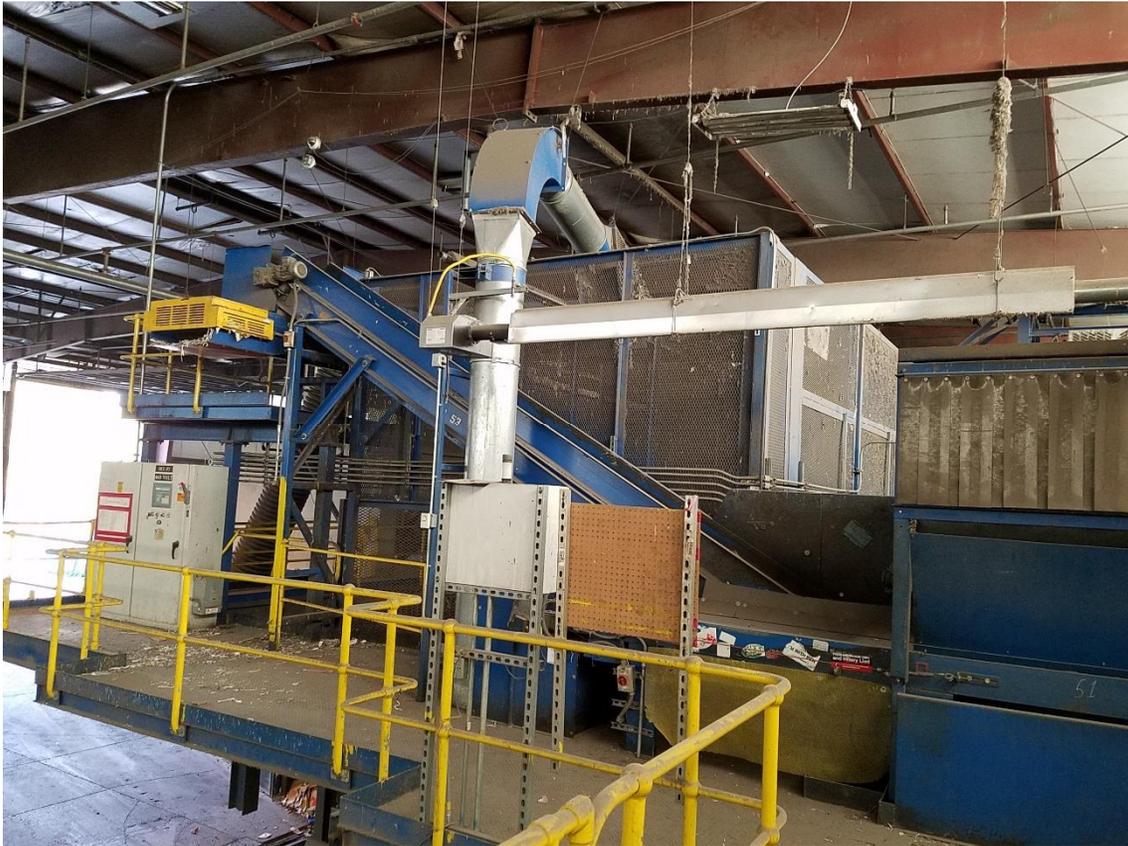
POS M-51 PET Q.C. Conveyor

- Insufficient Belly Guarding

Ref A8

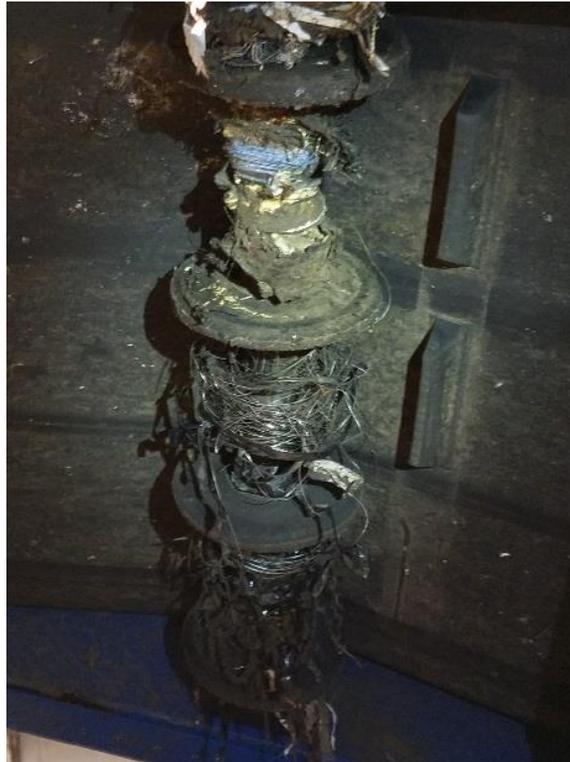
POS M-53 Pass Fraction Transfer Conveyor

- Heavily worn Return Roller
- Insufficient Guarding where conveyor comes thru platform

Ref A2, A3

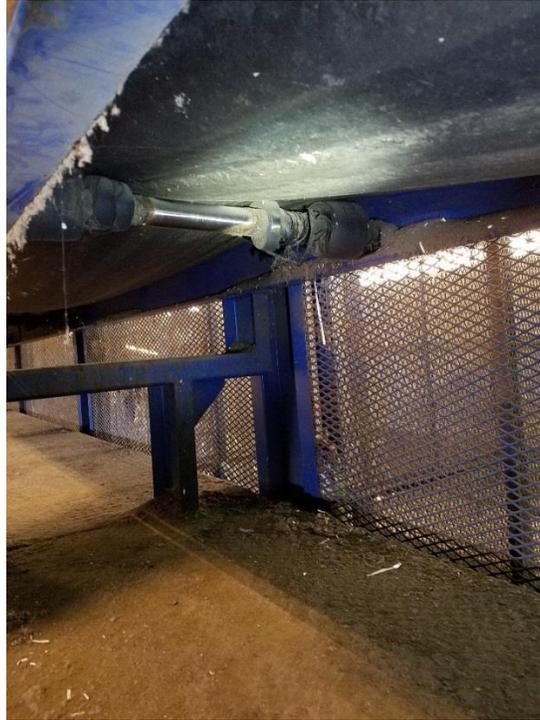
POS M-54 Container Sort Conveyor

- Missing Belly Guard
- Missing Return Roller, others ground flat
- Torn Belting at lace and shredded edge

Ref A3, A8

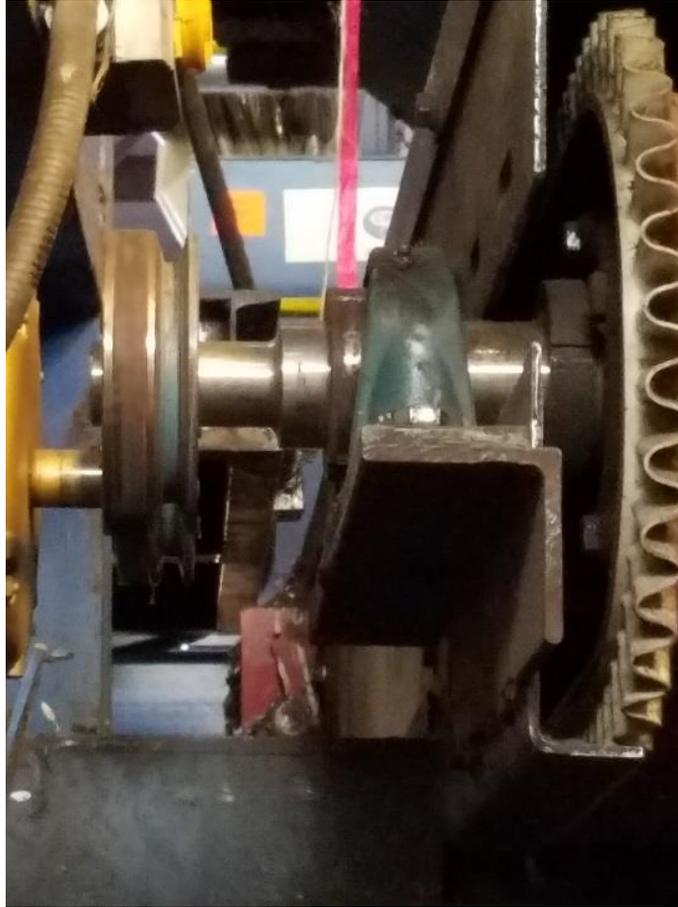
POS M-55 Eddy Current

- Missing one (1) Drive Belt
- Missing Bearing Cover

Ref A5, A8, A10

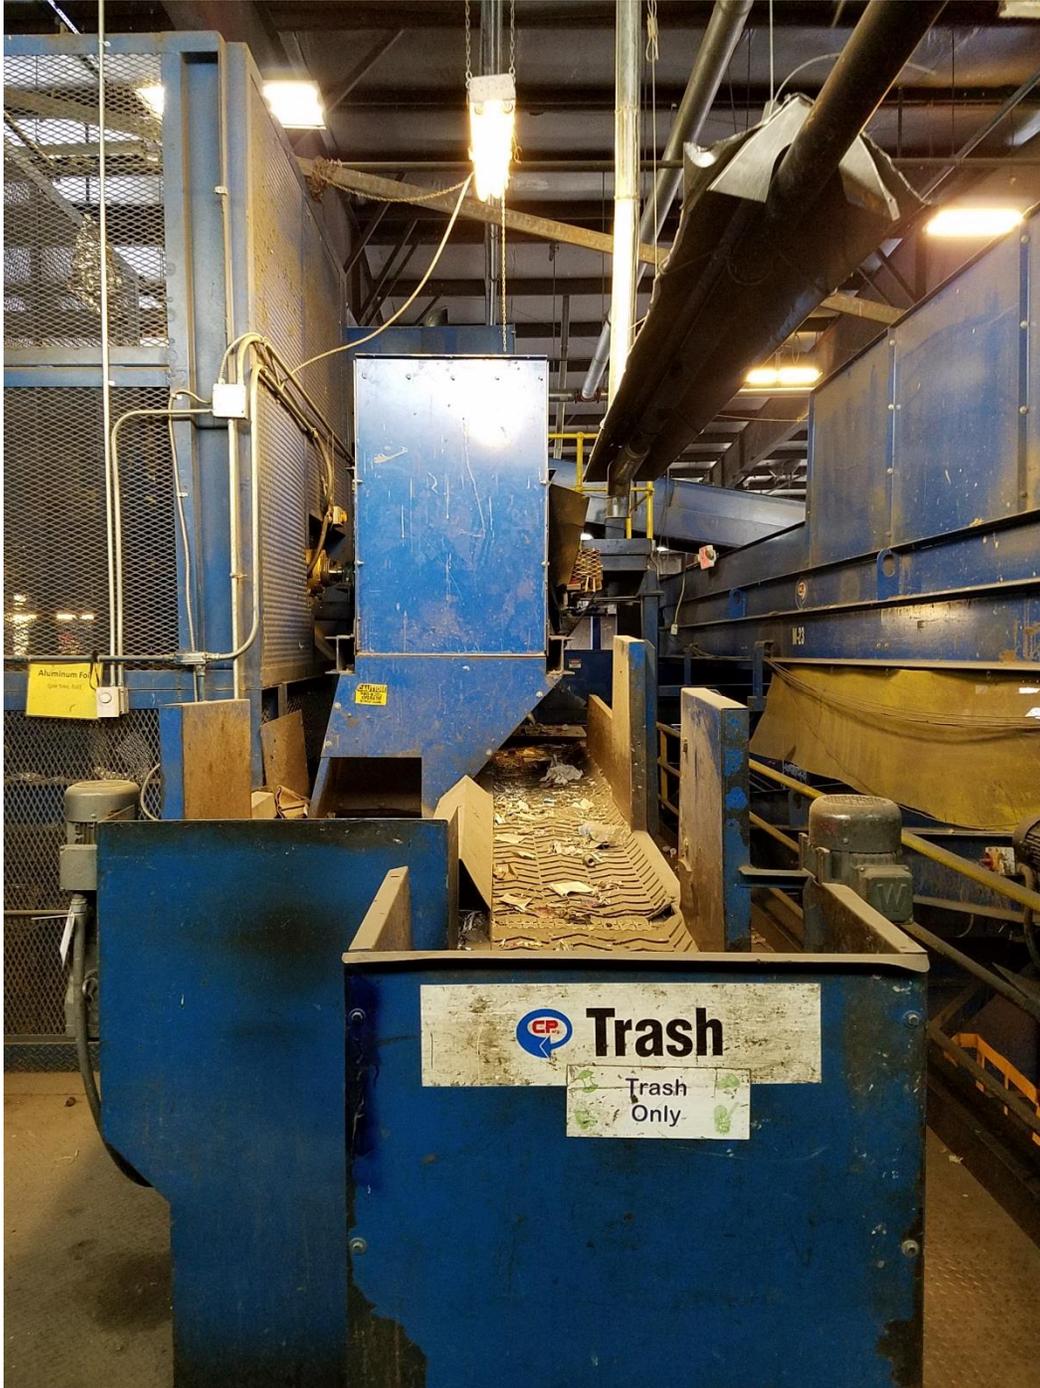
POS M-56 Alum Q.C. Conveyor

- Missing Belly Guard
- Drive leaks

Ref A4, A8

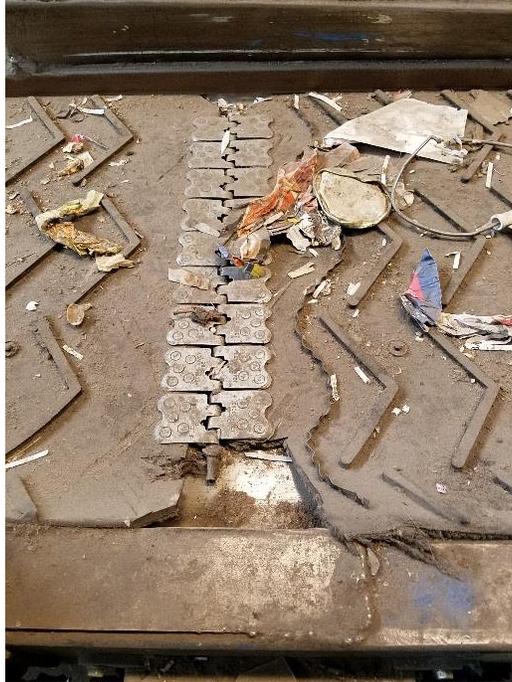
POS M-58 Pass Fraction Q.C. Conveyor

- Belt torn at lace
- Missing Return Rollers
- Missing Belly Guard
- No E-Stop at Sort Station

Ref A2

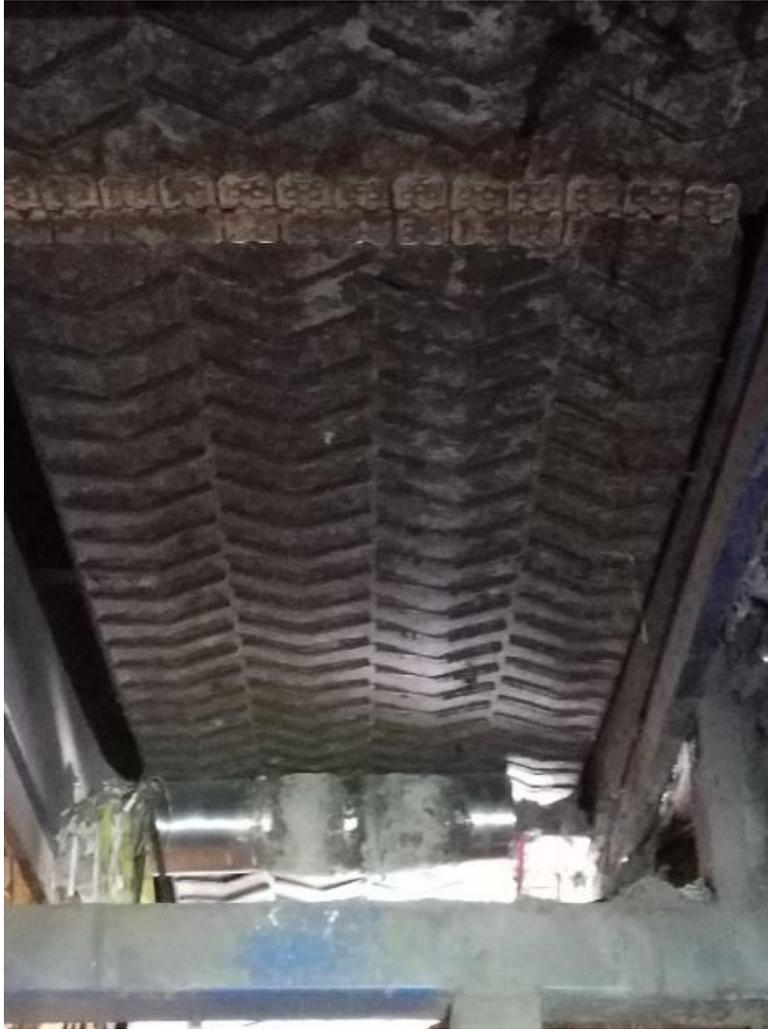
POS M-59 Trash Transfer Conveyor

- Return Roller Buildup
- Heavy Belt Wear

Ref A2, A3, A5

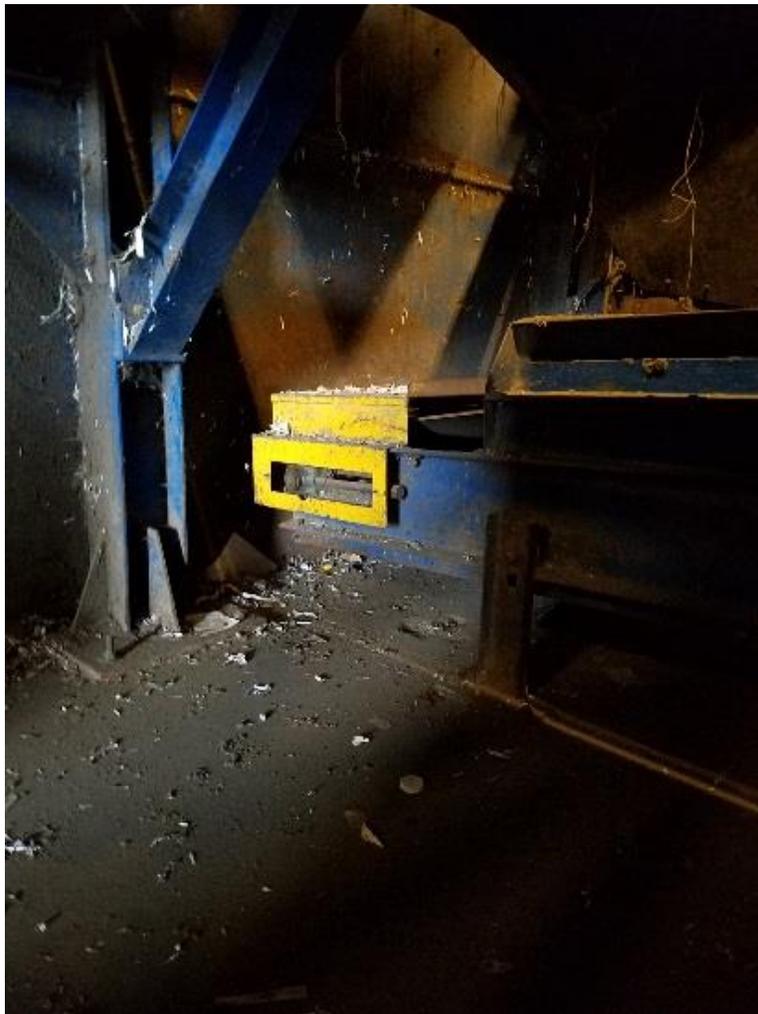
POS M-61 Glass Transfer Conveyor

- Missing Tail Guard over bearing
- Missing Return Rollers
- Drive leaking

Ref A2, A4, A8
