CITY OF ANN ARBOR
MATERIAL RECOVERY FACILITY
4150 Platt Road
Ann Arbor Michigan, 48108

PROCESS SYSTEM
INSPECTION REPORT

December 16, 2016

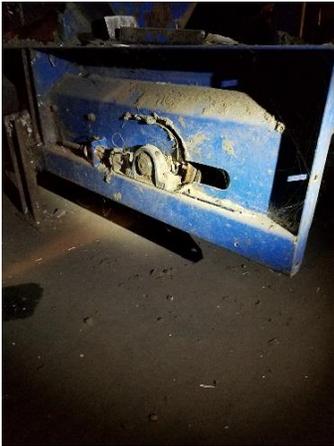
POS M-62 Glass Transfer Conveyor

- Tail Pulley wearing thru take-up
- Belt heavily worn
- Missing Tail Guard
- Belt Return Roller Jammed & Bypassed
- Wood used to hold up belting
- Broken electrical conduit

Ref A8, A10

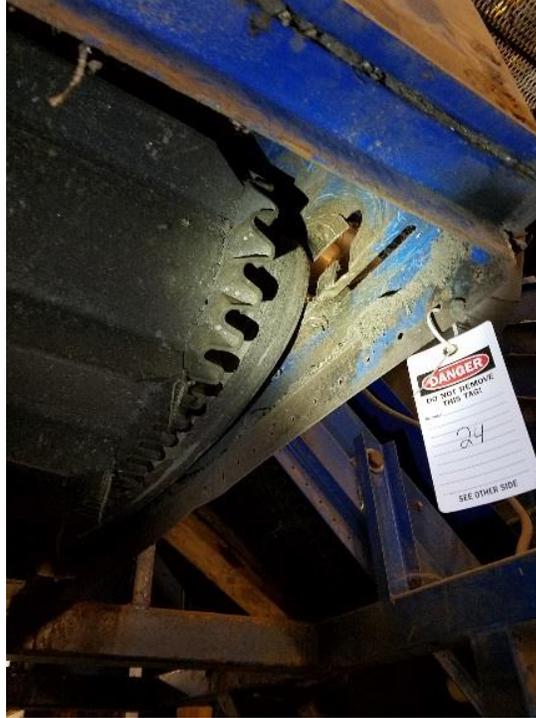
POS M-63A Glass Transfer Conveyor

- Tail Pulley worn thru Take-up
- Wood used as Return Guide
- Missing Belly guards
- Drive Leaks oil

Ref A6, A

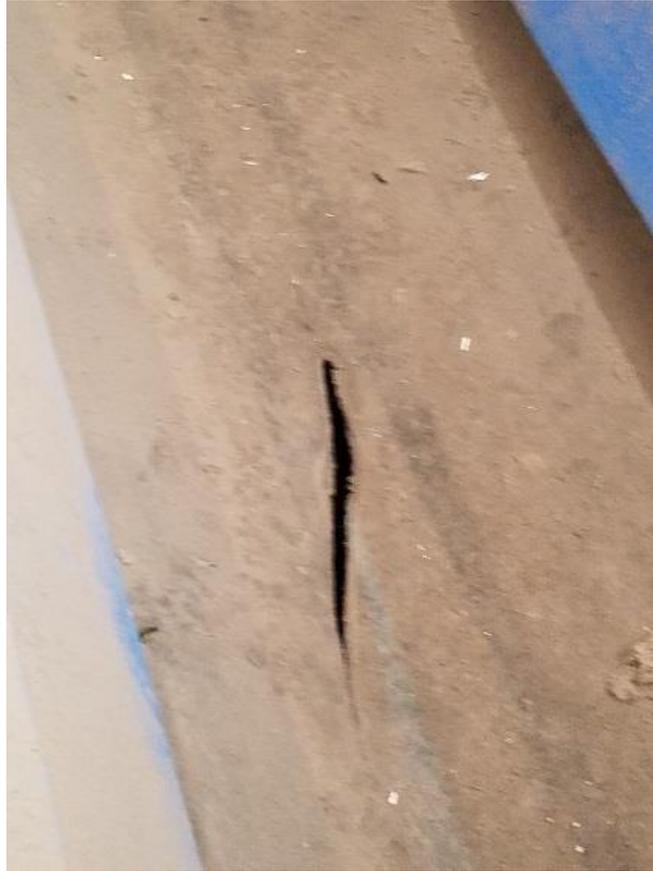
POS M-63B Glass Transfer Conveyor

- Torn Belting
- Missing Tail Guard
- Missing Idler guards

Ref A5

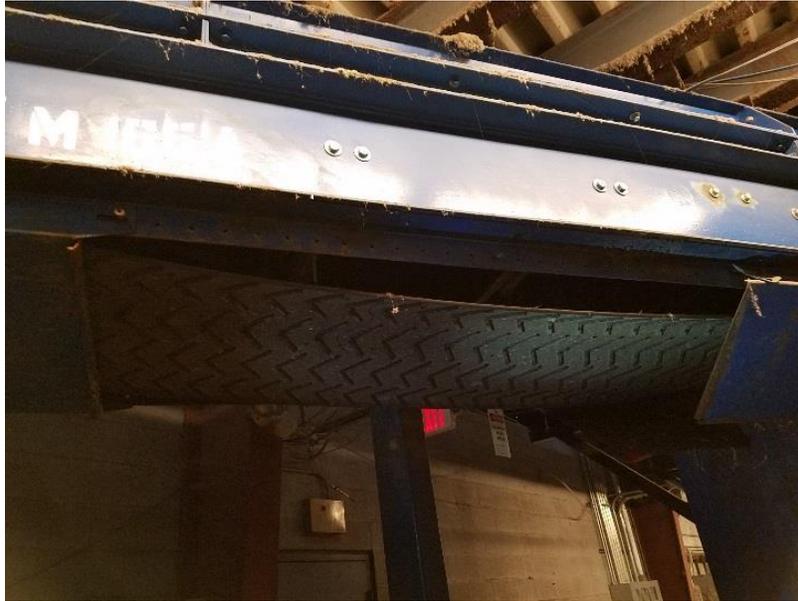
POS M-65A Glass Transfer Conveyor

- Missing Return Roller(s)
- Damaged Belt due to drag on chute
- Belt tracking right
- Tail Pulley heavily worn
- Drive leaks oil

Ref A2, A3, A5

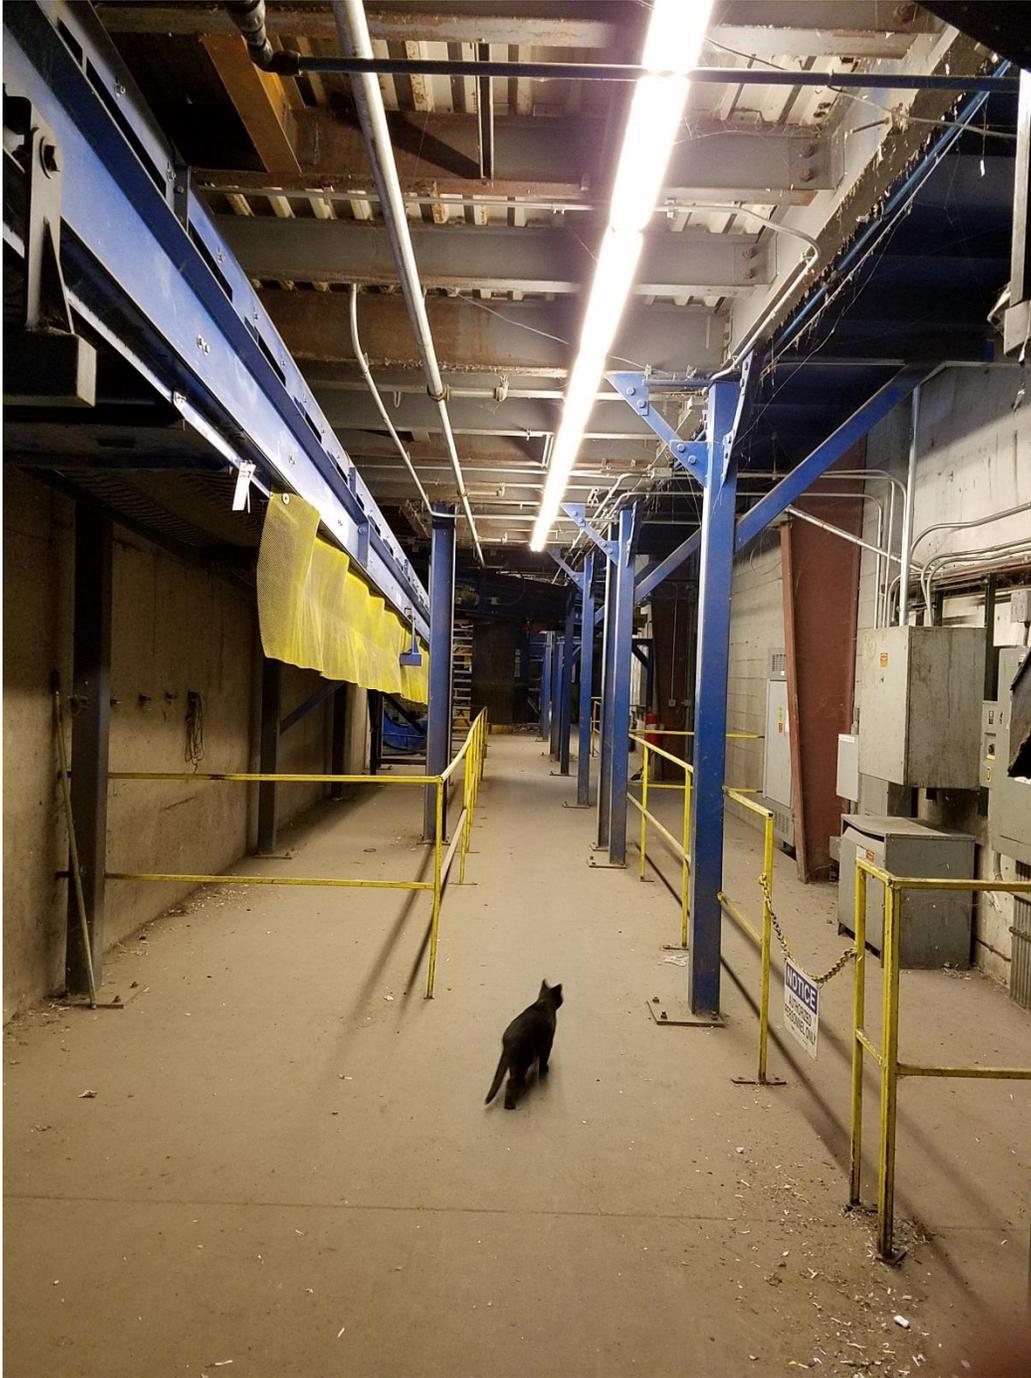
POS M-65B Glass Transfer Conveyor

- Heavy wear on belt
- Belt tracking right

Ref A5

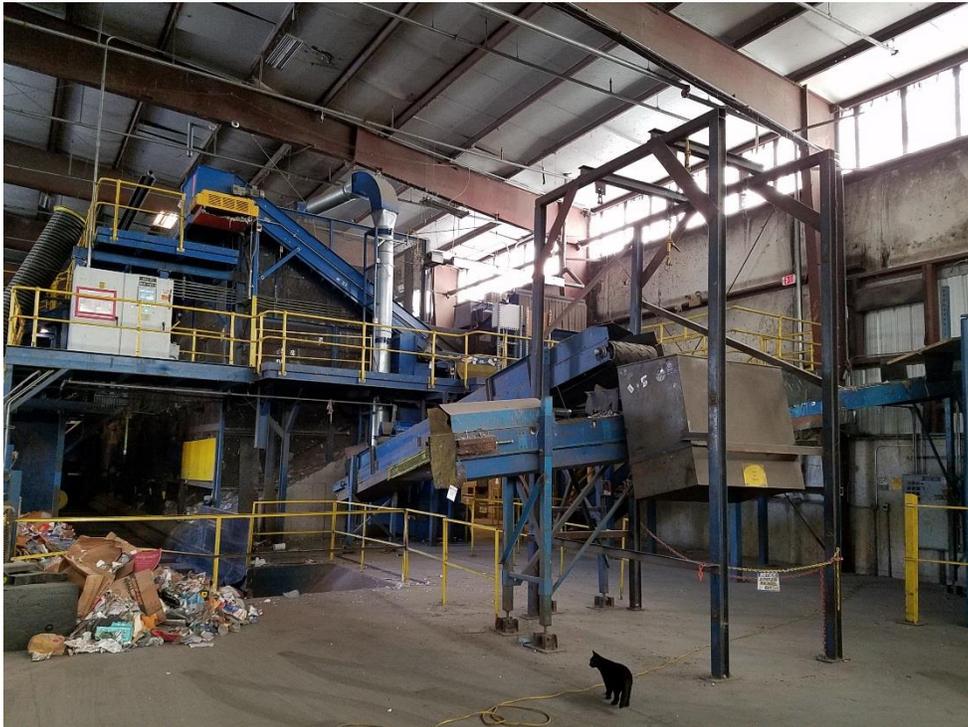
POS M-67 Glass Transfer Conveyor

- Buildup on Return Rollers

Ref A3

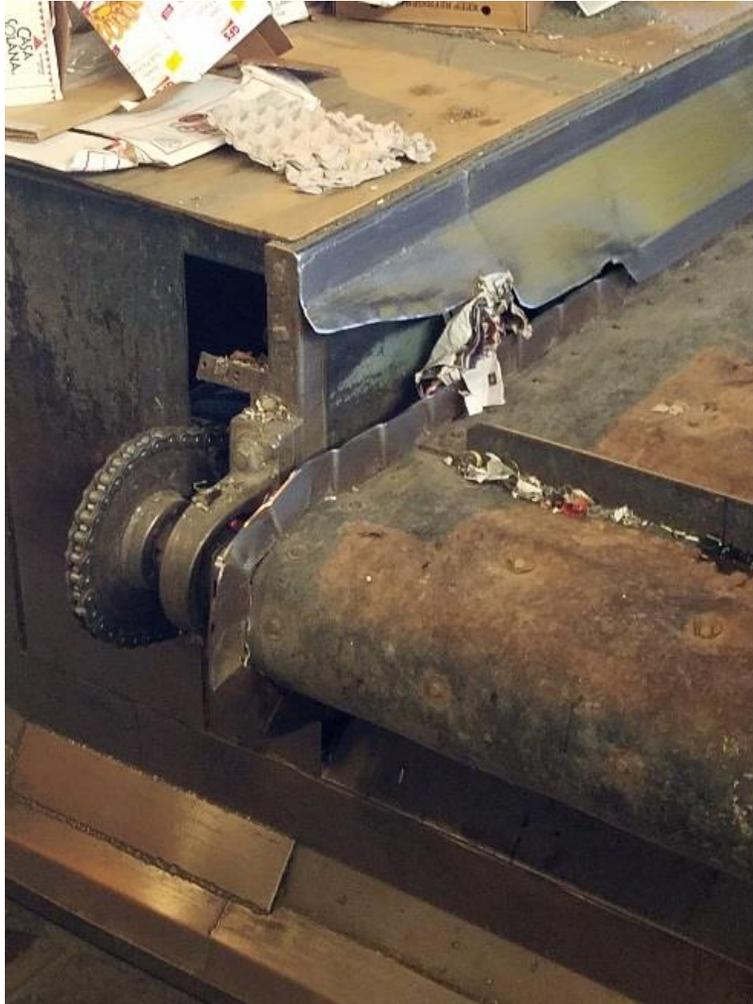
POS M-71 Silo & Bunker Upload Conveyor

- Sideboards worn thru at Head Pulley (both sides)

Ref A6

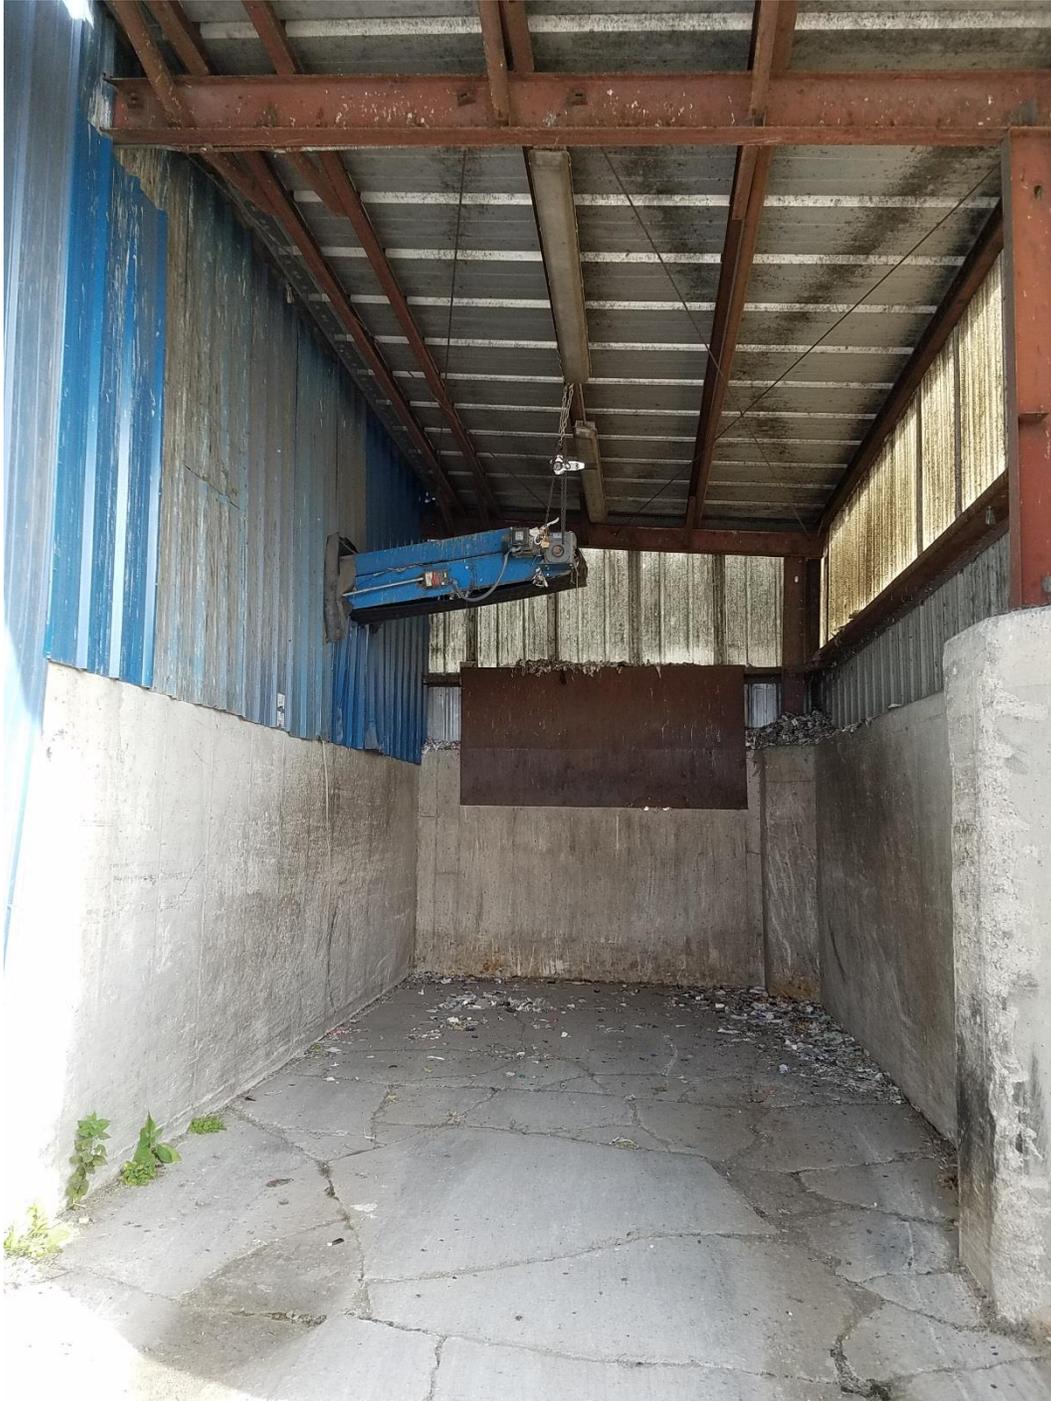
POS M-75 Glass Transfer Conveyor (to bunker)

- Head Pulley supported by chain-fall

Ref A15
