ADDENDUM No. 3

RFP No. 980

Interim Operation of Ann Arbor Material Recovery Facility (MRF) and Waste Transfer Station

City of Ann Arbor MRF Audit

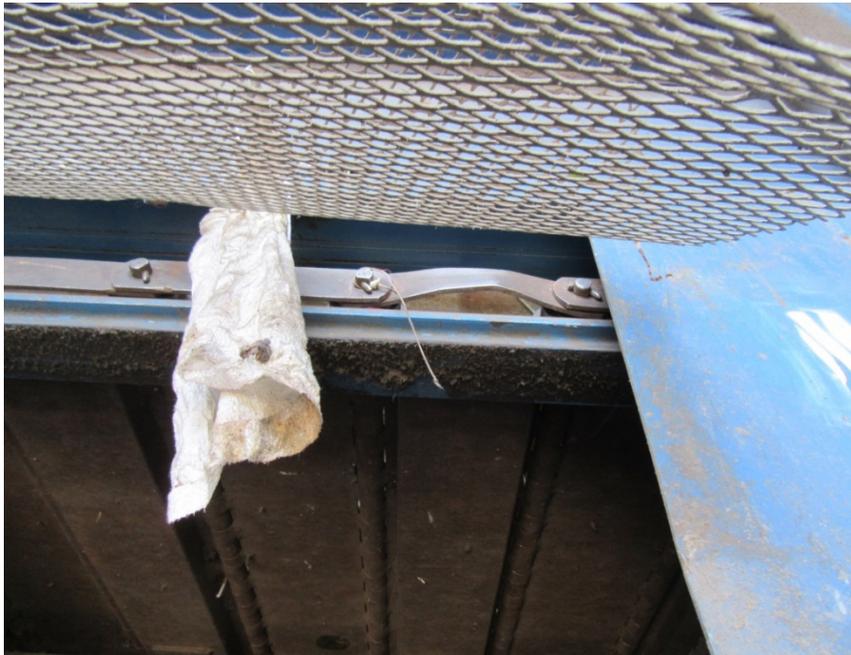
Photo A shows the damaged link in the belting. We recommend fixing the damaged links to prevent further damage to the belt.

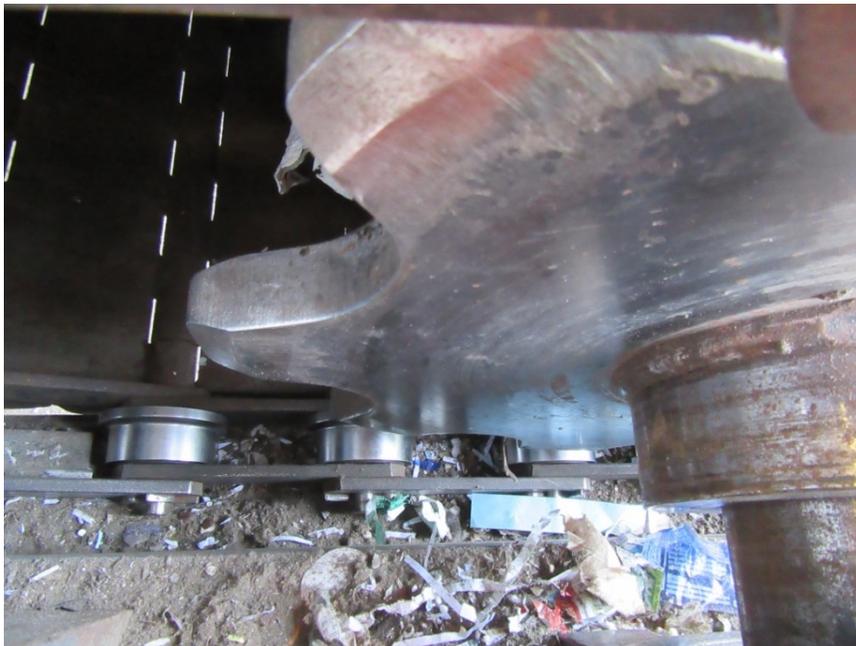
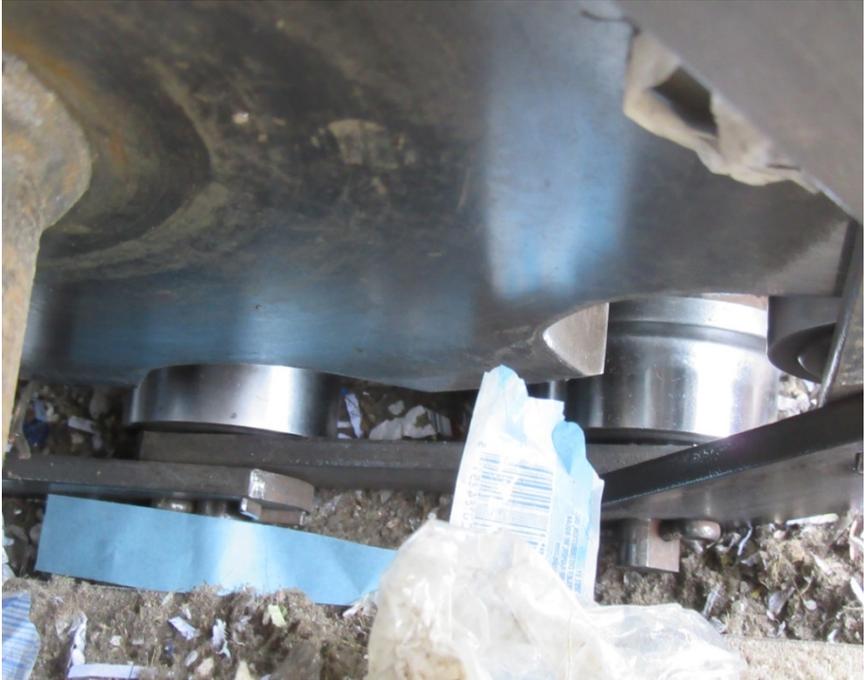
Photos A & B show the lack of tensioning on the belt. We recommend tensioning the belting on a regular basis to prevent premature wear of the belting and sprockets.

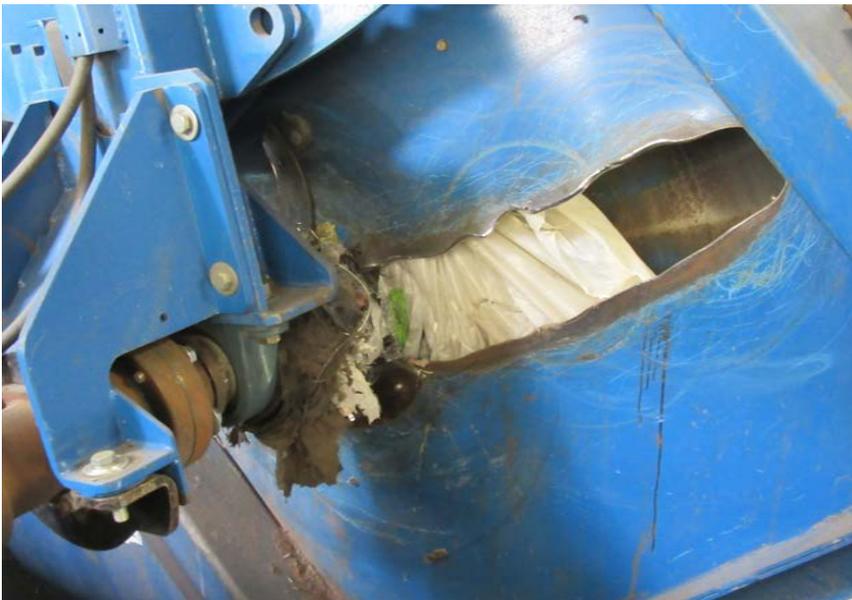
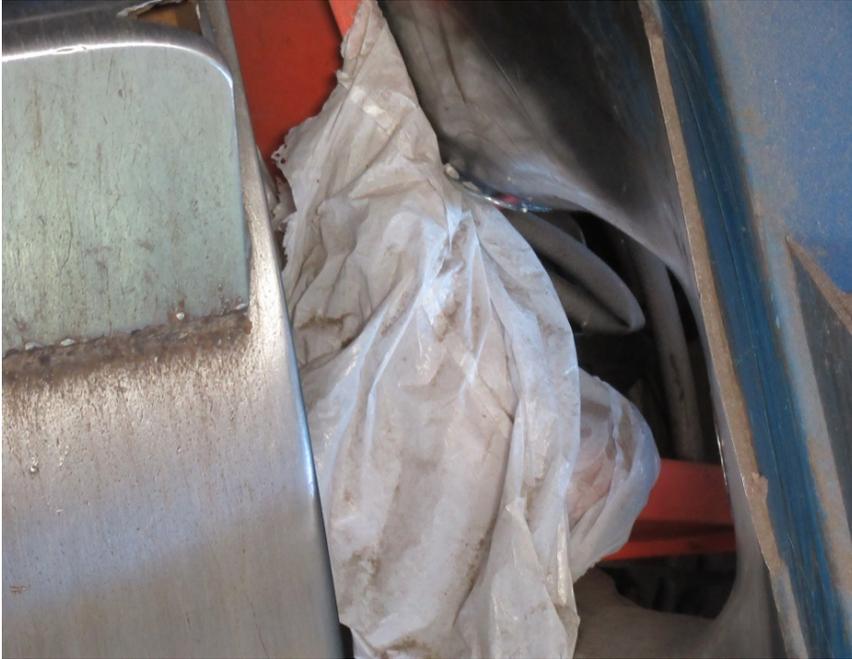
Photos A & B show the excessive wrapping around the Metering Drum shafts. We recommend removing these wrappings on a regular basis to prevent damage to the drum or to the support walls.

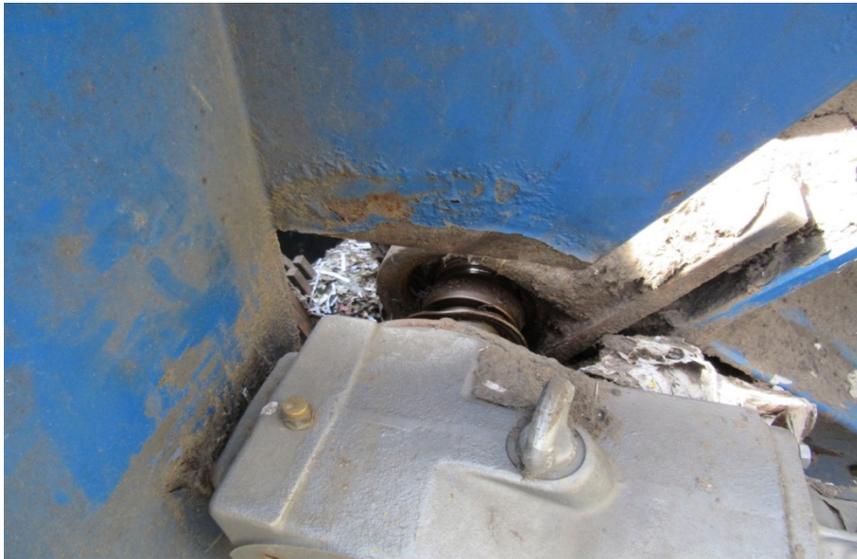
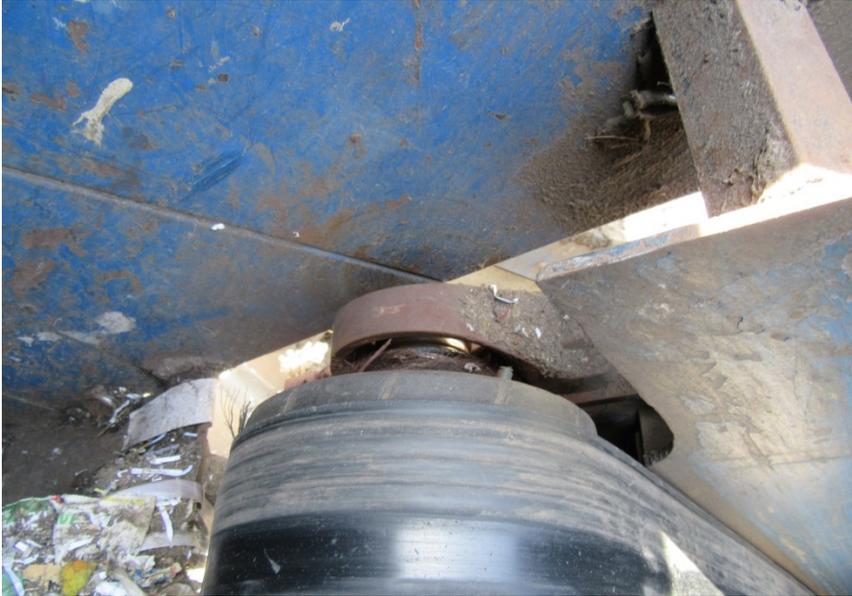
Photos A & B show the condition of the bearings. We recommend that both head shaft bearings are replaced as soon as possible.

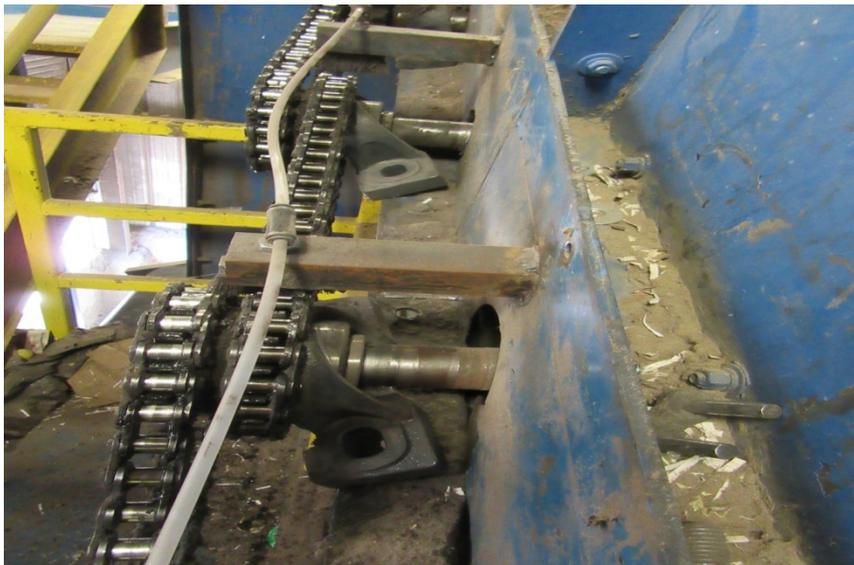
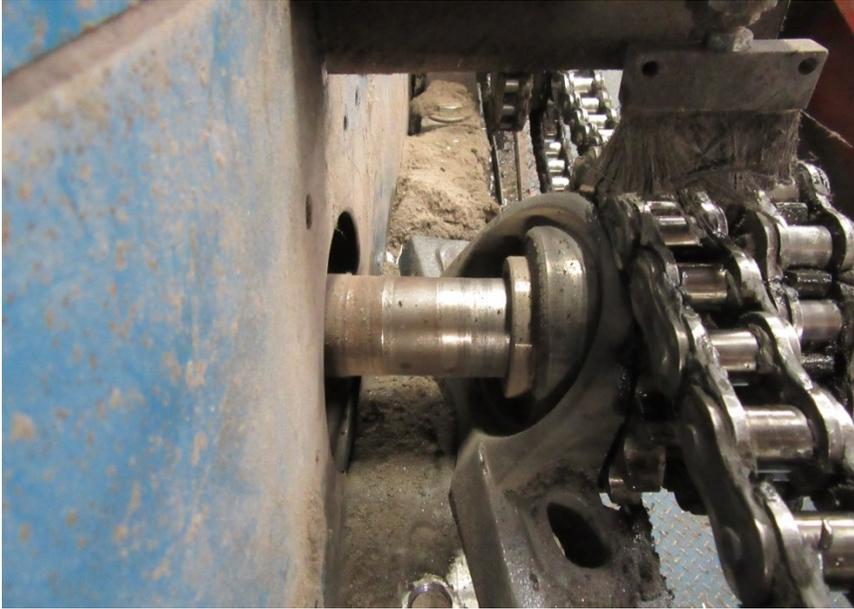
Photos A & B show damage to the bearings. These damaged bearings are a result of the misaligned rotors. Out of time rotors can cause material jams, damaging the bearings as shown. We recommend that the rotors are properly clocked on a regular basis to prevent this problem.

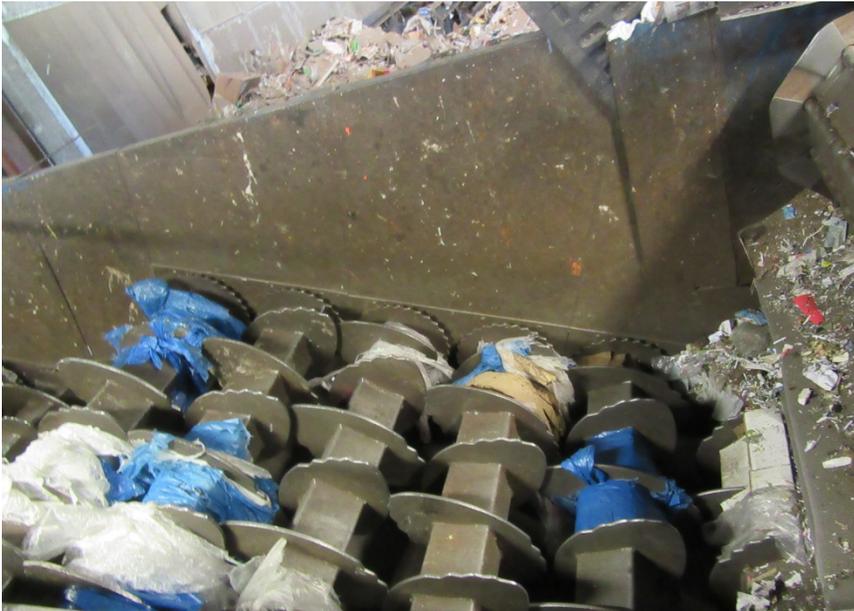
Photo C shows the misalignment of the rotors. This photo also shows the wrappings on the rotors. These wrappings can also lead to material jams resulting in damage to the shafts and bearings. We recommend removing all wrappings on a regular basis.

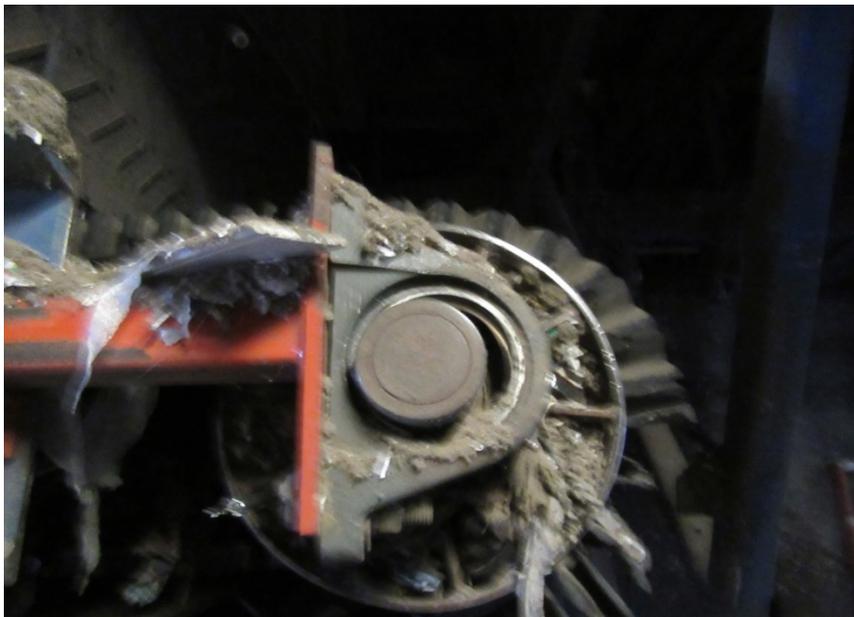
Photo A shows a bad tail pulley bearing. We recommend replacing this bearing to prevent damage to the shaft.

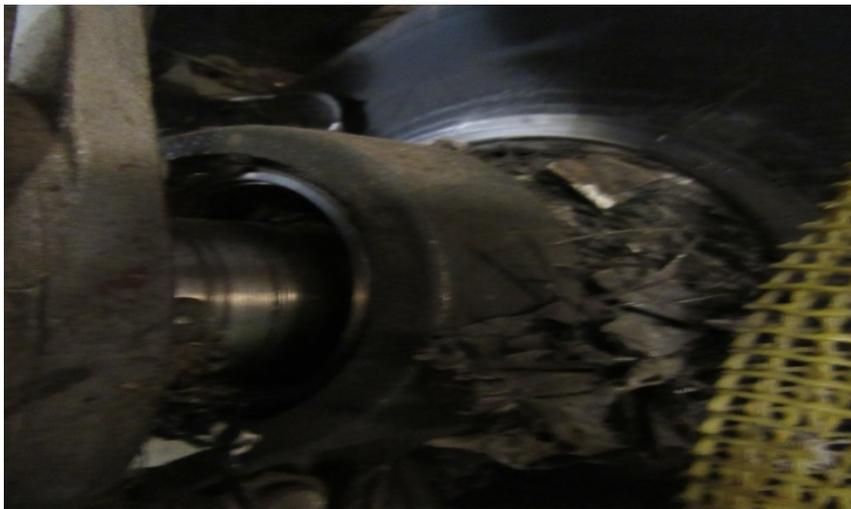
Photo A shows the bad bearing on the head pulley. We recommend replacing this bearing when possible to prevent shaft damage.

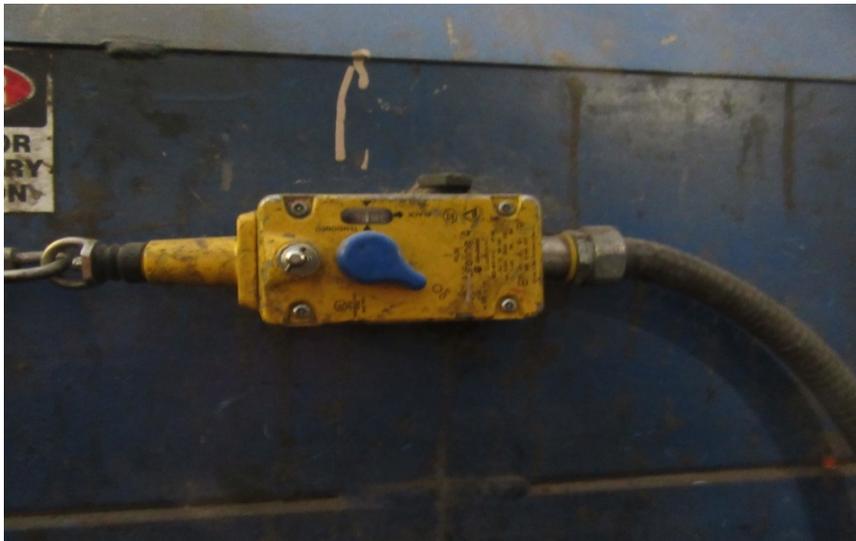
Photo A shows the missing Estop button for this conveyor. We recommend replacing the Estop button as soon as possible.

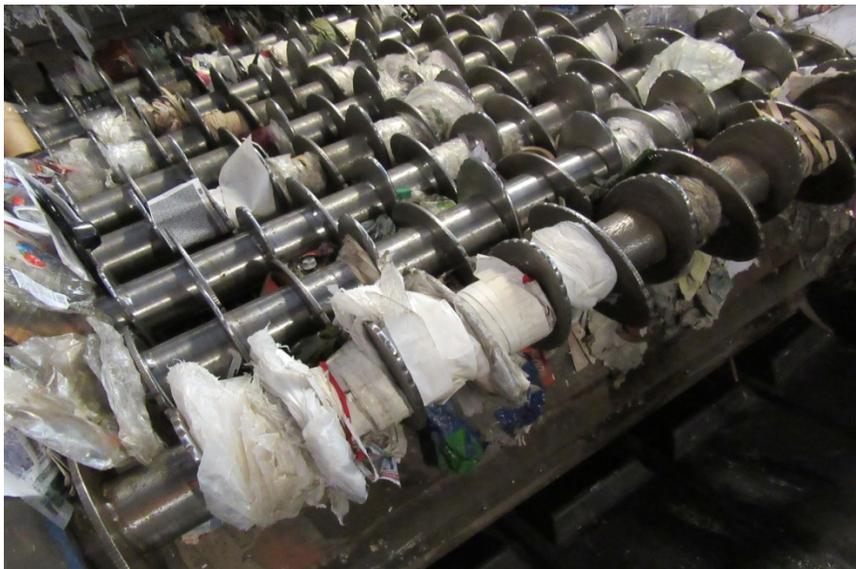
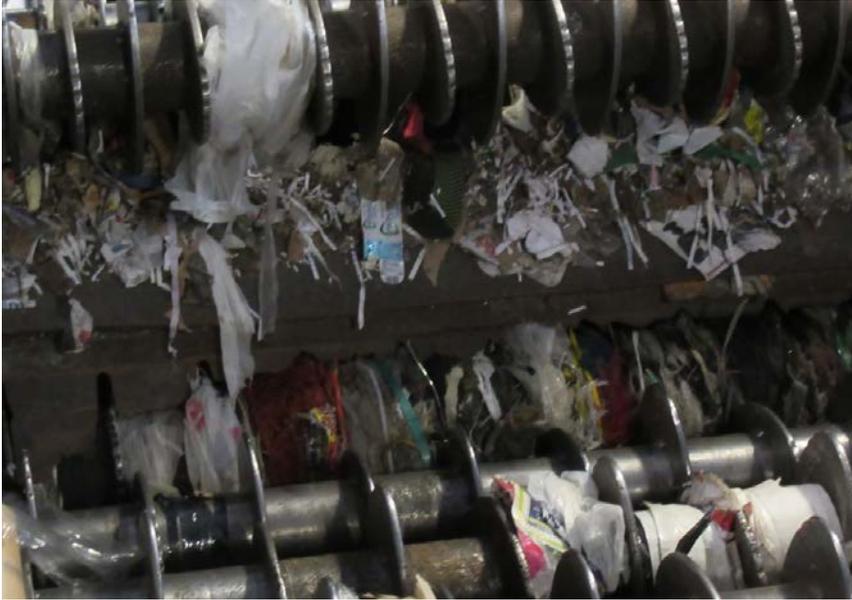
Photos A & B show the worn condition of the rotors. We recommend replacing these rotors to increase the separation performance of this screen. We also recommend removing the wrappings from the rotors on a regular basis to insure maximum separation performance and to prevent material jams.

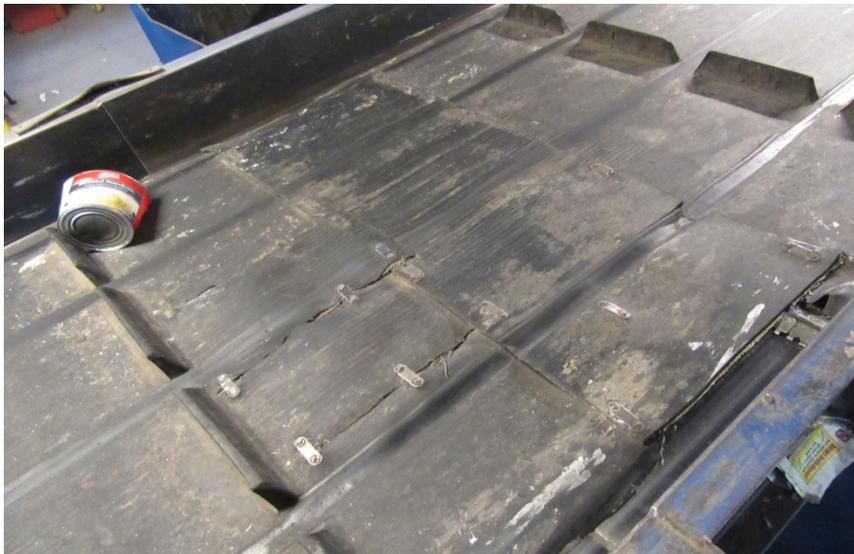
Photo A shows the worn condition of the belt. Some sections of belting are missing and other areas are patched. We recommend replacing this belt when possible to prevent material loss.

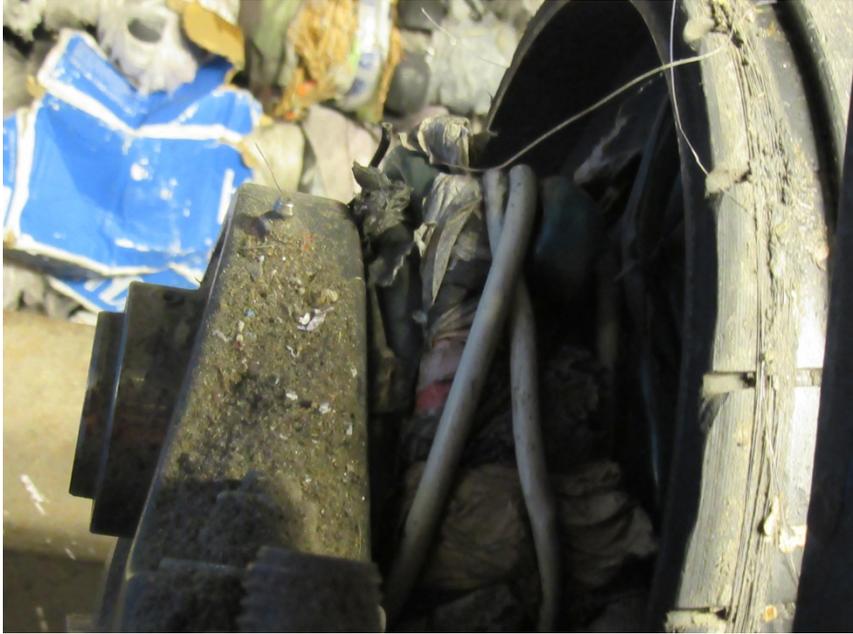
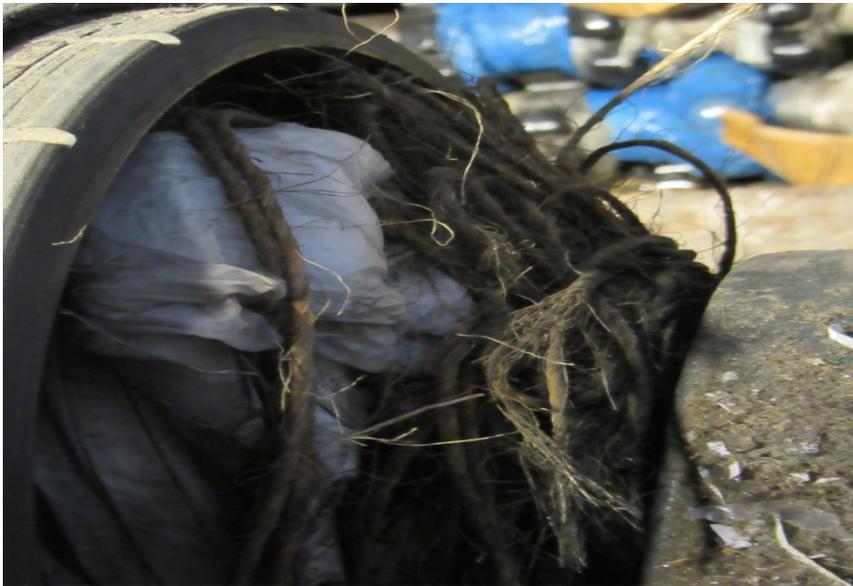
Photos B&C show the head pulley wrappings on both sides of the pulley. We recommend removing these wrappings on a regular basis to prevent damage to the bearings.

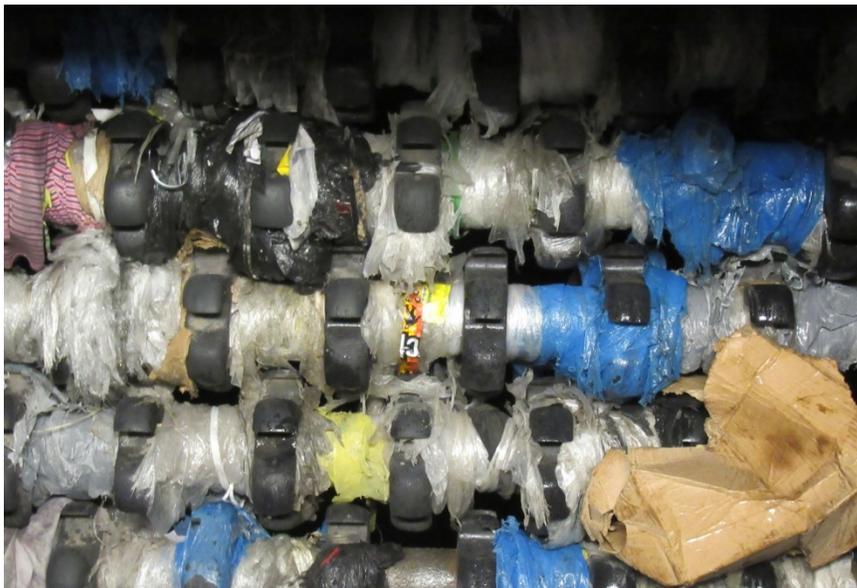
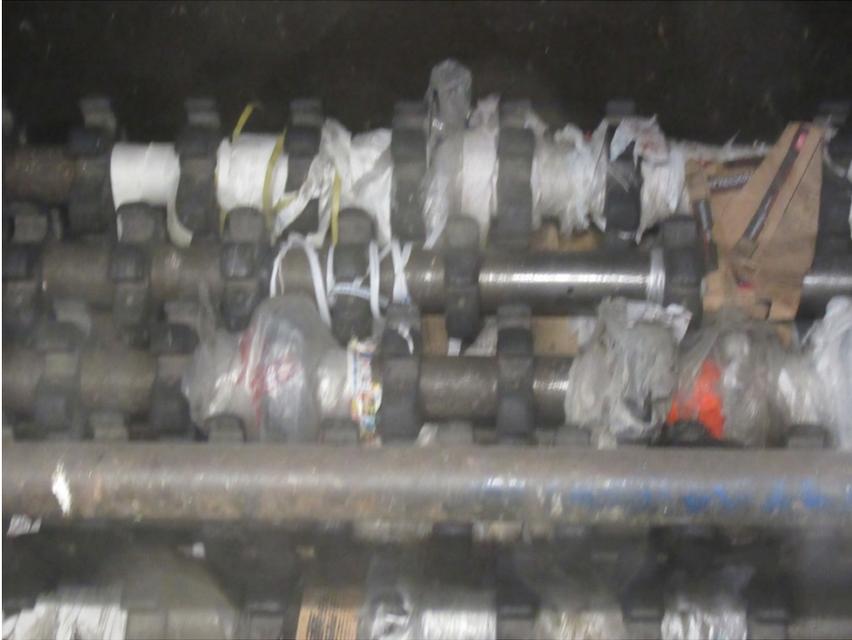
Photos A & B show the worn and missing finger discs. These discs are crucial to maximizing the material separation for this screen. We recommend replacing all of the finger discs on this screen. Also, the photos show the excessive amount of wrappings on the rotors. We recommend removing the wrappings on a regular basis to help maximize material separation.

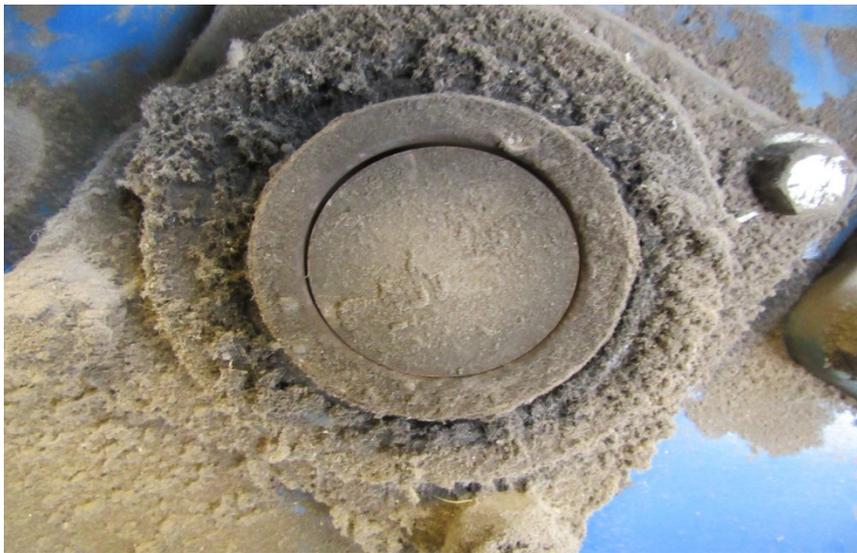
Photo A shows one of the many bad bearings on this screen. We recommend replacing all damaged bearings on this screen to prevent damage to the rotors.

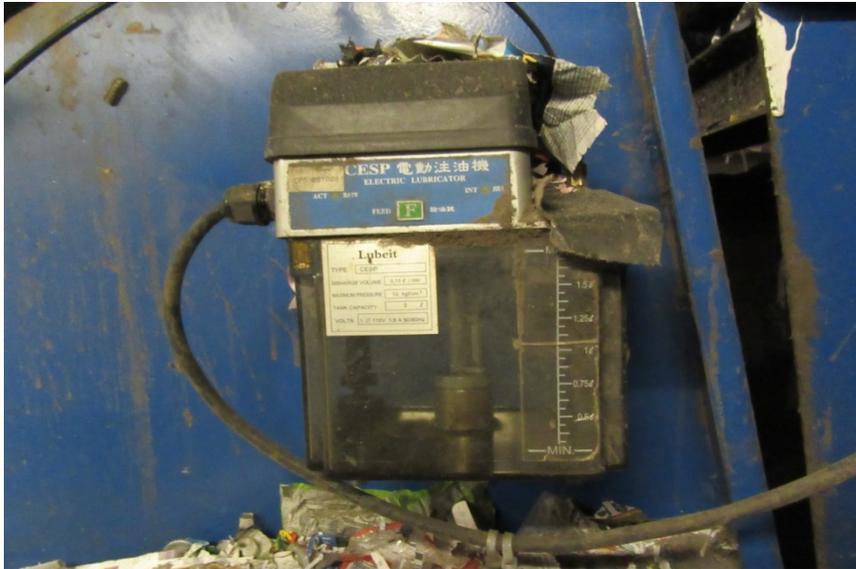
Photo B shows the empty oiler. We recommend that the oiler is filled and put back into use.

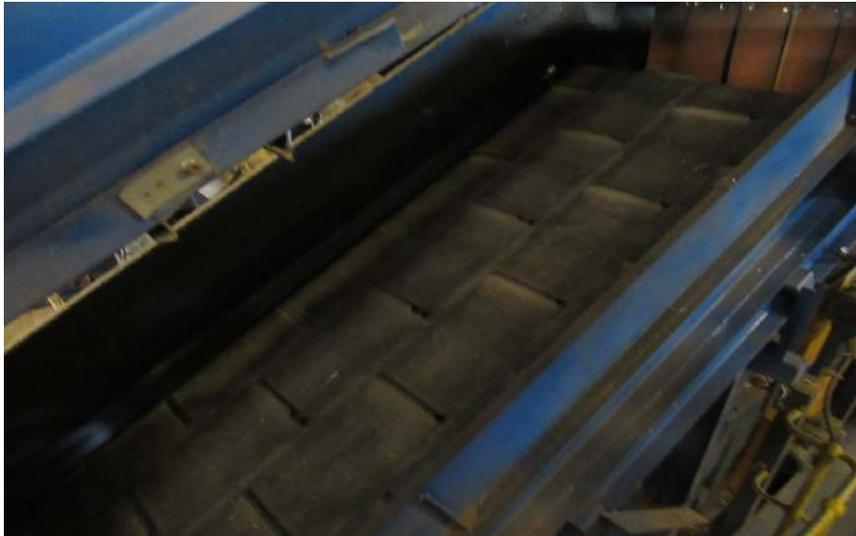
Photo A shows the worn condition of the belting. We recommend replacing this belt when possible.

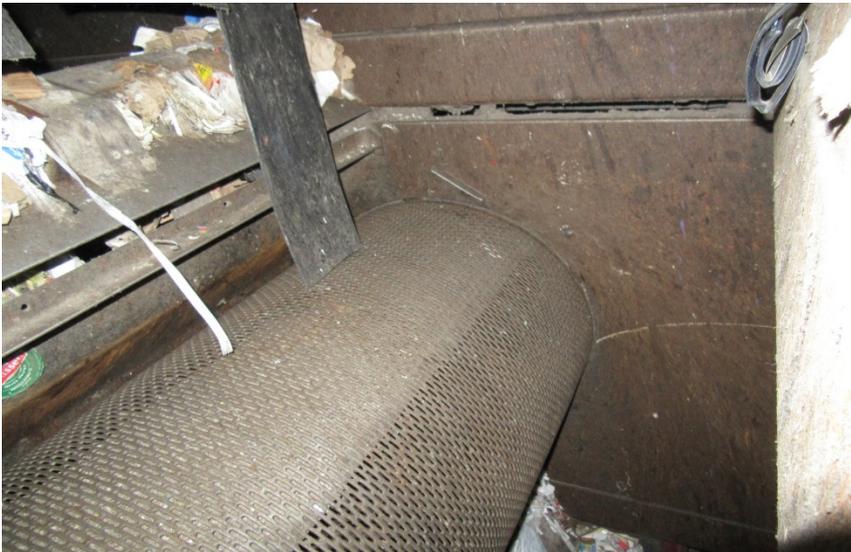
Photo A

ADS guide plate is missing. We recommend that the guide plate is replaced to increase performance.

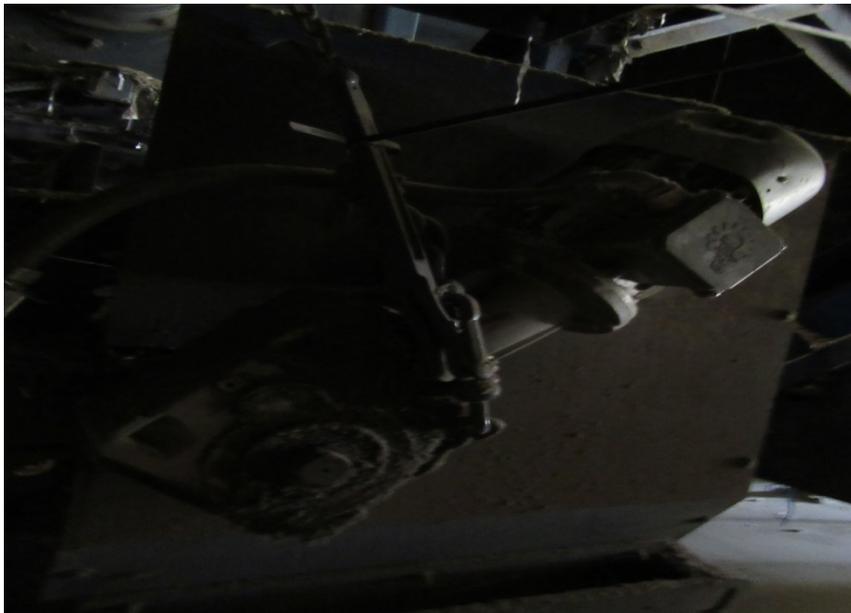
Photo A shows the gear motor supported by a chain. We recommend replacing the torque arm bracket and mounting the gear motor properly to prevent damage to the pulley or gear motor.

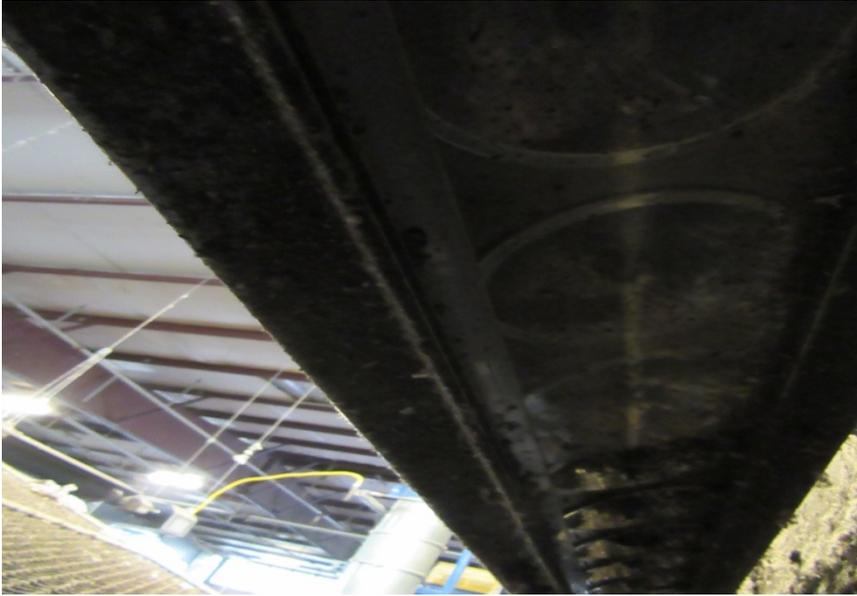
Photo A shows the missing glass on the light bar. One was on order at time of audit.

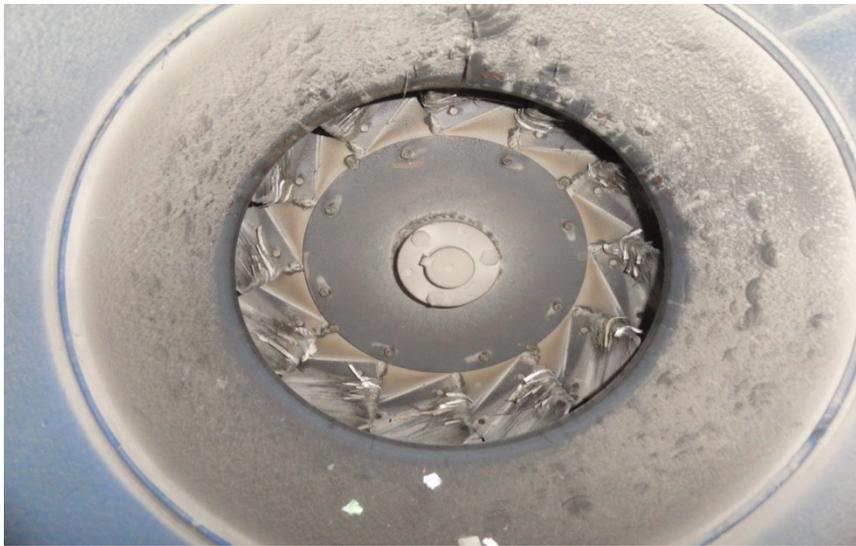
Photo A shows some debris that has built up on the impellor. We recommend that the impellor be cleaned on a regular basis. The silo blower overall is in good condition.

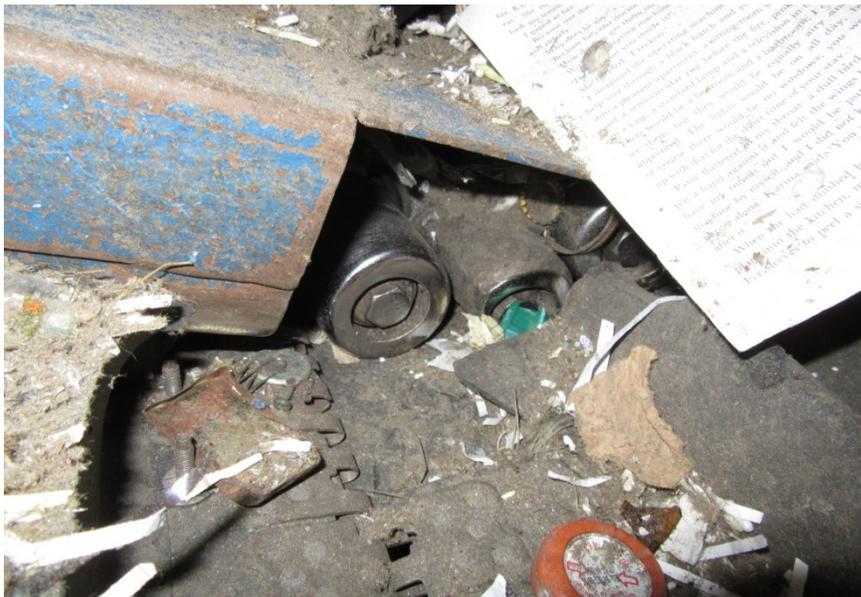
Photo A shows the jammed up- turn roller. We recommend replacing these rollers when possible. Also, the lacing is damaged and in need of repair to prevent material loss.

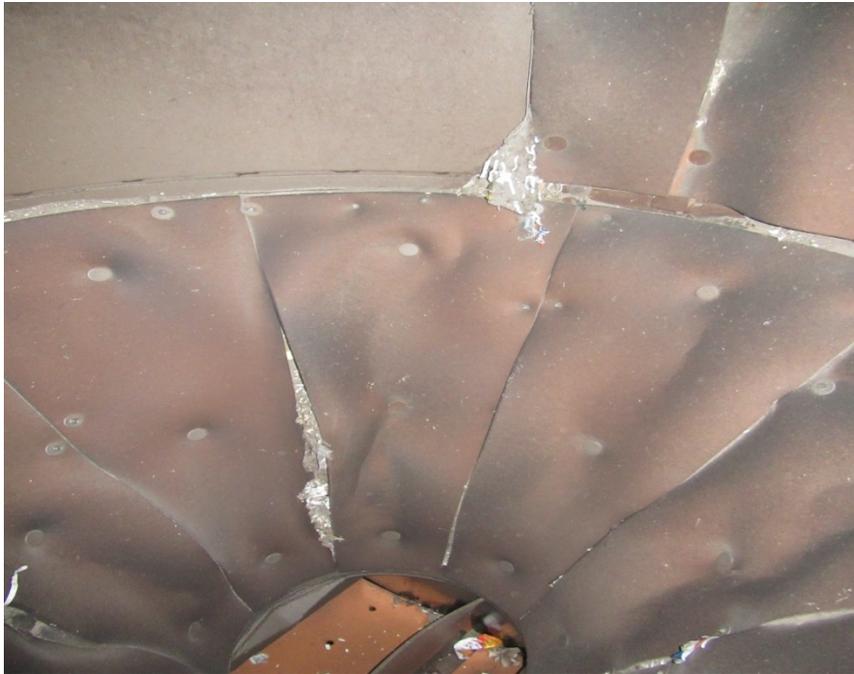
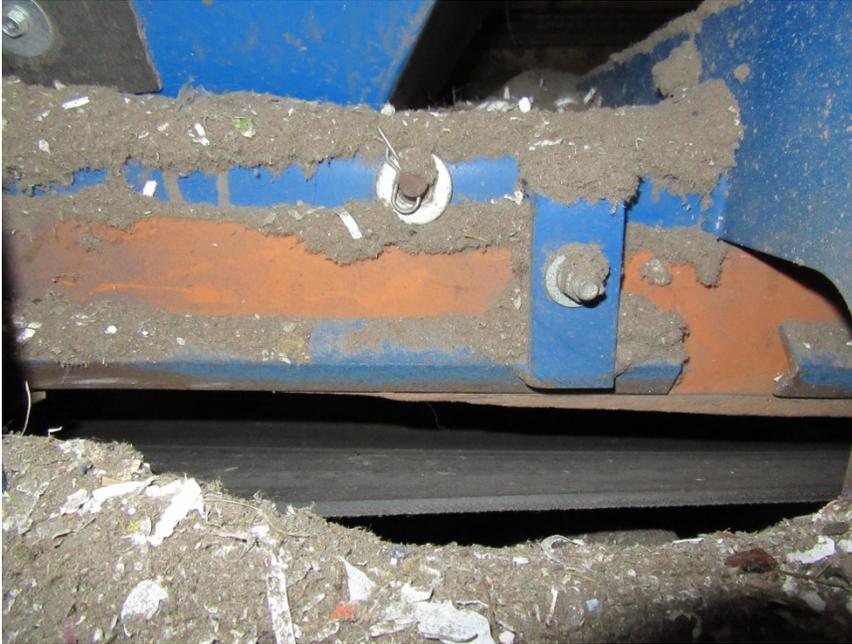
Photos A & B show the worn condition of the urethane liners in the cyclone. We recommend replacing these liners to help maximize the glass cleanup's efficiency. We also recommend that the seals be adjusted so that they meet the conveyor belt. This will help with the separation quality.

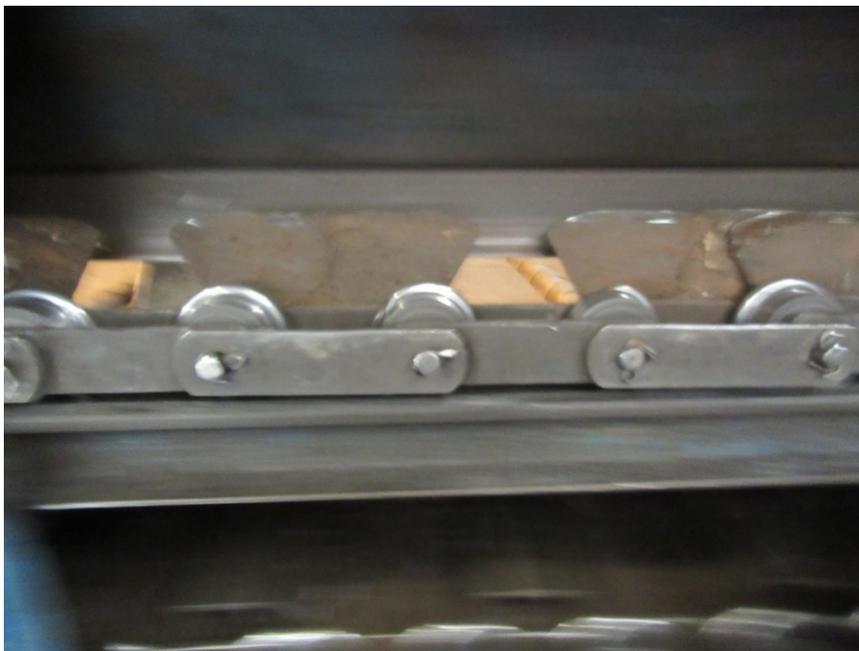
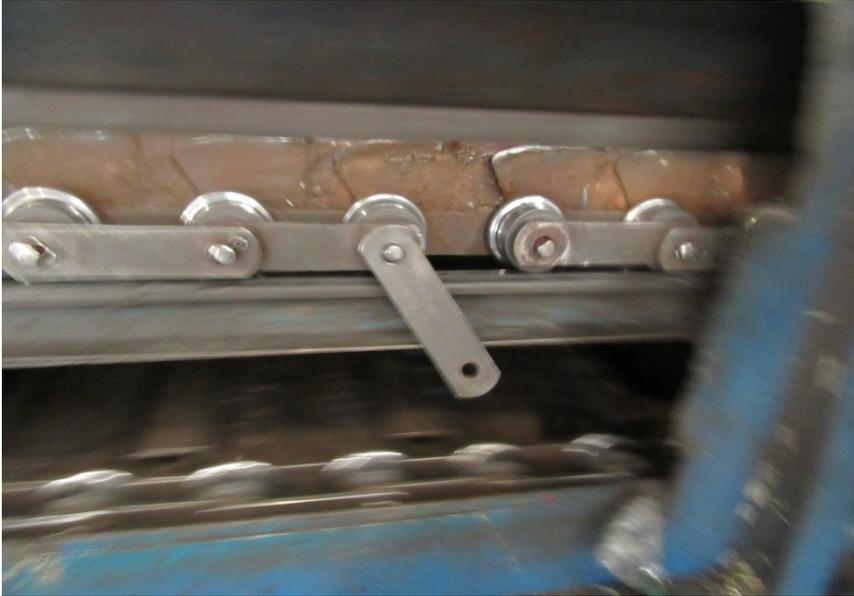
Photos A & B show the missing or damaged belting sections. We recommend replacing this belt when possible.

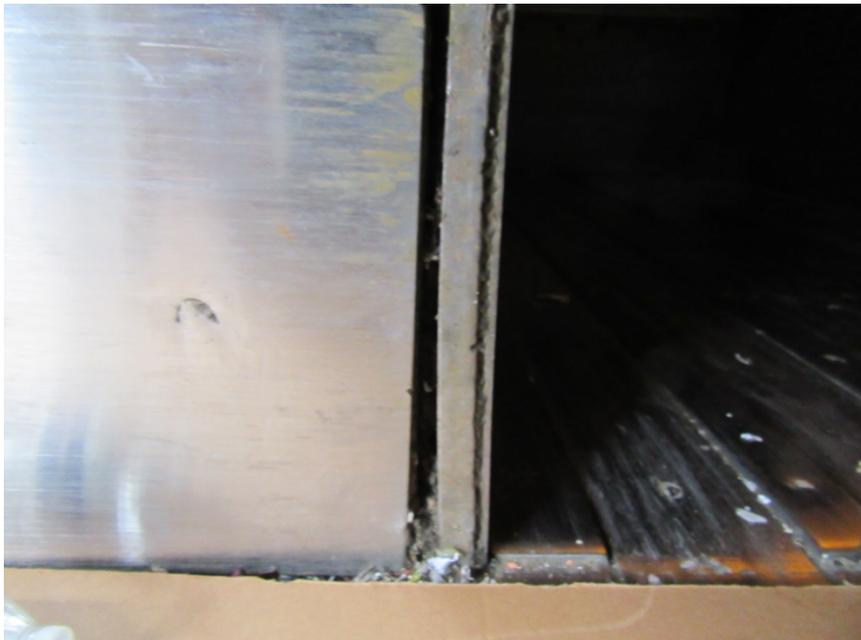
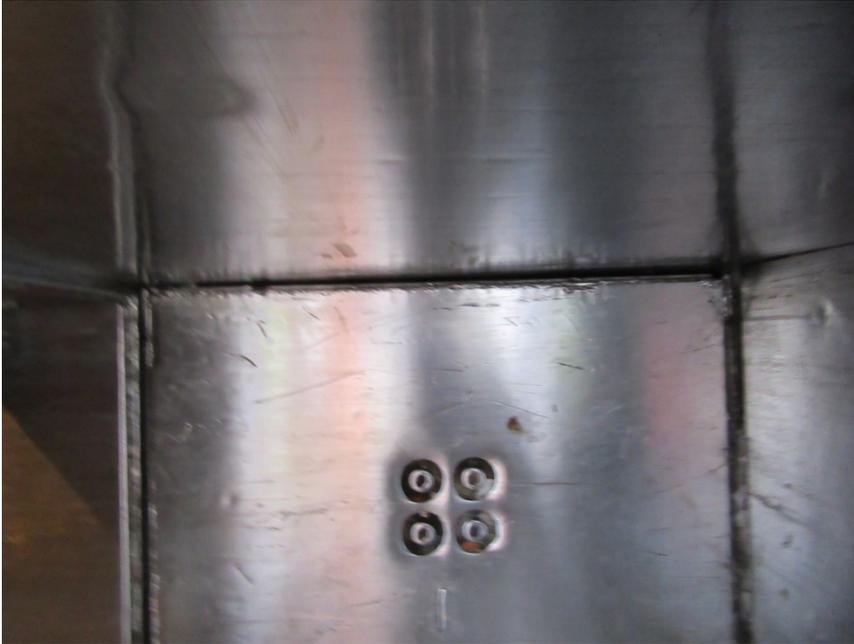
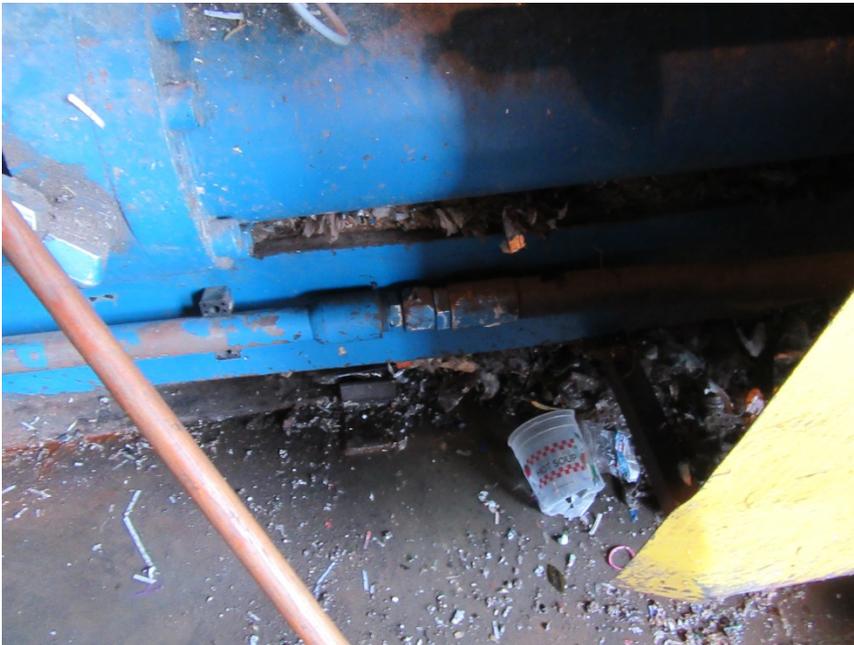
The overall condition of the baler is good. There is a ¼” knife gap that should be monitored. We also recommend flipping the blades. Shim and adjustment is also recommended. The door ram area needs to be cleaned and there is a radiator leak that was being repaired while we were on site.
