AMENDMENT NUMBER 1 TO AGREEMENT FOR PROFESSIONAL SERVICES BETWEEN UTILITIES INSTRUMENTATION SERVICE AND THE CITY OF ANN ARBOR

Technical Memo 3

SUBJECT: Ann Arbor Water Treatment Plant

Filter Pipe Gallery Flooding Rehab

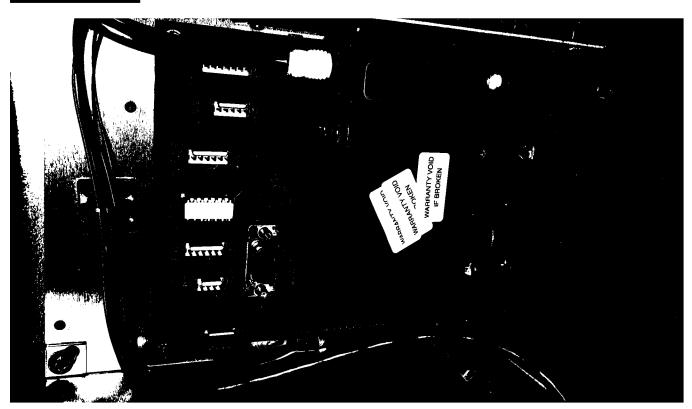
Inside of Hach Particle Counter Enclosure. Typical of 9. Contents of enclosure were immersed. Wire terminations are corroding.

The City is considering the possibility of replacing the existing particle counters with ChemTrac Model PC3400 particle counters, which is currently being piloted at the plant. The ChemTrac units are considered to be equivalent to the damaged Hach 2200 PCX units, but are less expensive. The project cost estimate has been based on the more expensive HACH replacement units.

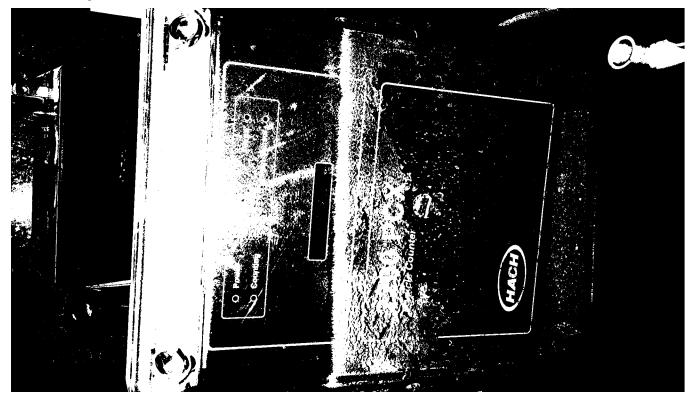
Hach Particle Counter. Water entered the gasketed enclosure and filled the devise approximately 2/3 of the way. Devise not functioning. Typical of 9.

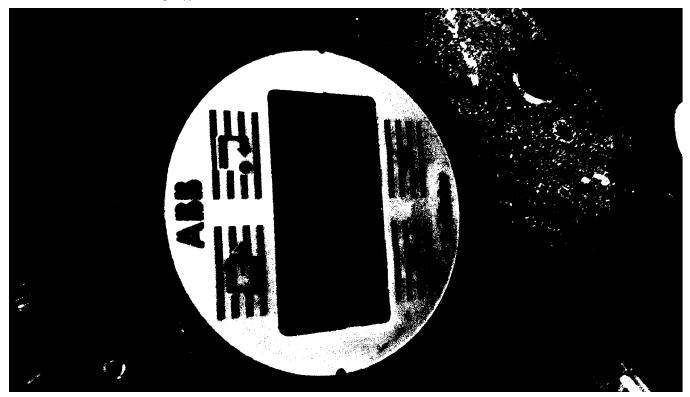
ABB Filter Headloss Sensor Display. Display was immersed and is not functioning. Typical of 16.

The existing pressure transmitters will be replaced with Rosemount Model 2051C pressure transmitters and associated 3-valve manifolds, which are equivalent to the damaged ABB pressure transmitters. Re-use of the existing 3-valve manifolds was considered; however, UIS estimated that the labor cost to remove the old manifolds and reinstall new would exceed the cost of the new manifolds. There were also questions about compatibility of the old manifolds with new differential pressure meters.

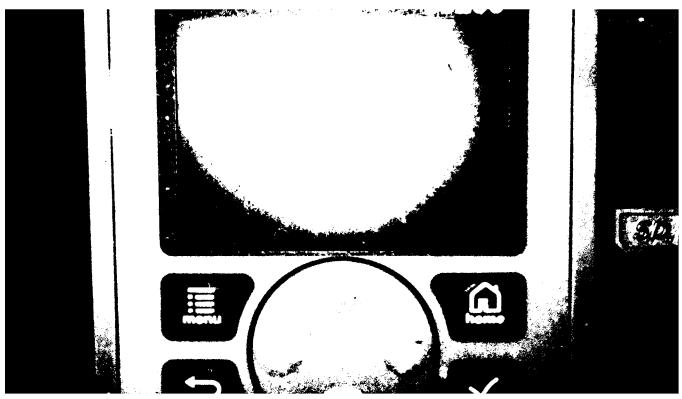
The existing turbidimeters were Hach model 1720E sensors which were housed within a 1720C well. Each turbidimeter had a Hach SC200 controller that facilitated communication with SCADA. The 16 turbidimeters and associated controllers were damaged as a result of the incident and should be replaced.

Hach Turbidimeter Controller. Devise was immersed and is not functioning. Typical of 16.

The 1720E turbidimeters have been phased out by Hach and are no longer available for purchase. The current equivalent offering from Hach is the TU5300 turbidimeter. Hach SC200 controllers are still available.

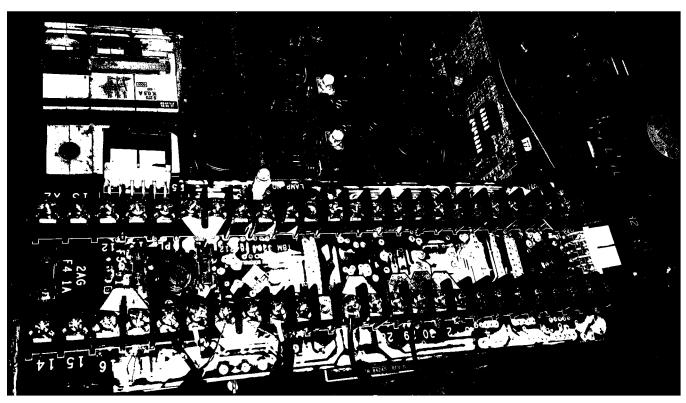
EIM valve actuator. Actuator was immersed. Water entered the enclosure and submerged wire terminals and network cards. Actuator not functioning. Typical of 21.

The existing EIM valve actuators which were damaged as a result of the incident will be replaced with Rotork's equivalent offering, the Model IQ3 valve actuator, around which the City has standardized. One reason for using the Rotork actuators is that they provide greater submergence protection than the EIM actuators. The Rotork actuators have a standard environmental sealing rating of IP66/68, which allows them to be temporarily submerged to a depth of up to 20 meters (65.6 feet) for 10 days.

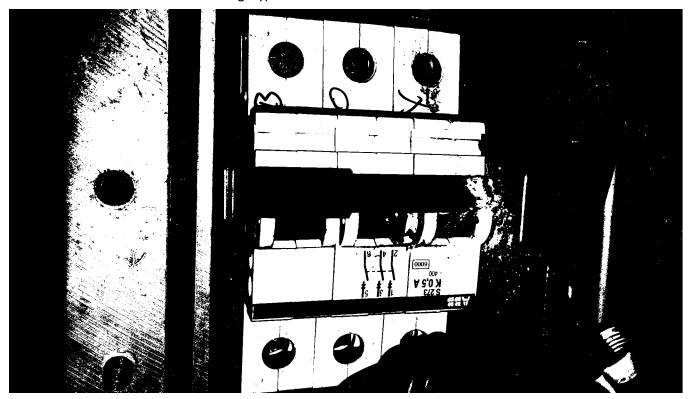
EIM Valve actuator 480V power supply breaker. Breaker was submerged when water entered the enclosure. Wires corroding. Actuator not functioning. Typical of 21.

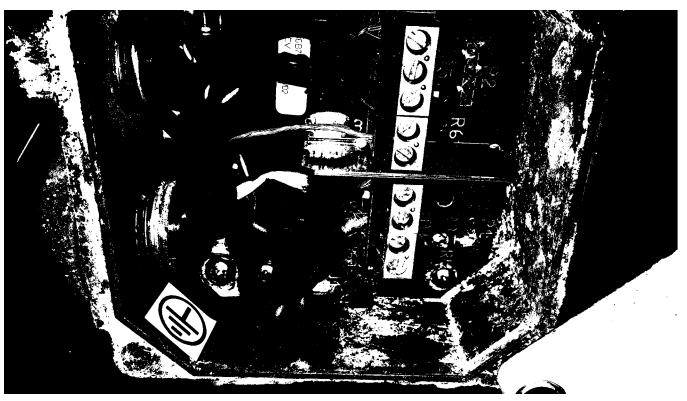
The existing electromagnetic flow meters are ABB model 10DX3111 with associated 50XM1000 flow indicating transmitters. In total, 16 flow meters and associated flow indicating transmitters were damaged as a result of the incident and should be replaced.

ABB Filter Effluent flow meter. Devise not functioning. Typical of 16.

The existing flow meters and transmitters will be replaced with Rosemount model 8750W units, which are equivalent to the damaged ABB units and the City's current standard. Both the Rosemount and new ABB flow meters were evaluated for replacement of the damaged meters. The existing ABB meters have functionality that allows them to be field-calibrated to confirm their accuracy. However, the new, similar model flow meters from ABB do not have this functionality. The provided Rosemount meters can be field-calibrated.

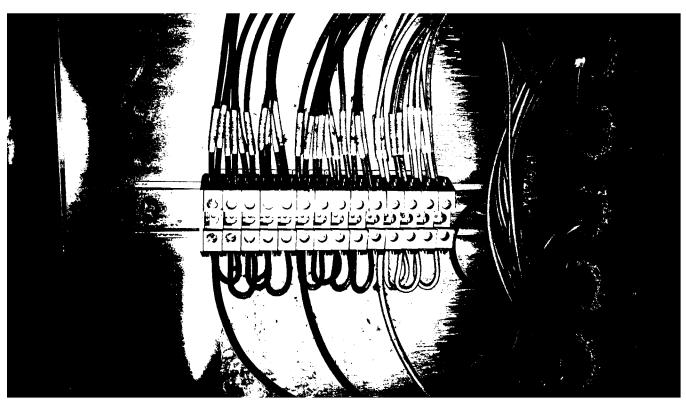
480V power distribution junction box. Water entered gasketed enclosure and filled approximately 2/3 of the enclosure. Wires terminations are corroding.
