CITY OF ANN ARBOR, MICHIGAN

**LOCAL BRIDGE PROGRAM FUNDING APPLICATION
FOR
PREVENTATIVE MAINTENANCE
FOR THE
E. MEDICAL CENTER DRIVE BRIDGE OVER THE
WOLVERINE LINE**

LOCAL BRIDGE PROGRAM FUNDING APPLICATION E. MEDICAL CENTER DRIVE BRIDGE OVER THE WOLVERINE LINE

FEDERAL STRUCTURE ID. NO. 814021200000R01 MDOT STRUCTURE NO. 11065

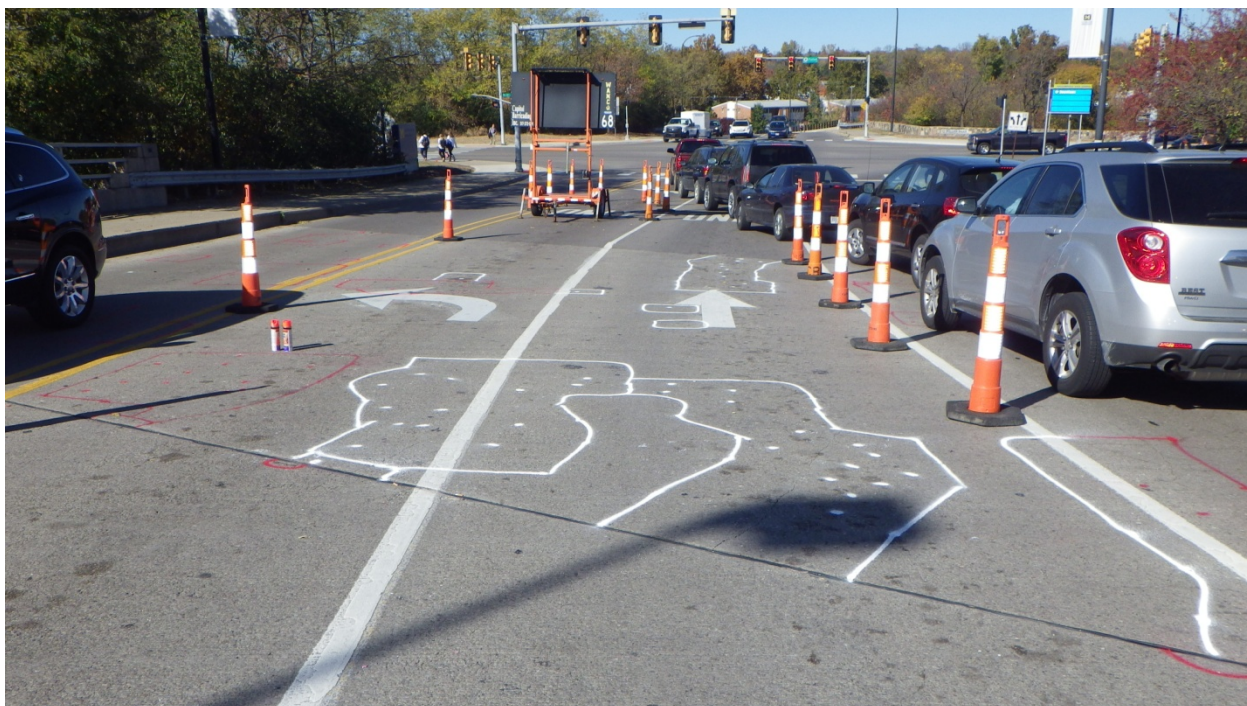
This structure is generally in fair condition. There are approximately 1,107 ft² (≈ 9.8% of the deck area) of delaminated and spalled areas. The north span has the largest concentration of spalled areas with approximately 29.4% of the north span being spalled and delaminated. The bottom side of the bridge deck has approximately 5% of the total area consisting of spalls (some with exposed reinforcement), delaminations, cracks with moisture and efflorescence, and rust stains. In order to better determine the amount of delaminated areas, we utilized infra-red thermal scanning technology in 2013 and again hand-sounded the deck in 2015 to locate and define the extent of delaminated areas.

Figure 2 Deck Delaminations in North Span (looking north)

The bridge is planned to have all steel beams, diaphragms, and cross braces cleaned and re-coated. The northerly pier cap is proposed to be removed and replaced. The expansion joints will be removed and replaced. At this time it is not believed that any of the beams ends will require significant steel repairs, however, some diaphragms under the expansion joints may need to be replaced depending upon their condition upon further inspection. The latex modified concrete wearing surface is planned to be removed and replaced (shallow overlay.) The guardrails will be

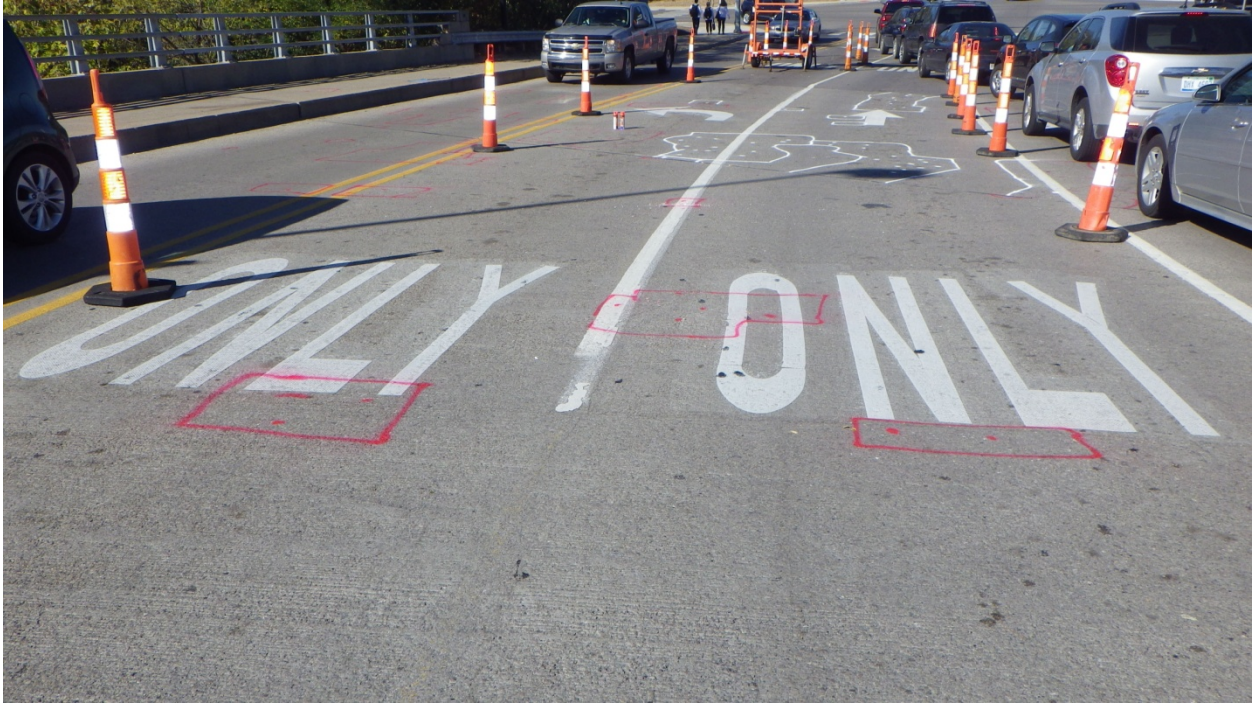
Figure 3 Deck Delaminations in Center Span (looking north)

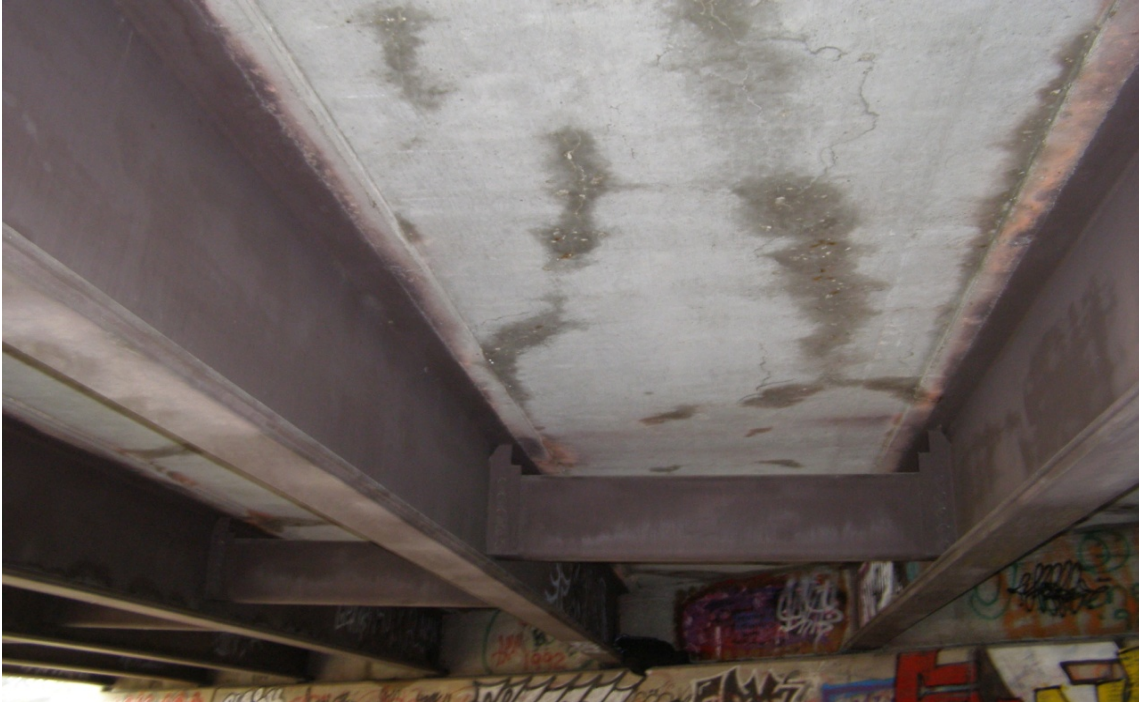
Figure 5 Moisture and Cracking in Bottom of Deck, Span 3

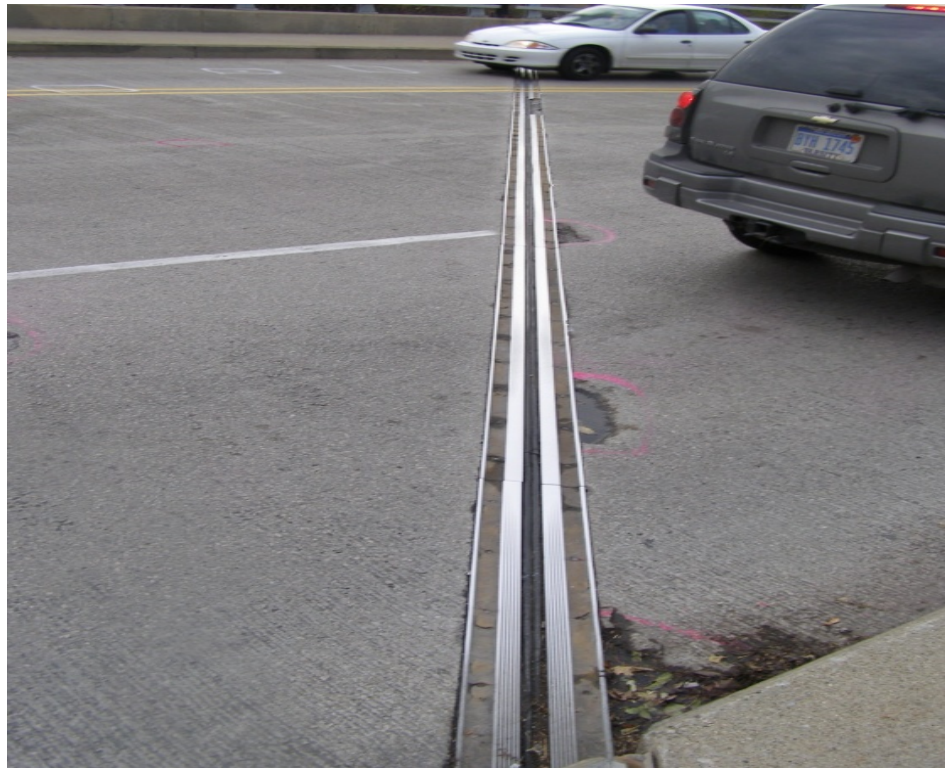
The paint system has failed. The expansion joints located over the piers are in poor condition. The glands in the expansion joints are torn and debris-filled. The joints leak causing corrosion at the beam ends and ponding water on the pier caps. The beam ends at the expansion joints are corroding, but there is no measurable section loss. The end diaphragms under the expansion joints also have corrosion without measurable section loss.

Figure 7 Spalling along South Expansion Joint (looking west)

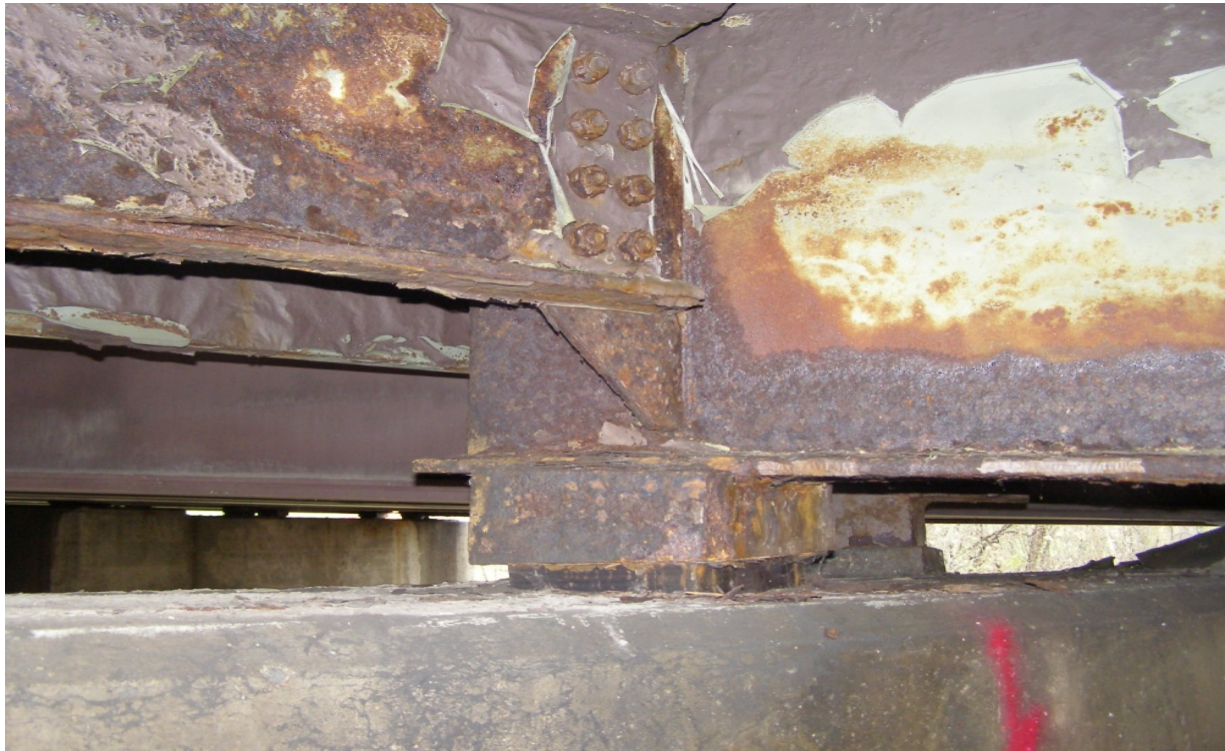
Figure 9 End Diaphragm and Beam End Surface Rusting and Paint Failure, Pier 2

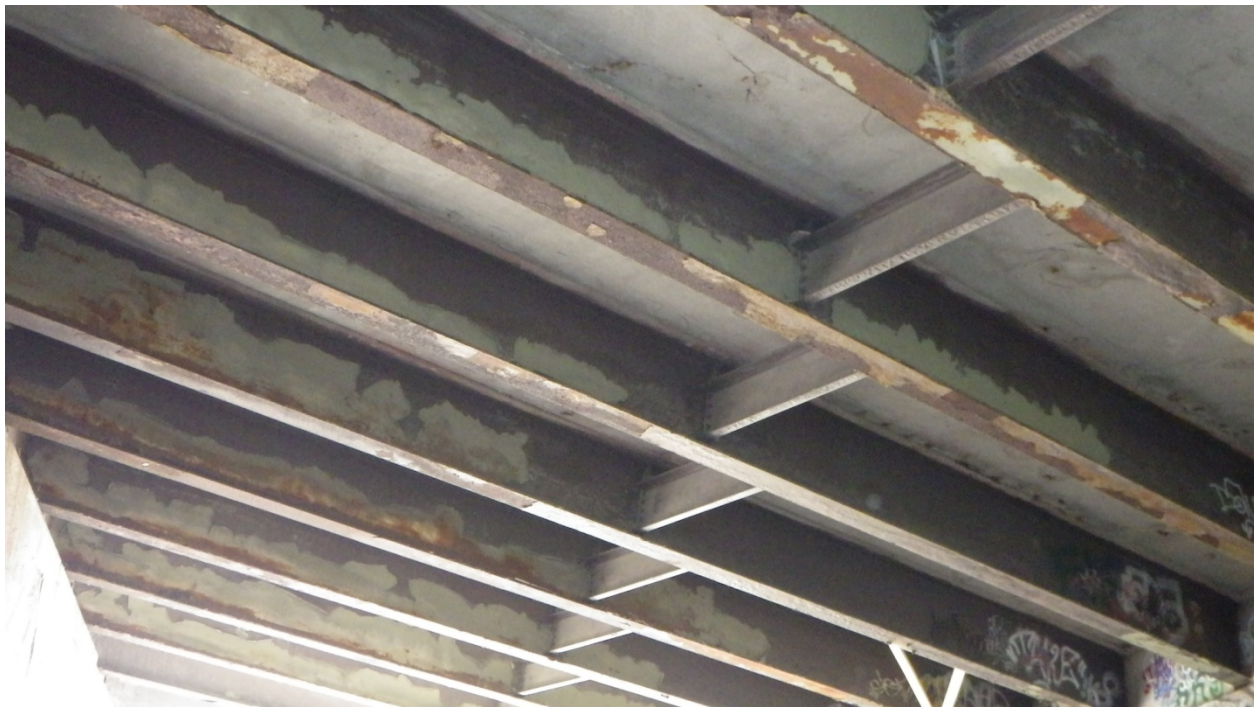
Figure 10 Typical Paint Failure

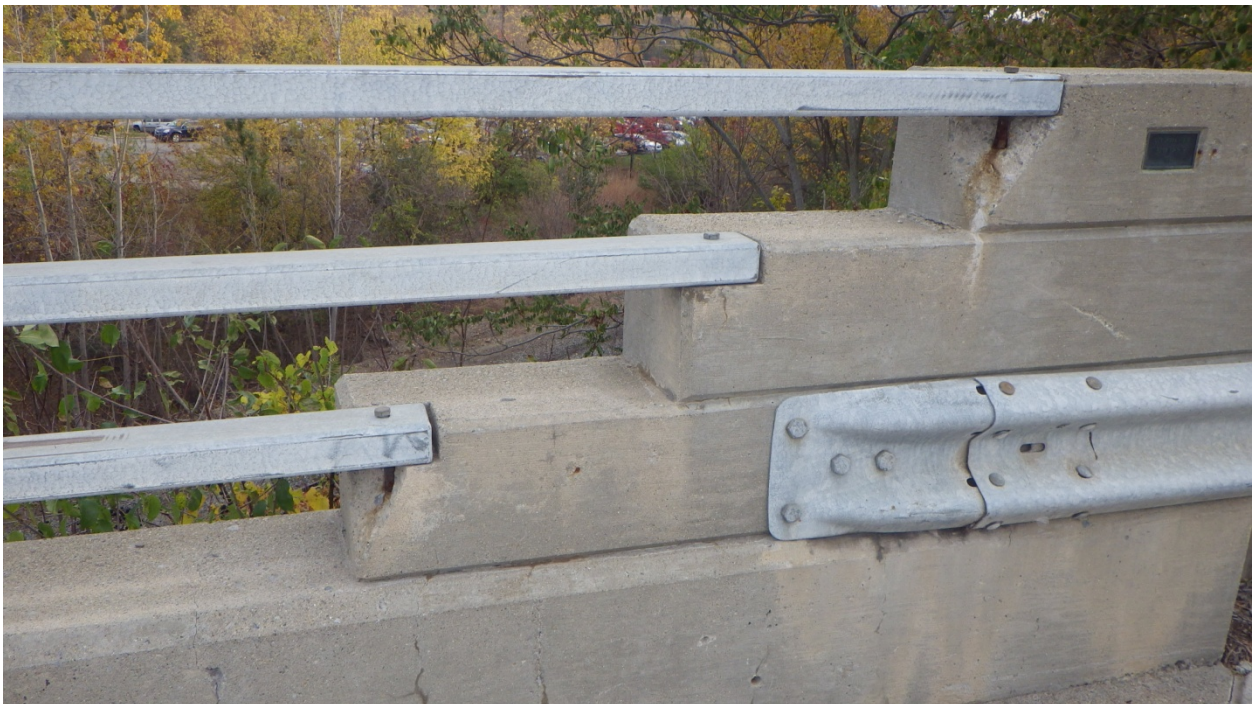
The bridge railings are in fair condition with vertical cracking at approximately 5' increments. The northeast, northwest, and southeast rail end walls have spalled concrete and exposed anchor bolts. The exposed bolts have rusted.

Figure 16 Typical railing end block failures

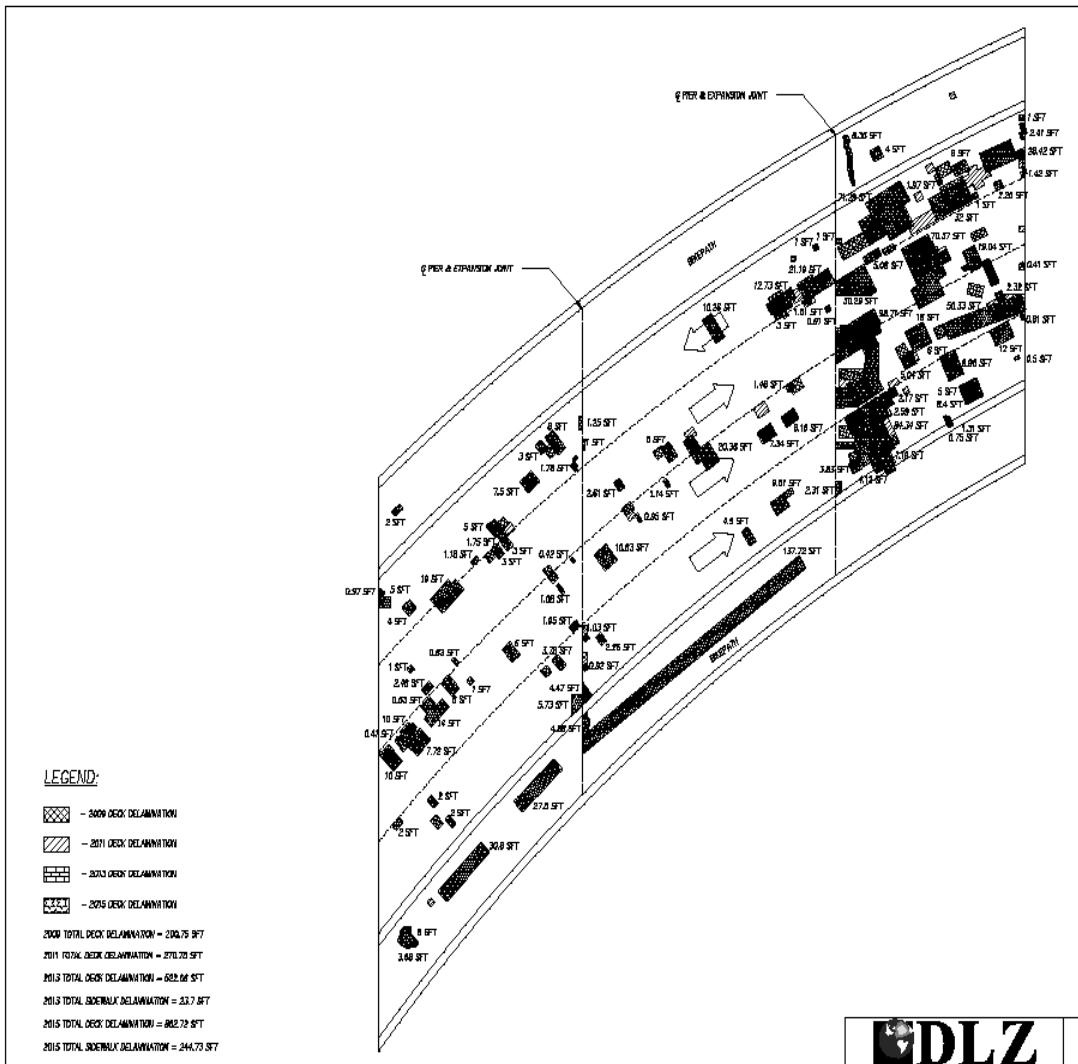
Figure 17 2015 Bridge Deck and Sidewalk Delamination Survey
