ANN ARBOR HISTORIC DISTRICT COMMISSION

Staff Report

ADDRESS: 223 E Ann Street, Application Number HDC22-1113

APPLICATION: The applicant seeks HDC approval to replace 22 non-historic wood windows with Andersen 400 series clad windows in a traditional profile.

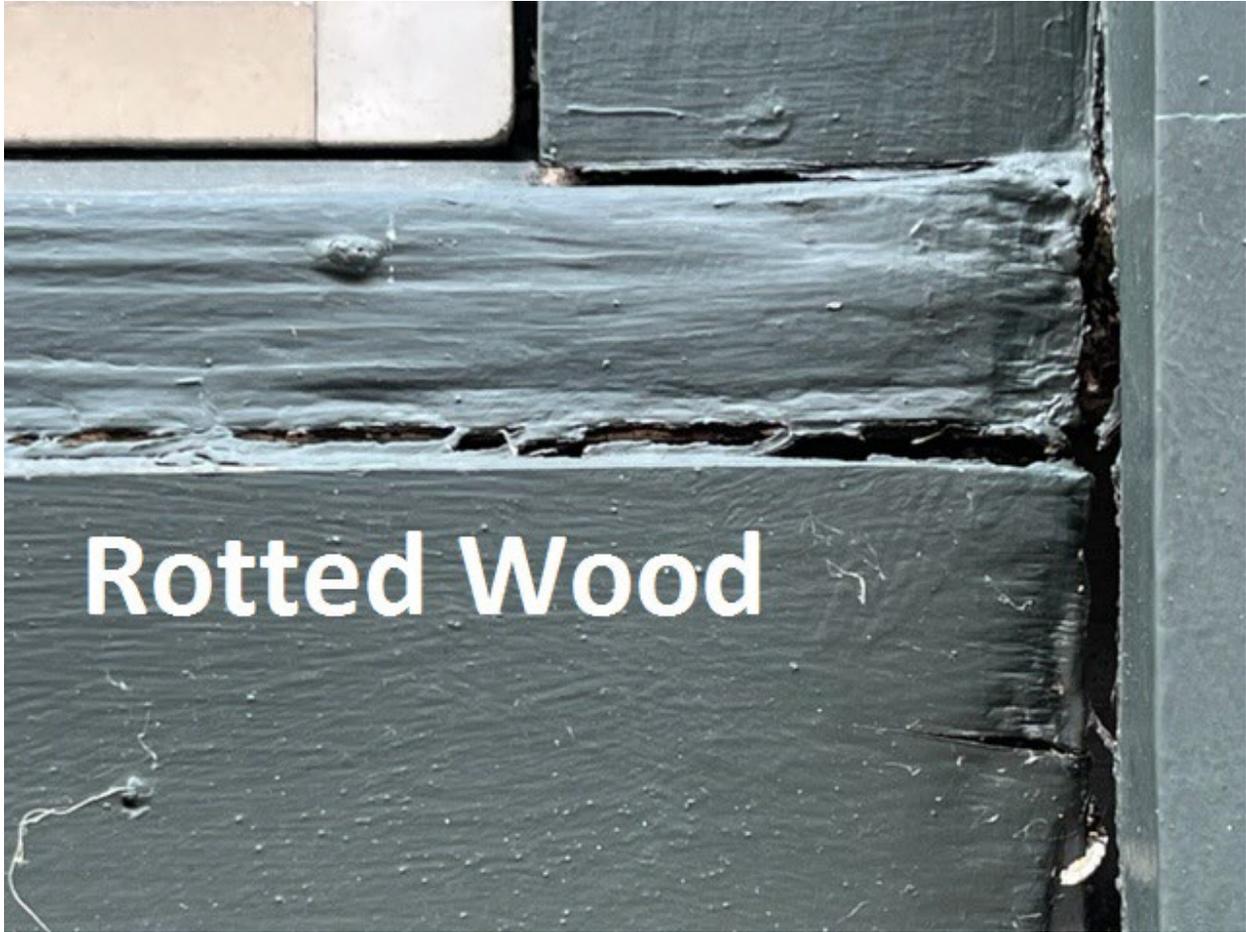
Rotted Wood Outside

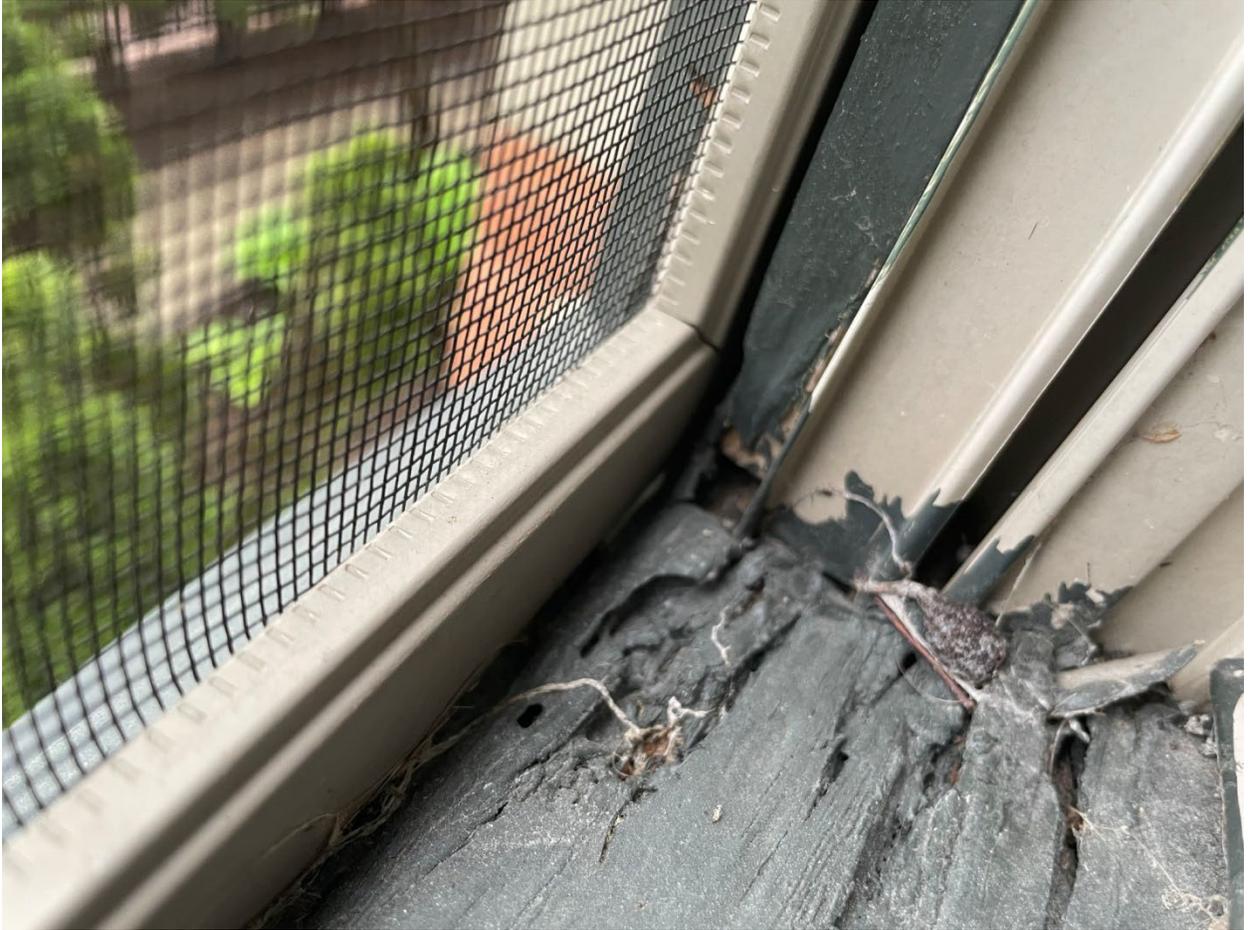
Unit 3 Inside Rot

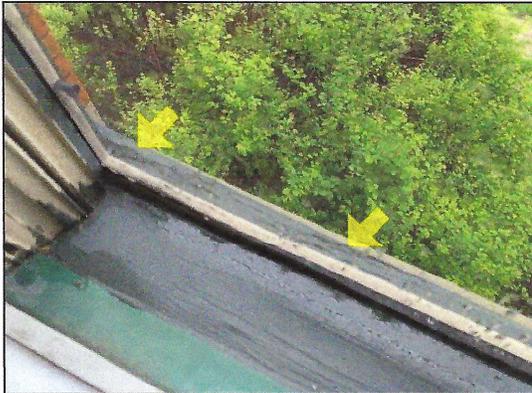
Paint peeling on exterior trim

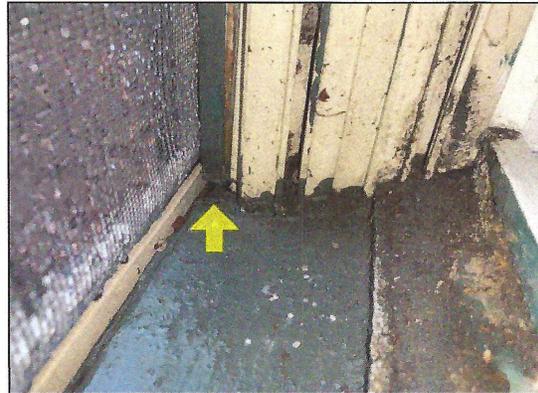
- Possible minor rot in basement window sills (see photo) - somewhat soft, but could be caulk - can be repaired when re-painted.

Possible minor rot in window sill (basement)
