West Park Storm Sewer Analysis and Repair Project

August 30, 2011

City of Ann Arbor

CTI and Associates, Inc.

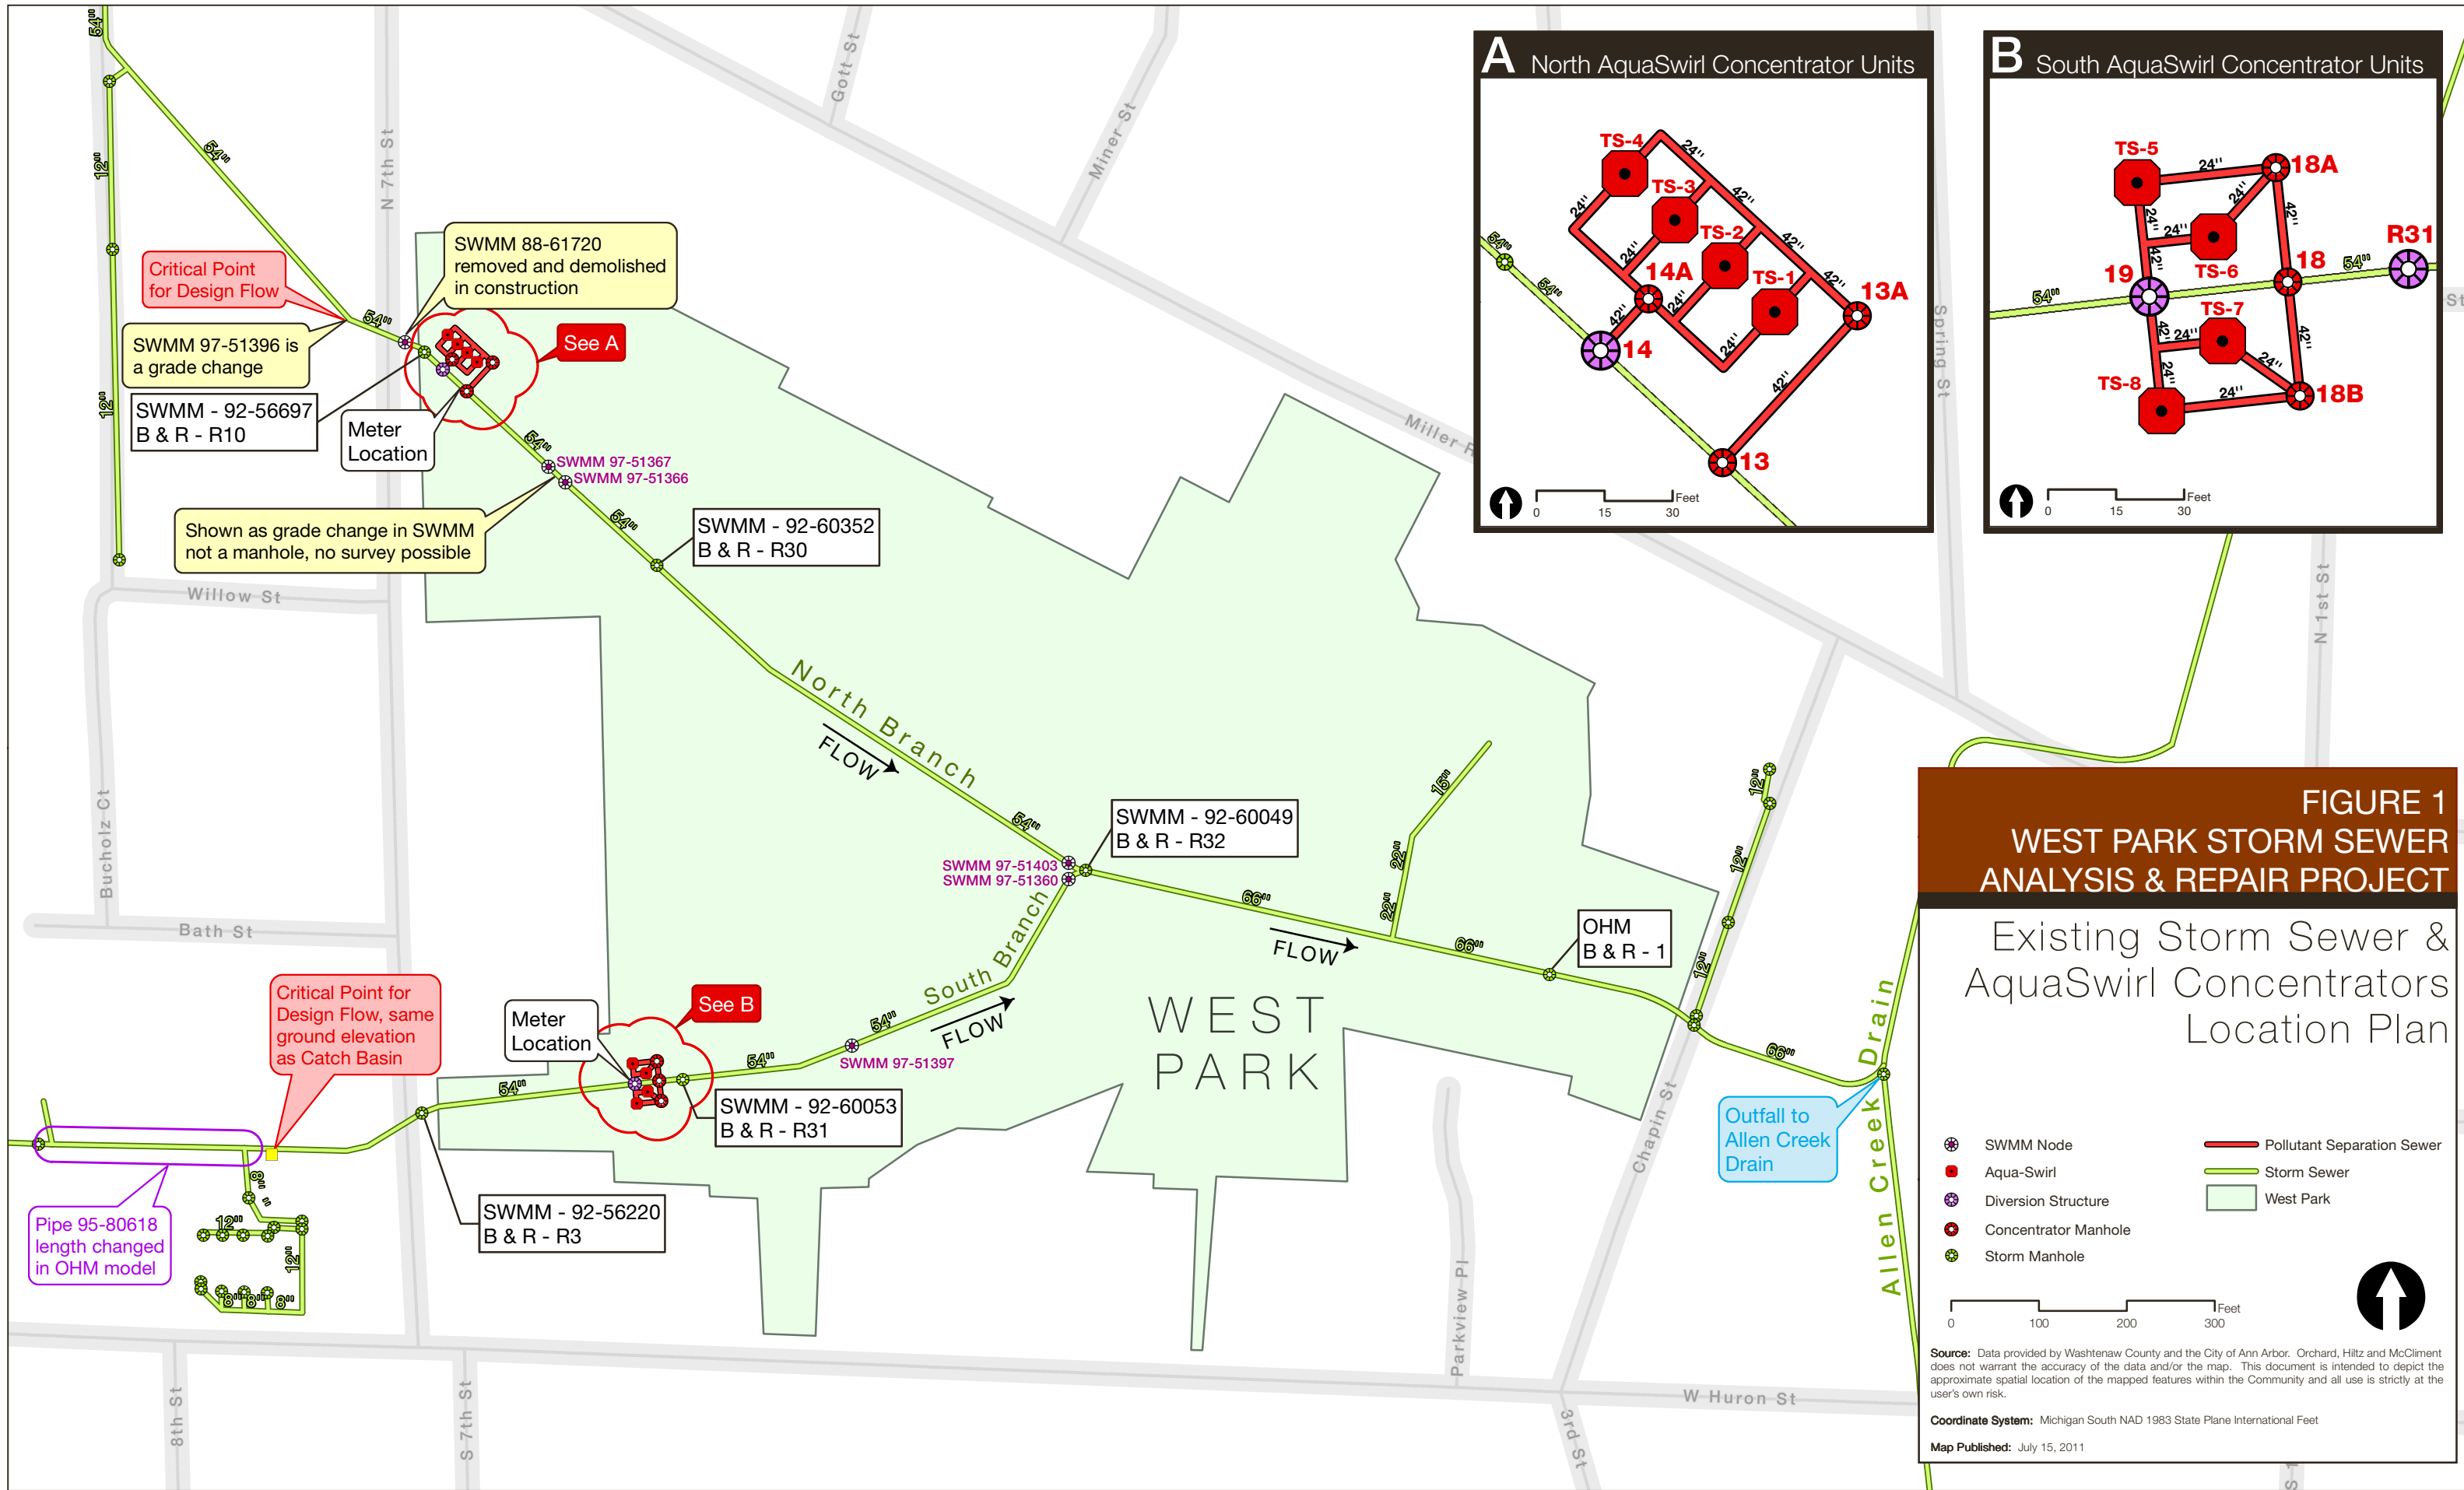
**FIGURE 1
WEST PARK STORM SEWER
ANALYSIS & REPAIR PROJECT**

In the summer of 2010, the City experienced significant flooding along the south branch of the drain. In October 2010, one of the ASC units (TS-4) collapsed along the north branch. These events prompted the City to remove the weirs from the diversion chambers, bulkhead the sewers to the treatment units and fence off the treatment units to protect the public from possible further collapse.

Existing Storm Sewer & AquaSwirl Concentrators Location Plan

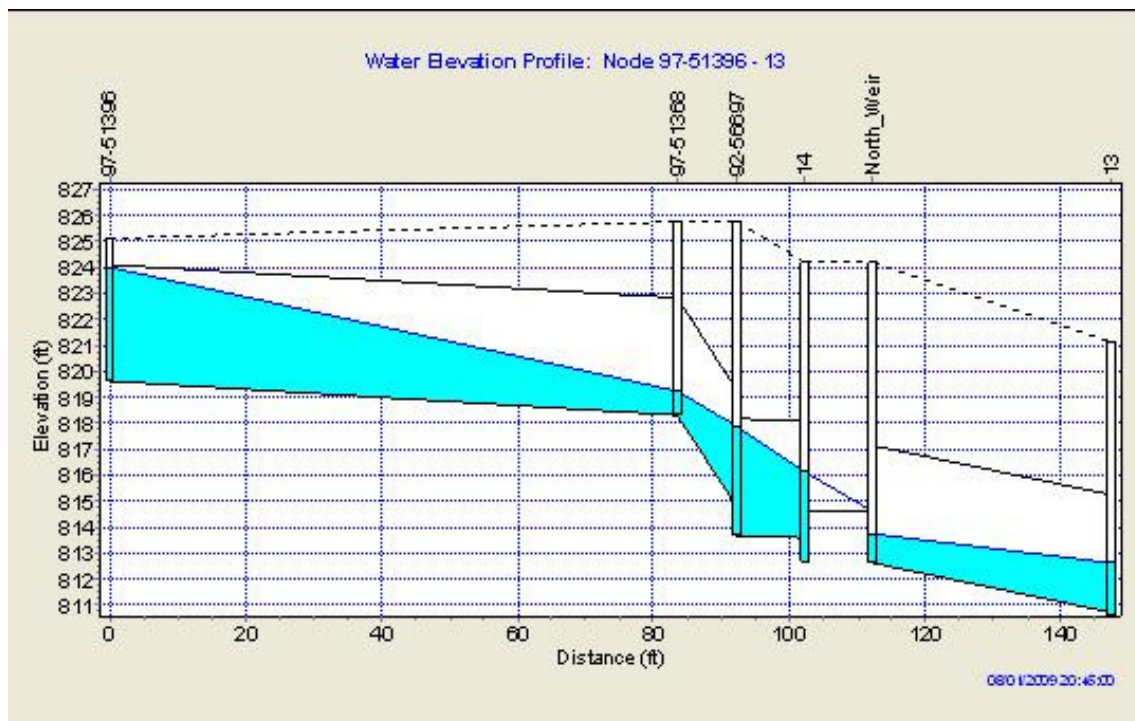
Figure 7: Elevation Profile of the North Branch: Between 7th Street and Treatment Units

The north branch contains about a four foot drop in elevation upstream of the treatment units and just to the East of 7th Street. A profile showing the drop prior to Structure 14 is shown below. Table F (Page 27) shows the results of the simulation.

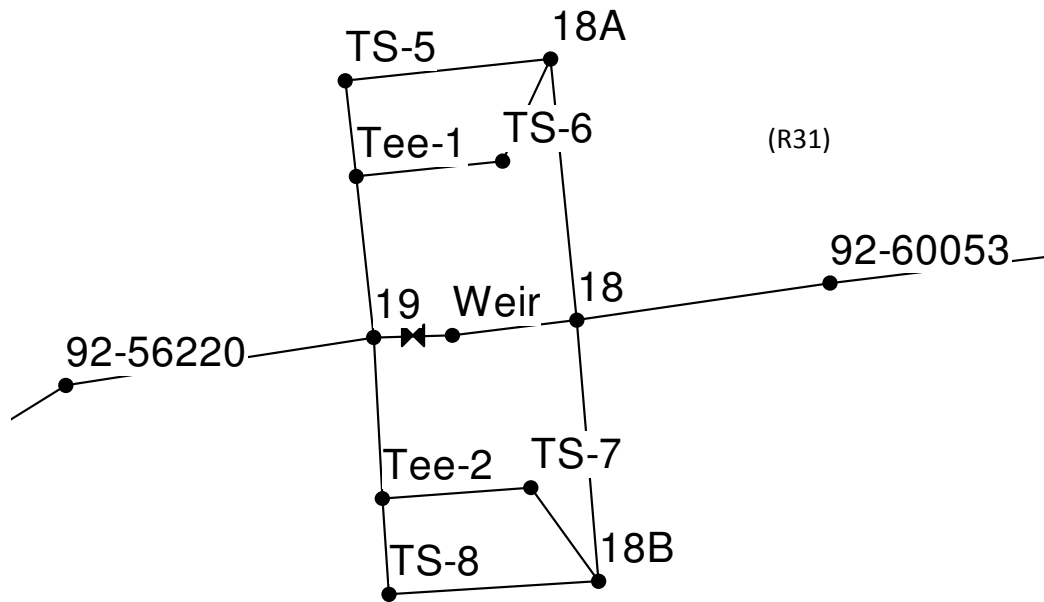
Figure 8: Existing South Branch Layout

The two different routing options for the 42” collector pipes are shown on the next page. For the re-routed pipe option, the collector pipes would take full advantage of the drop in MH 92-60053. Results of the analyses are presented in Table G on Page 29.
