## ANN ARBOR HISTORIC DISTRICT COMMISSION

### Staff Report

**ADDRESS:** 209 South Main Street, Application Number HDC12-164

**APPLICATION:** The applicant seeks HDC approval to replace six wood windows in the front elevation with six new wood windows.

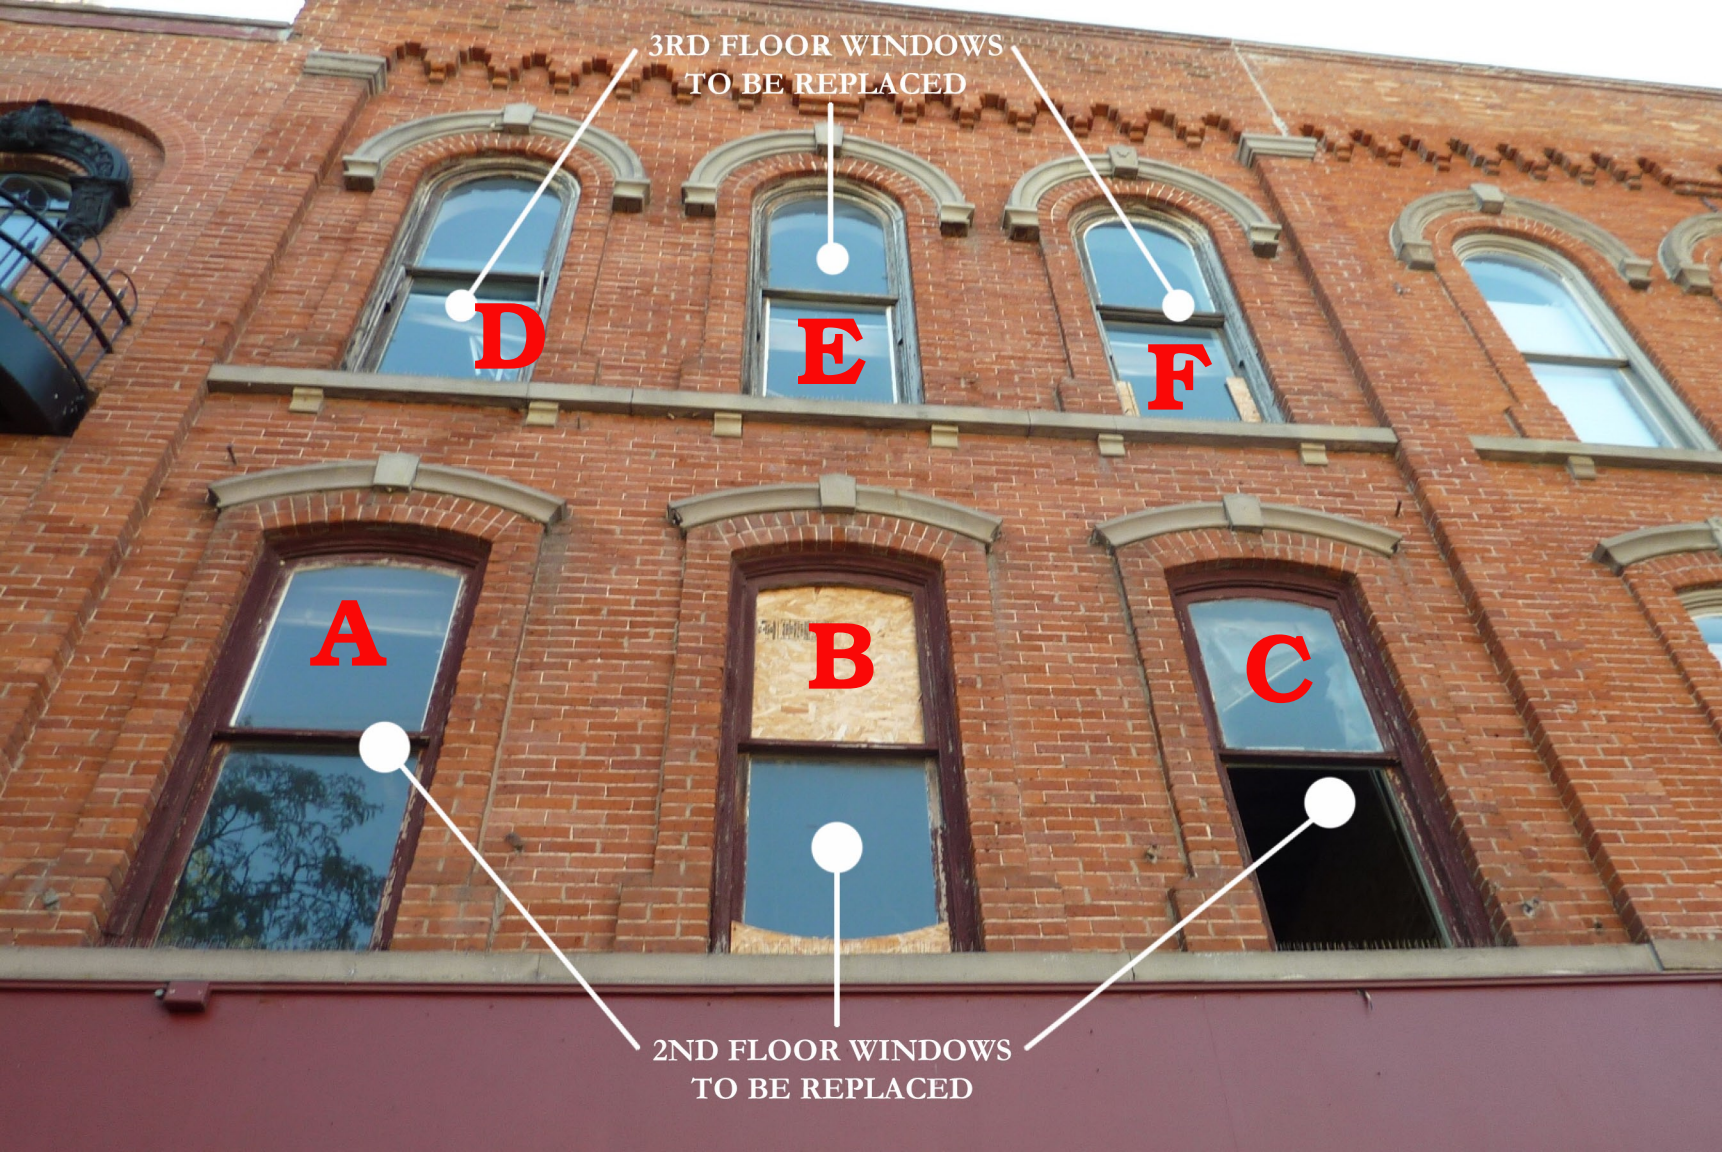
- A) Upper sash has severely weather damaged wood, North jamb stop missing, Lower sash has severely weather damaged wood, Sill needs replaced.
- B) Lower sash and jamb has severely weather damaged wood. Sill needs replaced.
- C) Upper sash has severely weather damaged wood as well as separation. Sill needs replaced.
- D) Both sashes have severely weather damaged wood with pieces missing, Glass missing, Sill needs replaced as well as brick molding.
- E) Both sashes have severely weather damaged wood with separation, glass missing, Sill needs replaced.
- F) Both sashes have severely weather damaged wood with missing pieces, glass missing, Sill needs replaced as well as brick molding.

In my opinion with above issues all windows should be replaced.

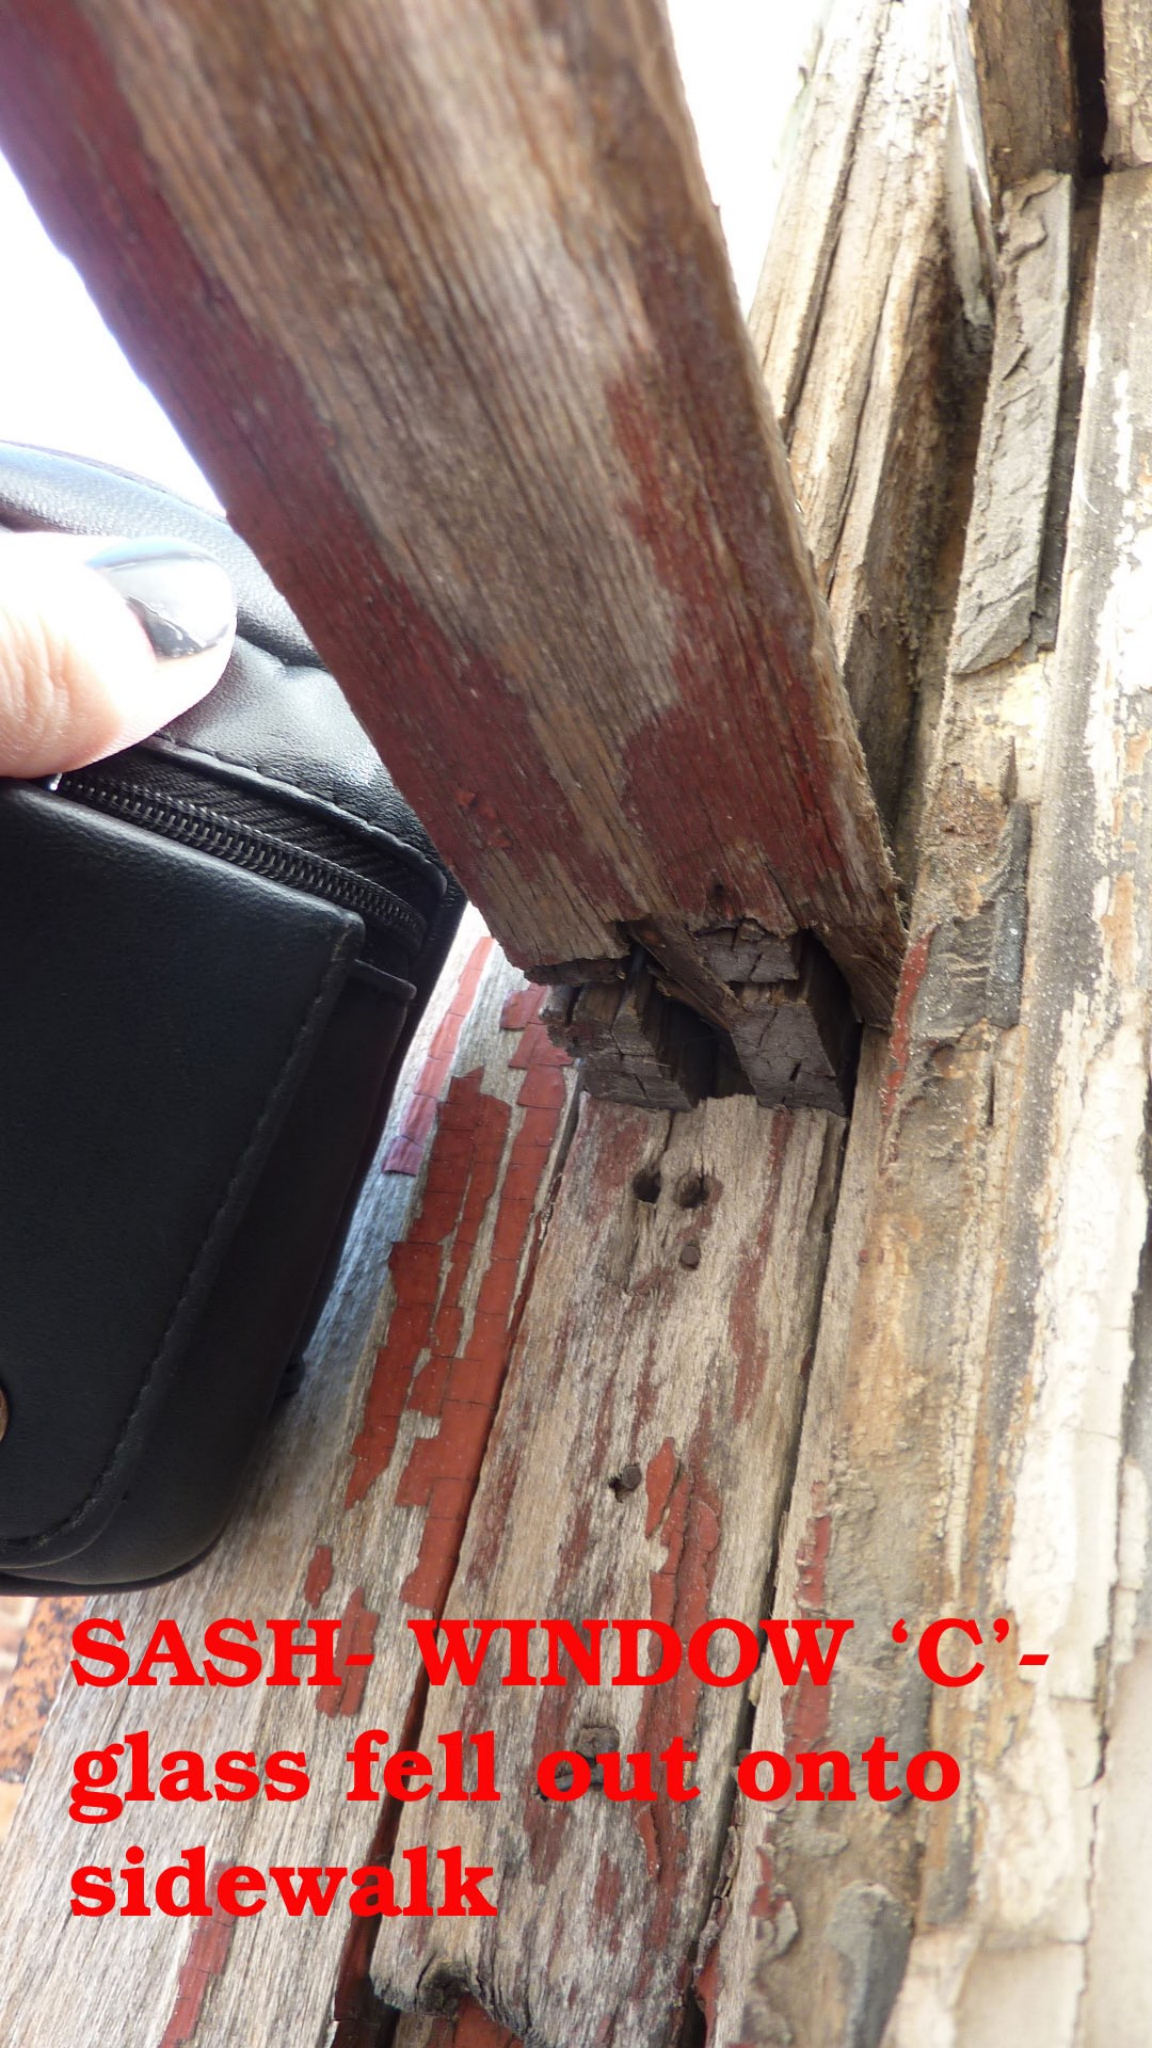
**SASH- WINDOW 'C'-  
glass fell out onto  
sidewalk**

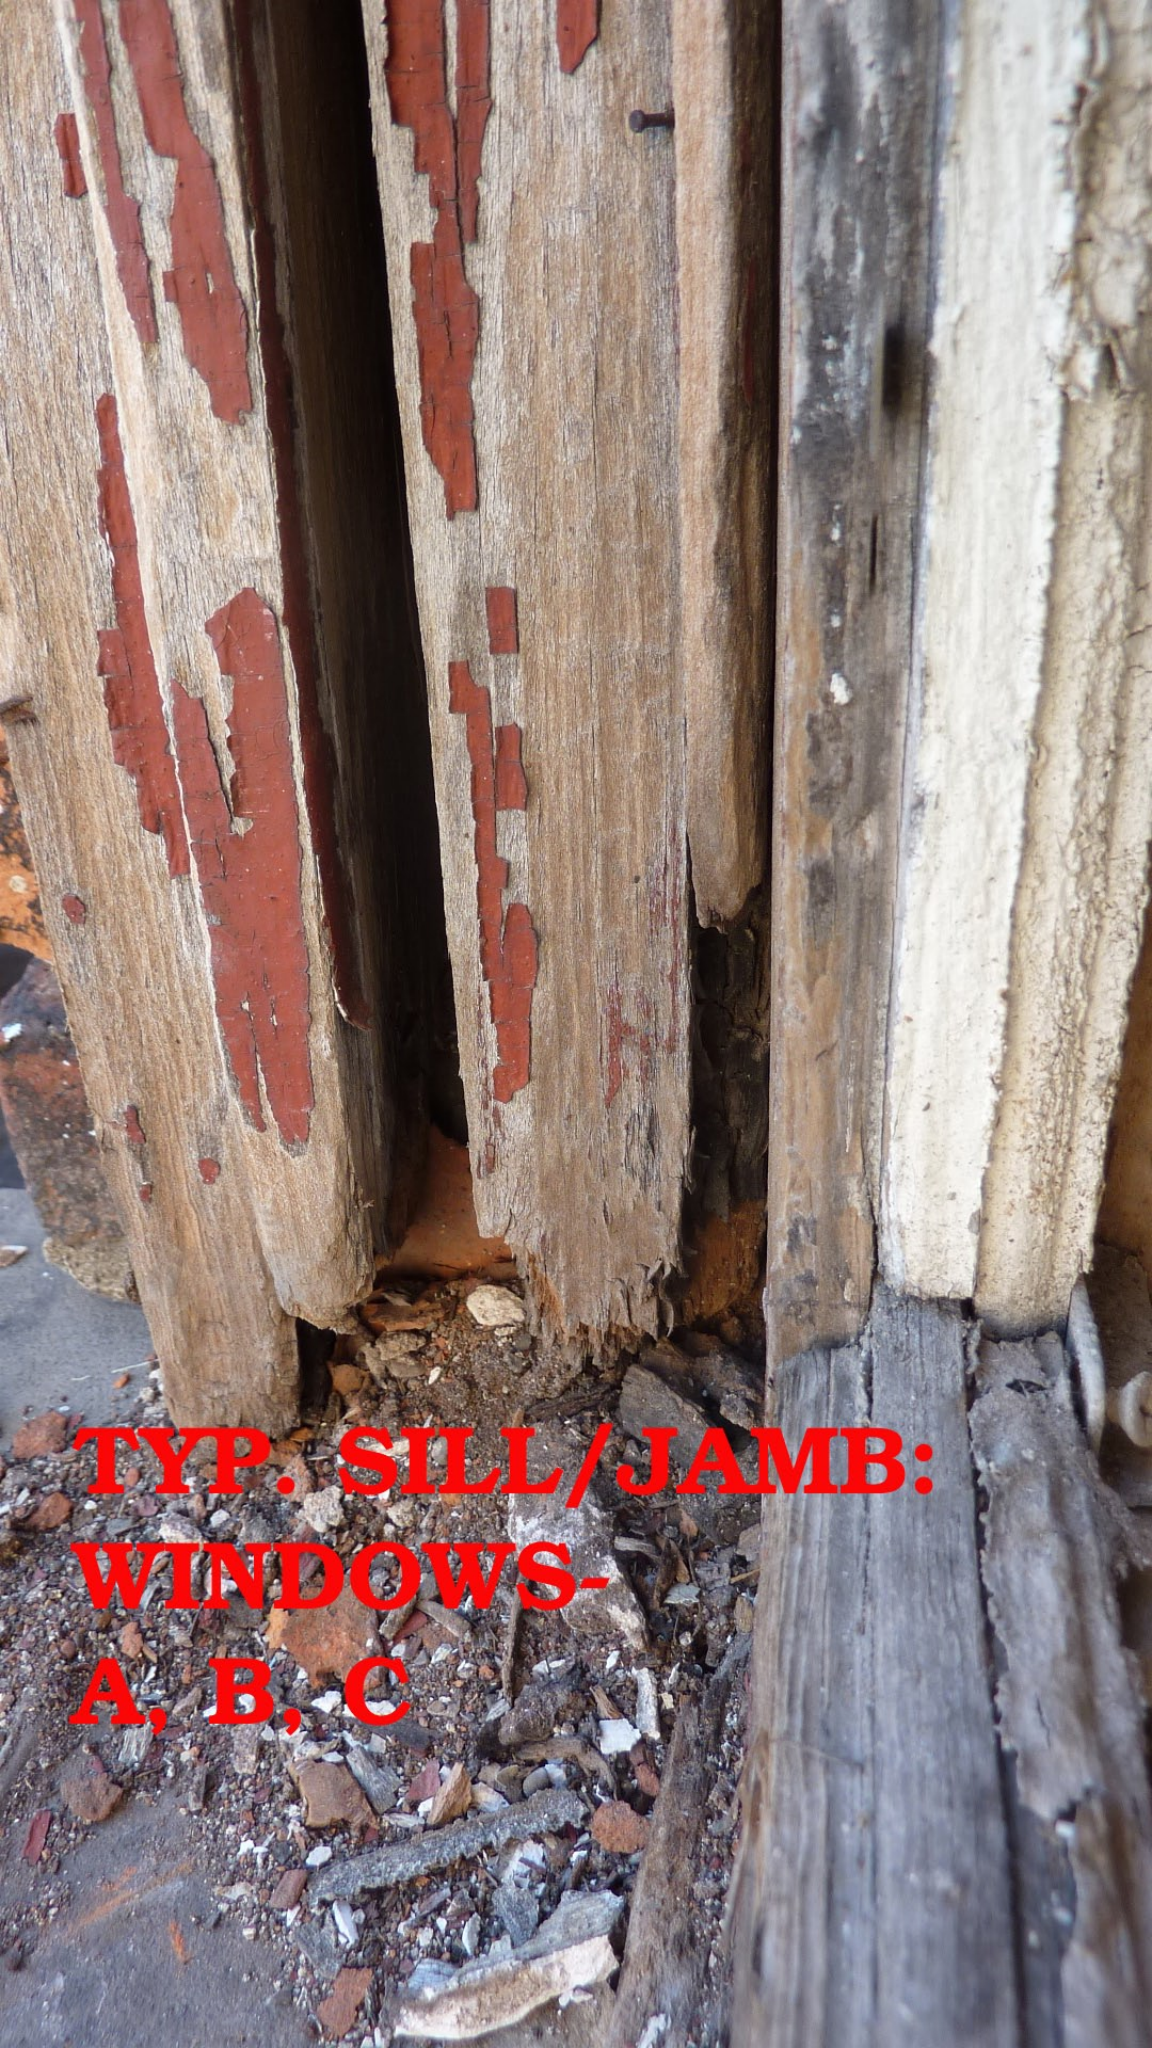
**TYP. SILL/JAMB:  
WINDOWS-  
A, B, C**

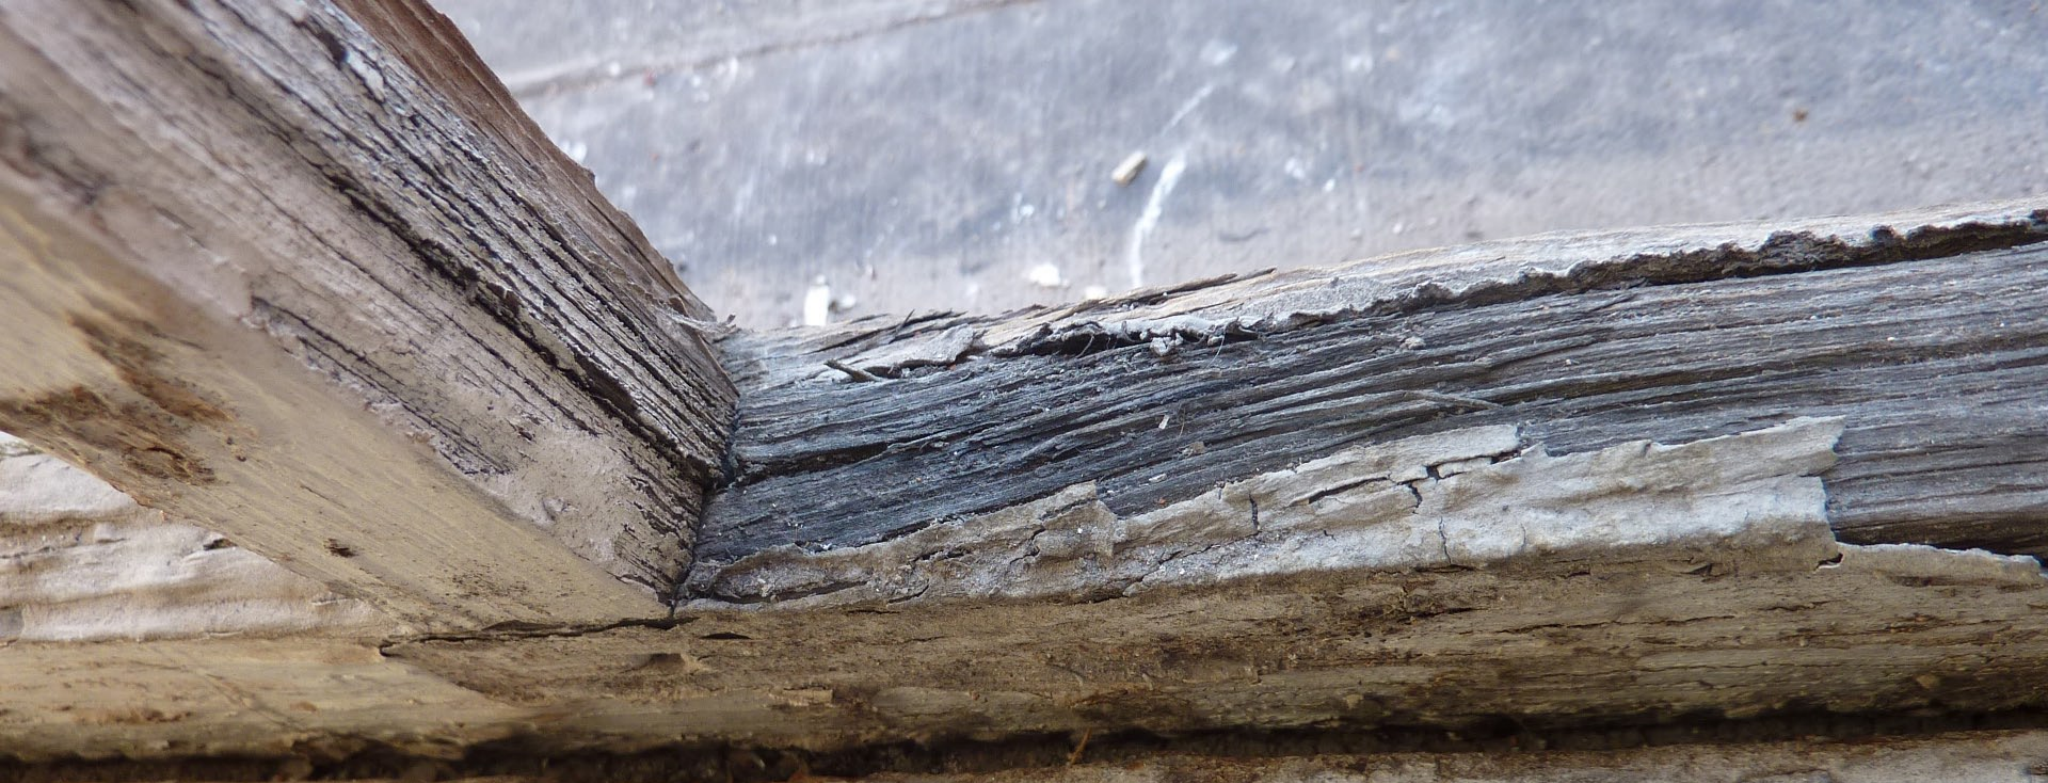
**TYPICAL RAIL CONDITION:  
WINDOWS D,E,F**

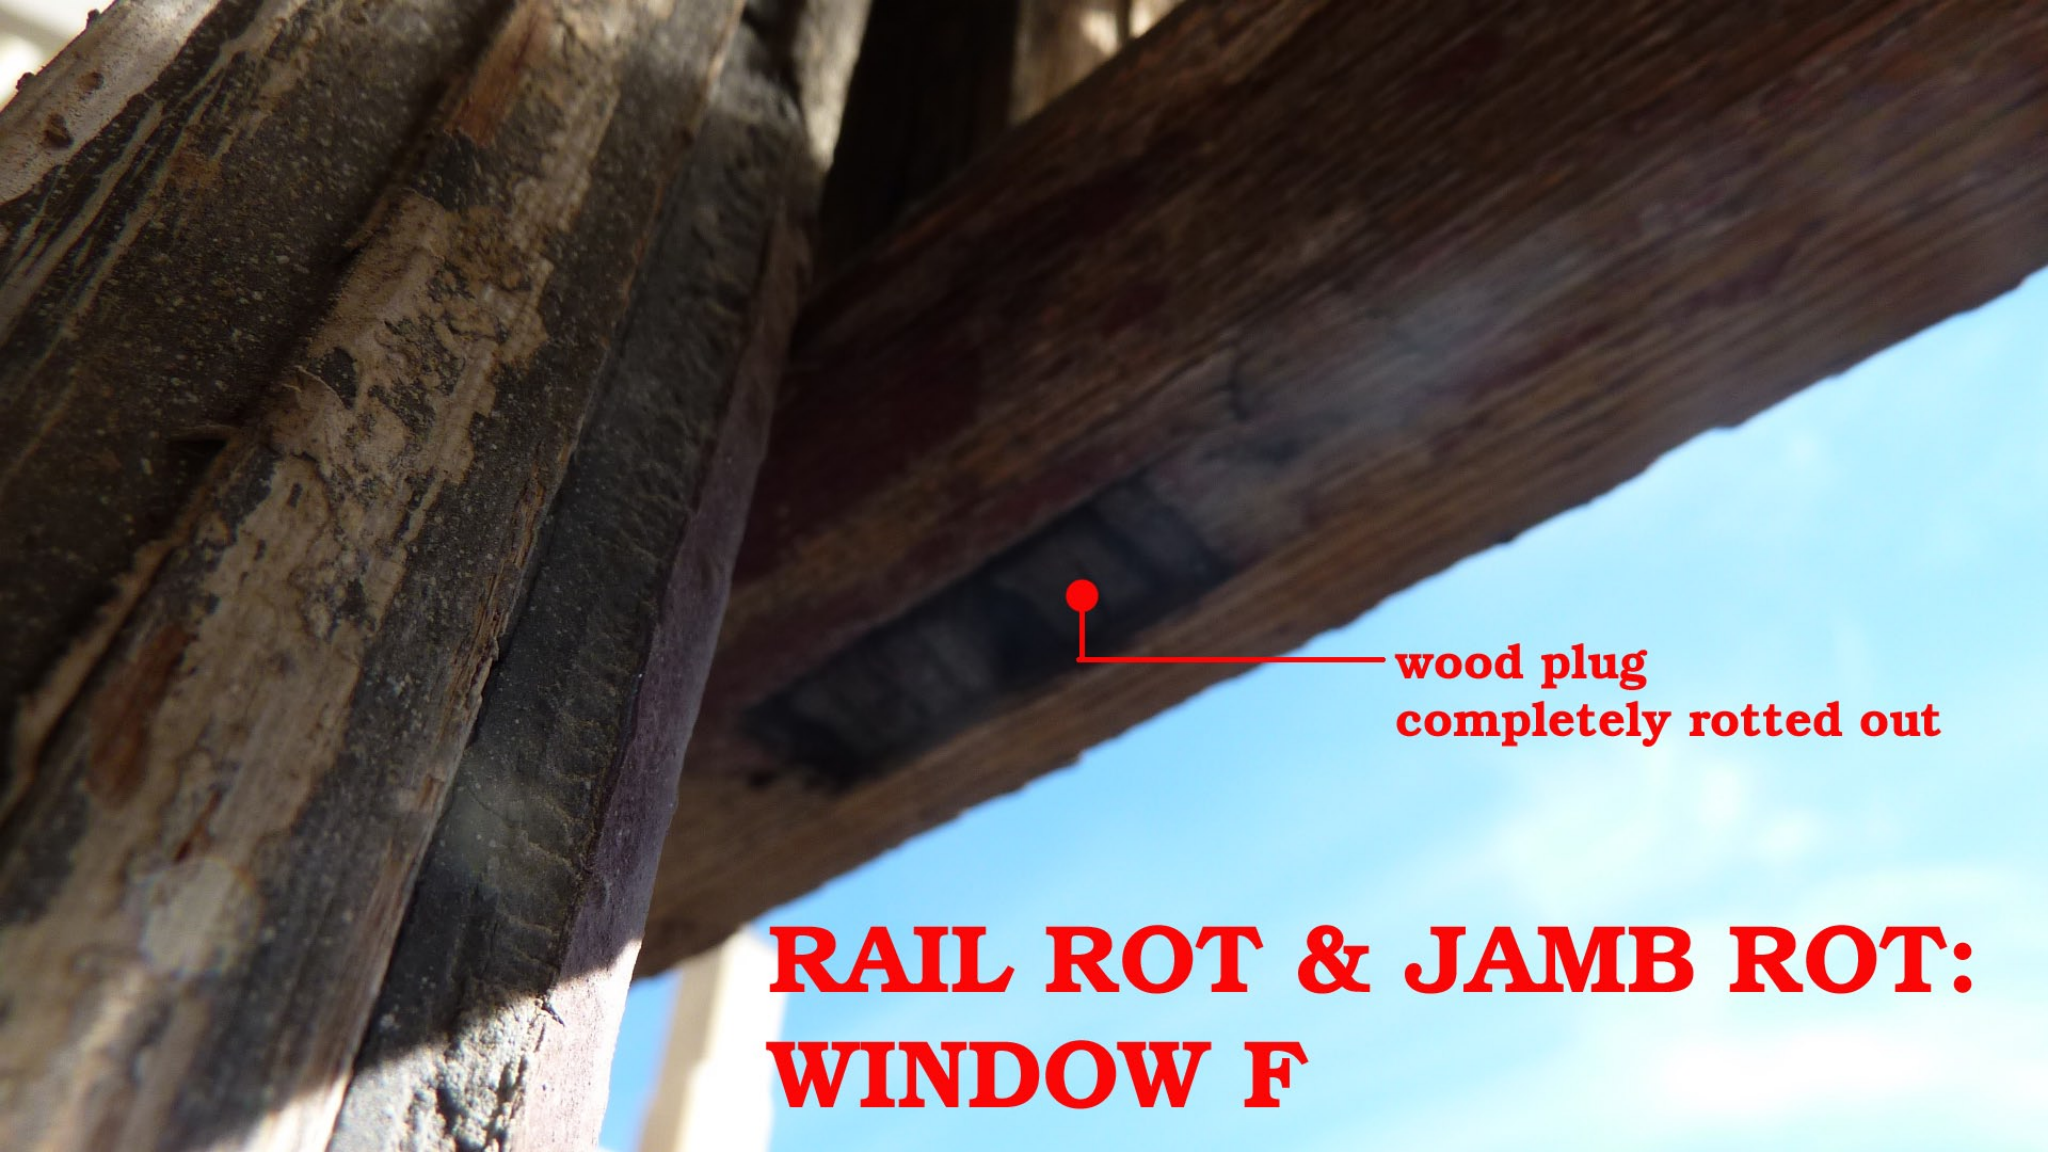
**wood plug  
completely rotted out**

**RAIL ROT & JAMB ROT:  
WINDOW F**

**EDGE OF  
UNSECURED  
GLASS**

**TEMPORARY STOPS  
TO HOLD  
UNSECURED GLASS:  
WINDOW D**

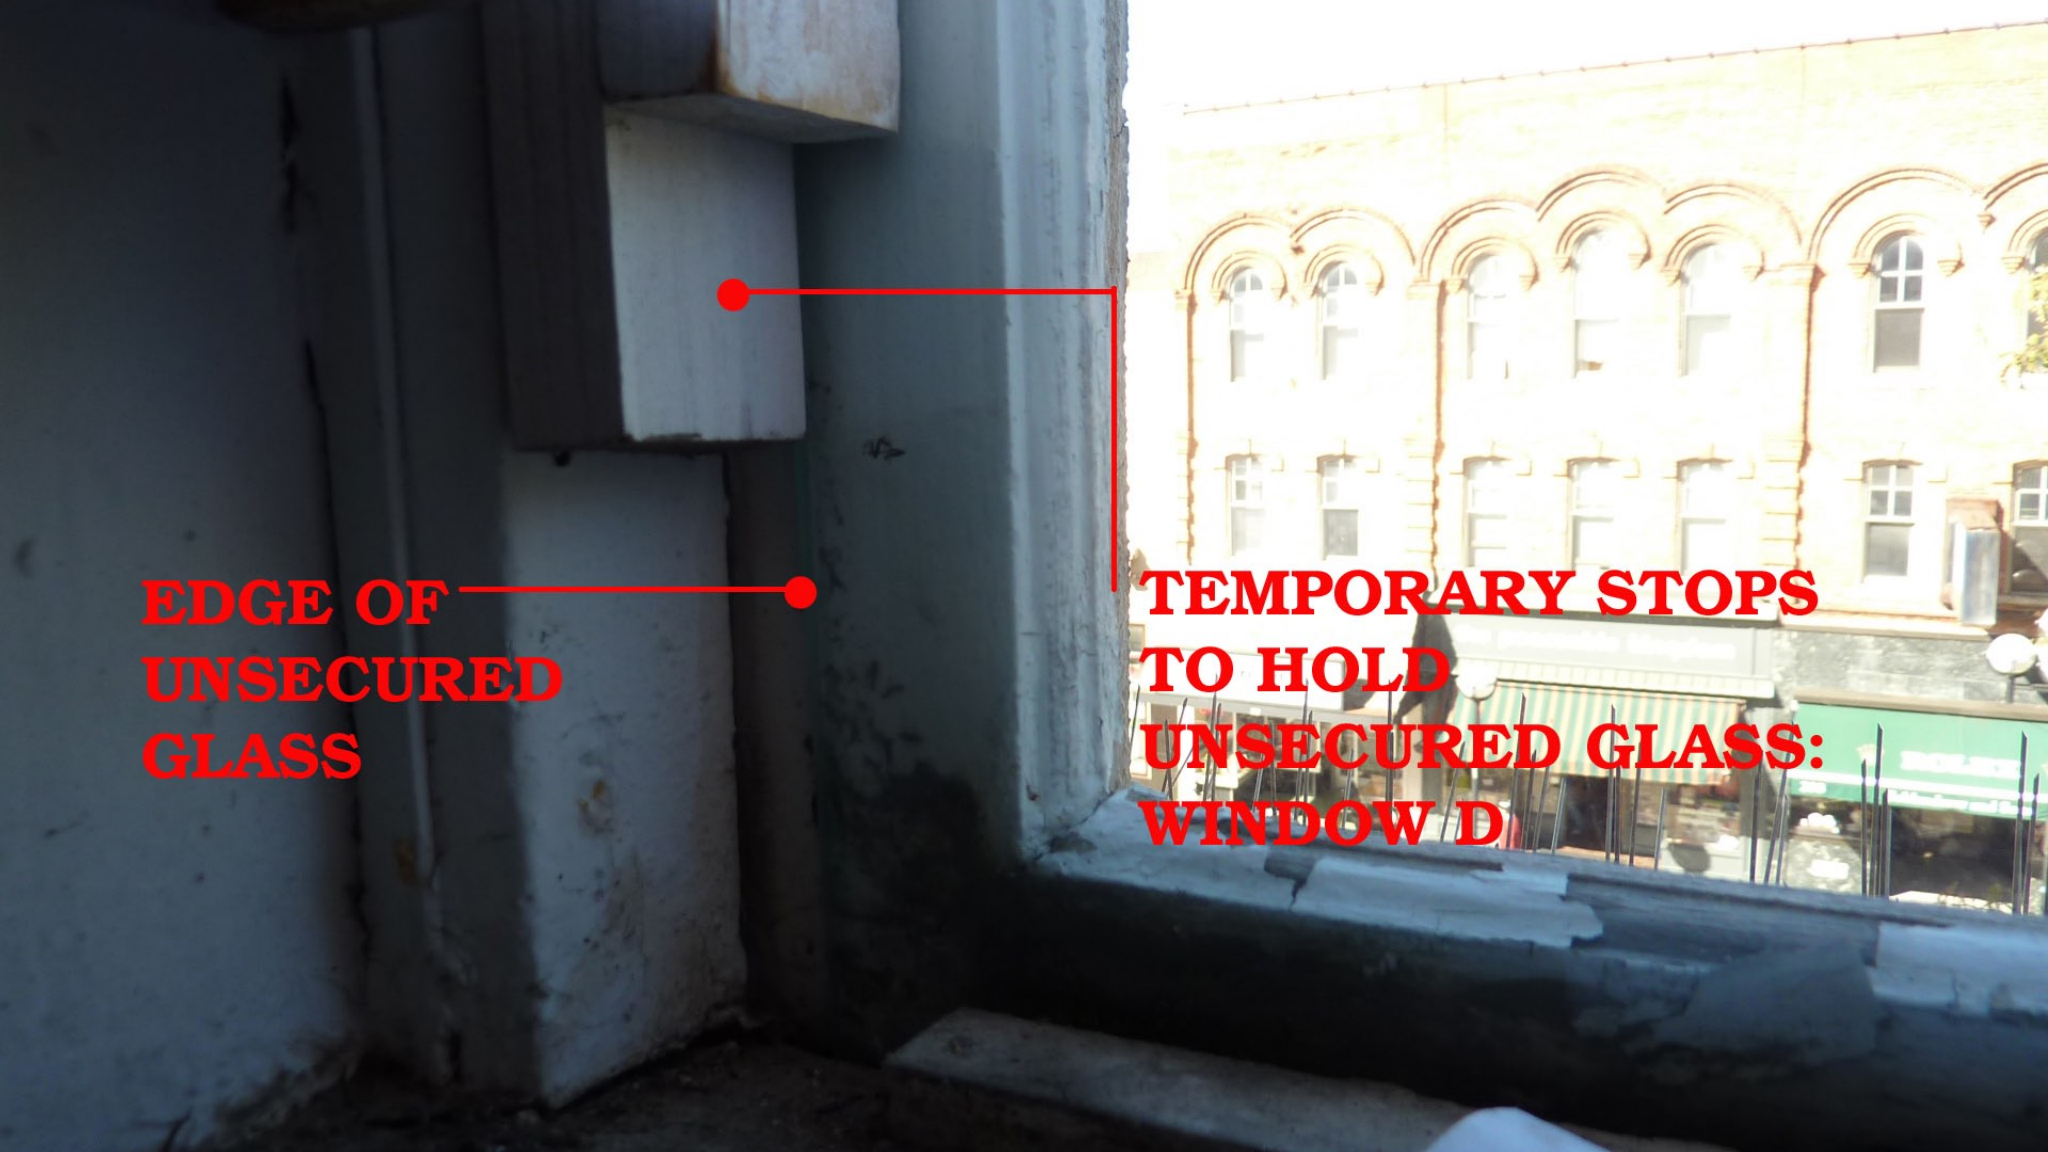
**TYPICAL SILL:  
WINDOWS A,B,C**

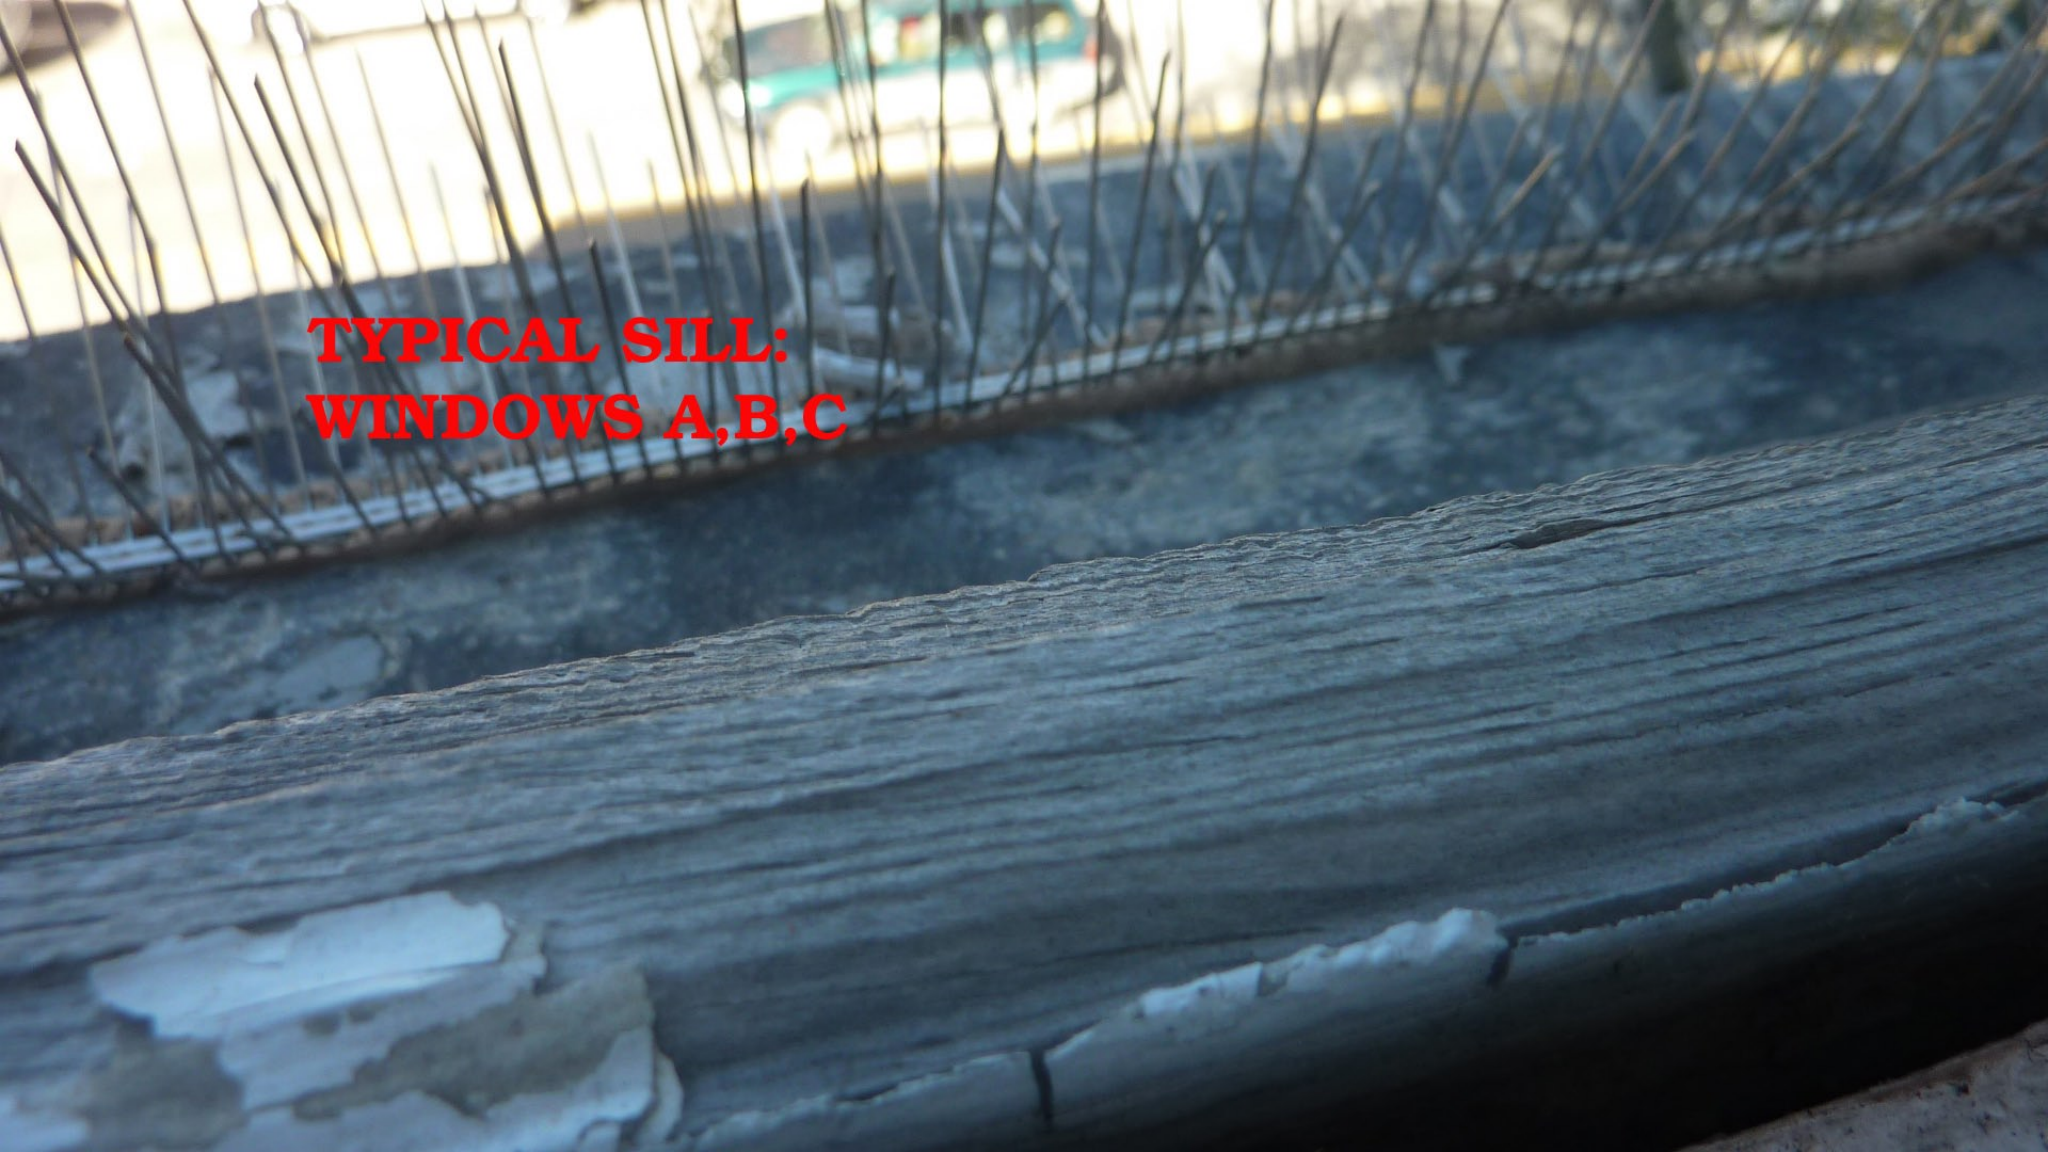
**TYPICAL SILL:  
WINDOWS A,B,C  
sill significantly  
rotted away**
