1335 Hill Street, Ann Arbor, MI 48104

Inspection Date:
12/16/2014

Prepared By:
Fletcher Inspections, Inc.

Report Number:
KO121614a

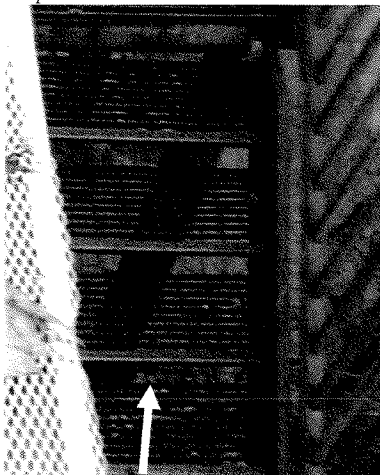
Open risers on exterior steps.

- 1) Exterior metal steps have open risers, and may present a trip hazard.

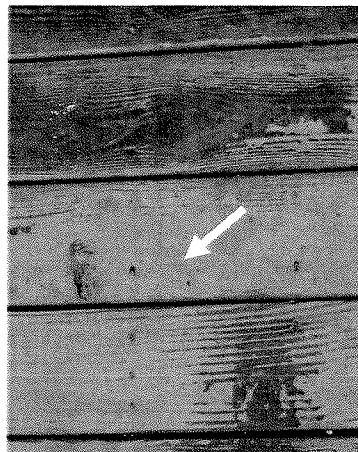
Algae/nails backing out of wood.

- 2) Recommend cleaning moss/algae from the upper deck wood floor; slip/safety hazard. Nails are backing out of porch and deck, creating a safety hazard. Replace with screws.
- 3) Two circuit breakers were double tapped (two wires attached to a circuit breaker) in the main service panel: repair as needed by a licensed electrician; safety hazard. The circuit breaker for the alarm system was spray-painted red and held in the open position by a screw. Potential safety hazards. There was a missing breaker (and an open slot) in the second floor electric sub-panel; safety hazard.
- 4) The receptacle for the second-floor washing machine was hot/neutral reverse (wired backwards); safety hazard. Missing cover for junction box in west attic; safety hazard. Test GFCI-protected outlets on a monthly basis (the mechanical portion tends to stick if not operated regularly).

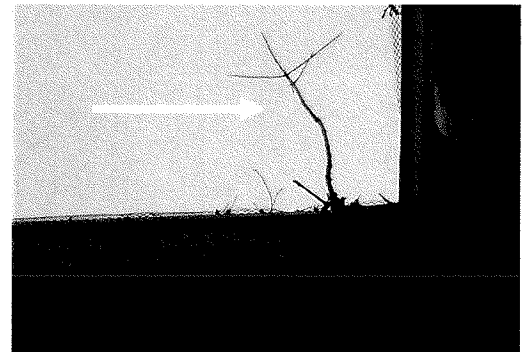
Gutters are filled with tree branches, leaves.

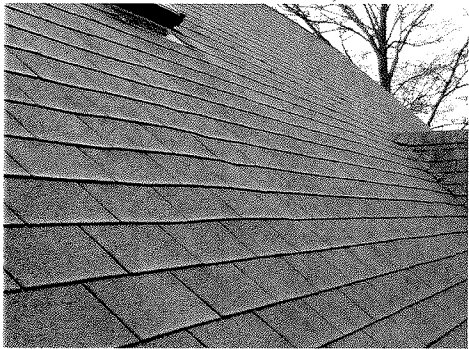
Roof appeared to be nearing end of its useful life; budget to replace soon. Recommend evaluation by qualified roof contractor. Wet roofs are sometimes difficult to evaluate, as water does not show the full effect of cupping, curling. Roof covering showed signs of curling, cupping and aging (sheathing stamped 1994). Recommend cleaning moss/algae from the roof. There are several nail pops (the nails that secure the shingles to the sheathing become loose and back out) visible; repair as needed. Some wood was in contact with roof; rot risk.

Roof showing signs of cupping/curling.

- 1) Trees and vegetation need to be trimmed away from the house.
- 2) Roof appeared to be nearing end of its useful life; budget to replace soon (see above).

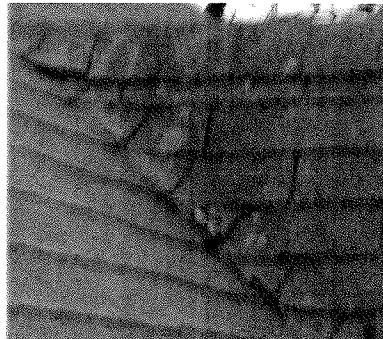
Moss/algae buildup on roof.

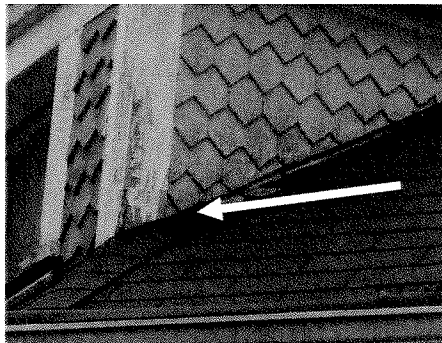
Wood in contact with roof has rotted.

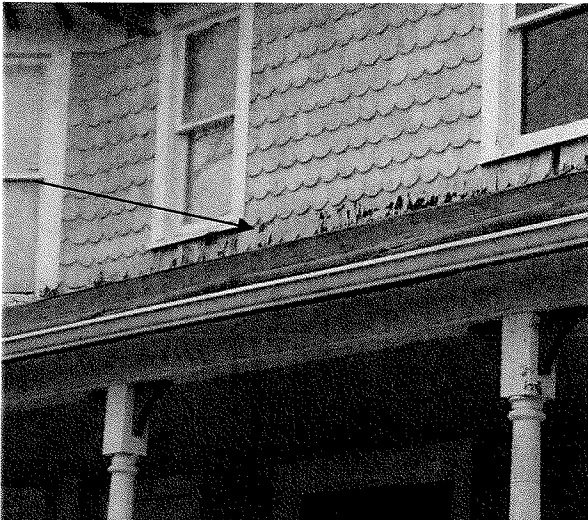
Siding over east porch damaged/rotted.

- 4) Wood siding had some damage and was in need of repair or replacement. Window sills need to be scraped, caulked and painted.
- 5) The insulation in all three accessible portions of the attic may be covered with a mold-like substance. Some of the black may also be the result of filtering, which is when air escapes through gaps and is filtered through the insulation causing it to darken. Recommend evaluation and any necessary remediation by qualified contractor.

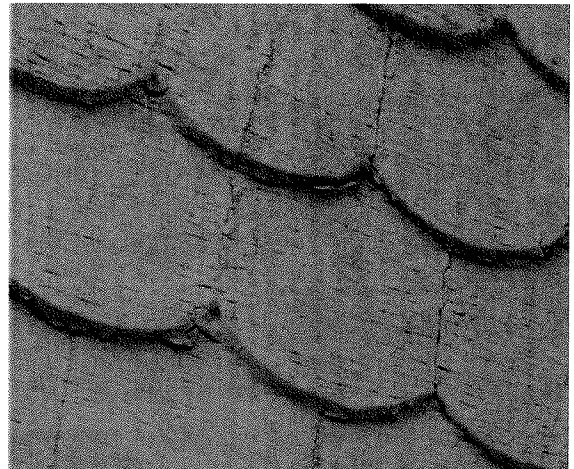
Scalloped siding requires maintenance/replacement.

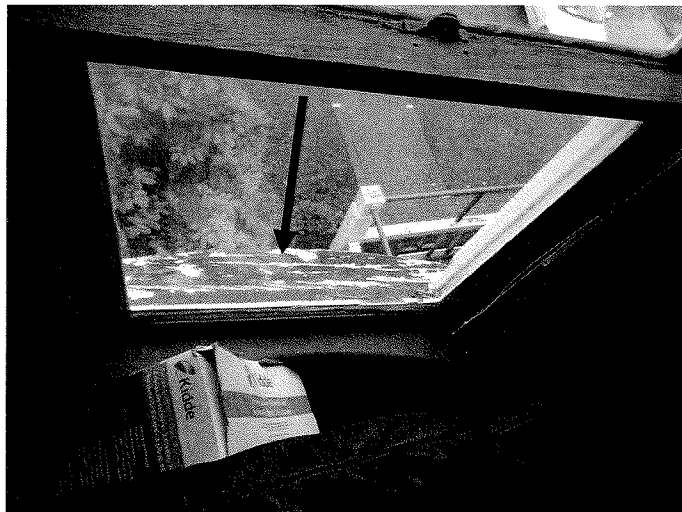
Window sills require maintenance.

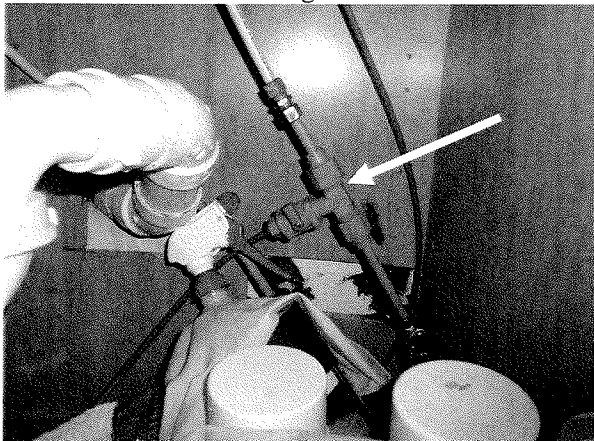
There was some polybutylene plumbing supply below sinks that should be replaced. Polybutylene piping is known to fail. The left front burner was missing on the second floor kitchen range.

Polybutylene supply lines at sinks.

Polybutylene supply lines should generally be reevaluated by a licensed plumber. Caulking should be maintained around the top of shower surrounds to prevent water intrusion behind the wall. One of the second floor showers has not been maintained, and water getting behind wall may be causing the growth of a mold-like substance. The second floor bathroom on the south end of the house was inaccessible due to storage.

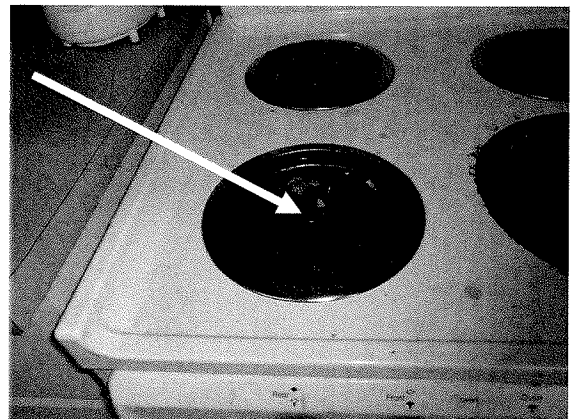
Burner missing from range.

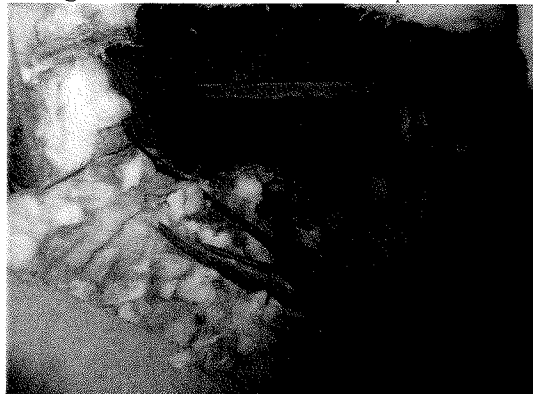
The insulation in all three accessible portions of the attic may be covered with a mold-like substance. Some of the black may also be the result of filtering, which is when air escapes through gaps and is filtered through the insulation causing it to darken. Recommend evaluation and any necessary remediation by qualified contractor. Many of the rafters have been sistered to newer lumber for support. Sheathing, examined from the attic, had some water damage, repair as needed. Attic insulation was marginal and should be upgraded. Attic ventilation was insufficient and should be improved. Junction box in west attic needs to be covered; safety hazard. There was water damage on the ceiling of the north bedroom of the second floor. Repair as necessary. Many of the windows in the house did not operate with normal effort, and most of the pulleys and ropes (counterbalances) were not functional. Typical imperfections, cracks, and nail pops were observed on the walls and ceilings throughout the house. Homes built prior to 1978 may contain lead-based paint.

Possible mold-like substance in east attic, north.

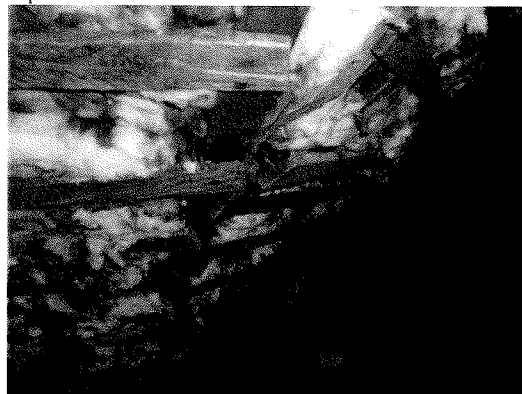
Possible mold-like substance in east attic, south.

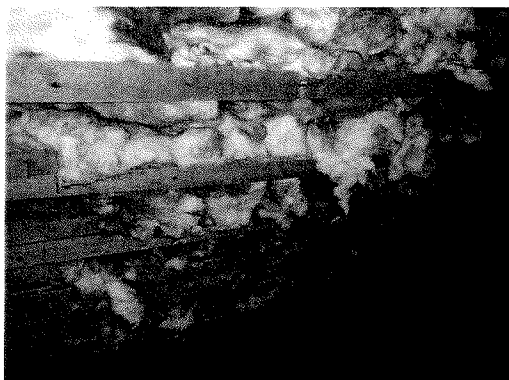
Possible mold-like substance in west attic.

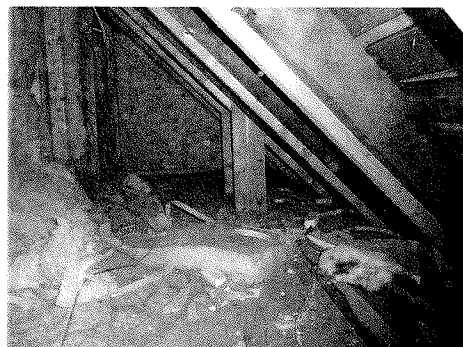
Displaced insulation in east attic, north.

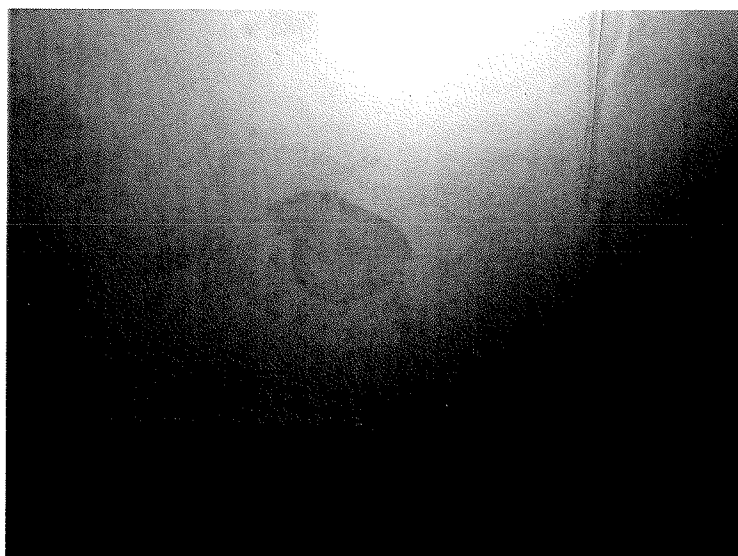
Moisture staining on ceiling of second floor bedroom.

- 7) There was water damage on the ceiling of the north bedroom of the second floor. Repair as necessary.
- 8) Many of the windows in the house did not operate with normal effort, and most of the pulleys and ropes (counterbalances) were not functional.

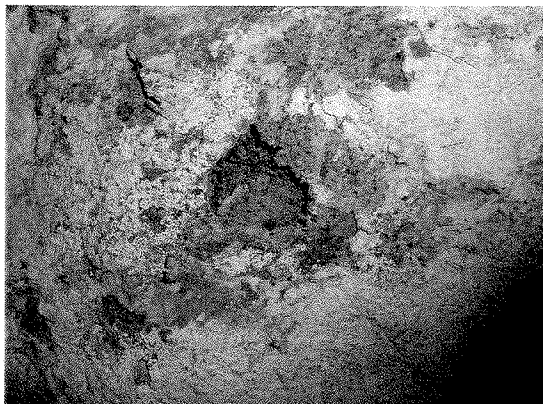
Apparent deterioration of mortar in fieldstone walls (1).

- 9) Fieldstone foundation walls, which have been covered with a coat of concrete, appear to be deteriorating in several areas and may require repair. Recommend further evaluation by a qualified contractor or licensed engineer.

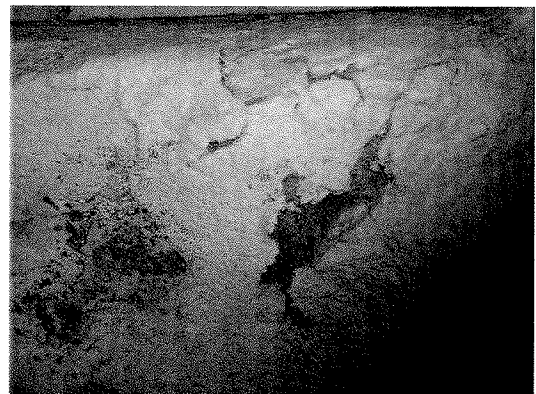
Apparent deterioration of mortar in fieldstone walls (2).

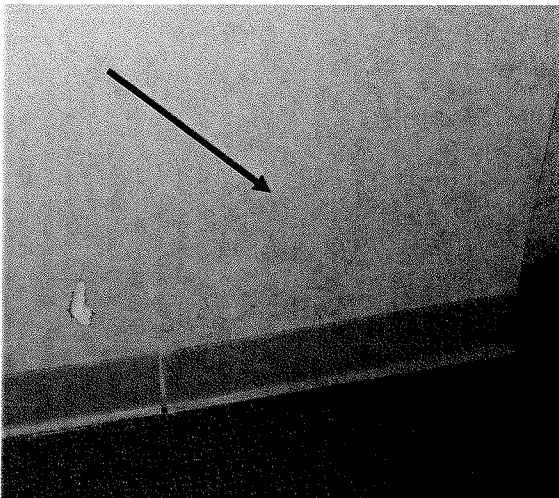
Moisture staining behind drywall at base of stairs.

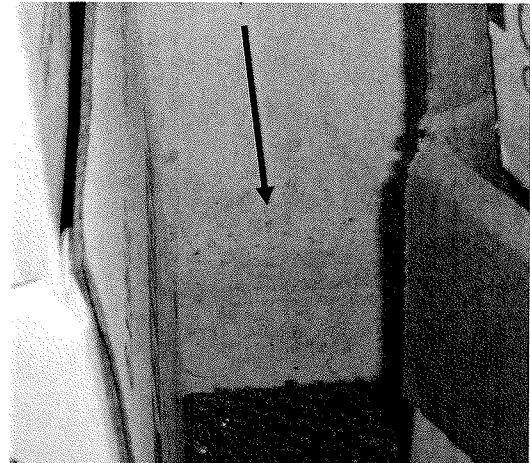
Moisture staining behind drywall, south wall.

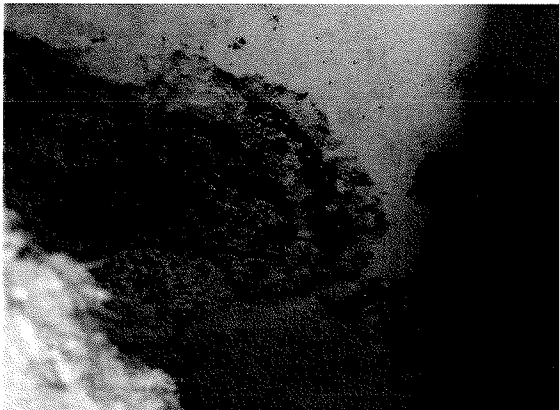
Mold-like substance behind wall, north basement.

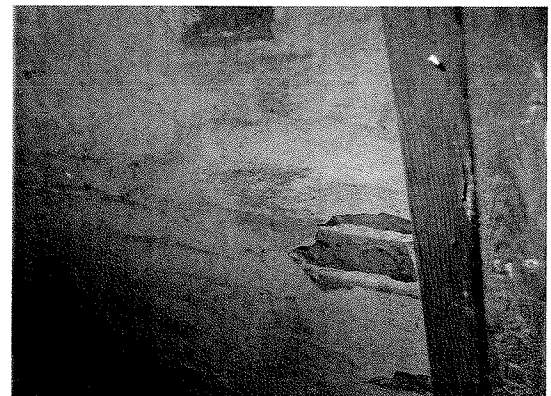
Spalling, deterioration of brick in central basement wall.

- 10) The brick wall running through the center (north-south) of the basement appears to be the primary support for the main girder. The brick wall has been broken in areas to allow duct work to pass through, and the bricks in the wall are spalling behind the coat of concrete applied to the same. The main girder in the downstairs bathroom shower, for example, does not appear to be properly supported. Floor joists as viewed from the basement are rotated, cracked, bulged, and improperly notched. Recommend full evaluation of basement structure by a qualified contractor or licensed structural engineer.

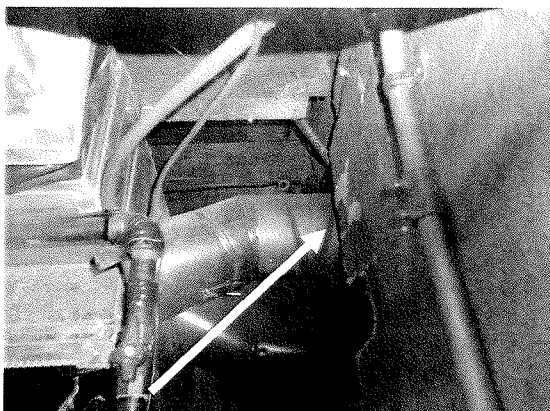
Brick wall broken to allow ductwork to pass through.

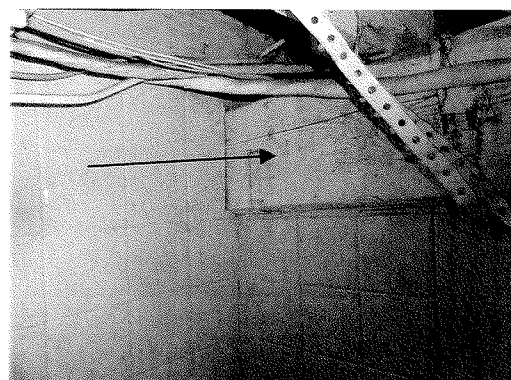
Main girder not properly supported, in shower.

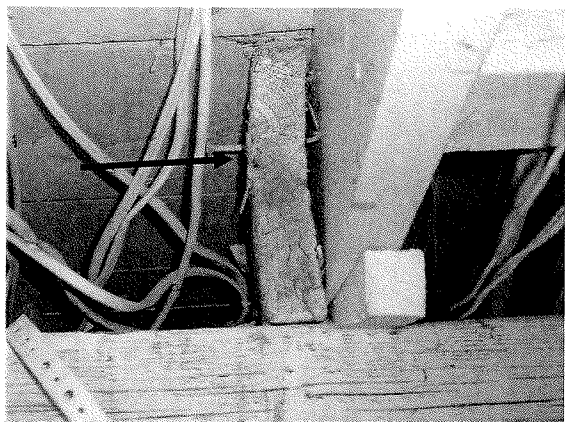
Basement joist bulging, nailed.

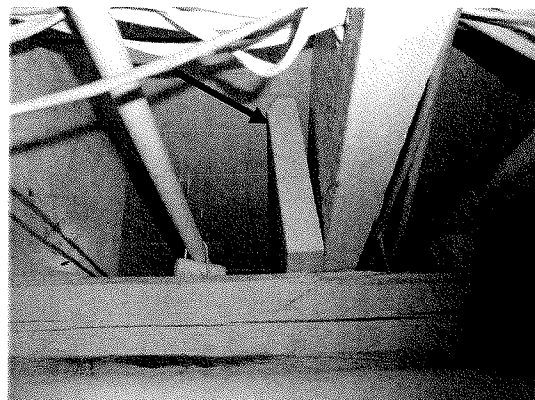
Basement joist "rolling"; not properly supported.

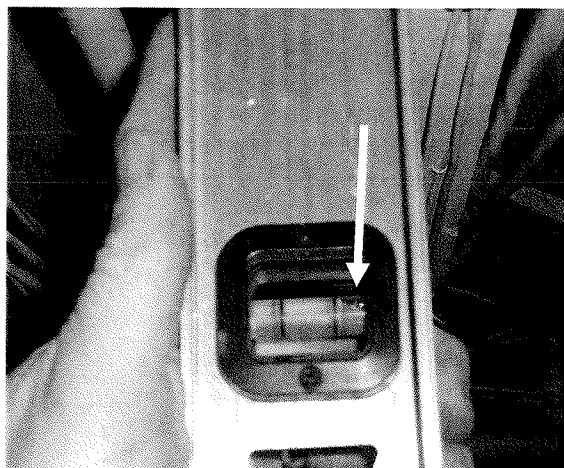
Basement joist rotated.

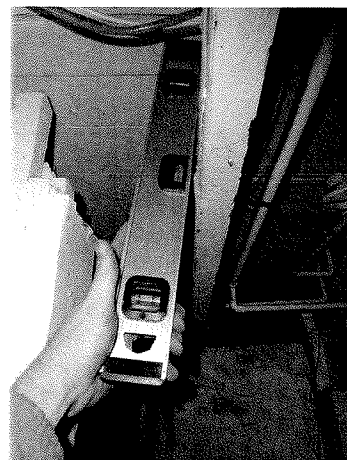
Basement joist cracked, rotated.

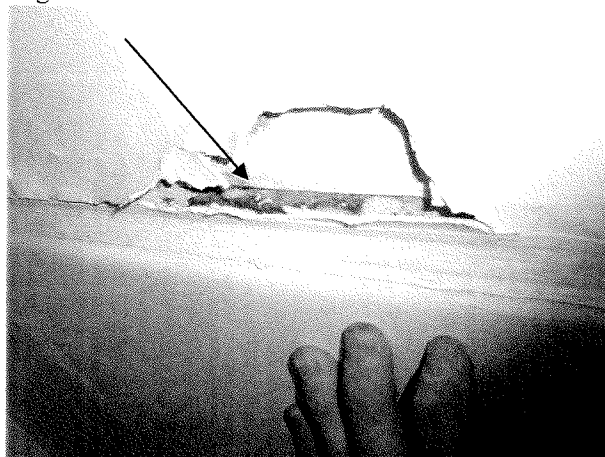
Second floor shower surround, with mold-like substance behind wall.

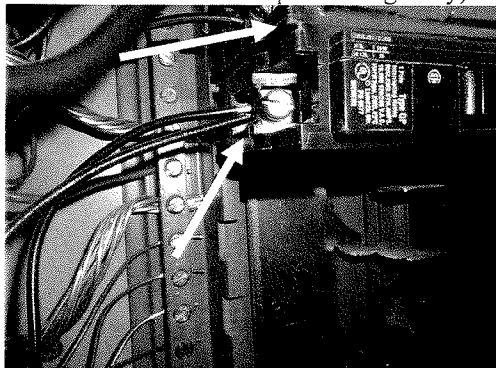
Two circuit breakers were double tapped (two wires attached to a circuit breaker) in the main service panel: repair as needed by a licensed electrician; safety hazard. The circuit breaker for the alarm system was spray-painted red and held in the open position by a screw. Potential safety hazards. There was a missing breaker (and an open slot) in the second floor electric sub-panel; safety hazard. The receptacle for the second-floor washing machine was hot/neutral reverse (wired backwards); safety hazard. Missing cover for junction box in west attic; safety hazard. Test GFCI-protected outlets on a monthly basis (the mechanical portion tends to stick if not operated regularly).

Double-tapped circuit breaker and red alarm breaker.

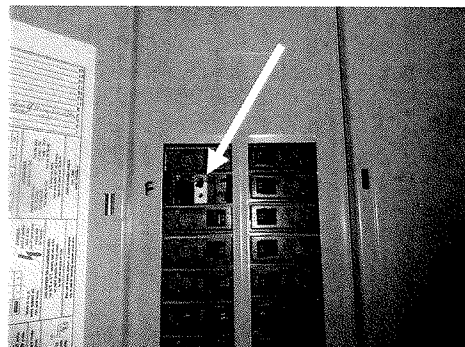
Open slot in second-floor sub-panel.
