DANGEROUS BUILDING NOTICE AND ORDER

Re: 111 South Main Street, Ann Arbor, Michigan
Parcel Identification Number ("PIN"): 09-09-29-132-014

REPORT

July 1, 2015

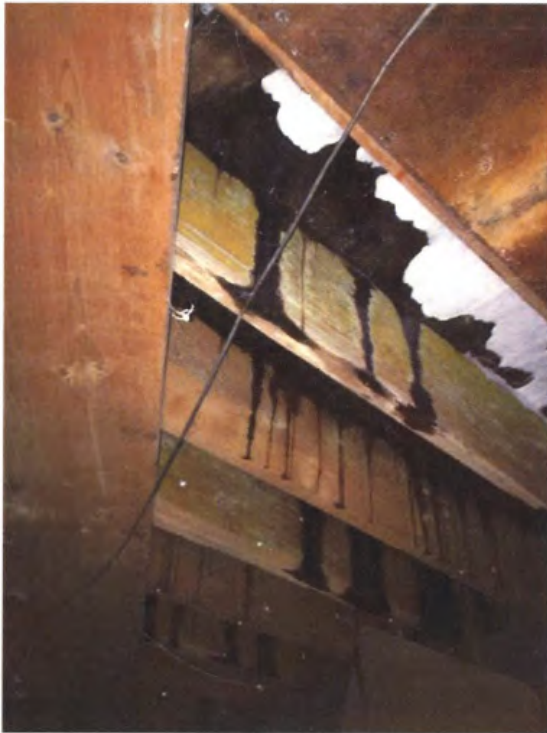
Our inspection revealed that there is significant water damage to the structure occurring mostly in the west 60' of the building. The water damage includes saturation of the plywood flooring throughout the visible portions of the west 60' and localized damage to a portion of the floor joists. See Image 1 attached. In addition there is a large tree growing from the roof and the framing around that tree is severely damaged. See Image 2 attached.

The majority of the plywood subfloor is damaged beyond repair due to water saturation and while still providing some structural integrity to the floor is not considered adequate as a subfloor material or bracing material to the joists below. As such, the joists in the floor have an unbraced compression flange and do not meet strength requirements required for the loading. The majority of the joists appear to be in good condition, however there may be localized rotting at the bearing points of the joists where water could accumulate. These areas were not able to be inspected due to the mold throughout the building.

Typical floor framing condition showing saturated subfloor, localized water damage to floor joists and mold growth.

Due to the conditions noted above the structure does not meet building code requirements. Access to the building should be limited and we recommend that efforts to remediate and remove the mold and all interior non-structural elements be taken as soon as possible. Once that effort has been completed the plywood should be removed in order to expose the top face of the wood joists and bearing conditions. Once those conditions are exposed an additional inspection will be required to determine which joists or portions of joists will need repair, replacement or strengthening. Once this is completed the joists can be re-supported with a new sub-floor and roof, and the building will again meet structural building code requirements and can be considered safe.

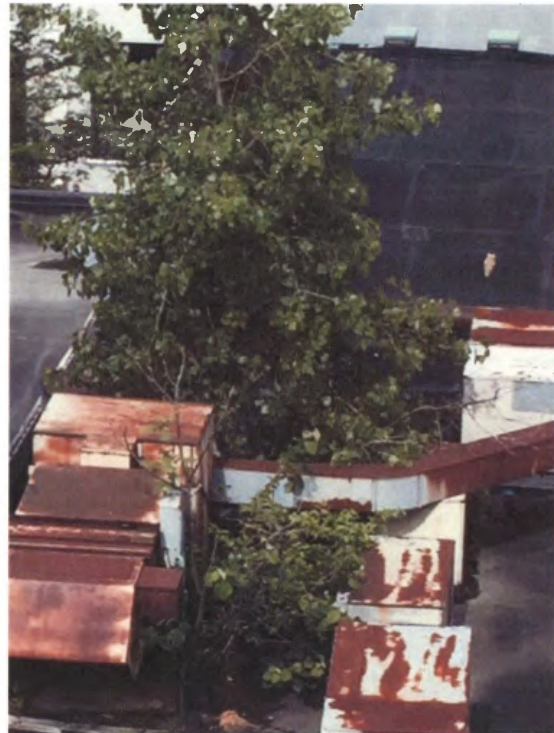
Image 2

Image of the roof showing tree and vegetation growth from adjacent structure.
