West Park Historical Band Shell

Building Foundation Investigation
Summary of Findings and Recommendations

Presented by Rich Nacey, P.E.
Structural Department Head

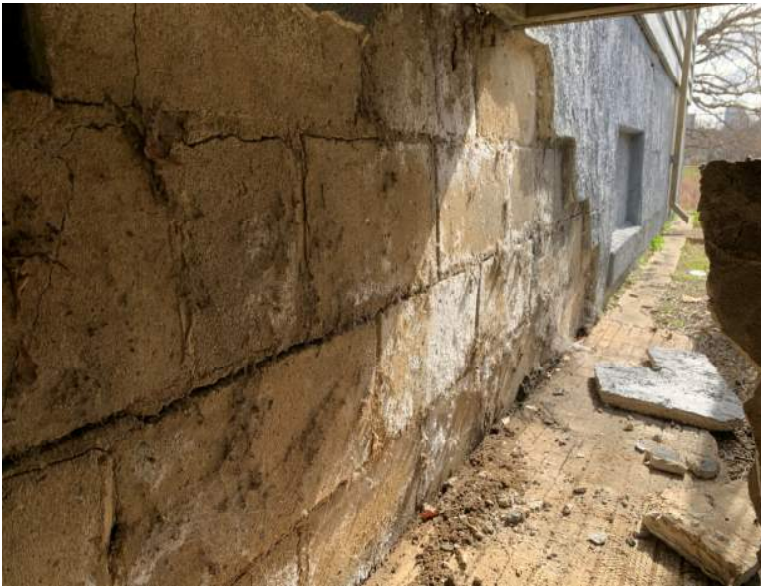
Photo 3:

- Above ground masonry block laterally bowing outward .
- Numerous cracks caused by lateral and settlement movement
- Block efflorescence
- Debonded of stucco finish

- Masonry foundation walls above grade are not salvageable.
- The root cause for the block wall lateral bowing needs to be corrected.
- A thorough review of the contract drawings documents and changes (not available during Phase I) needs to occur.
- Below grade masonry foundation walls and footings need to be investigated via local excavations for salvageability.
- Soil borings are required at and away from the structures for historical comparisons.
- Surrounding saturated grade has detrimental effects to the foundations.
- Public safety concerns due to lateral bowing walls – fenced area now required.

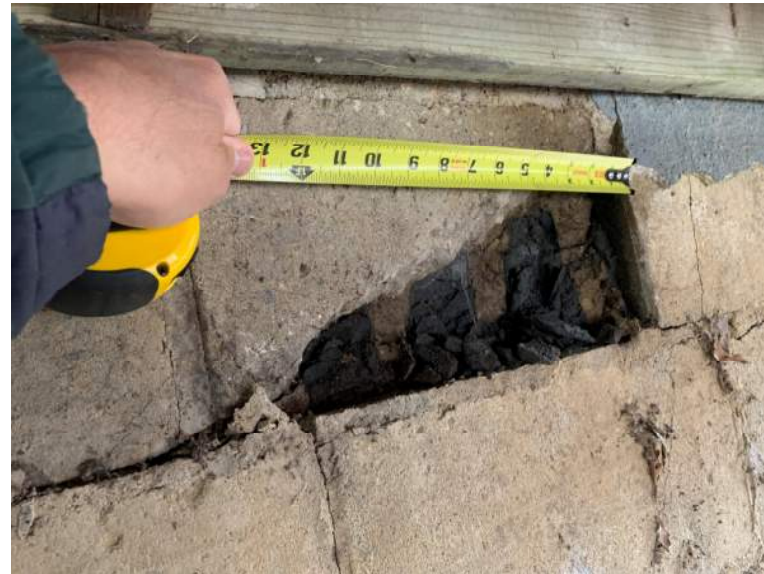
Photo 4:

- Extensive masonry block deterioration
- Extensive grout deterioration.

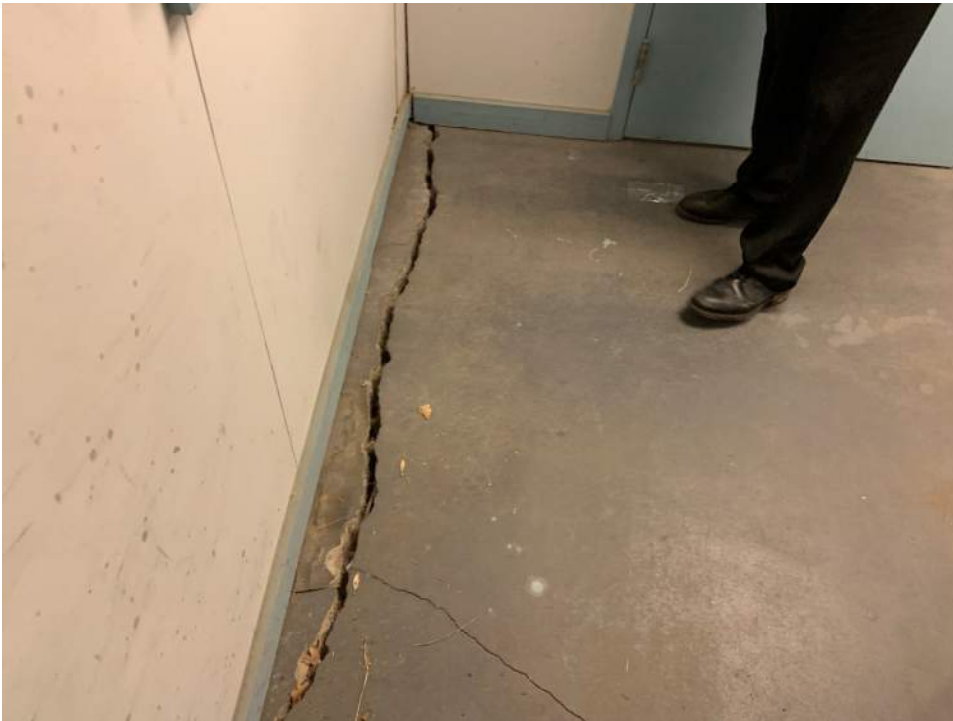
Photo 5:

- Large cracks within concrete floor slab, perpendicular to lateral wall bowing

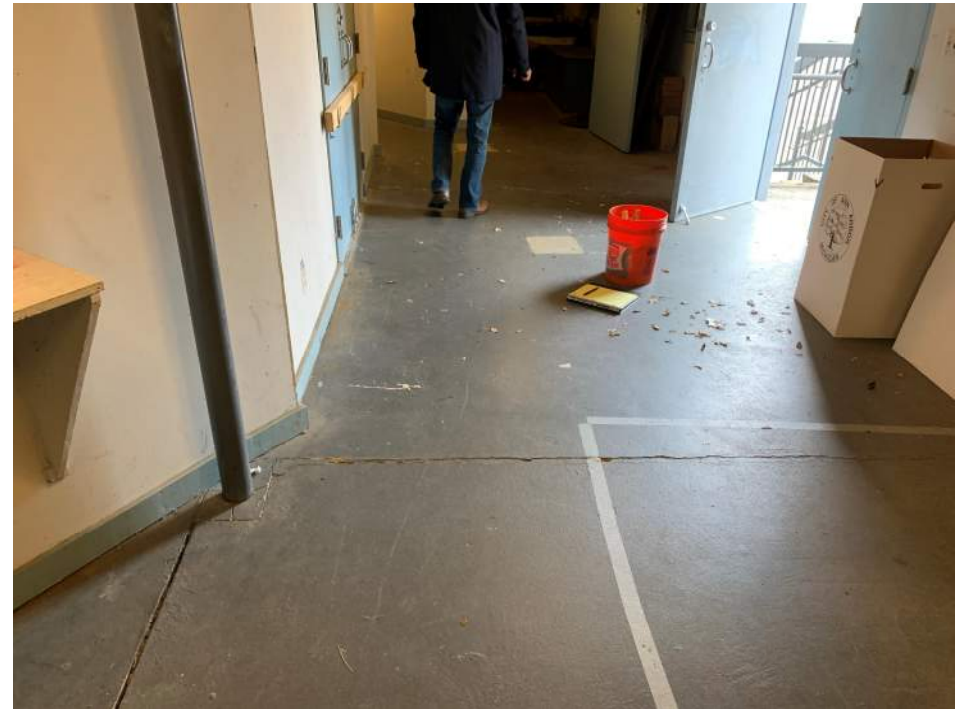
Photo 6:

- Additional floor cracks and steel column pocket deterioration

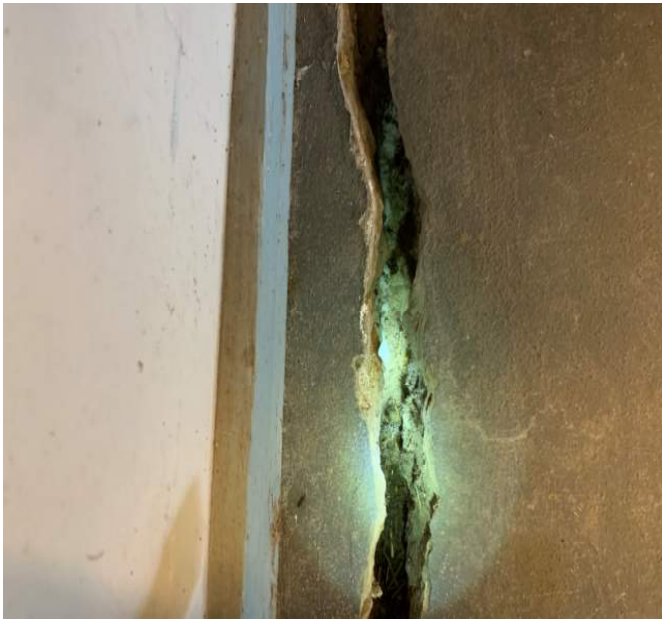
Photo 7:

- Cementations type fill materials.
- Underneath all of the floor slab.

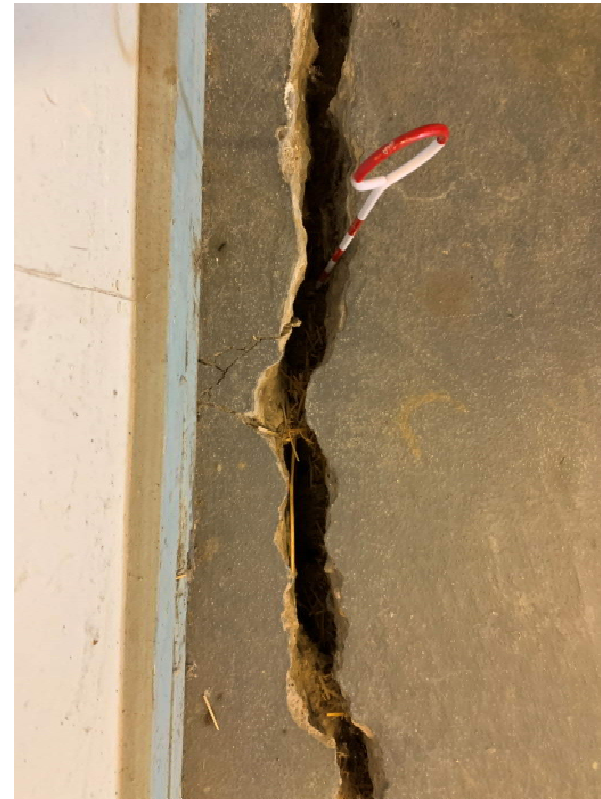
Photo 8:

- Consistency has changed from lightweight concrete to sand backfill

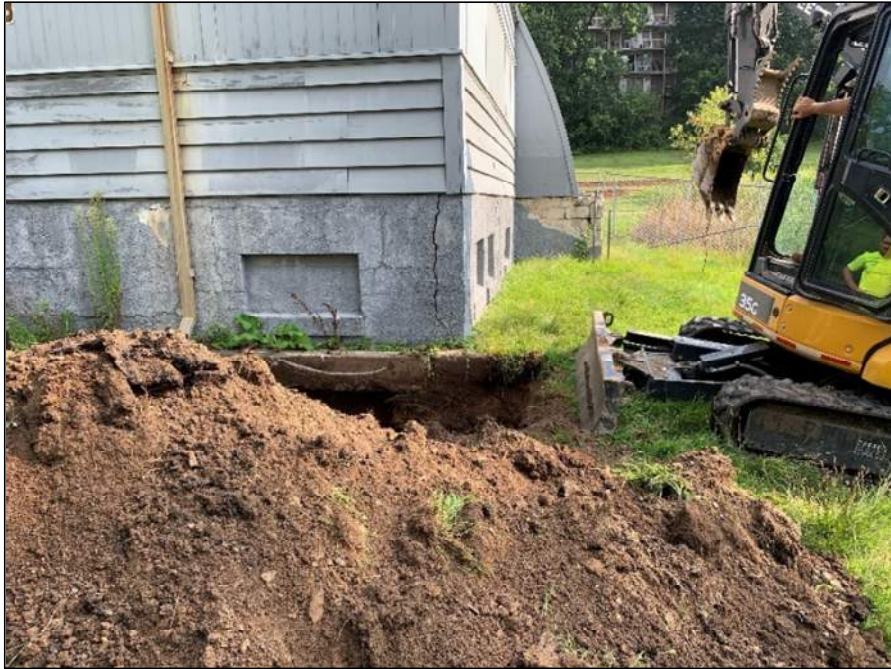
Photo 9: Weeping Corner Wall Cracks

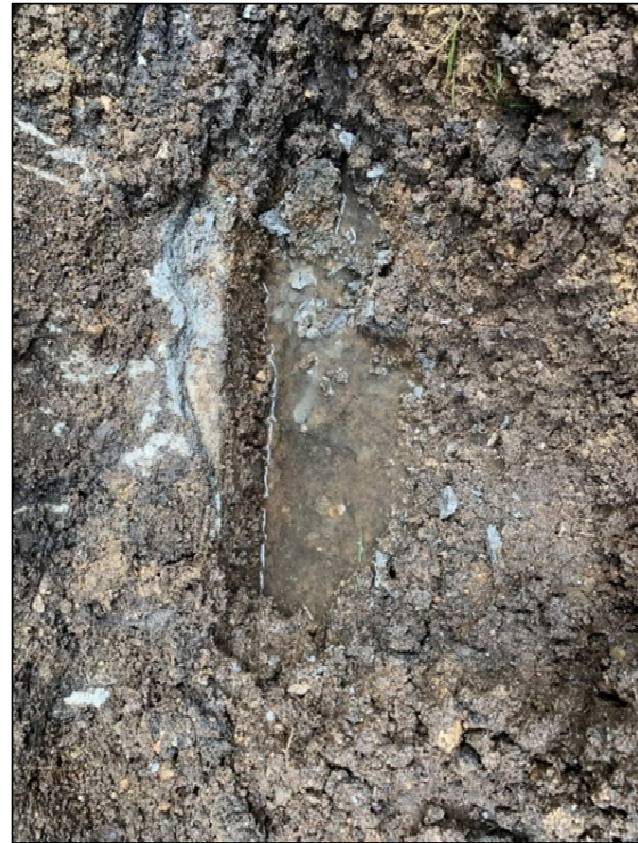
Photo 10:

- Saturated and Local Erosion at Footing
- Ground water flowing under footing

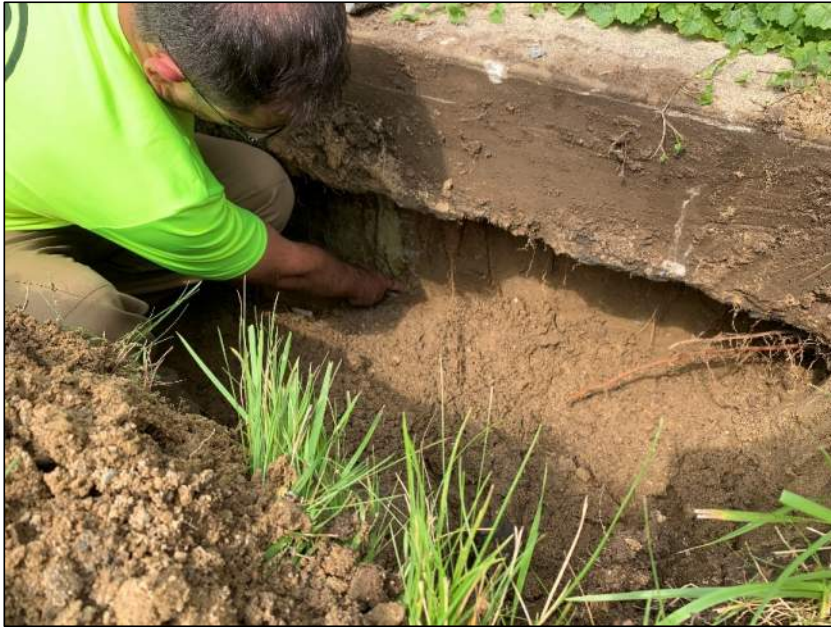
Photo 11: Along East Wall

- Saturated soils
- Weeping wall cracks

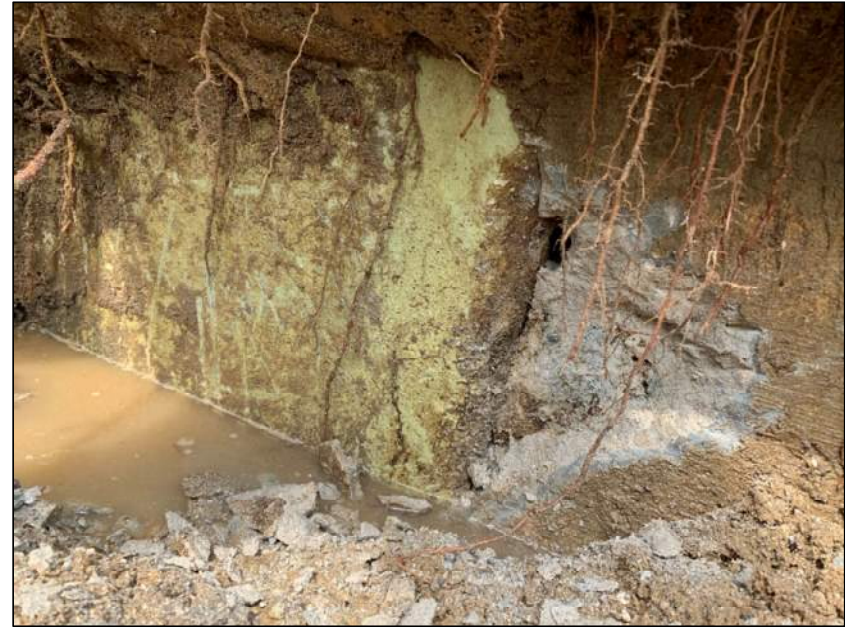
Photo 12: Deteriorated Basement Door Infill Area

- Saturated soils
- Weeping wall cracks
- Voids within walls

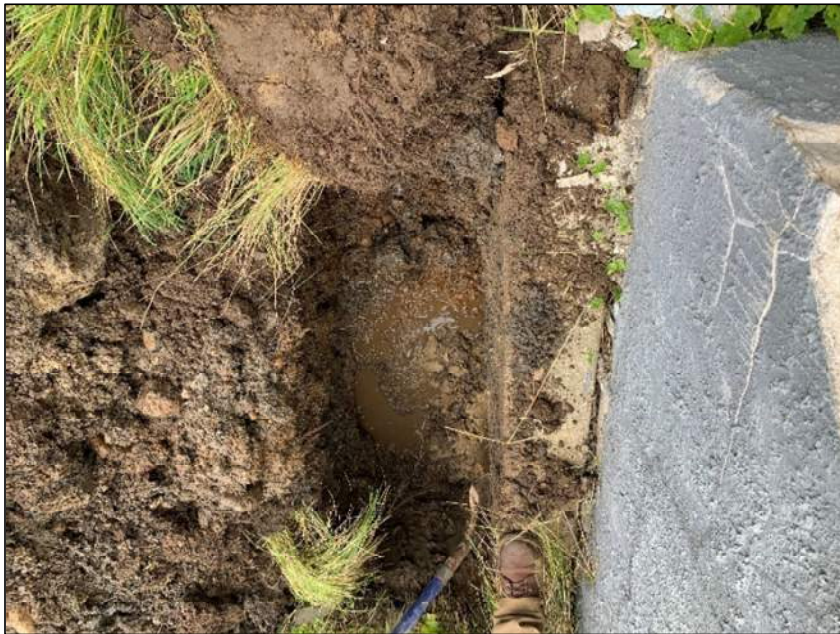
Photo 13: Saturated Soils and Local Erosion along wall and footing

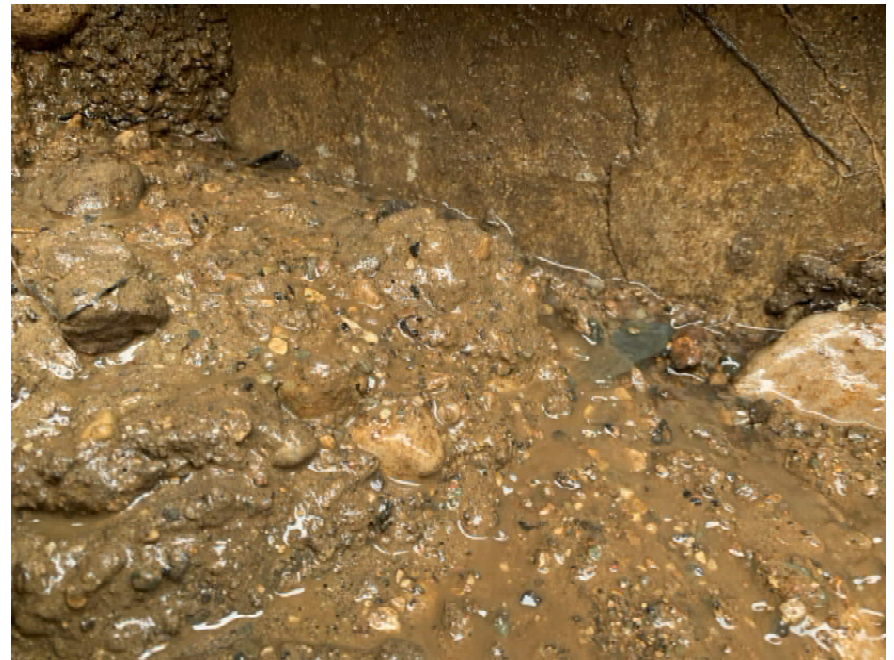
Photo 14: Flowing ground water along East wall
