415 West Washington Historic Structure 2017 Reassessment

415 West Washington, Ann Arbor, MI, 48103
Follow-up to Rueter Associates Assessment of August 29, 2013
November 1, 2017

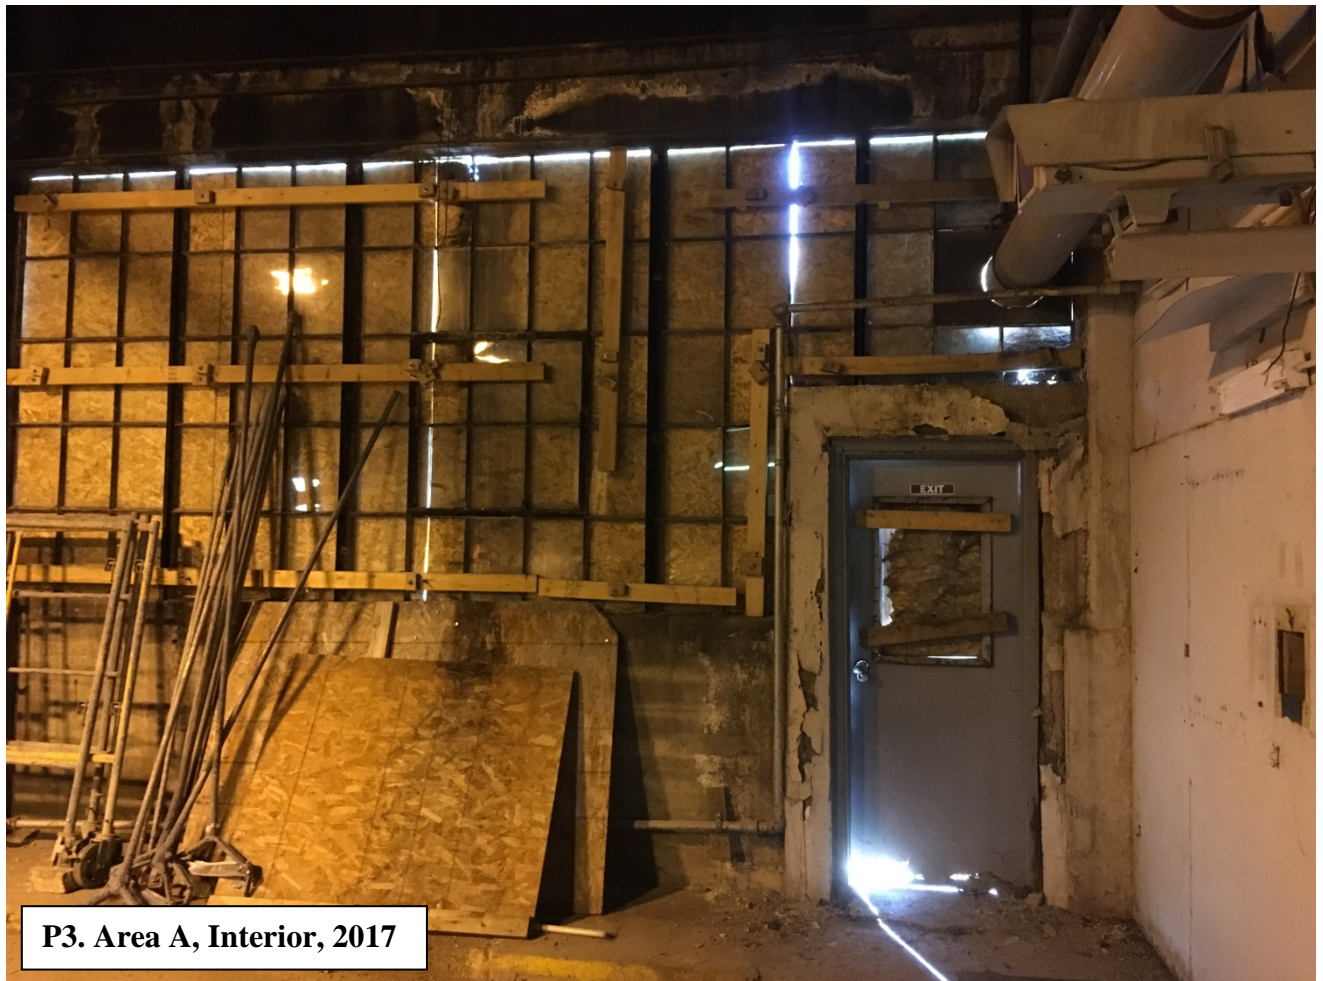
P3. Area A, Interior, 2017

Area A Condition Evaluation – Area A appears to have experienced marginal progressive deterioration since the 2013 Assessment. This is evident primarily due to rusting of metal doors, spalling of concrete encasement of lattice columns, and staining of roof deck from leaks near mechanical equipment penetrations. As stated in the 2013 Assessment, the mechanical and electrical systems are not readily adaptable for potential future uses. This portion of the building could possibly be renovated for uses similar to its current use (e.g. storage / warehouse) notwithstanding the floodplain issue. However, because this area is structurally contiguous to Area B, the feasibility of such reuse is significantly diminished.

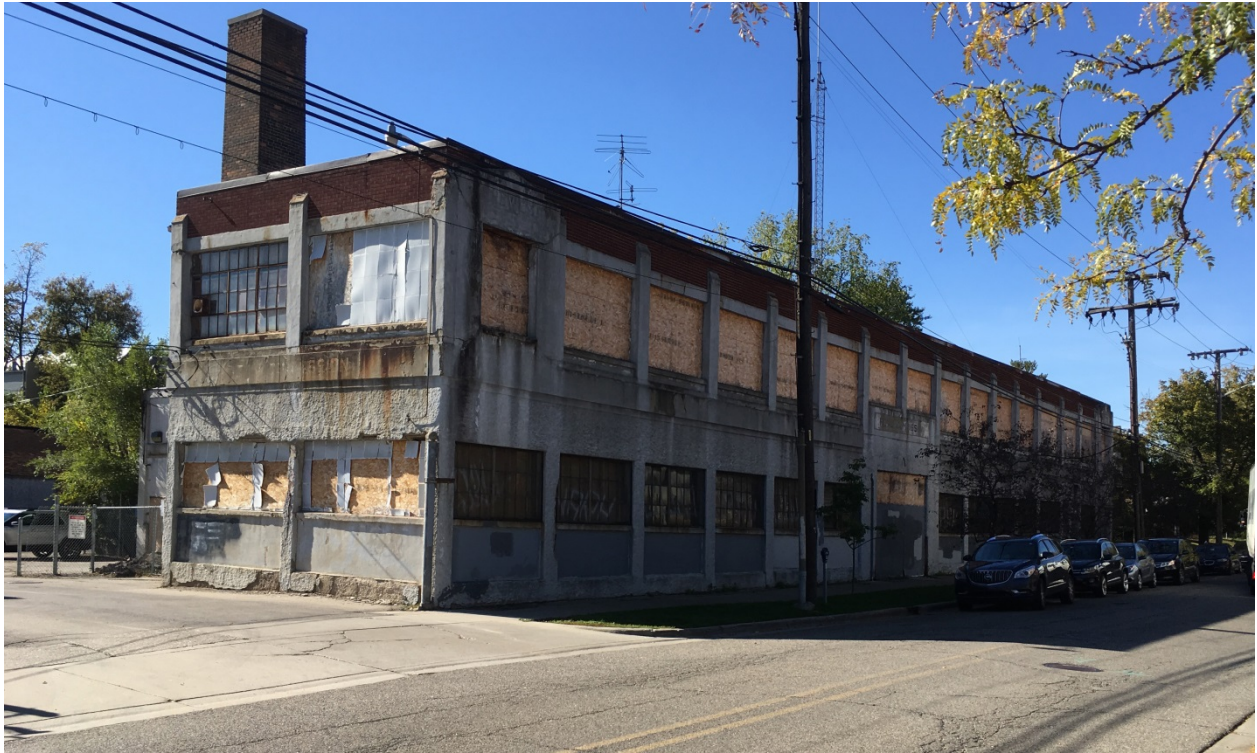
P9. North Façade, 2017

New OSB sheathing appears to have been installed over the upper windows. The plywood security panels with simulated painted window sashes seen in the 2013 photo are no longer visible. These were either removed or covered over by the new OSB sheathing. The overall visual appearance of the north and east facades is very poor.

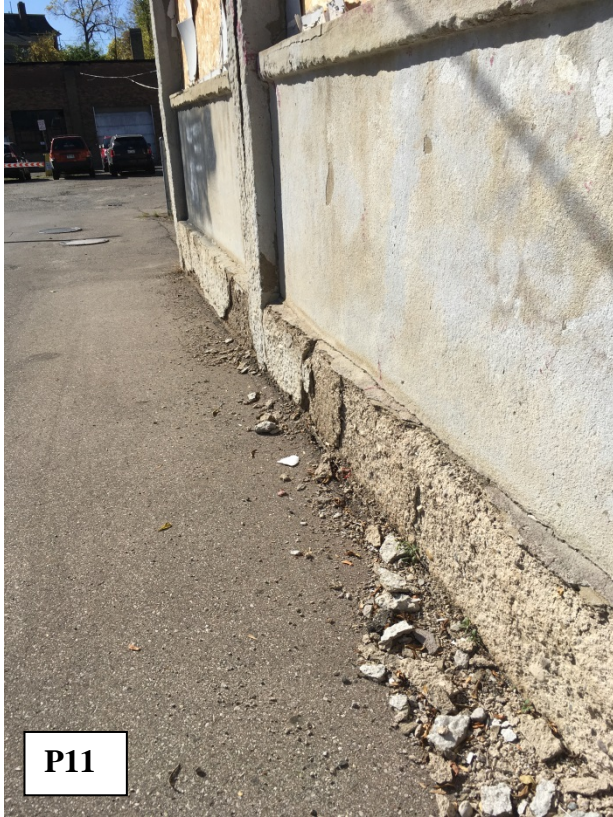
P11

Area B Condition Evaluation - Area B appears to have experienced significant progressive deterioration since the 2013 Assessment. This is evidenced by debris on grade along the base of the wall from recent spalling concrete (P11), severe cracking of reinforced concrete columns exposing internal reinforcing bars (P7 & P8), and stress cracks at window lintels along north wall (). We believe that these and other observations are indicative of significant degradation of the primary load bearing structural components of the building. The interior finishes are not suitable for reuse of any type (P15 & P16). Although the 2013 Assessment suggested repairing the existing windows due to their historical character, we do not believe this would be possible while still meeting the current Michigan Energy Code.

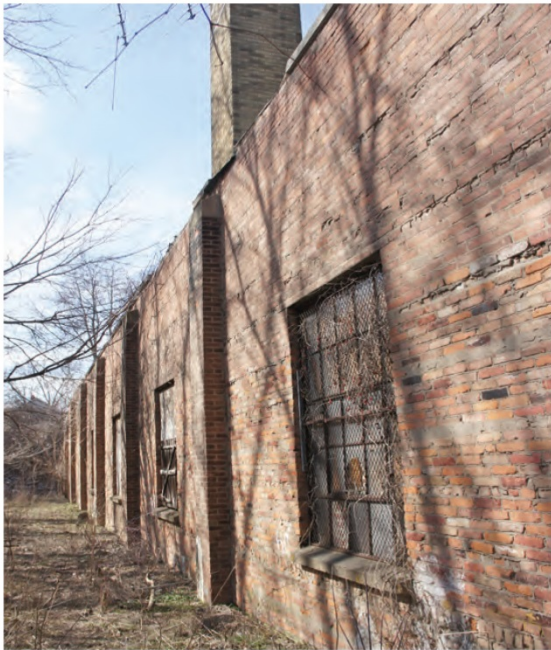
P23. 2013 Assessment Photo

Area D Condition Evaluation - Area D appears to have experienced minimal progressive deterioration since the 2013 Assessment. Our assessment of this area was limited to the exterior of the building because access to the interior was not possible. The brick appears to be in substantially the same condition as the 2013 Assessment. This area is being utilized as equipment storage by a City department and could not be accessed at the time of our inspection. However, from observations through windows, no significant signs of change were observed.

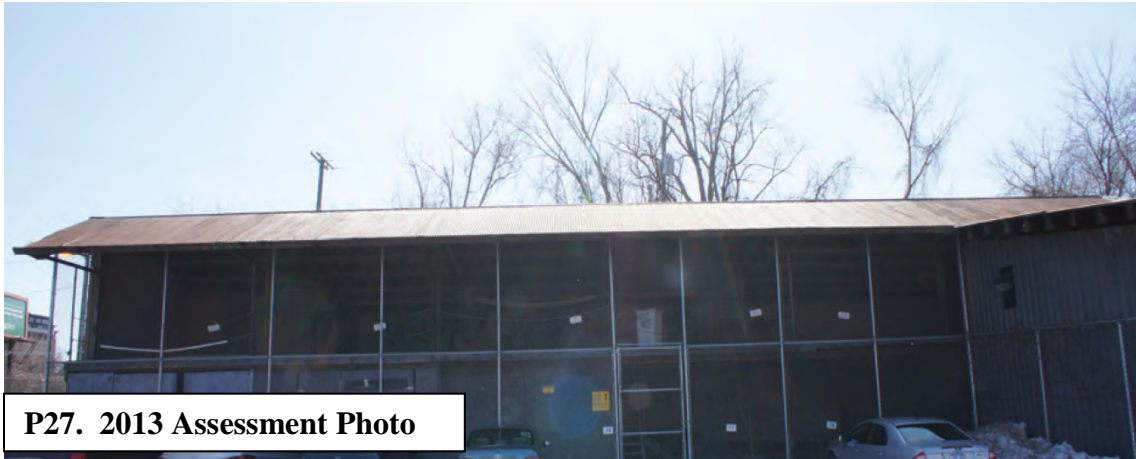
P27. 2013 Assessment Photo

Area E Condition Evaluation - Area E appears to have experienced marginal progressive deterioration since the 2013 Assessment. The corrugated metal roof appears to have experienced progressive rusting since the 2013 Assessment; however there does not appear to be leakage at this time. Our assessment of this area was limited due to the inability to access the interior of the building. We note that this building was excluded from Rehabilitation estimates in the 2013 Assessment in any case.
