## **Notice to Proceed - 1218 W. Huron St.**

## **1218 W. Huron Garage**

## Repairs needed (Larger repairs)

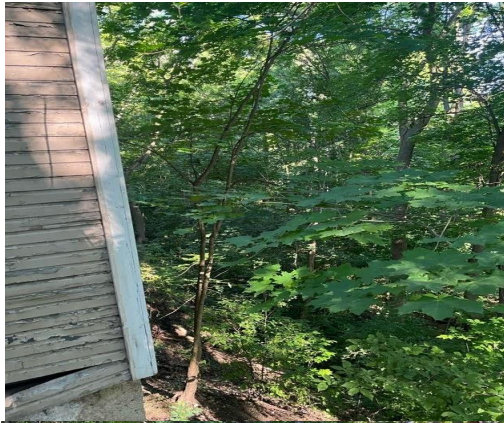
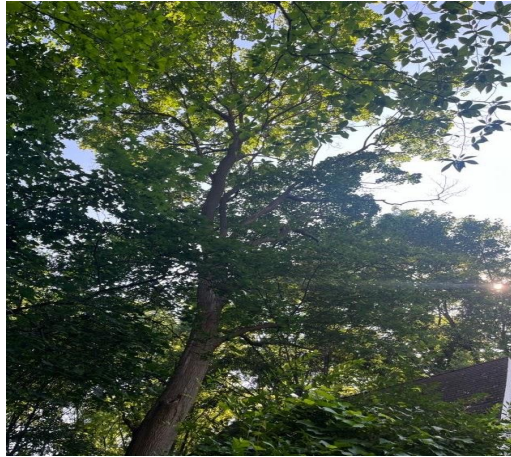
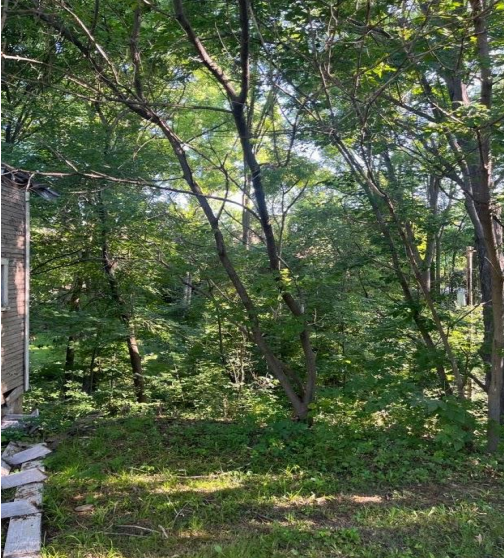
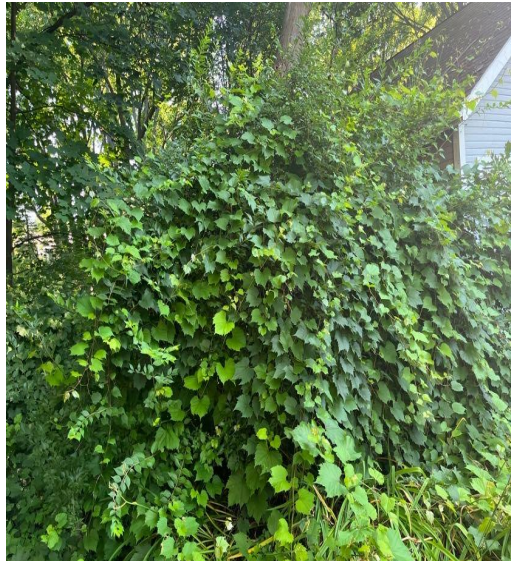
### **Area around the garage:**

To provide a safe work site and to provide room for construction equipment to do the work on the garage specifically for the foundation work, the area around the garage would need to be cleared. 4 trees (1 mature), a bush and ground covering plants would need to be removed. Due to the hillside being too weak from eroding, safety shoring would need to be in place as well.

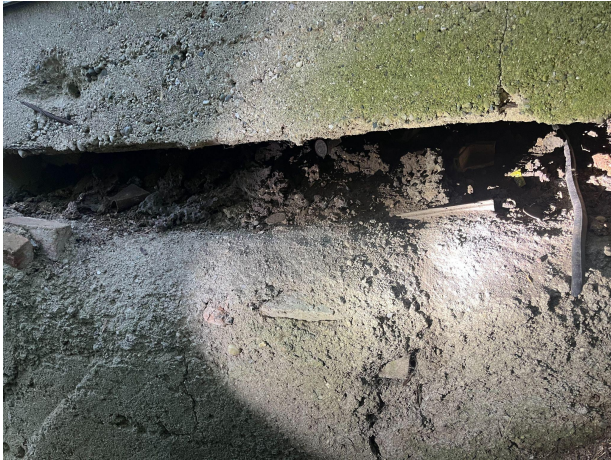
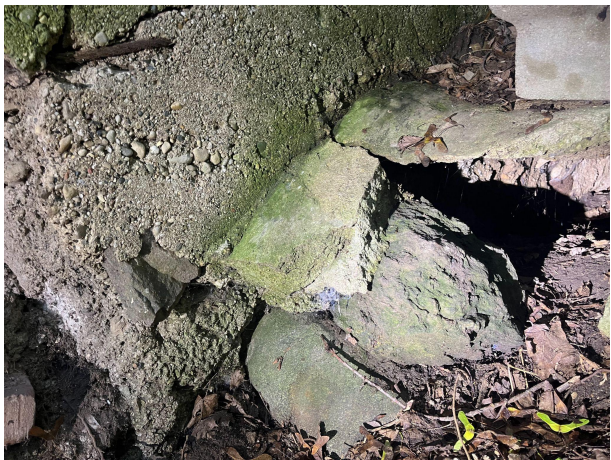
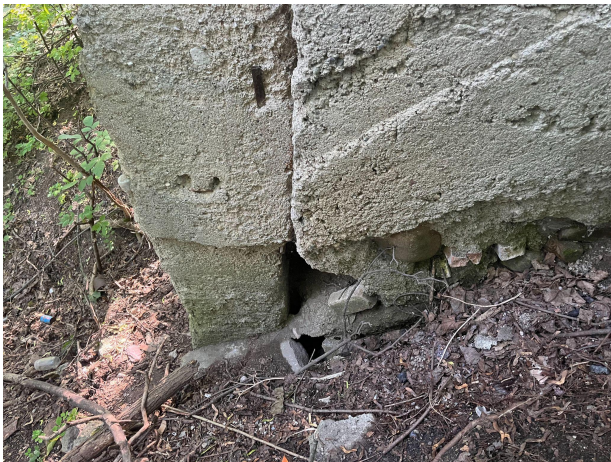
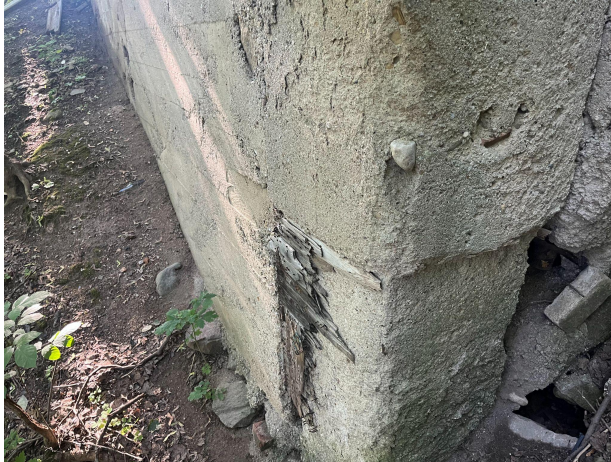
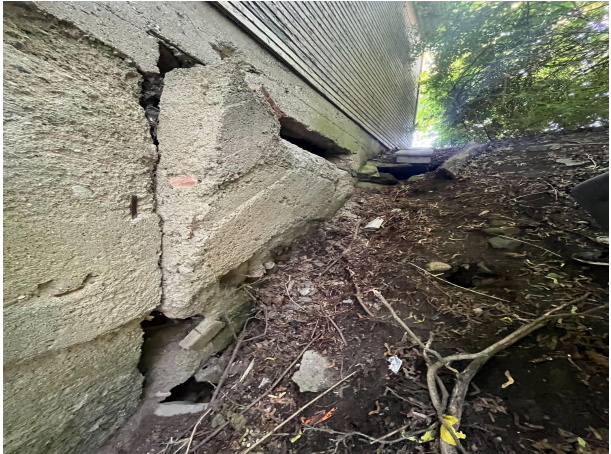
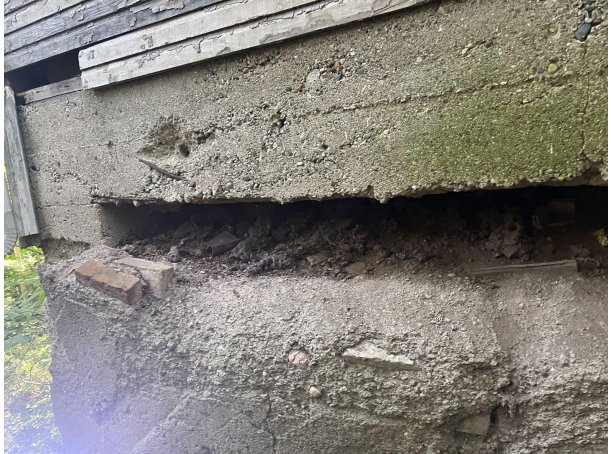
**Foundation walls and footing**

The foundation walls are very eroded and footings disturbed. The entire garage structure would need to be moved off of foundation. They would dig and set footings, then pour or build block foundation walls. The location of the foundation would likely need to be moved away from the eroding hillside..

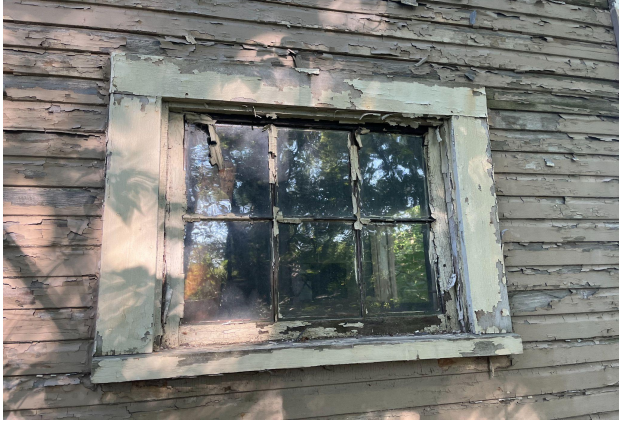
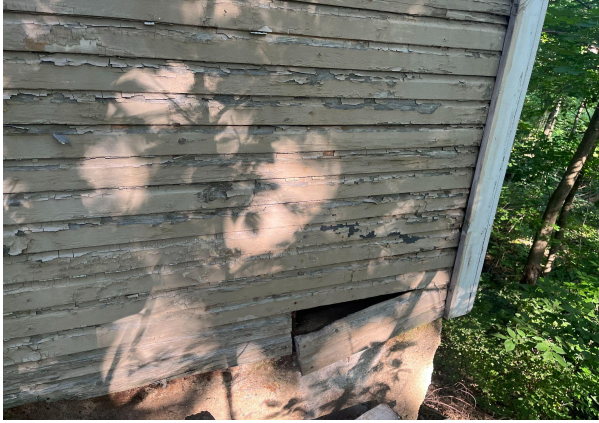
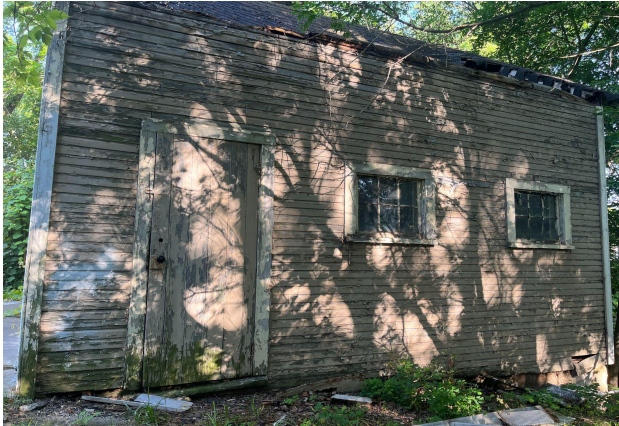
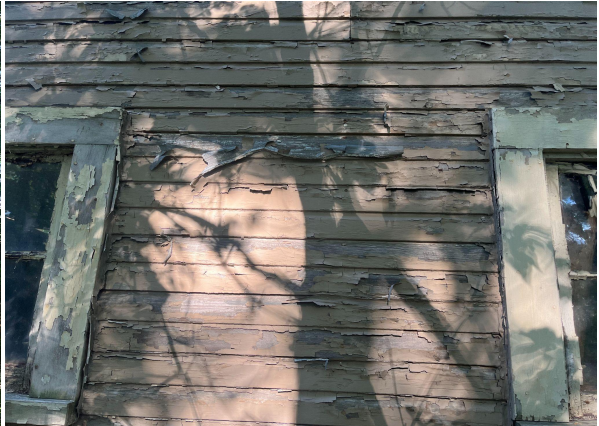
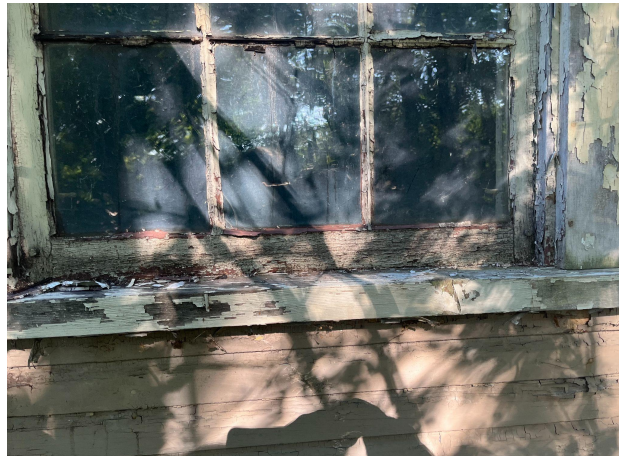
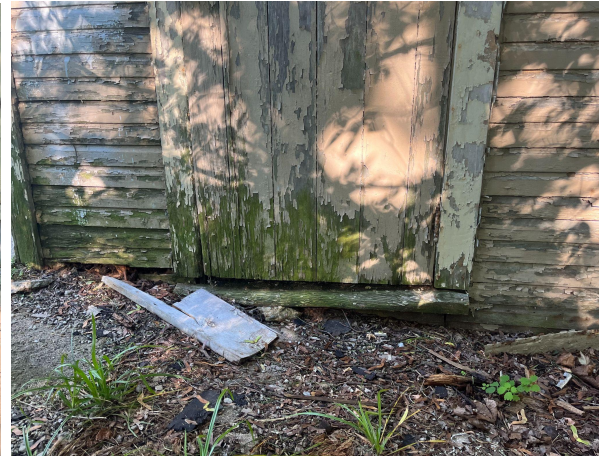
**Exterior West Side of garage**

Lead based paint scraping to remove flaking paint and repaint. Rotted wood on window sill, some of the window framing and the door sill and framing. Would need to replace the window sill, some of the window framing, door sill and and door framing. Patch siding on the lower right corner.

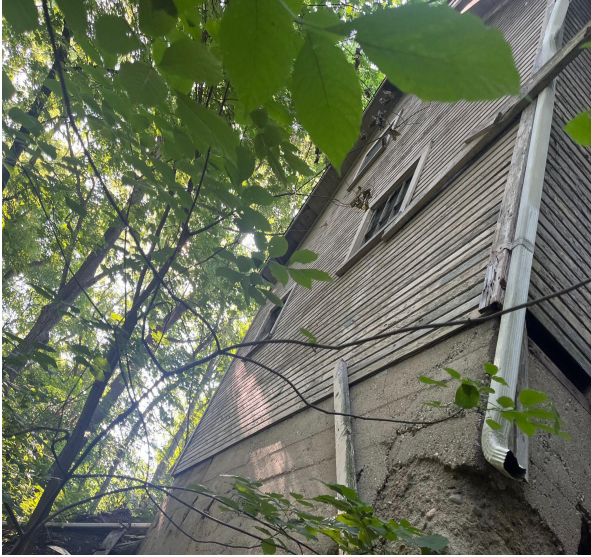
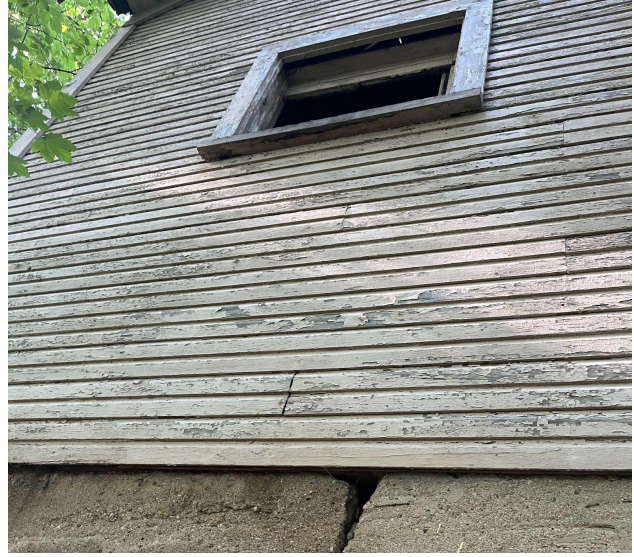
### Exterior East Side and Back Side of garage

The exterior of the east side has some cracks where wood siding is off and has flaking paint. Would need to be scraped and likely re-paint. Replace boards or secure loose boards when possible.

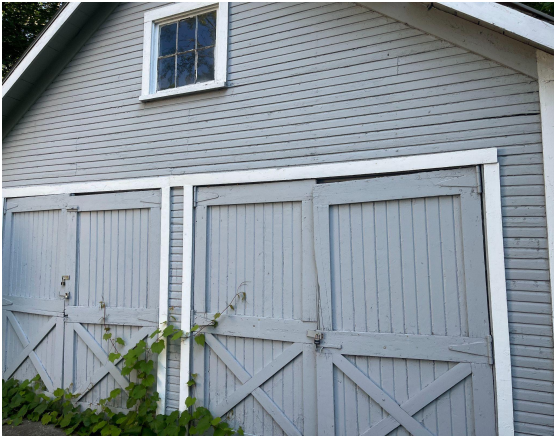
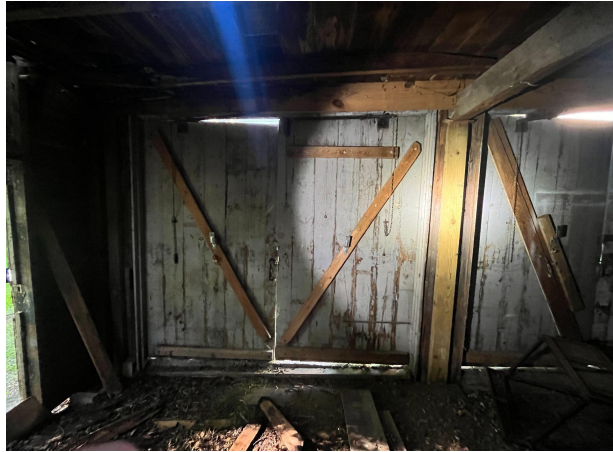
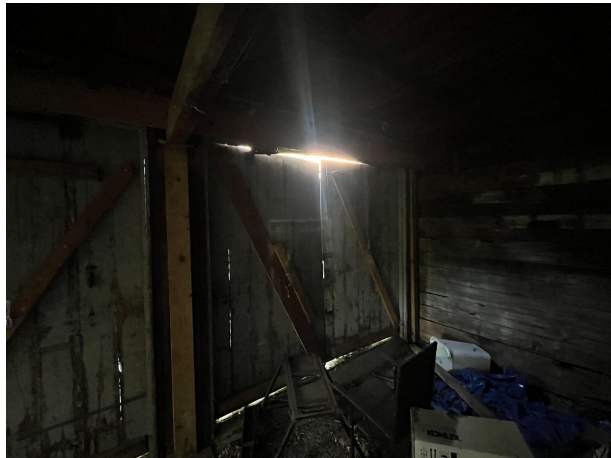
### Exterior Front side of the garage

Rotting on the inside of the door frames. The doors would need to be straightened and doors would need to be reworked.

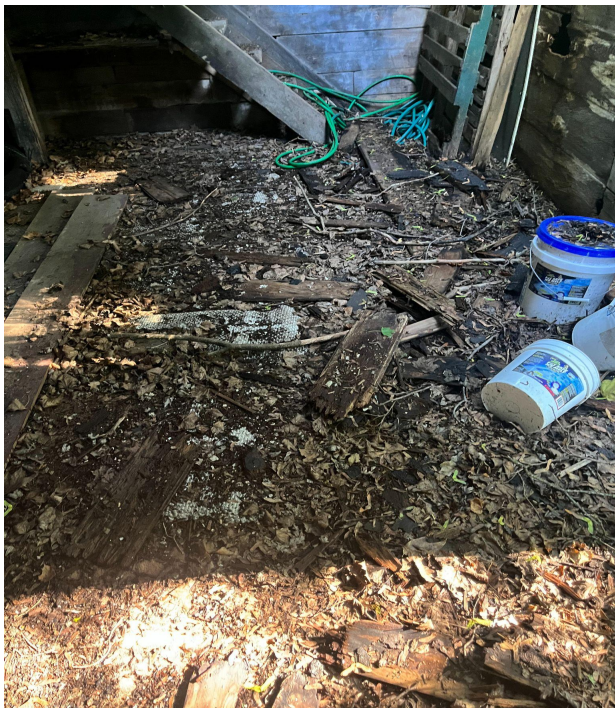
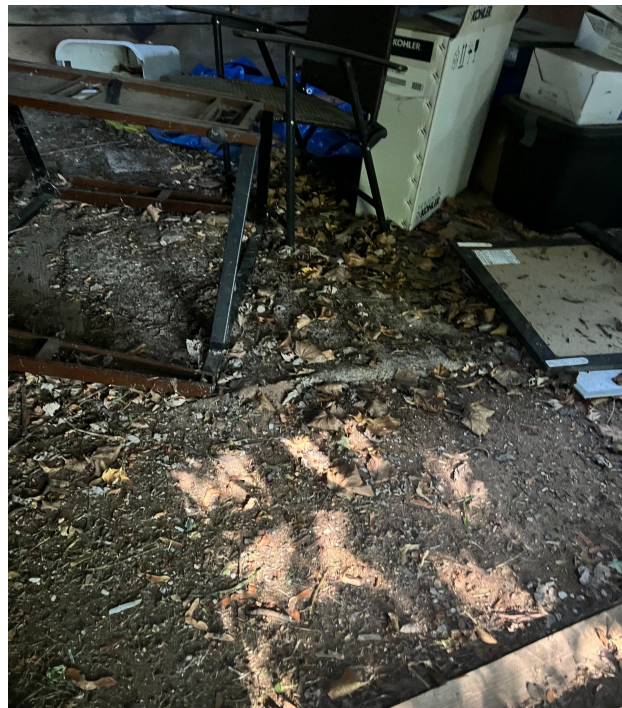
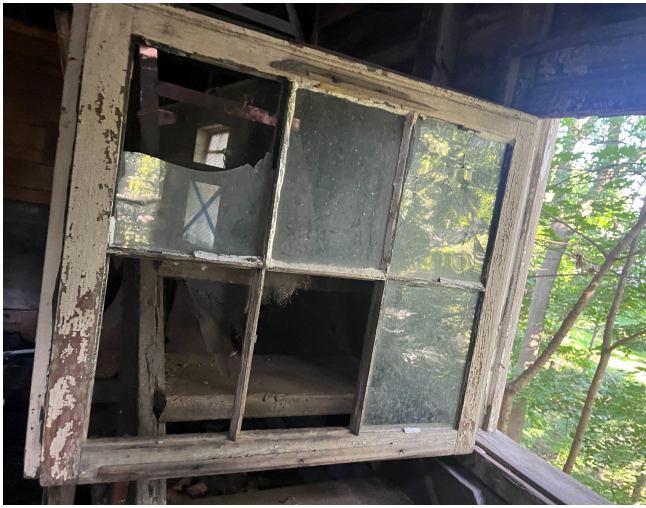
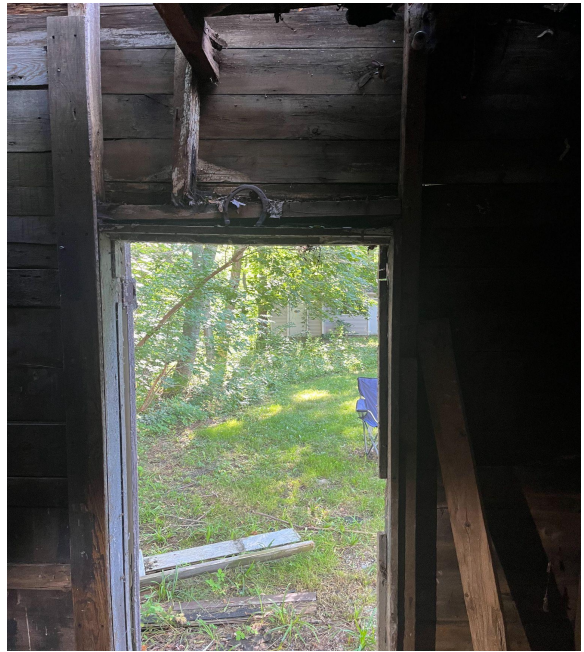
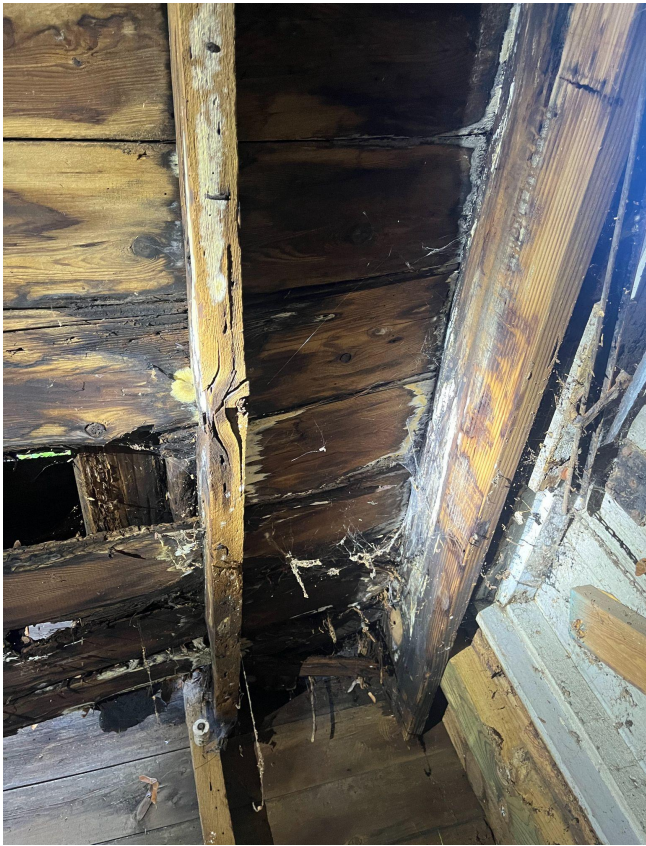
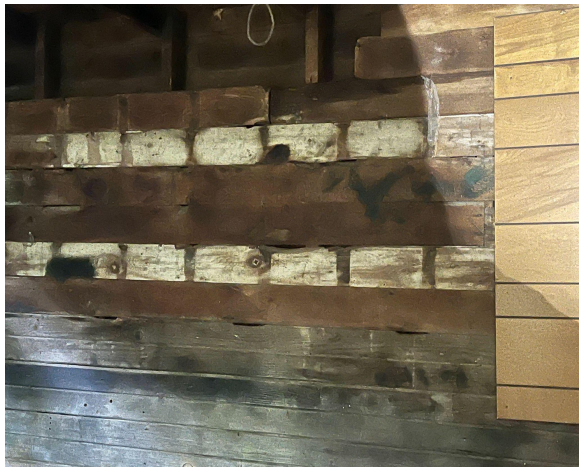
### **Photos of interior:**

The entire floor is weak, rotted and patched together. The current floor is not weight bearing. The floor frame and subfloor need to be replaced.

The east side of the roof is completely caved in. From the interior, the rafters, ridge beam, decking, gable ends and connections are all destroyed. There would be no way to salvage material for the roof. The side of the roof that hasn't fallen has cracks allowing moisture and comprising the whole structure. It would need to be completely re-shingled as well.

Many of the interior boards, framing and joists are rotted and would need to be replaced. Much of the interior had repairs with varying sizes that don't support a strong structure.

Electrical is not to code and would need to either be replaced or removed completely.

Glass is broken in the two back windows, the framing on most of the windows has rotted and is in need of replacing.
