DOCUMENTATION and RECORDATION REPORT

**439 South Division Street
(Known locally as the Arthur Miller House)
Ann Arbor, Michigan**

**Prepared by:
Ilene R. Tyler and Susan Wineberg
Ann Arbor Preservation Alliance**

Project Summary and Description of Existing Conditions

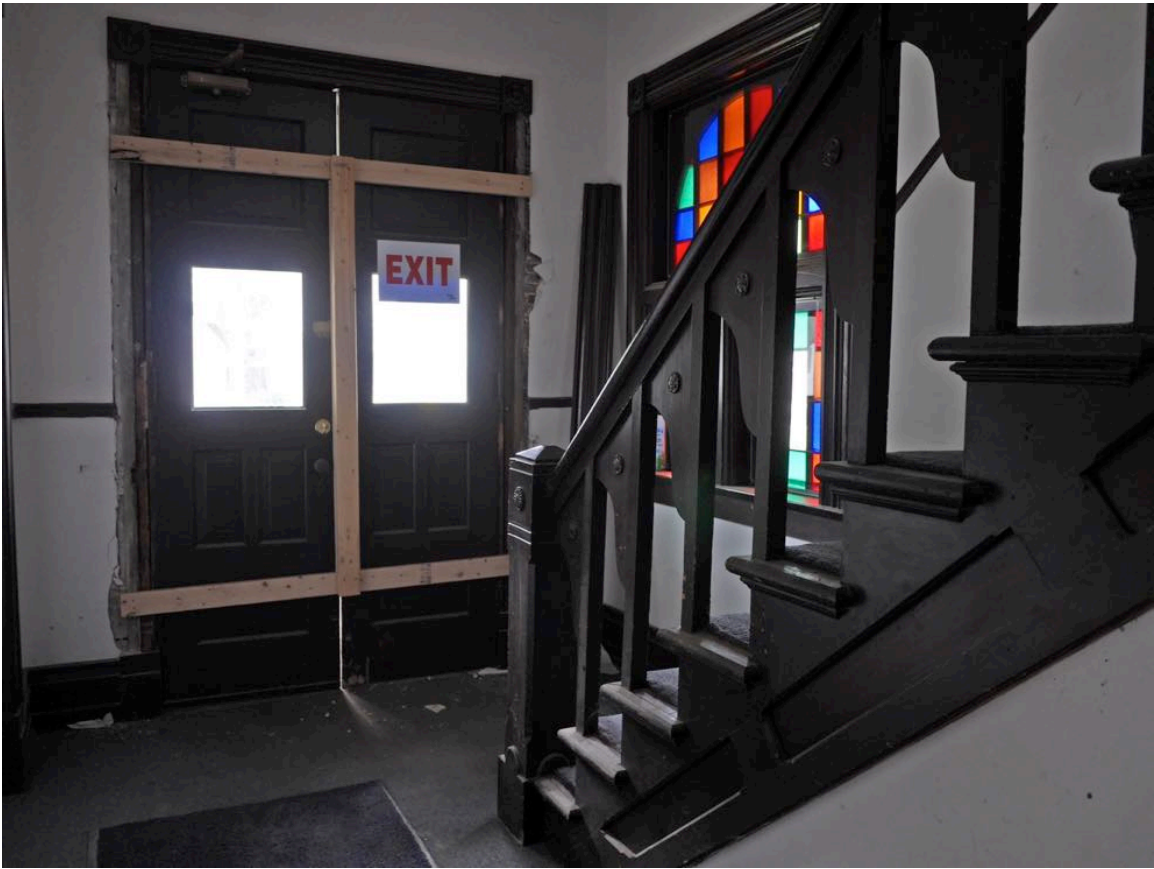
Photo No. 1 (image No. 1): Front entry hall including staircase and original double doors, now boarded up for security.

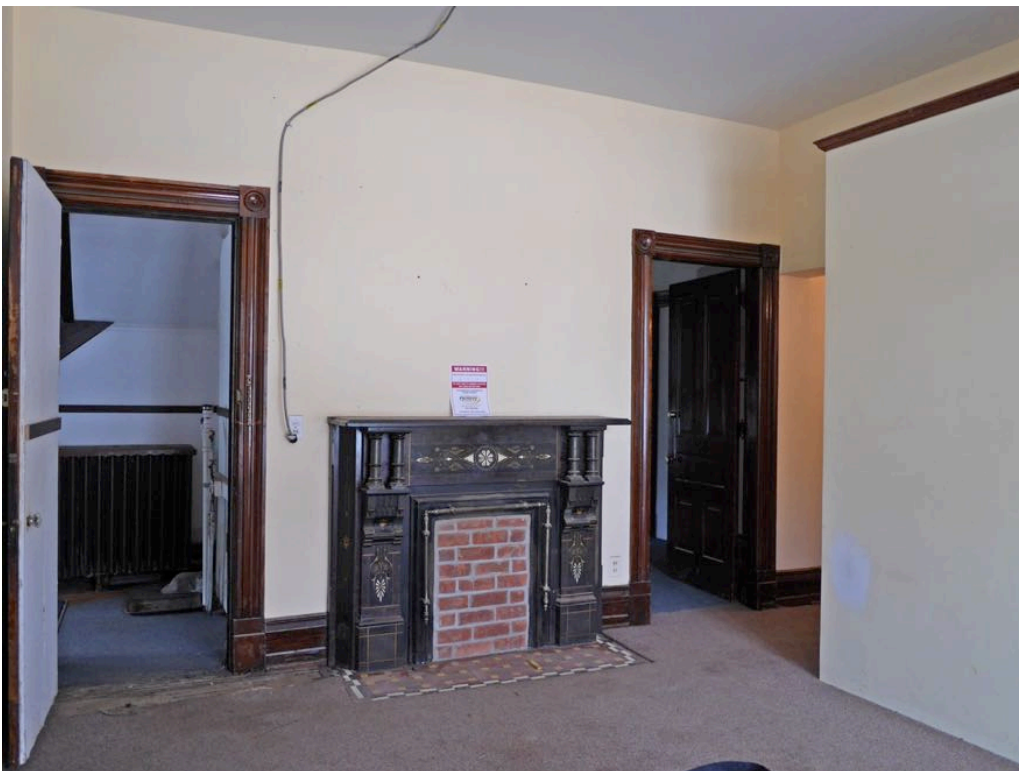
Photo No. 2 (image No. 5): View north in original dining room, showing decoratively painted metal fireplace, between original door openings.

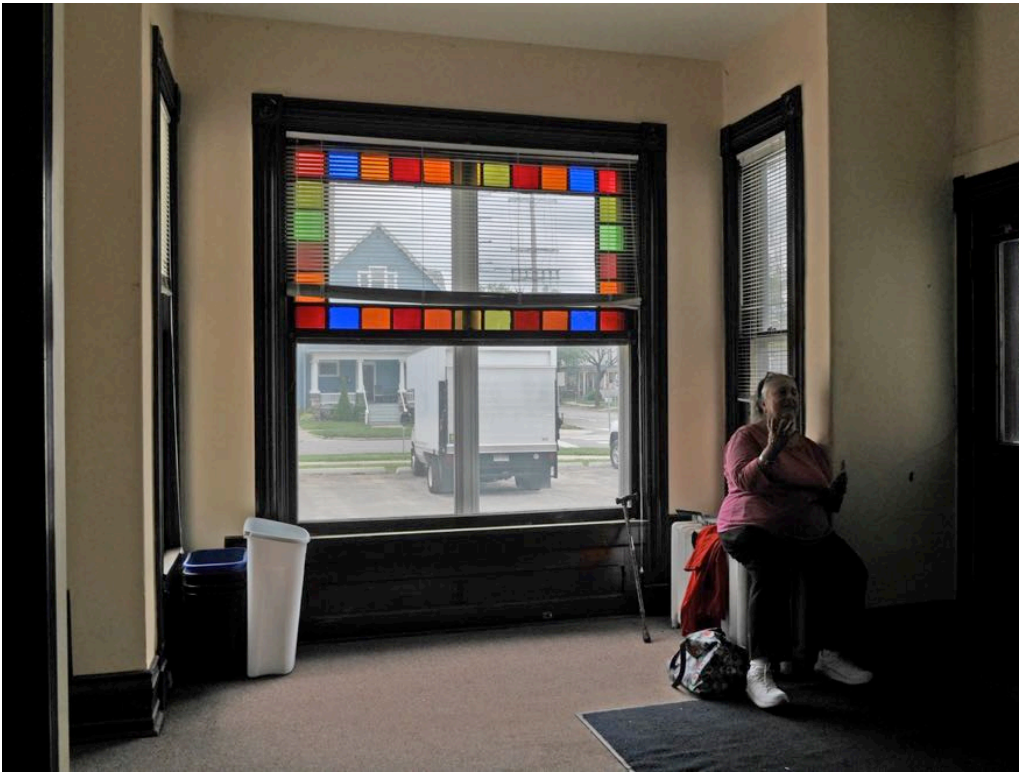
Photo No. 3 (image No. 8): View south in first floor dining room of projecting bay with colored glass border in upper sash.

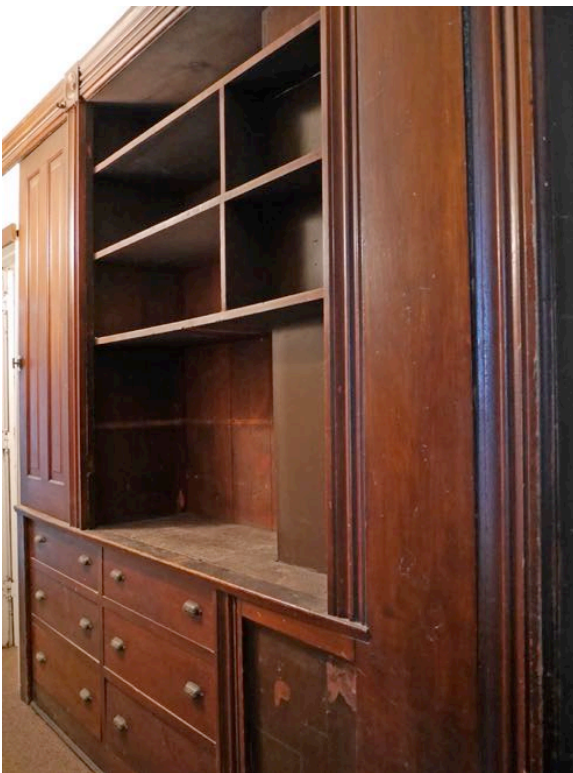
Photo No. 4 (image No. 11): Close-up photo of built-in cabinets in the first floor corridor. Cabinets look like they would have been for the kitchen/dining room.

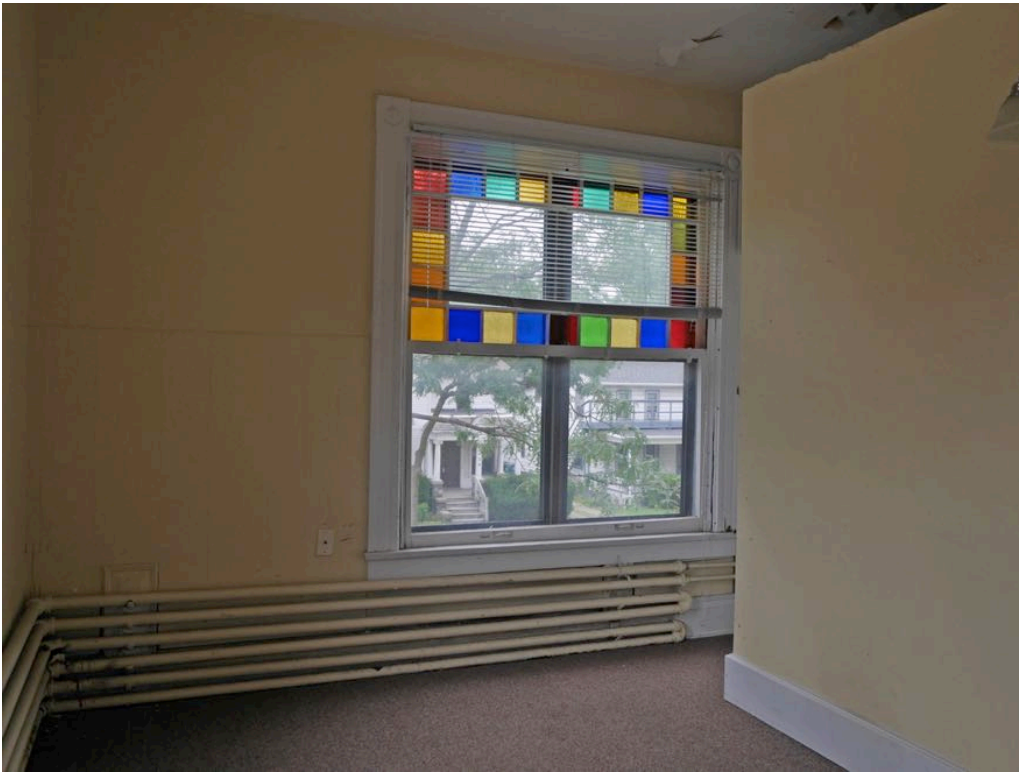
Photo No. 5 (image No. 16): Second floor front bedroom windows have the same colored panes as windows on the first floor. Note unusual radiant heating pipes.

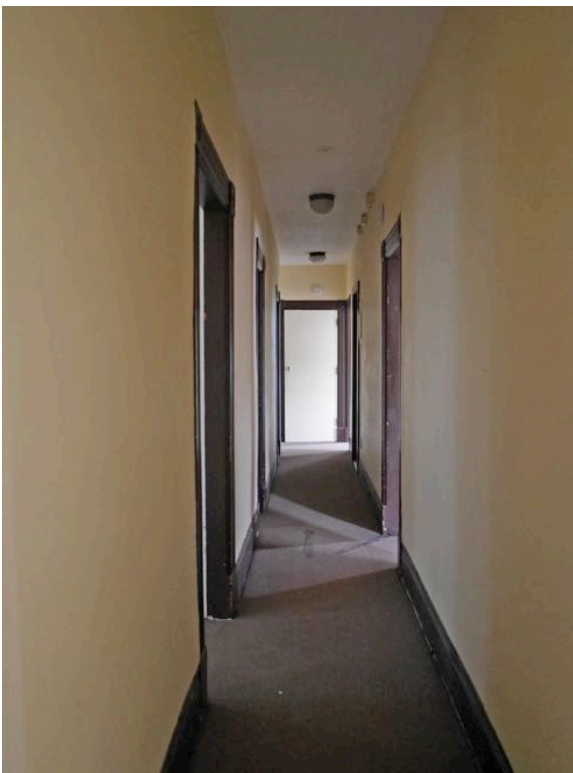
Photo No. 6 (image No. 18): View east down second floor corridor. Original doorframes suggest this is the original corridor width for single-family use.

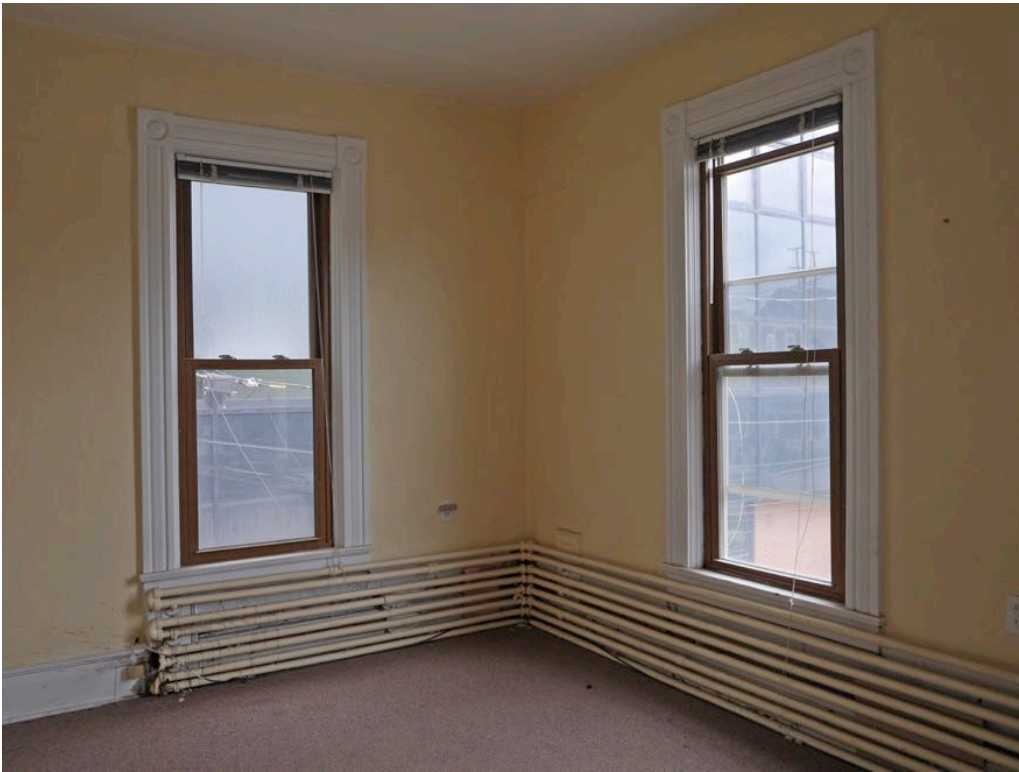
Photo No. 7 (image No. 21): Southeast corner windows of back bedroom (BR #6 on second floor sketch plan) with unusual radiant heating pipes below them.

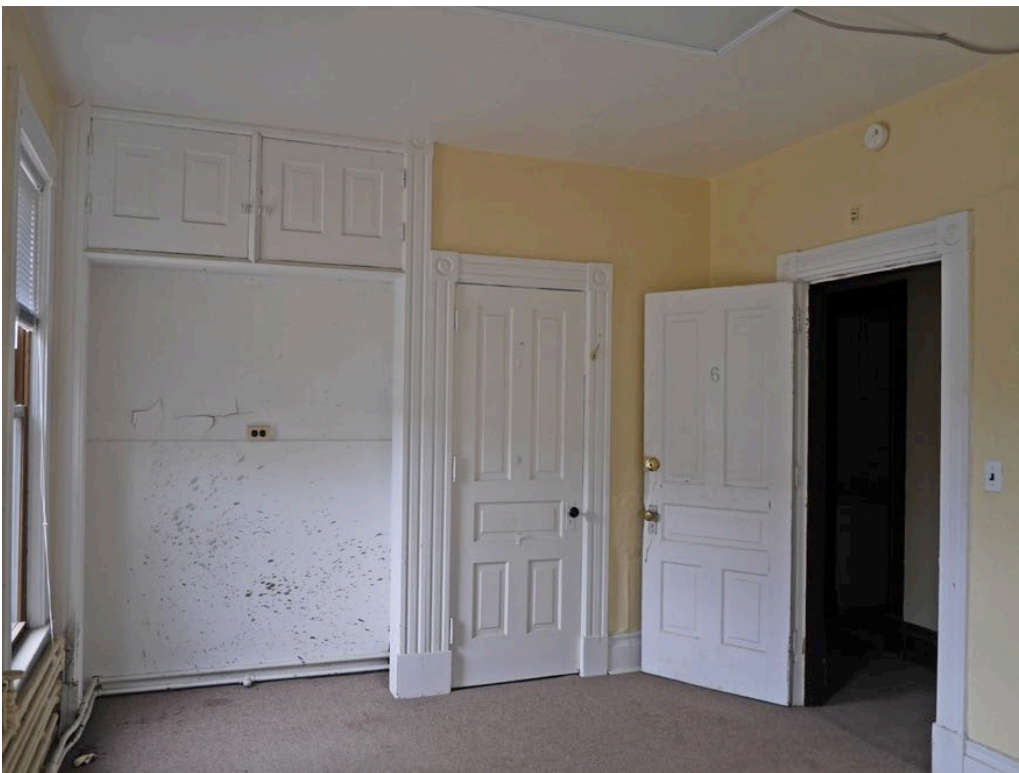
Photo No. 8 (image No. 22): Southeast corner bedroom (BR #6 on second floor sketch plan) with built-in closet and storage cupboards and original doors.

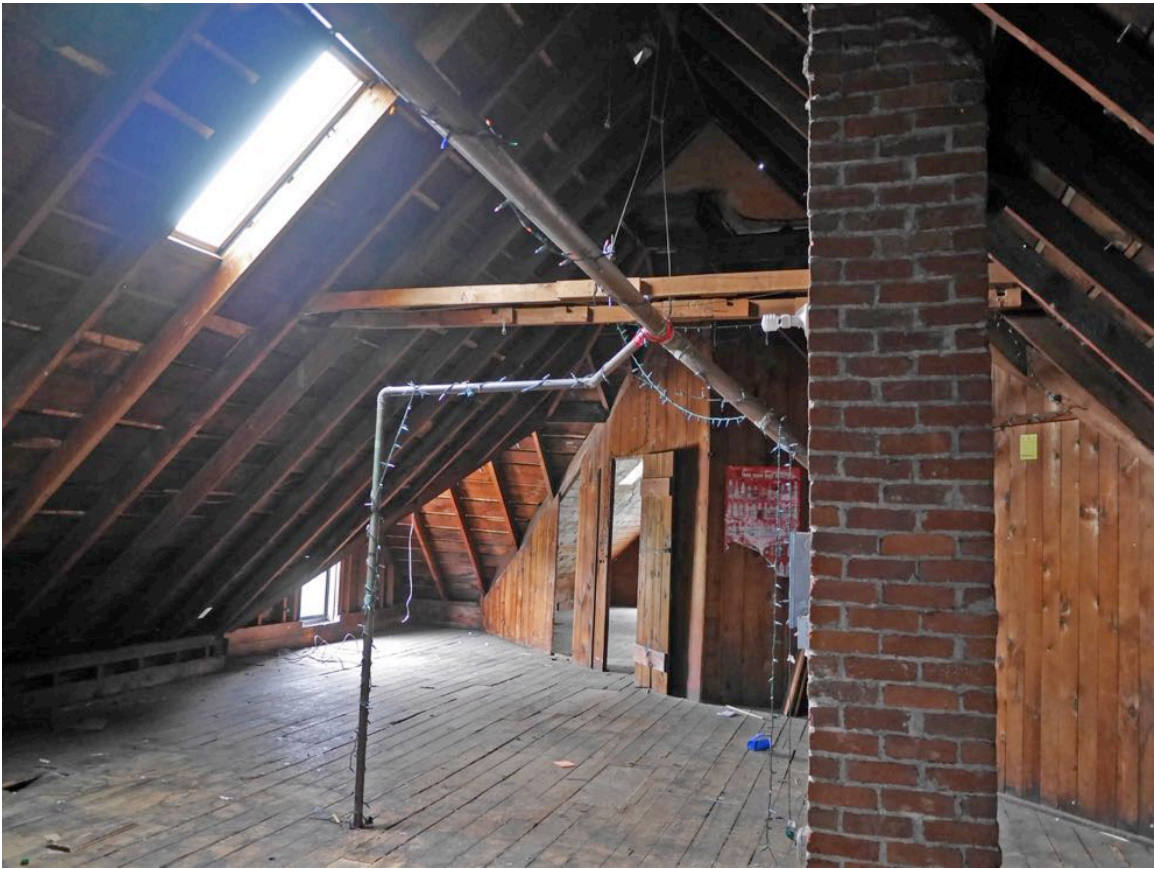
Photo No. 9 (image No. 24): Attic open space looking west. Angled wall follows roof gable.

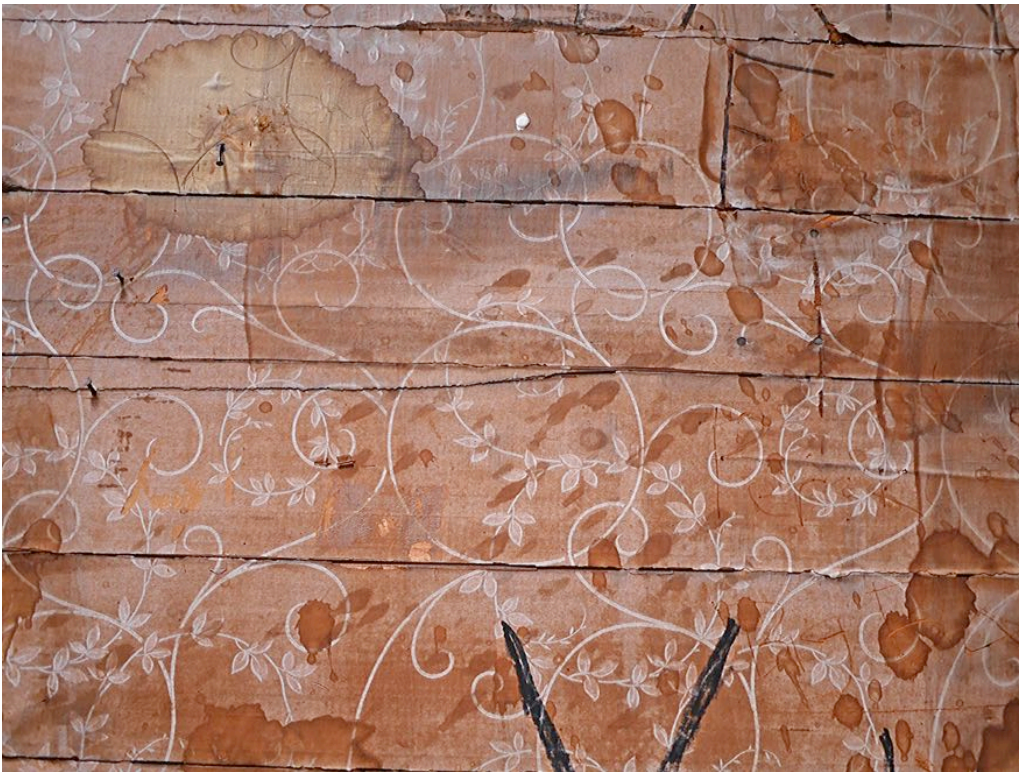
Photo No. 10 (image No. 29): Detail of wallpaper that covered the boarded sloped ceiling in the front/west room of the attic.

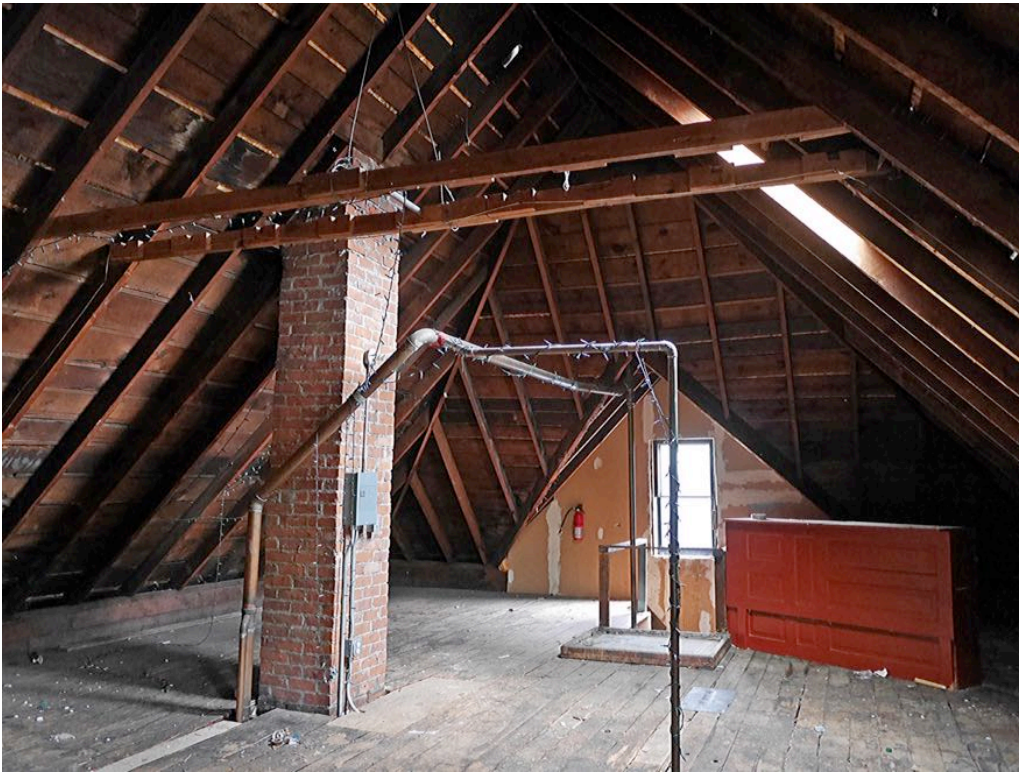
Photo No. 11 (image No. 30): Attic open space looking east. Extra doors were used to create a makeshift bar for parties.

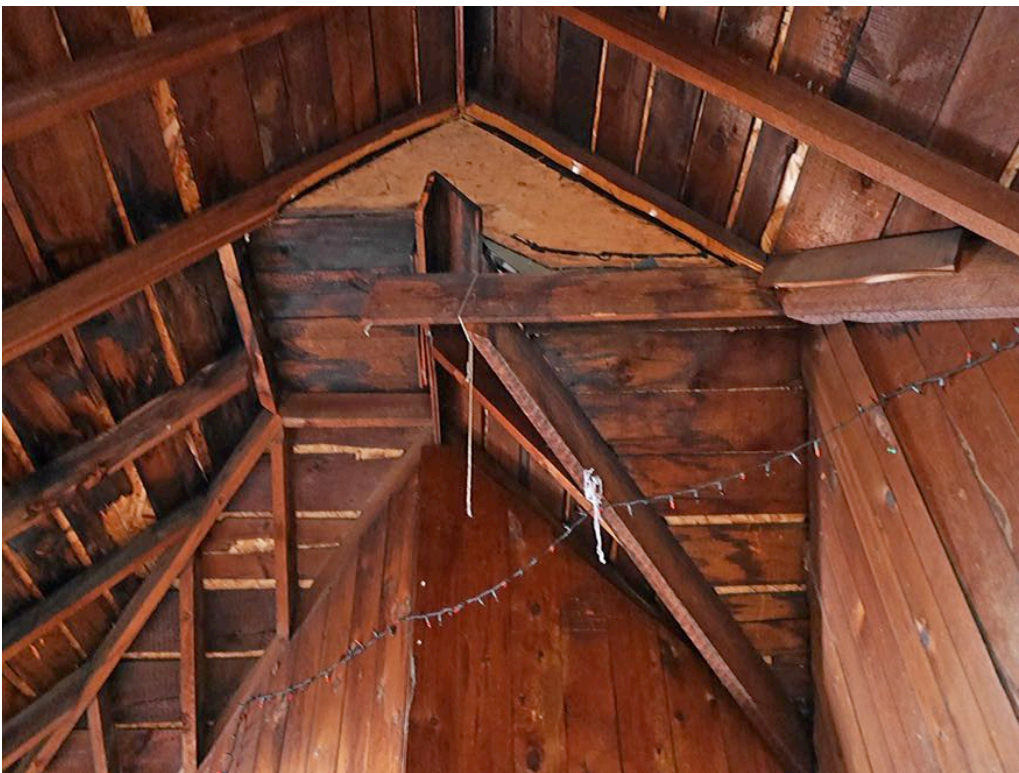
Photo No. 12 (image No. 31): View of roof framing at offset from front (west) roof to rear (east) portions of the roof. Cutout rafters and plywood gable filler suggest this has been altered, but also confirm that the entire house was built at one time.

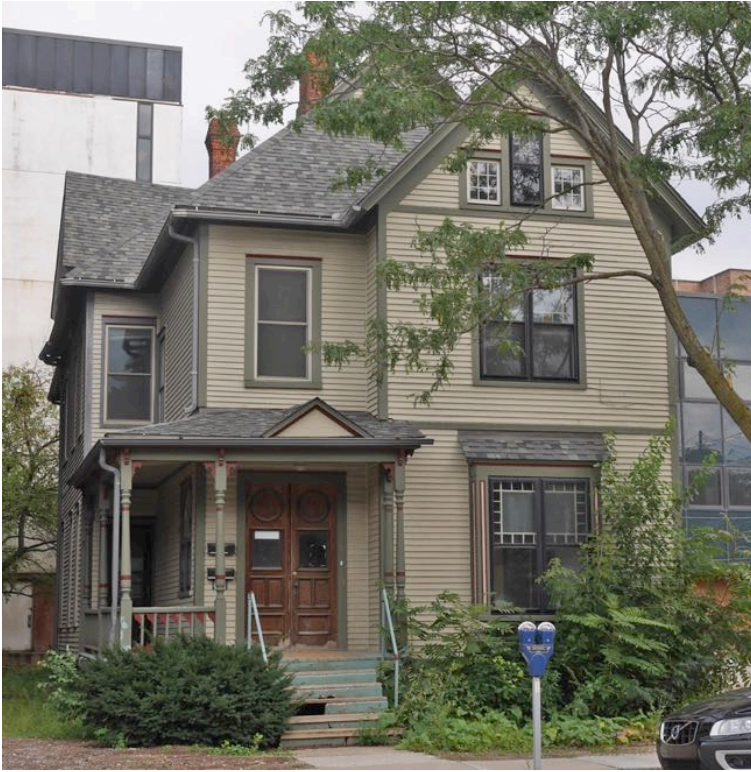
Photo No. 13 (image No. 35): West façade fronts onto S. Division Street. It has a landscaped 15-foot setback from the S. Division sidewalk.

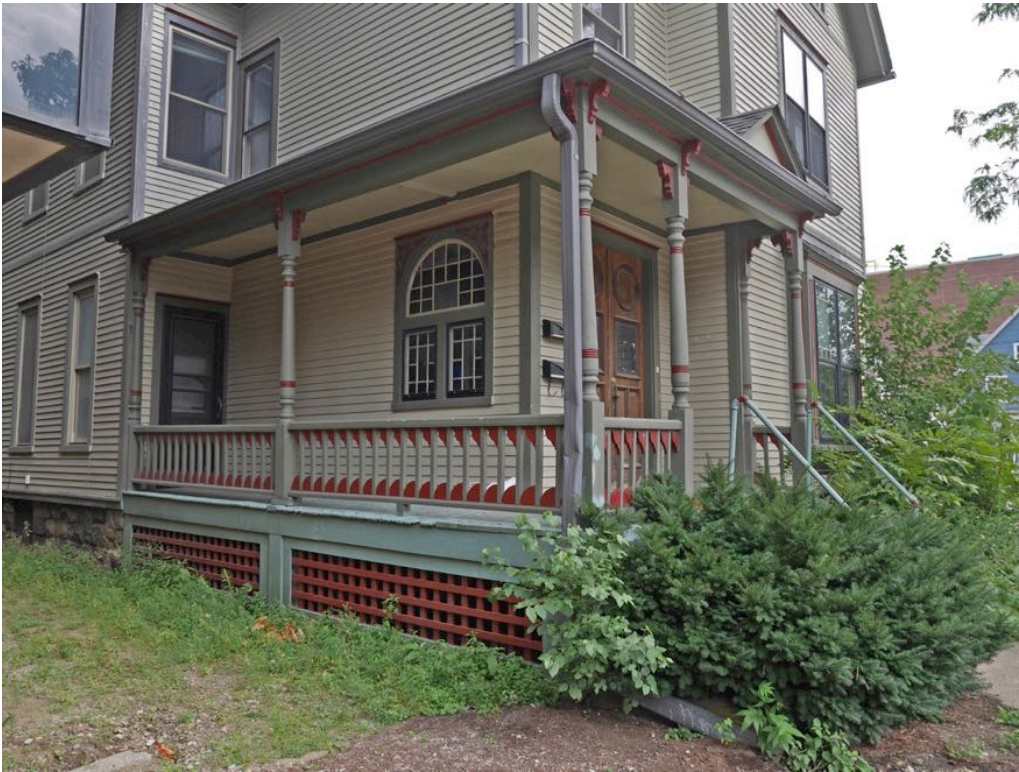
Photo No. 14 (image No. 38): View of front porch showing intact unique railing system, Italianate brackets, and lattice.

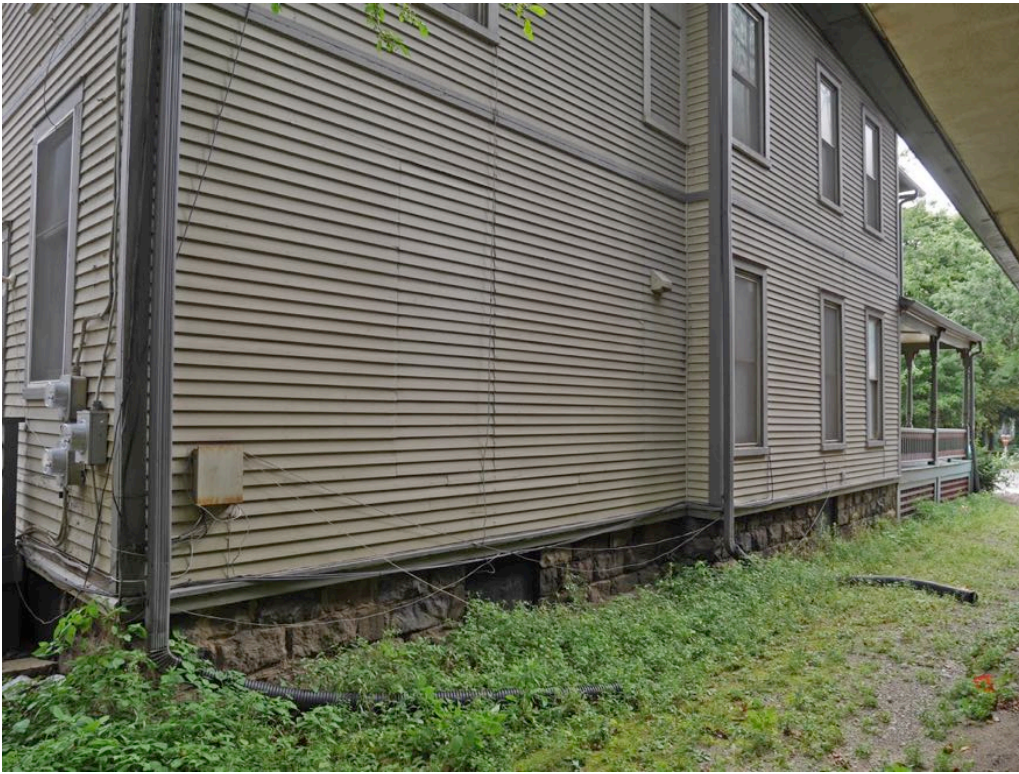
Photo No. 15 (image No. 40): North elevation retains its windows in the western half of the house, but those in the eastern half were blocked up and covered with siding. Mortar joints exhibit eroded and missing mortar.

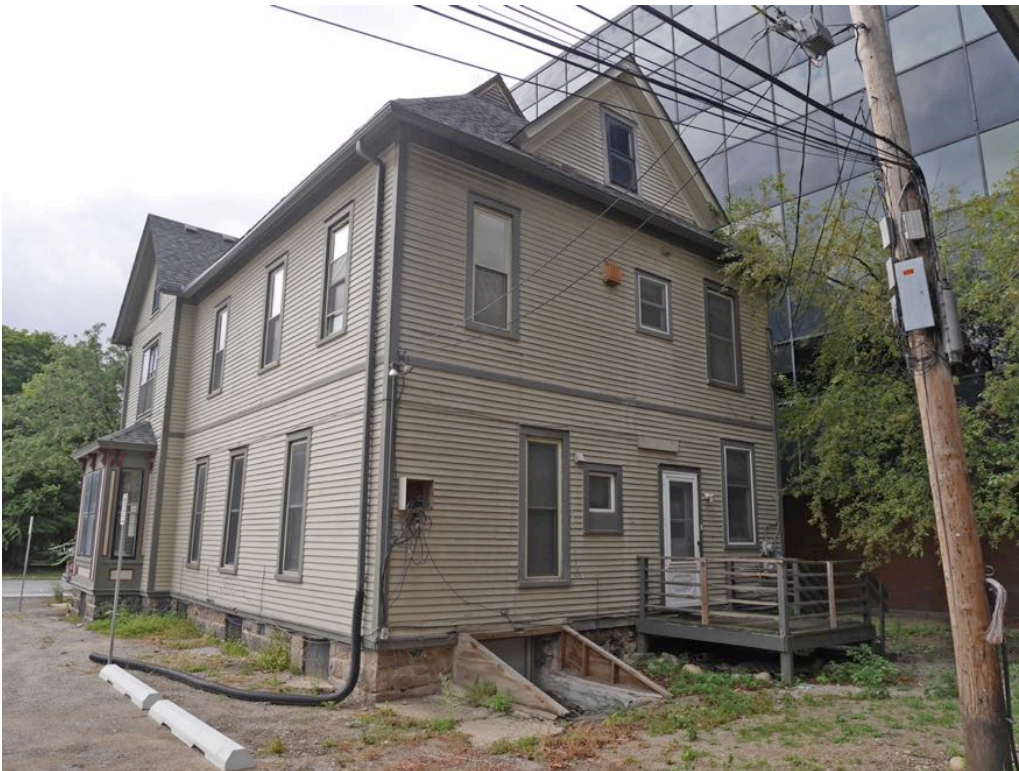
Photo No. 16 (image No. 44): East elevation is where most change has occurred. The original "back" door has been changed to a small window, and a new door added that leads into the modern kitchen. Cellar door cover is missing.

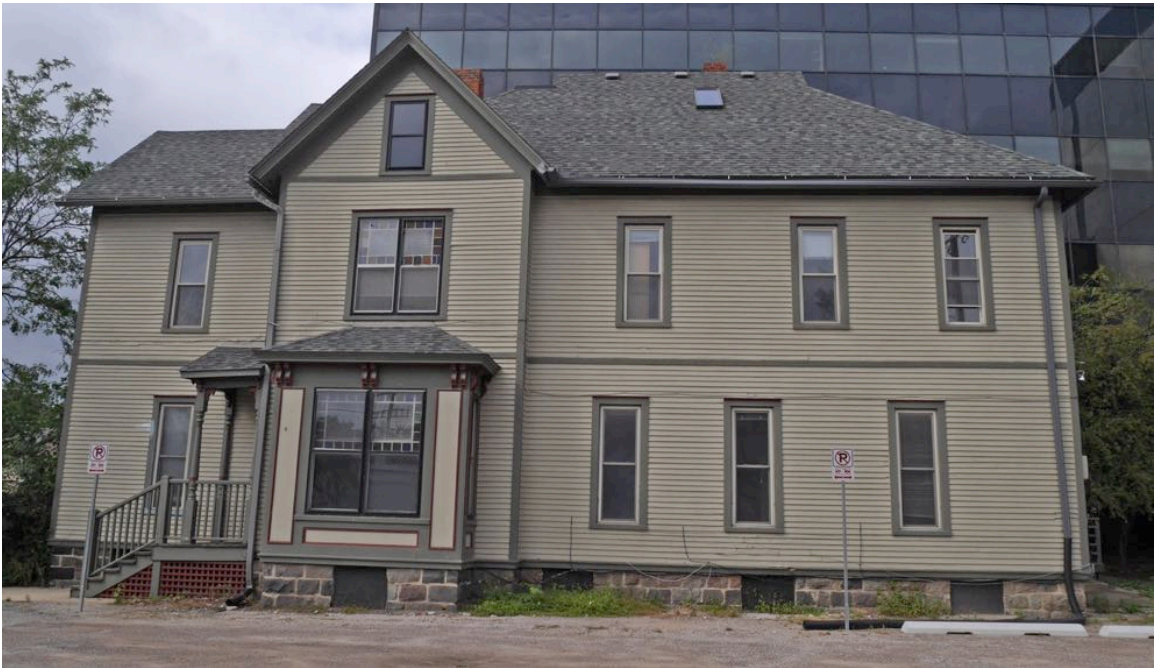
Photo No. 17 (image No. 46): South elevation faces a vacant lot. Bay window and porch are in very good condition. From this view it is also easy to see that the asphalt roof shingles are new.

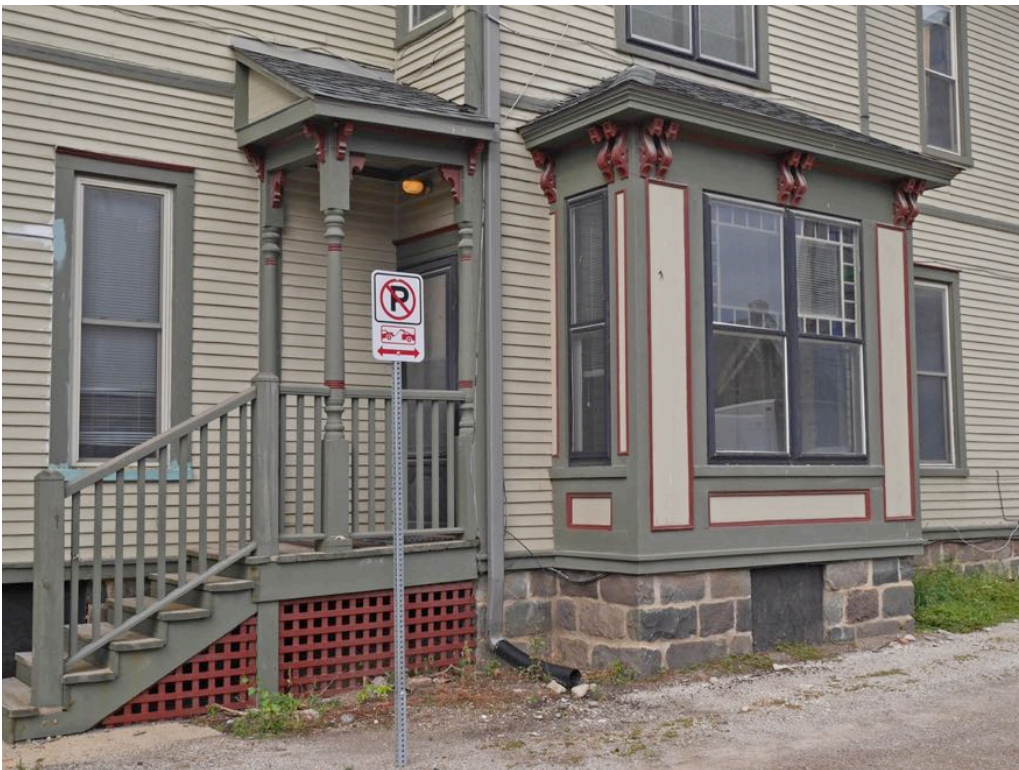
Photo No. 18 (image No. 48): View of side porch and bay window showing intact unique railing system, Italianate brackets, and lattice
