<b>OWNER</b>	<b>APPLICANT</b>
<b>Name:</b>	Gregory Smith	Same
<b>Address:</b>	1017 W Liberty Ann Arbor, MI 48103	
<b>Phone:</b>	(414) 303-0641

In 2014 a screen porch was approved behind the house (HDC14-061 Trakit).

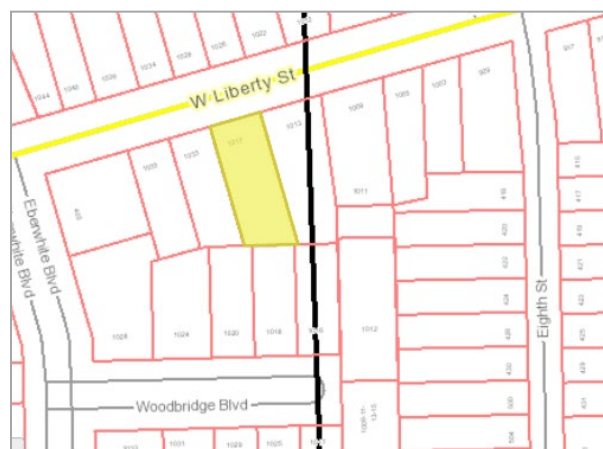
**APPLICABLE REGULATIONS: From the Secretary of the Interior's Standards for Rehabilitation:**

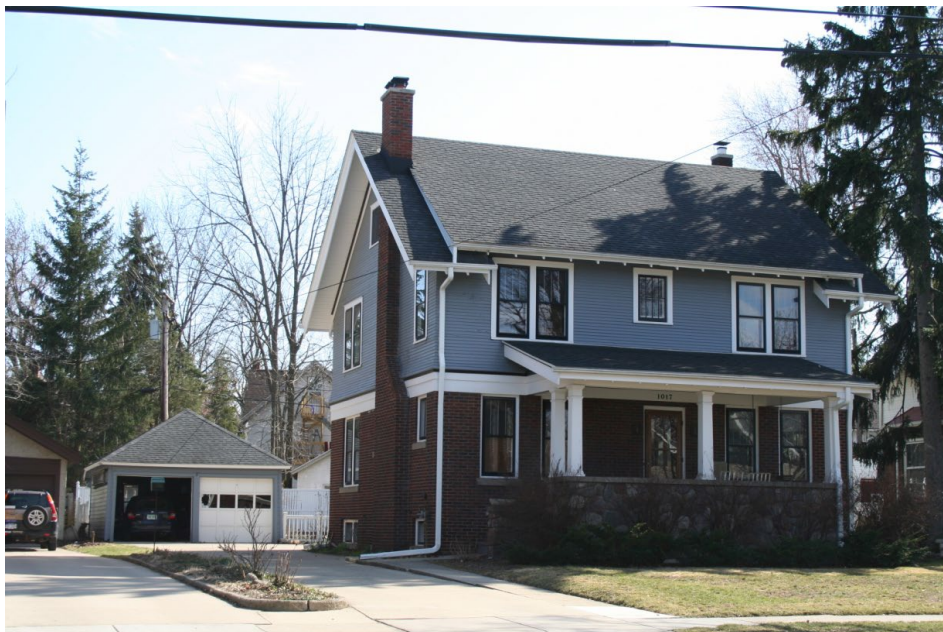
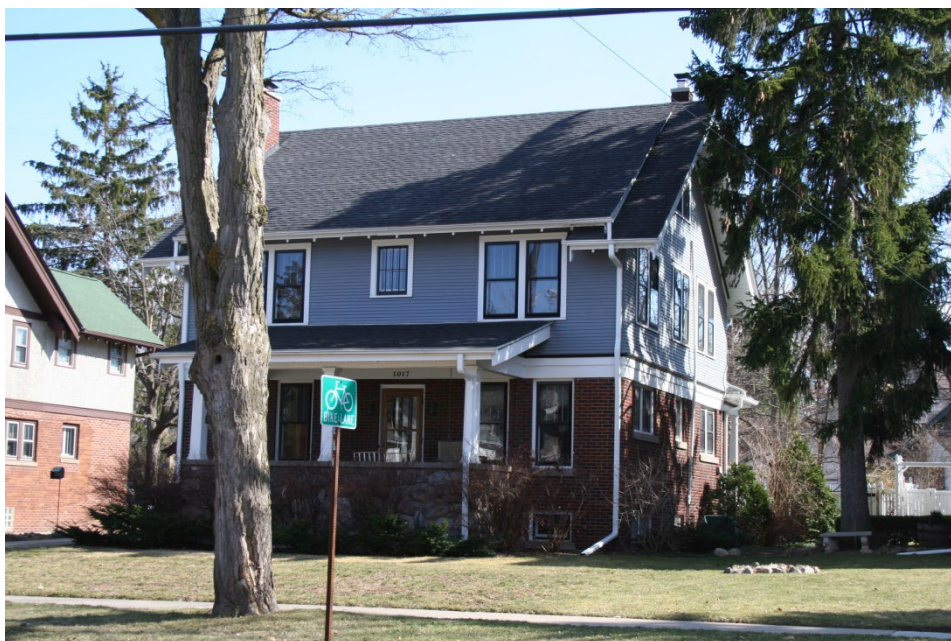
1017 W Liberty Street (Survey photos, 2008)

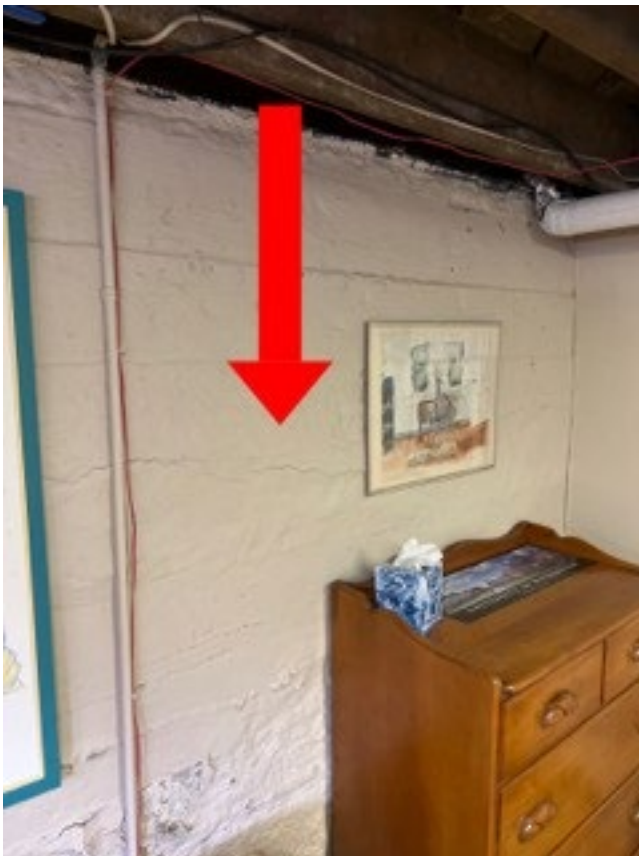
Horizontal cracking/bowing of the foundation, the foundation is flaking due to water intrusion

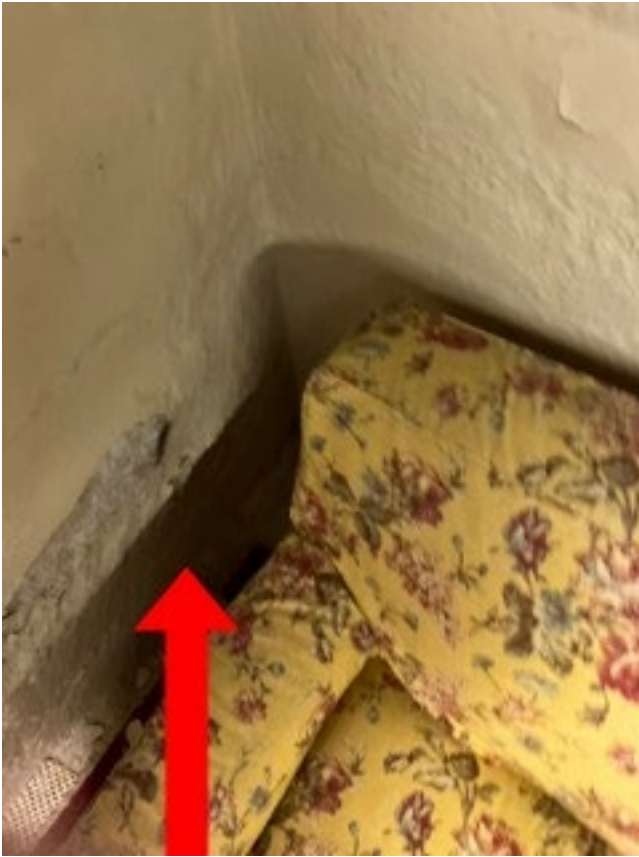
The foundation is flaking/crumbling due to water intrusion

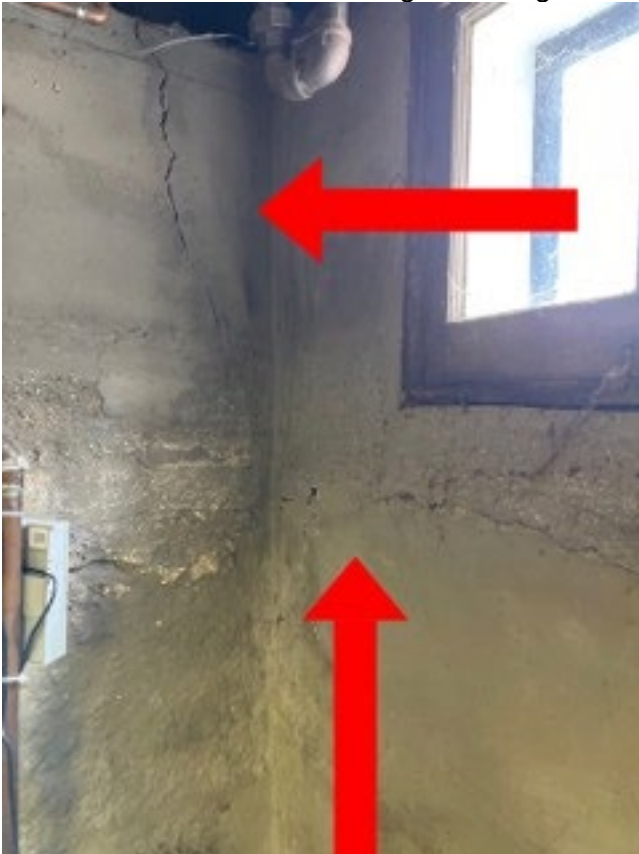
Settling cracks in the foundation, bowing present, the foundation is flaking/crumbling due to water intrusion, active water intrusion in this area

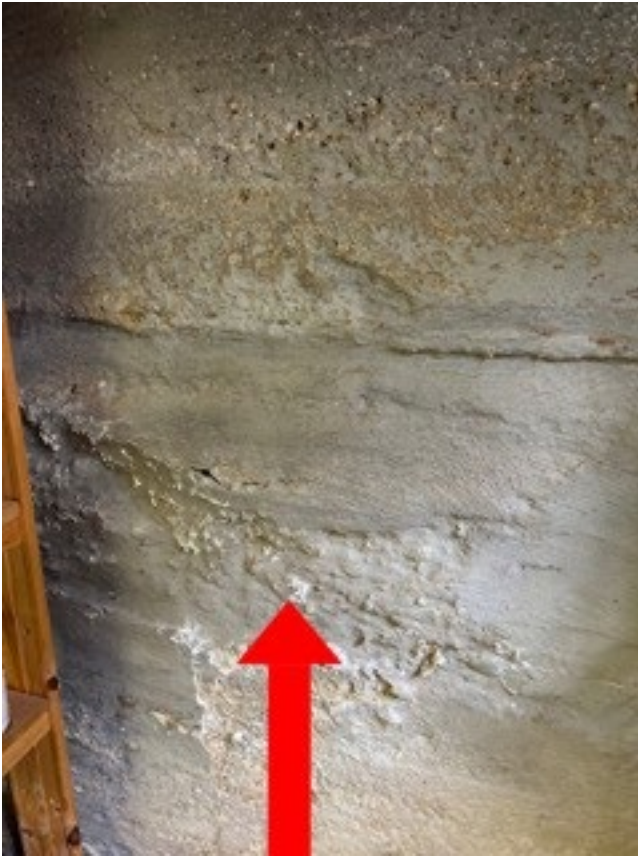
Areas of the foundation are flaking due to water intrusion, horizontal cracking and bowing noted in areas

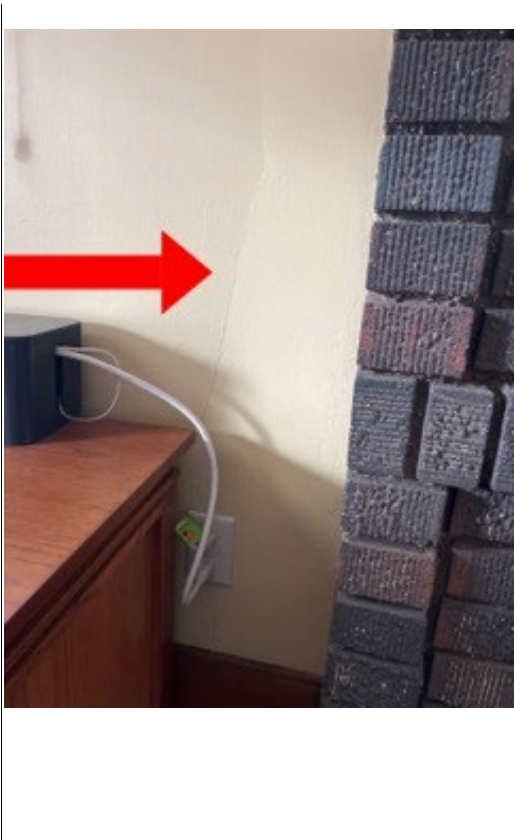
Settling cracks in living room wall

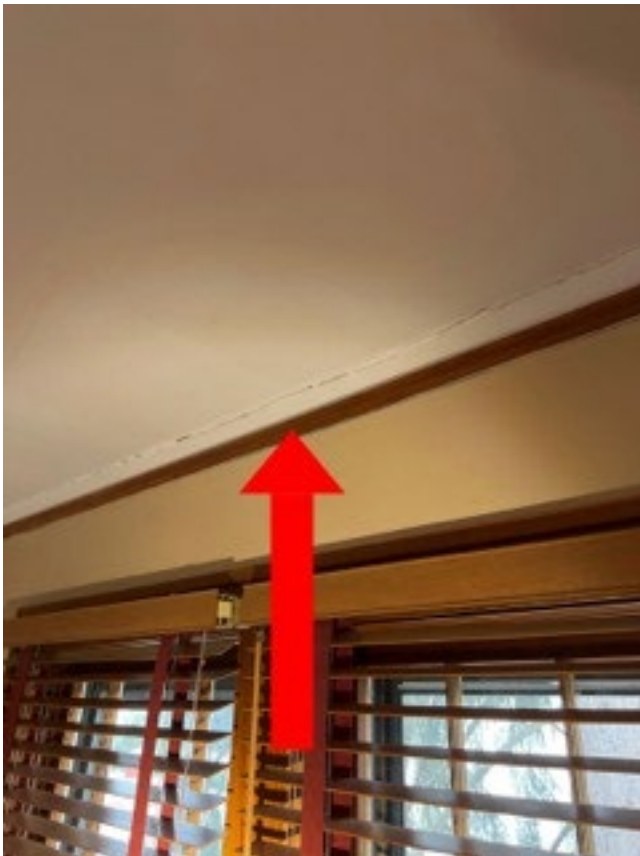
Settling crack in plaster wall covering

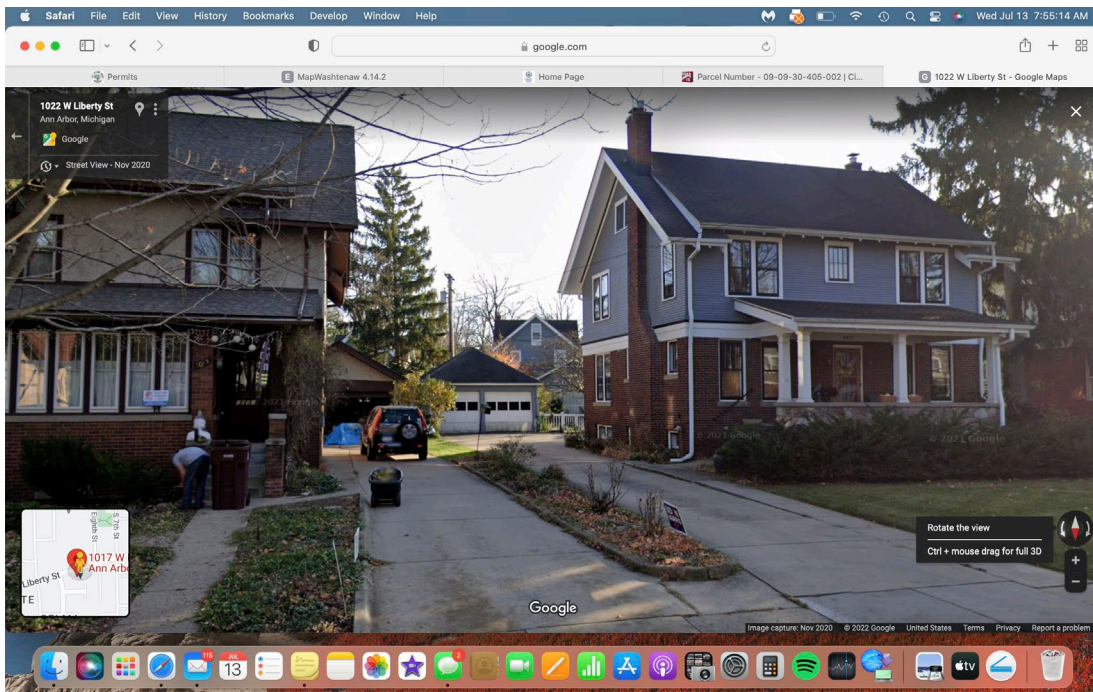
on the back 1/4. This planting bed provides visual relief that is more pronounced than the planting bed between our house and driveway.

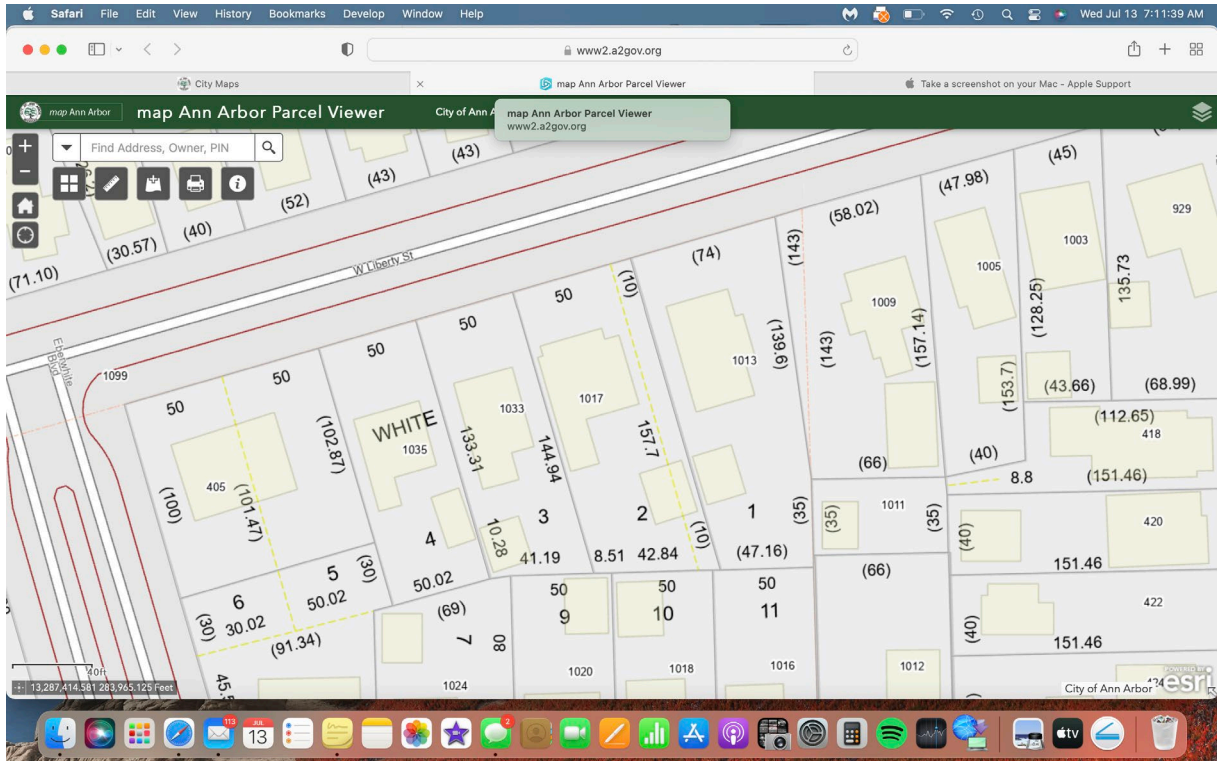
If this proposal is approved and once the work is completed we would follow Mr. Arnsdorf's recommendations for repairing the inside of the basement foundation wall. With the basement foundation wall complete we would repair the plaster and lath walls throughout the house.

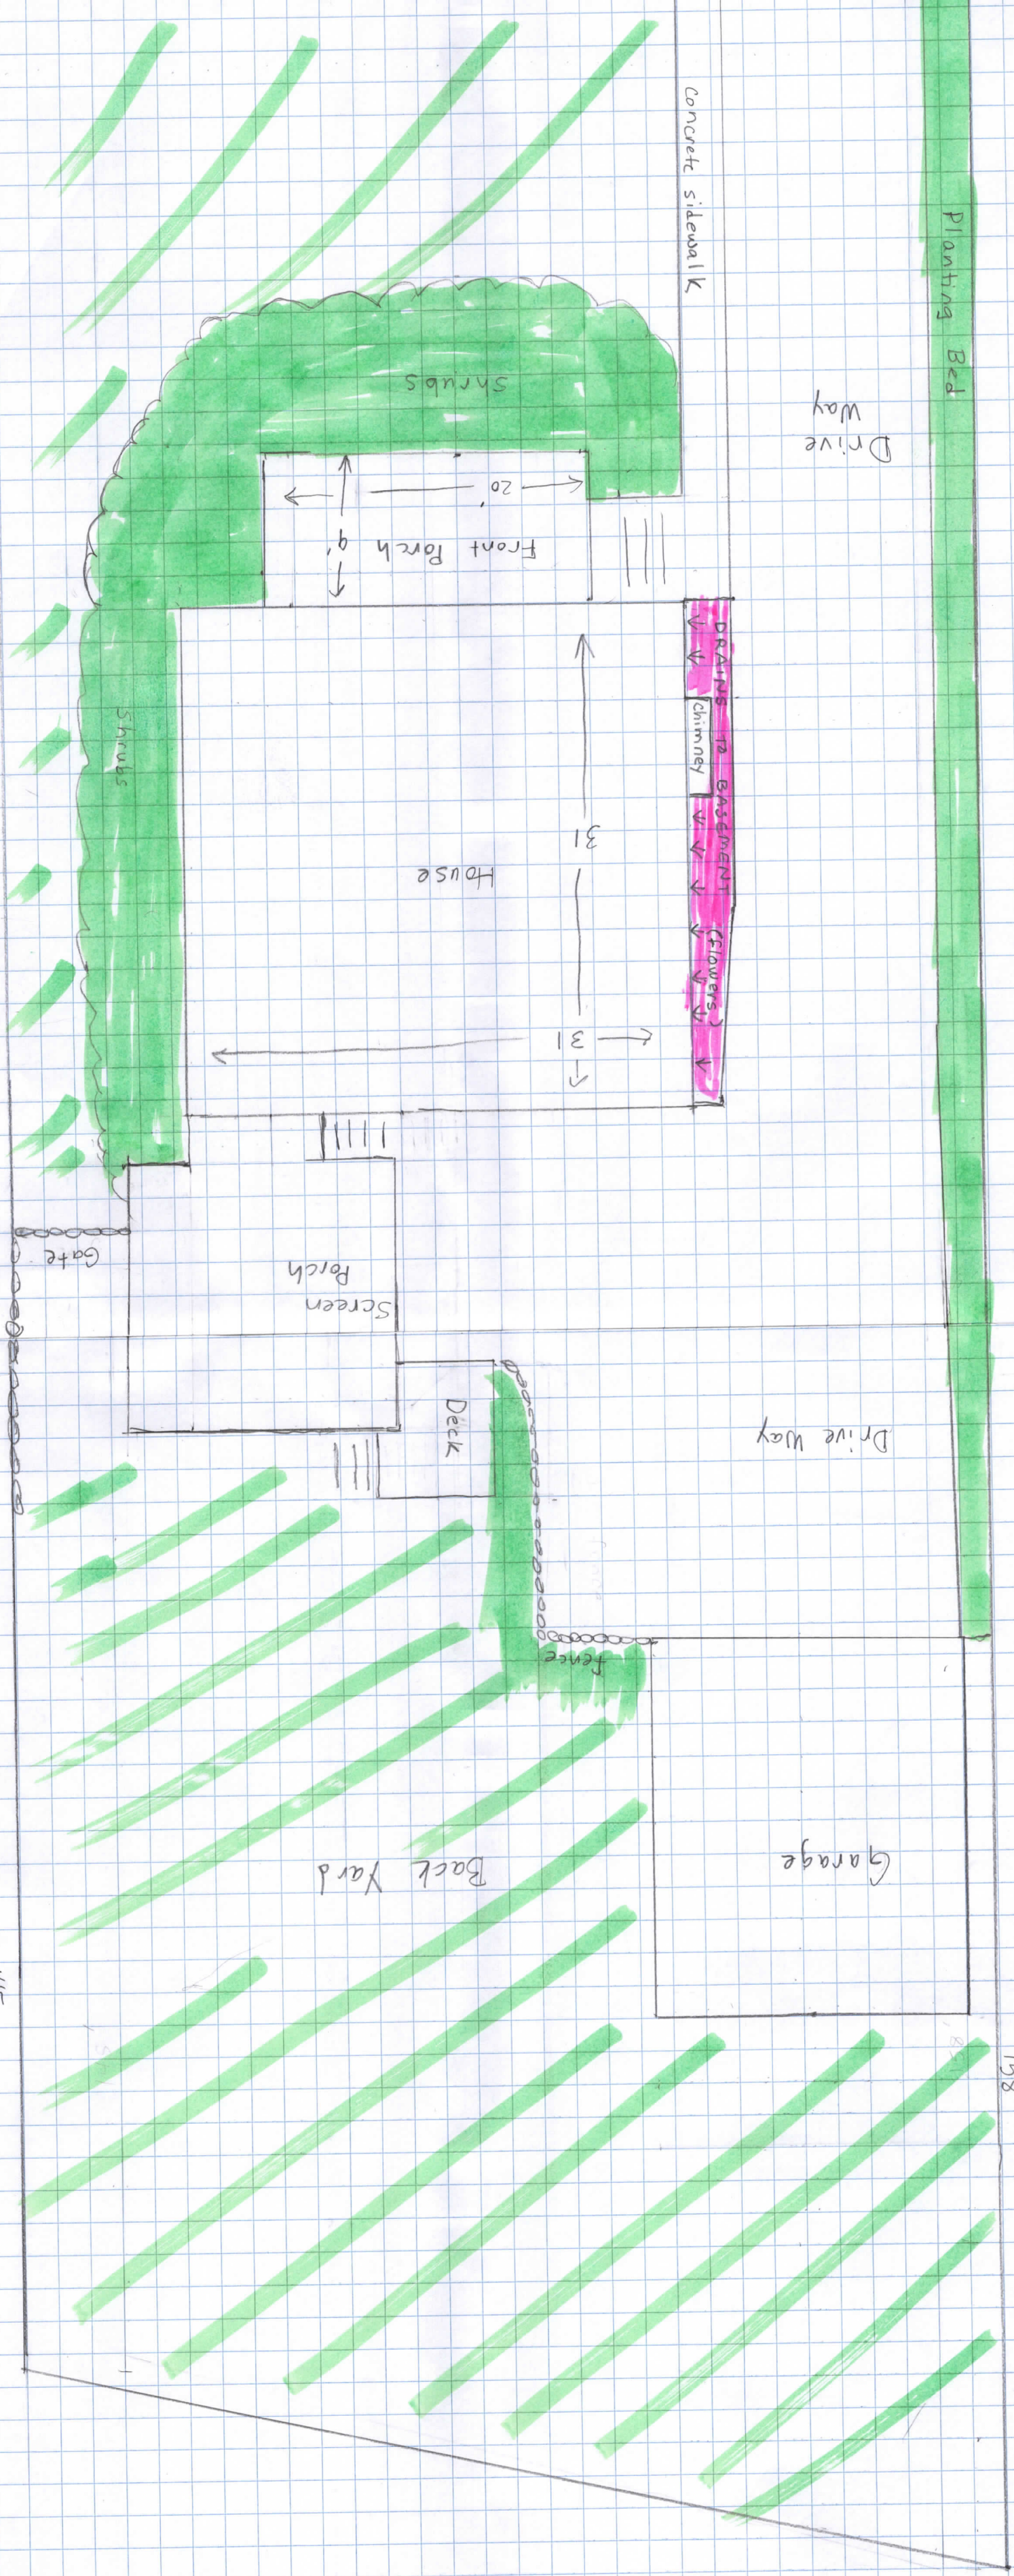
My wife and I are submitting a request to replace two garage doors with doors of the same design. Both doors have extensive wood rot on the lower panels caused by a lack of proper maintenance and subsequent water infiltration. Additionally, the seals on the bottom of the doors are substantially damaged or missing, which has exacerbated the problem. We propose to replace the two doors with steel doors of the same design, size and window and panel configuration. We are committed to maintaining the historic integrity of our home and garage, and we are eager to work with the Commission.

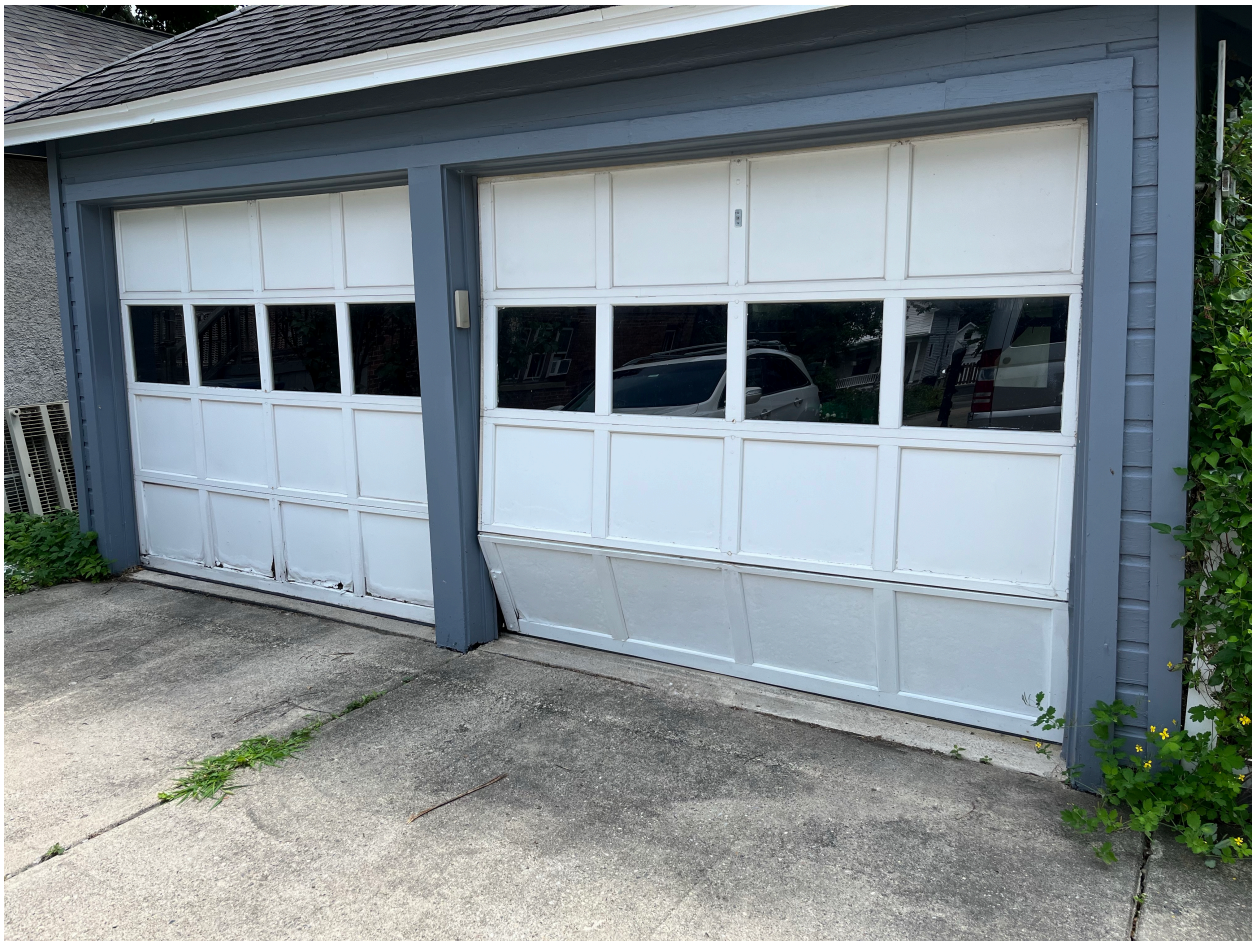
Additionally the west door lower panel is so rotted it can no longer hold the hardware necessary for the door to function. The east door damage is profound with all 4 lower panels almost fully rotted.

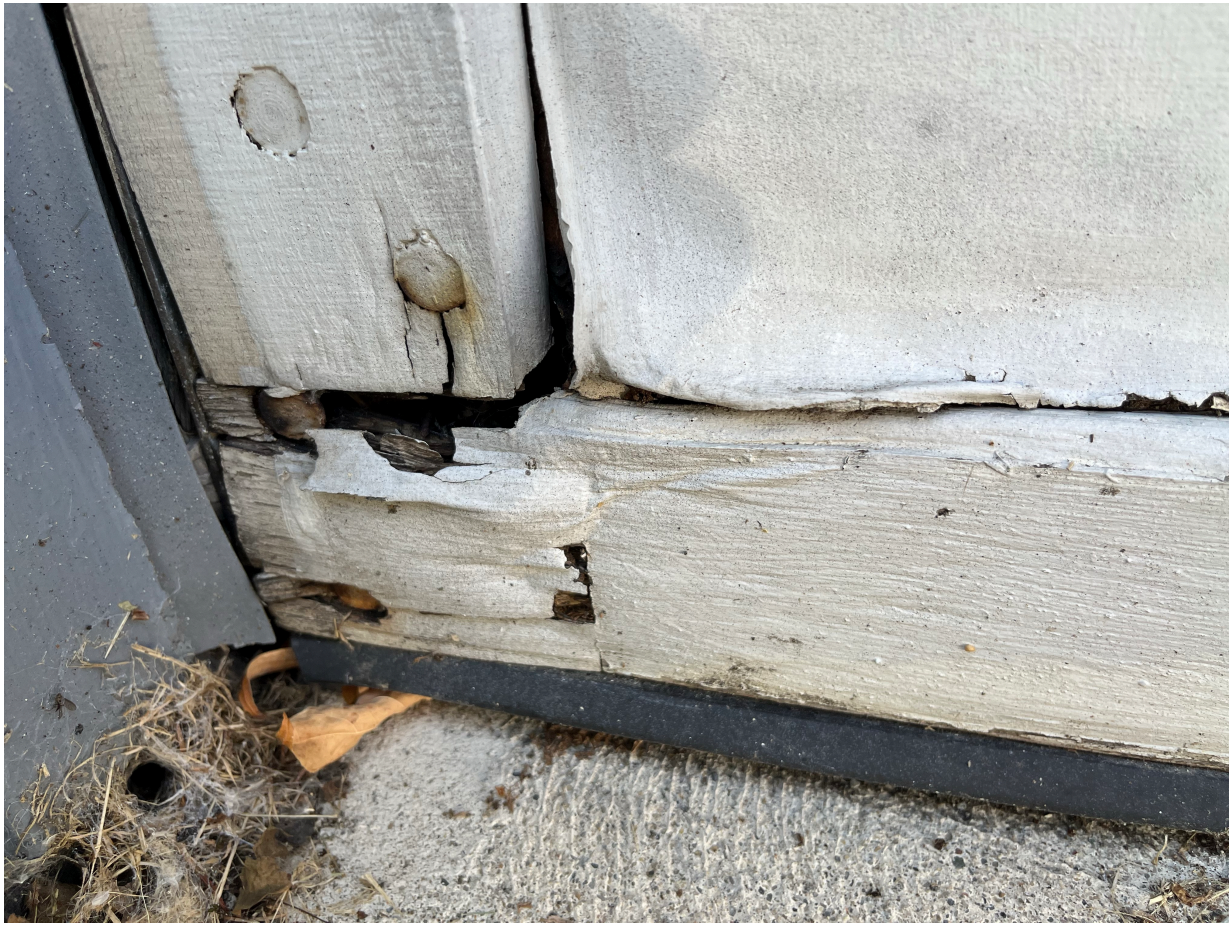
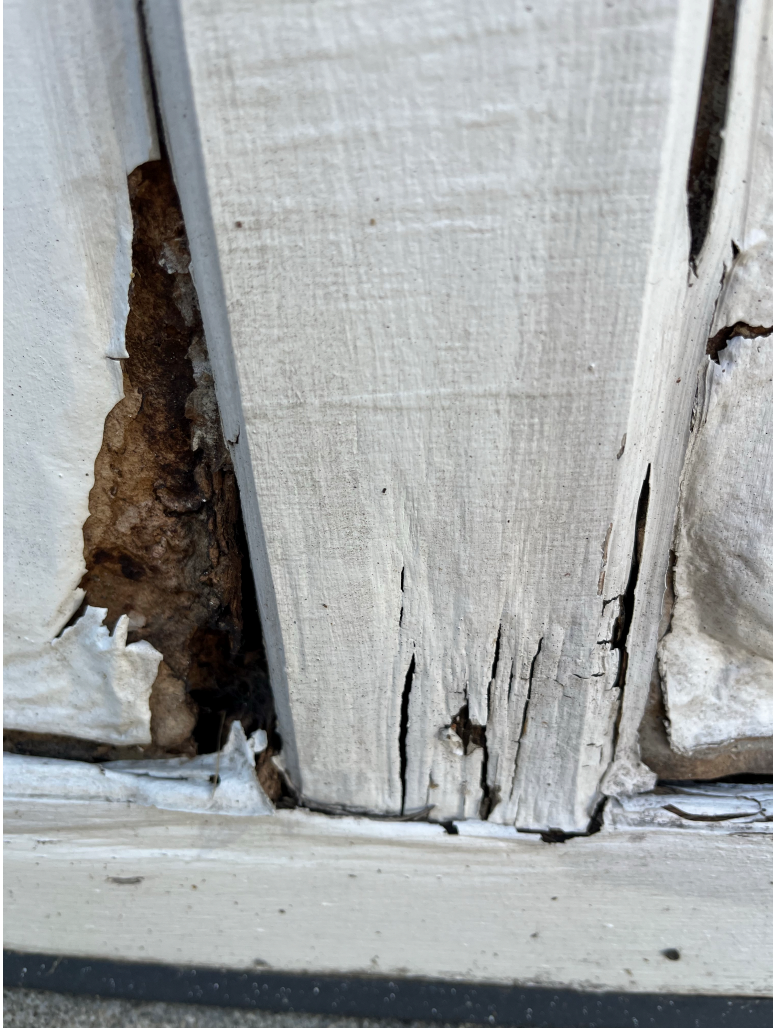
I have spoken to representatives from four garage door replacement companies. All four representatives indicated that the lower section of the doors can't be replaced. They all offered steel doors that have the same design/look, size of recessed panels and glass configuration. All four companies indicated they have used steel doors to replace wood doors in homes in historic districts of Ann Arbor. Below is a photo of the door proposed by Ann Arbor Door.

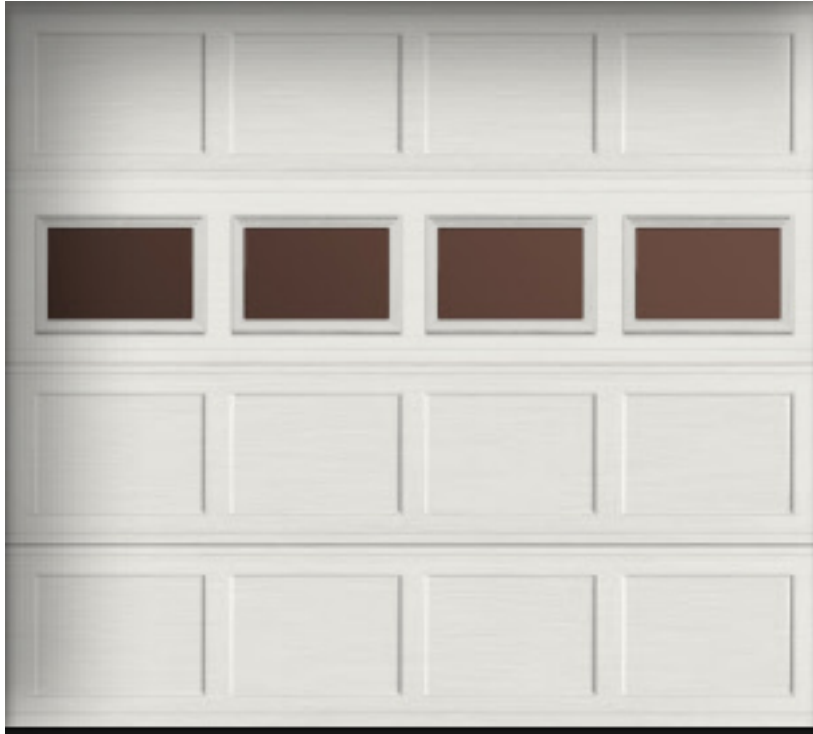
Due to the fact that I have not contracted for these these garage doors while waiting for the decision of the Commission we don't have detailed drawings or specifications. The photograph below is the door we propose to use. It is the same size of the current doors, has the same 4 vertical and 4 horizontal recessed panel design with window panels for the second panel from the top. They will look identical to the current doors.
