# ROAD SAFETY AUDIT

## PLYMOUTH ROAD

ANN ARBOR, MI

DATE: OCTOBER 2025

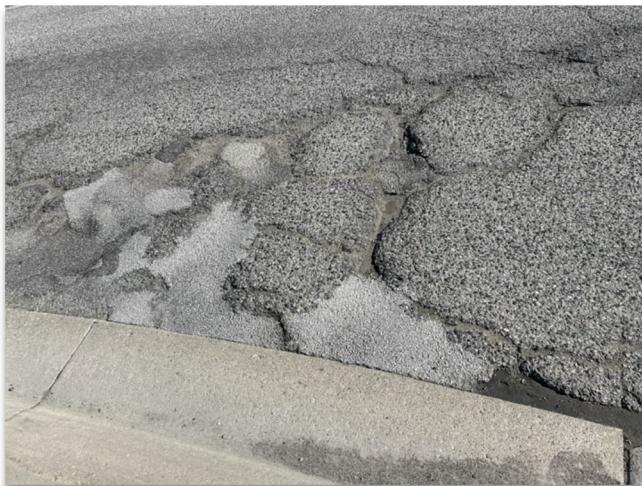
***Cracked Pavement on Plymouth Road***

Consider repaving the corridor to improve pavement condition and friction performance, with particular attention to the crosswalks along the corridor. Repaving the roadway will enhance safety for pedestrians and cyclists by providing a smoother and more even surface, reducing the potential for trips and falls. Improved pavement conditions will allow crosswalk markings to be more visible and durable, making it easier for motorists to identify pedestrian crossing areas and react accordingly.

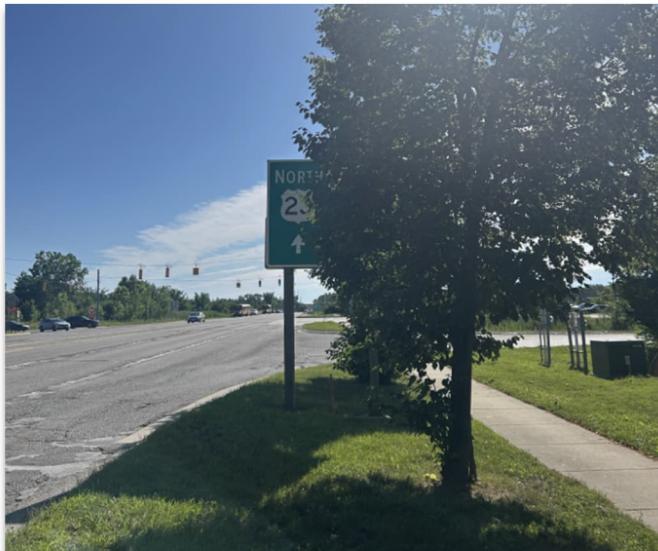
**Vegetation Obstructing Signage**

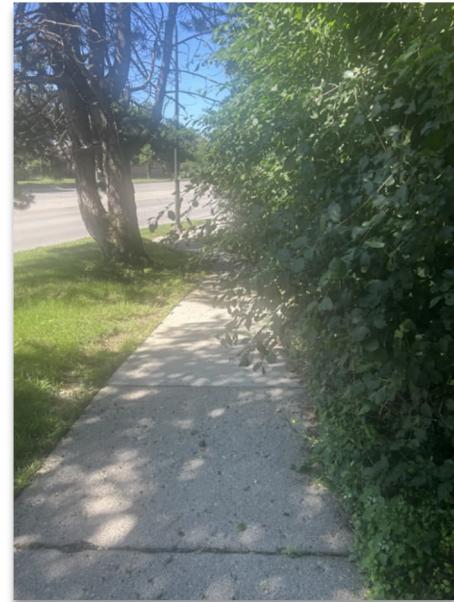
**Vegetation Obstructing Sidewalk**

It is recommended that the overgrown vegetation obstructing the Southbound US-23 On Ramp intersection and sidewalk be trimmed. This action will improve pedestrian safety by enhancing the visibility of pedestrians crossing at the intersection, allowing motorists to see them more clearly and react in a timely manner. Additionally, trimming the vegetation will reduce obstacles along the sidewalk, making it easier and safer for pedestrians to navigate. Having clear and unobstructed pathways is essential for the safety and accessibility of all road users, particularly vulnerable individuals such as children, the elderly, and those with limited mobility.

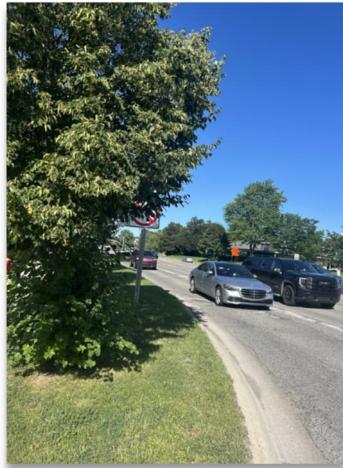
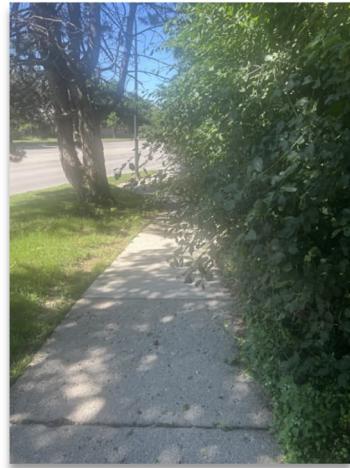
The field review identified overgrown vegetation obstructing sight lines at the Southbound US-23 On Ramp. This obstruction poses several safety concerns for vulnerable road users as the ramp is a free flow on ram to southbound US-23 and reduced visibility poses concerns for VRU road users making this crossing. Reduced visibility means that motorists may not be able to see pedestrians in time to react, increasing the potential for crashes. Furthermore, overgrown vegetation was observed along the sidewalks within the study area. Vegetation obstructing sidewalks creates obstacles by impeding pedestrian movement, forcing individuals to navigate around the overgrowth, which can be particularly challenging for VRU such as children, the elderly, and individuals with limited mobility. Examples of the overgrowth are depicted in Figure 17.

***Vegetation Obstructing Visibility at Southbound US-23 On Ramp***

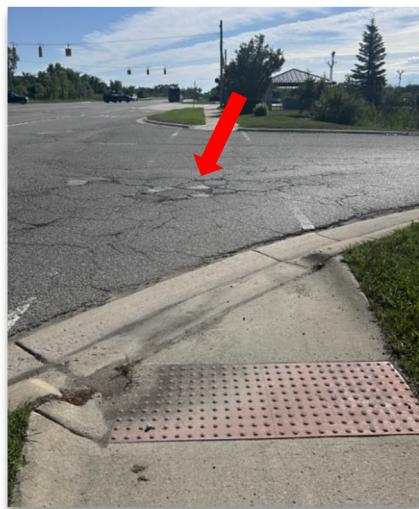
Furthermore, it was observed that there are faded crosswalk pavement markings and broken concrete in the crosswalks, as shown in Figure 18. The faded markings can create confusion for drivers, as they may not notice that it is a crosswalk and therefore may not be aware of the need to watch for pedestrians. This lack of awareness can increase the potential for crashes. Additionally, broken concrete can become trip hazards for pedestrians using the crosswalk.

**Figure 18 - Faded Crosswalk Marking and Broken Concrete at Southbound US-23 On Ramp**

Consider refreshing crosswalk markings, particularly at the Southbound US-23 On Ramp and Plymouth Road Park and Ride, to enhance the visibility of the crosswalks and notify motorists of possible pedestrian crossings. It is recommended to use continental or other high-visibility crosswalk markings to further enhance visibility, as opposed to the traditional crosswalk markings currently present at the crosswalk.

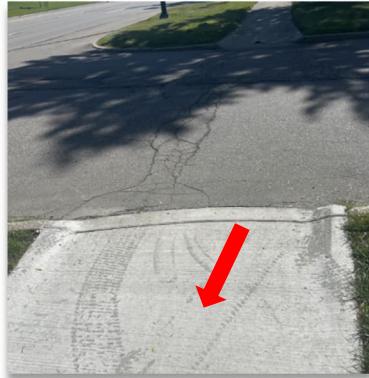
Furthermore, it was observed that there are missing and broken detectable warning surfaces at several crosswalks. These surfaces are crucial for the safety of impaired vulnerable road users, such as individuals with visual impairments, as they provide tactile cues indicating the boundary between the sidewalk and the roadway. The absence or damage of these warning surfaces can lead to confusion and disorientation, increasing the potential for crashes. Without these tactile indicators, visually impaired pedestrians may inadvertently step into the roadway. A missing detectable warning surface at a driveway can be seen in Figure 19.

**Figure 19 - Missing Detectable Warning Surface at Driveway Crosswalk**

It is recommended that detectable warning surfaces and ADA ramps be replaced or installed where needed, ensuring they are fully ADA compliant. These improvements will provide safety benefits, particularly for visually impaired individuals. Detectable warning surfaces offer tactile cues that alert visually impaired pedestrians to the presence of crossings, helping them navigate safely. ADA ramps help all pedestrians, including those with mobility impairments, access sidewalks and crosswalks without difficulty. By implementing these measures, we can create a safer and more inclusive environment for all road users.

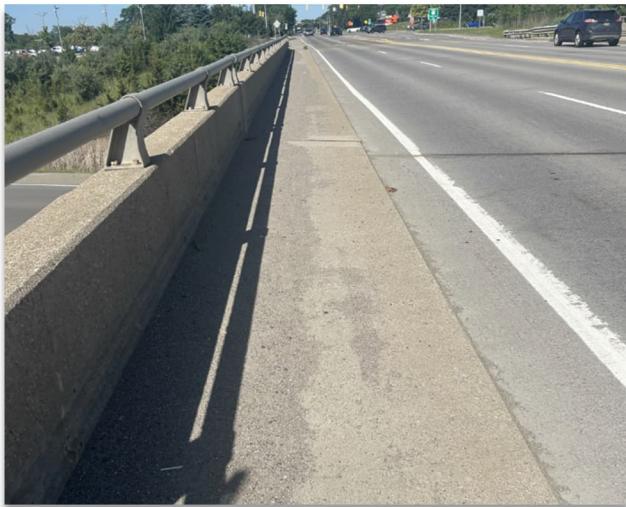
Debris and gravel were seen on the US-23 overpass shoulder and ‘sidewalk’, as shown in Figure 20. This is a safety concern for both pedestrians and cyclists. A well-travelled path from the end of the sidewalk along Plymouth Road onto the ‘sidewalk’ of the US-23 overpass was observed, indicating pedestrians and bicyclists regularly traverse the US-23 overpass. The presence of debris and gravel can create slip and trip hazards, making it difficult for pedestrians to maintain their footing and increasing the potential for falls. For bicyclists, the loose gravel can cause loss of traction, leading to potential crashes and injuries.

**Gravel Along US-23 Overpass**

It is recommended that debris and gravel be cleared from the US-23 overpass shoulder and sidewalk. Removing these obstacles will reduce the potential for trips and falls for pedestrians, leading to a safer walking environment. For bicyclists, clearing the gravel will improve traction and reduce the potential for falls, which could lead to conflicts or near misses with motorized vehicles. Having a clean and unobstructed pathway is essential for the safety and accessibility of all road users, particularly vulnerable individuals such as children, the elderly, and those with limited mobility.

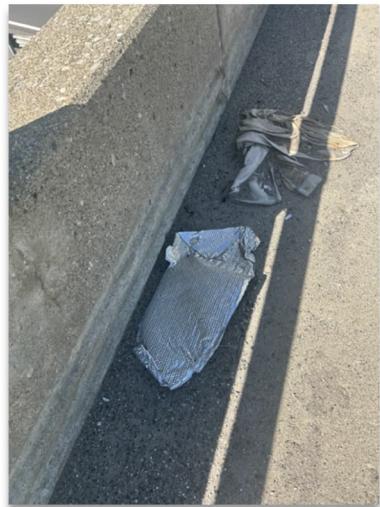
**Debris Along US-23 Overpass**  
**Figure 20 - US-23 Overpass Obstructions**

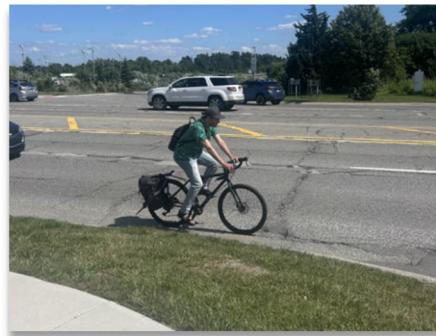
Lastly, while bicycle parking facilities are provided at the Park and Ride, there are no dedicated bicycle facilities connecting to this location. While no cyclists were observed using the bicycle parking area during the field review, they were observed traversing the corridor along Plymouth Road. Without a dedicated facility or otherwise delineated area of the roadway, cyclists are forced to share the road with motor vehicles, increasing the potential for crashes and injuries. Drivers may also be less likely to expect the presence of cyclists without the indications provided by bike lanes, signage, or other delineation. Figure 21 shows a bicyclist riding in the roadway with no dedicated bicycle facility.

**Figure 21 - Bicyclist Observed Riding in the Roadway**

Consider installing bicycle facilities within the roadway. If these facilities are installed, it is essential to include proper pavement markings such as intersection conflict markings and bike boxes at intersections. These markings will make bike paths more visible to motorists, improving driver awareness for the presence of cyclists and allowing motorists to navigate safely near them. By installing visible bike paths, a safer and more accessible environment for all road users is created, particularly for bicyclists who currently lack dedicated space within the roadway.

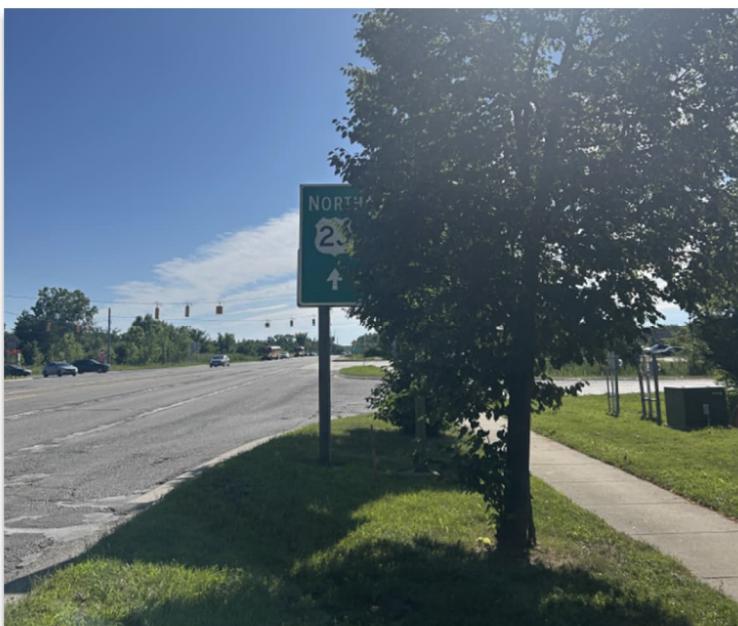
During the field review, the team observed that vegetation was obstructing not only crosswalks and sidewalks, as mentioned in the vulnerable road user section, but also roadway signs and signals. This obstruction can reduce the time motorists have to identify traffic signals, signage, or other roadway conditions, limiting their ability to react and respond accordingly.

*Vegetation Obstructing Signage*

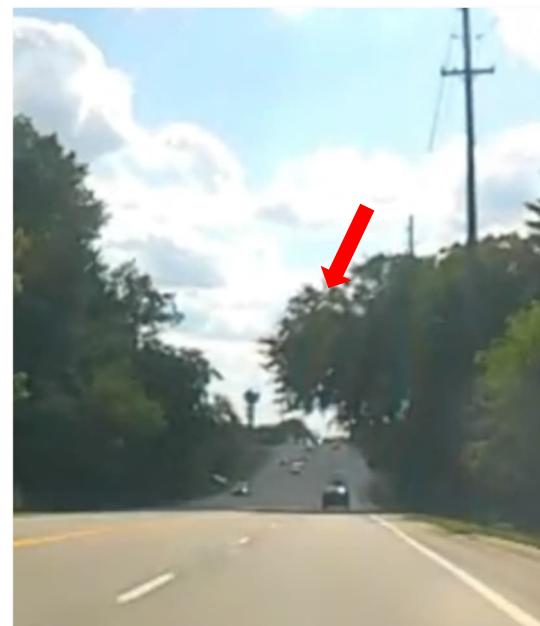
*Vegetation Obstructing Signal*

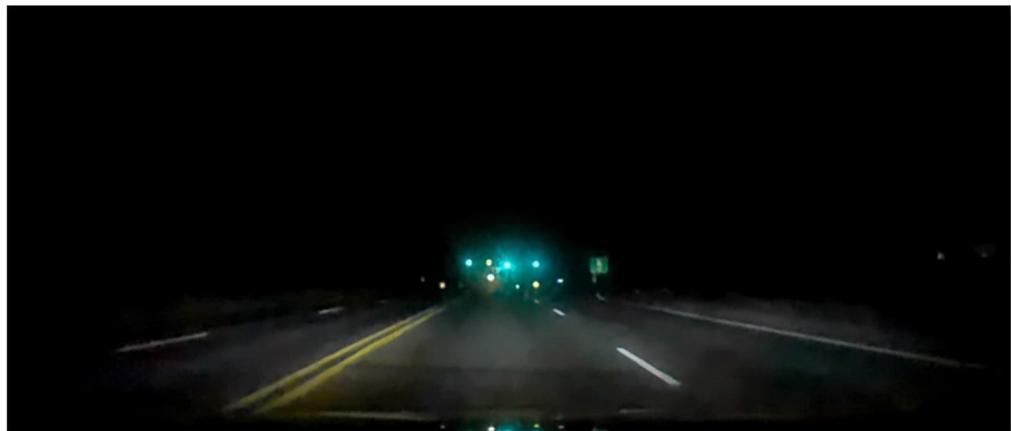
During the nighttime field review, the RSA team observed that there was no overhead or intersection lighting east of the Southbound US-23 On-Off Ramp intersection. The lack of lighting along Plymouth Road can be seen in Figure 28. This lack of lighting makes it more difficult for both motorists and pedestrians to see and be seen, increasing the potential for dark or low light condition crashes. Pedestrians, especially those who are visually impaired, may find it challenging to navigate safely in low-light conditions. Additionally, motorists may have difficulty identifying crosswalks, pedestrians, and other potential hazards, further exacerbating the need for adequate lighting. Having proper lighting in this area is essential for the safety and accessibility of all road users.

**Figure 28 - Lack of Corridor Lighting Along Plymouth Road, East of Southbound US-23 On-Off Intersection**

Consider installing overhead lighting east of the Southbound US-23 On-Off Ramp intersection, such as the lighting shown in Figure 29. Overhead lighting improves visibility during nighttime and adverse weather conditions, allowing drivers to see the road, signs, and potential hazards more clearly. This increased visibility can help reduce the potential for crashes by enabling drivers to react promptly to changing road conditions.

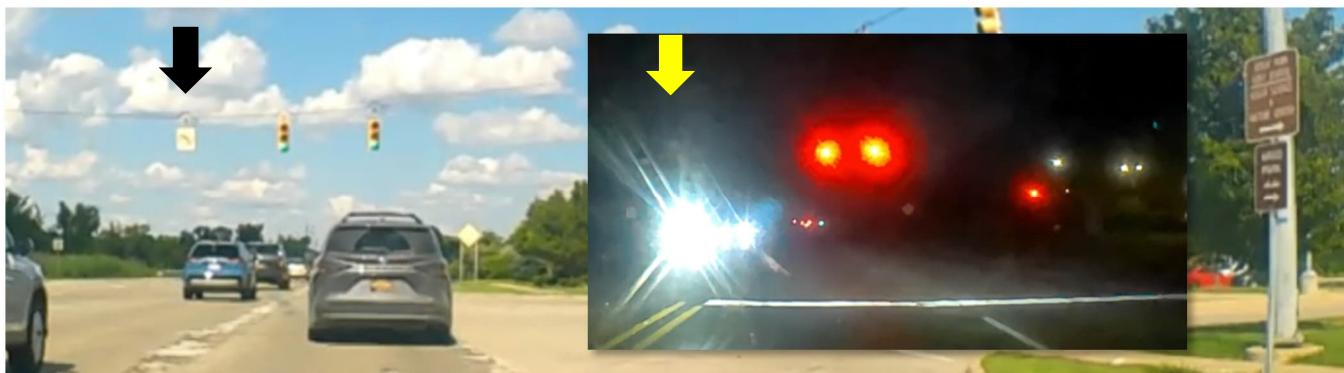
Additionally, during the nighttime field review, it was observed that there are non-illuminated “Left-Turn” and “No Left Turn” case signs at the southbound US-23 On-Off ramp intersection. This lack of illumination reduces the visibility of the signs for drivers, which can lead to missed turns or sudden lane changes, increasing the potential for crashes to occur. Additionally, the “No Left Turn” case sign is one wrong way driving preventative measure that is not as visible under dark lighting conditions. Non-illuminated signs can also be difficult for unfamiliar drivers to see, especially in low-light conditions. Figure 31 shows the eastbound approach of the southbound US-23 On-Off Ramp intersection during daylight and nighttime conditions. From the figure, it shows the left-turn case sign visible during daytime conditions but no longer visible during nighttime conditions.

Figure 31 – Non-illuminated Left Turn Case Sign at Southbound US-23 On-Off Ramp Intersection

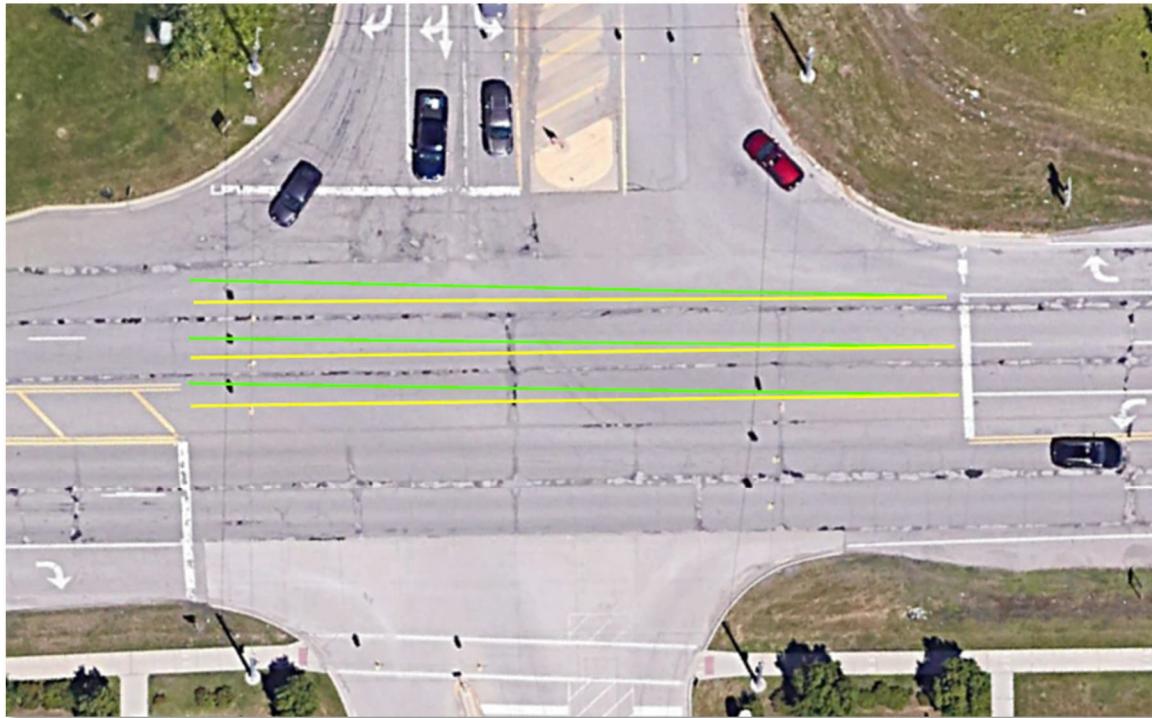
It was observed that there is a lane alignment shift through the westbound approach at the southbound US-23 On-Off ramp intersection, with the alignment shifting approximately 8 feet to the right. This shift could potentially create confusion for drivers, especially those unfamiliar with the area, leading to sudden lane changes or hesitation. Such actions can increase the likelihood of sideswipe same direction and rear end crashes and disrupt the smooth flow of traffic. Additionally, deteriorating pavement joints were observed in the roadway along the approach, which may be mistaken for pavement markings under inclement weather conditions or sun glare. Figure 32 below illustrates the alignment shift, with the yellow guidelines representing the alignment of the roadway if there was no shift and the green guidelines representing the transition of the lane lines along the roadway.

**Figure 32 - Illustration of the Alignment Shift at Southbound US-23 On-Off Ramp Intersection**

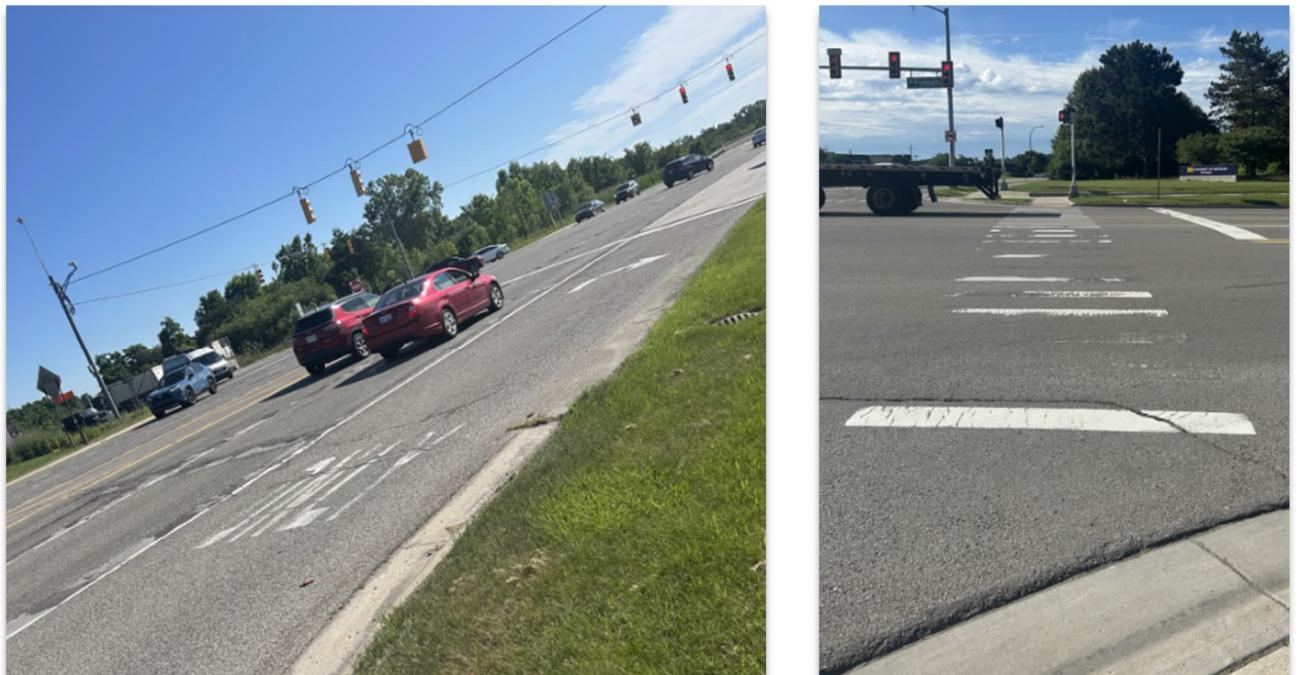
During the field review faded or missing pavement markings were observed throughout the study corridor, as shown in Figure 35. This lack of clear markings can lead to several safety concerns, including confusion for drivers about lane boundaries and proper turning paths. Without visible pavement markings, drivers may inadvertently drift out of their lanes or make incorrect turns, increasing the potential for crashes. Additionally, faded or missing markings can make it difficult for pedestrians to identify safe crossing areas, further compromising safety. Addressing these issues is essential to provide clear guidance for all road users and to enhance the overall safety and functionality of the corridor.

**Figure 35 - Faded Pavement Markings**

Consider installing recessed wet reflective pavement markings as it would enhance safety and visibility along the corridor. These markings are designed to remain visible even in wet conditions, providing clear guidance to drivers during rain or other adverse weather. This increased visibility can help prevent crashes by improving the visibility of lane boundaries and other important road indicators. Additionally, recessed markings are less prone to wear and tear from traffic, making them a durable and longer-lasting solution. Overall, installing these pavement markings would contribute to a safer and more reliable driving environment, especially during adverse weather conditions.

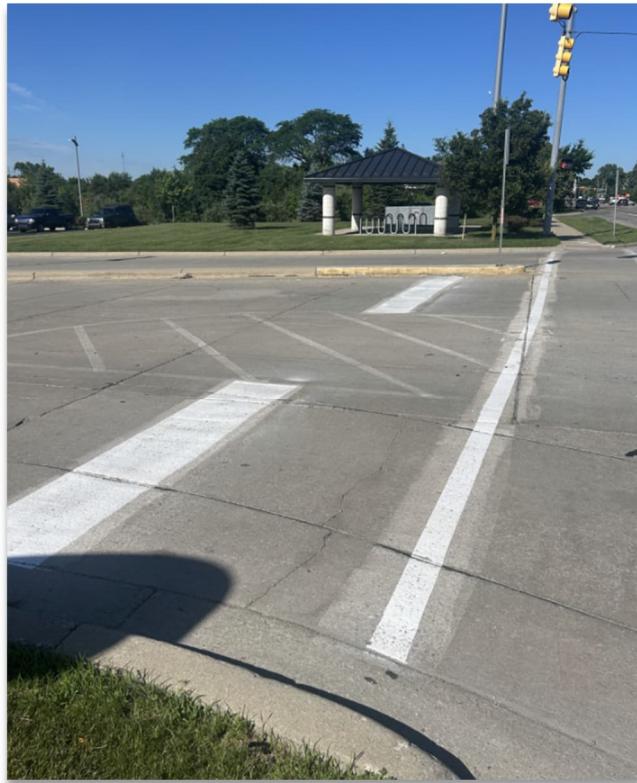
Furthermore, the stop bar at the Plymouth Road Park and Ride includes a gap to separate the left turn and right turn movements which is delineated by hatched pavement markings. This hatched area is significantly worn, resulting in a lack of clear delineation. Additionally, there is no signage to inform drivers of lane designation. This absence of distinct information can lead to confusion for drivers, potentially resulting in improper lane usage and increased potential for sideswipe crashes. Figure 36 depicts the gapped stop bar at the Park and Ride.

**Figure 36 - Gapped Stop Bar at Plymouth Road Park and Ride**

Consider adding delineators to the gapped stop bar, as well as adding arrow pavement markings and lane use signage on the approach. These improvements may enhance safety by providing clear and visible guidance to drivers, reducing confusion and the potential for crashes. Refreshed hatched markings and delineators will clearly indicate the separation of lanes, helping drivers follow the correct paths. Updated arrow markings and lane use signage will provide clear instructions on lane usage, reducing the likelihood of improper lane changes.

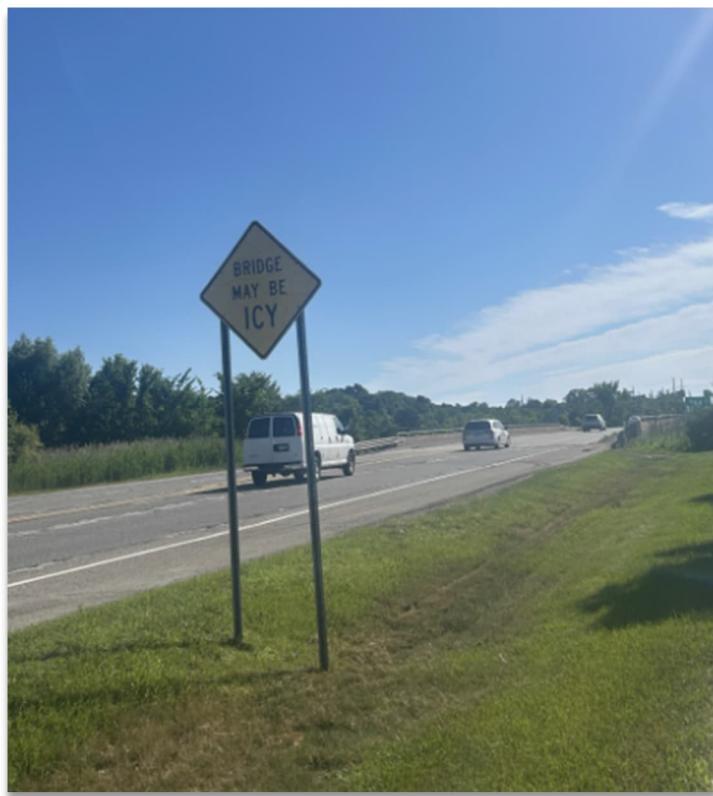
It was observed that the "Bridge May Be Icy" signs placed before the US-23 overpass were cracked and exhibited minimal retroreflectivity at nighttime. This reduced visibility and legibility increases the potential for drivers to be unaware of the presence of the bridge. Additionally, these older style signs have been replaced in the current version of the MMUTCD (Michigan Manual on Uniform Traffic Control Devices). The sign present for the eastbound traffic is shown in Figure 38.

**Figure 38 - "Bridge May Be Icy" Signs at US-23 Overpass**

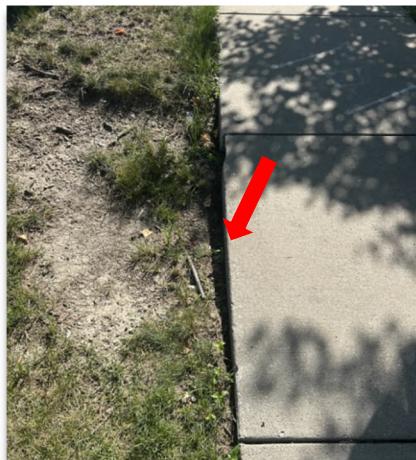
**Figure 42 - Depression Adjacent to Sidewalk**

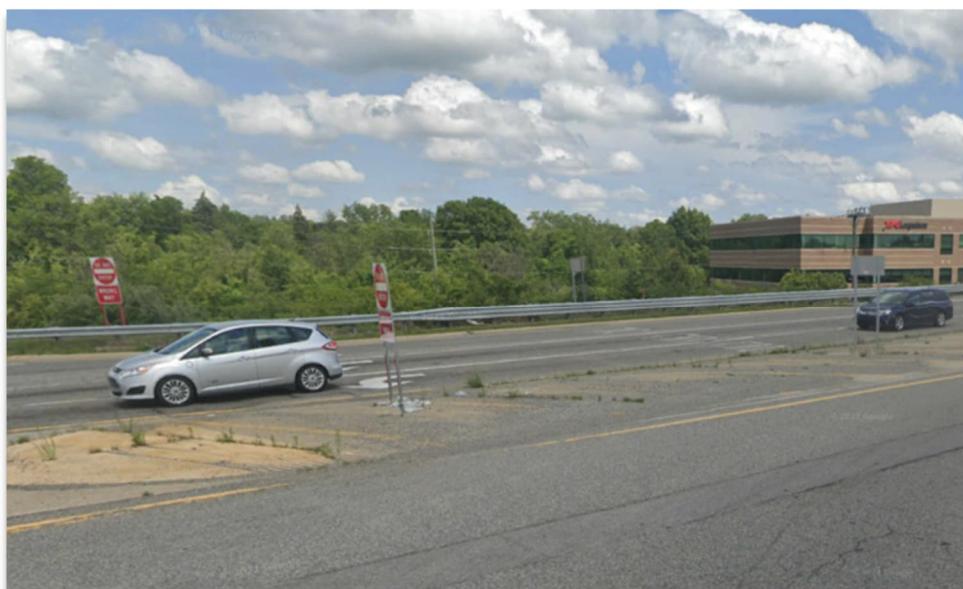
**Figure 43 - Debris Present in Median at Northbound US-23 On-Off Ramp Intersection**
