Fitzpatrick Structural Engineering, P.C.

April 17, 2014

RE: 202 E Washington, Ann Arbor, Michigan

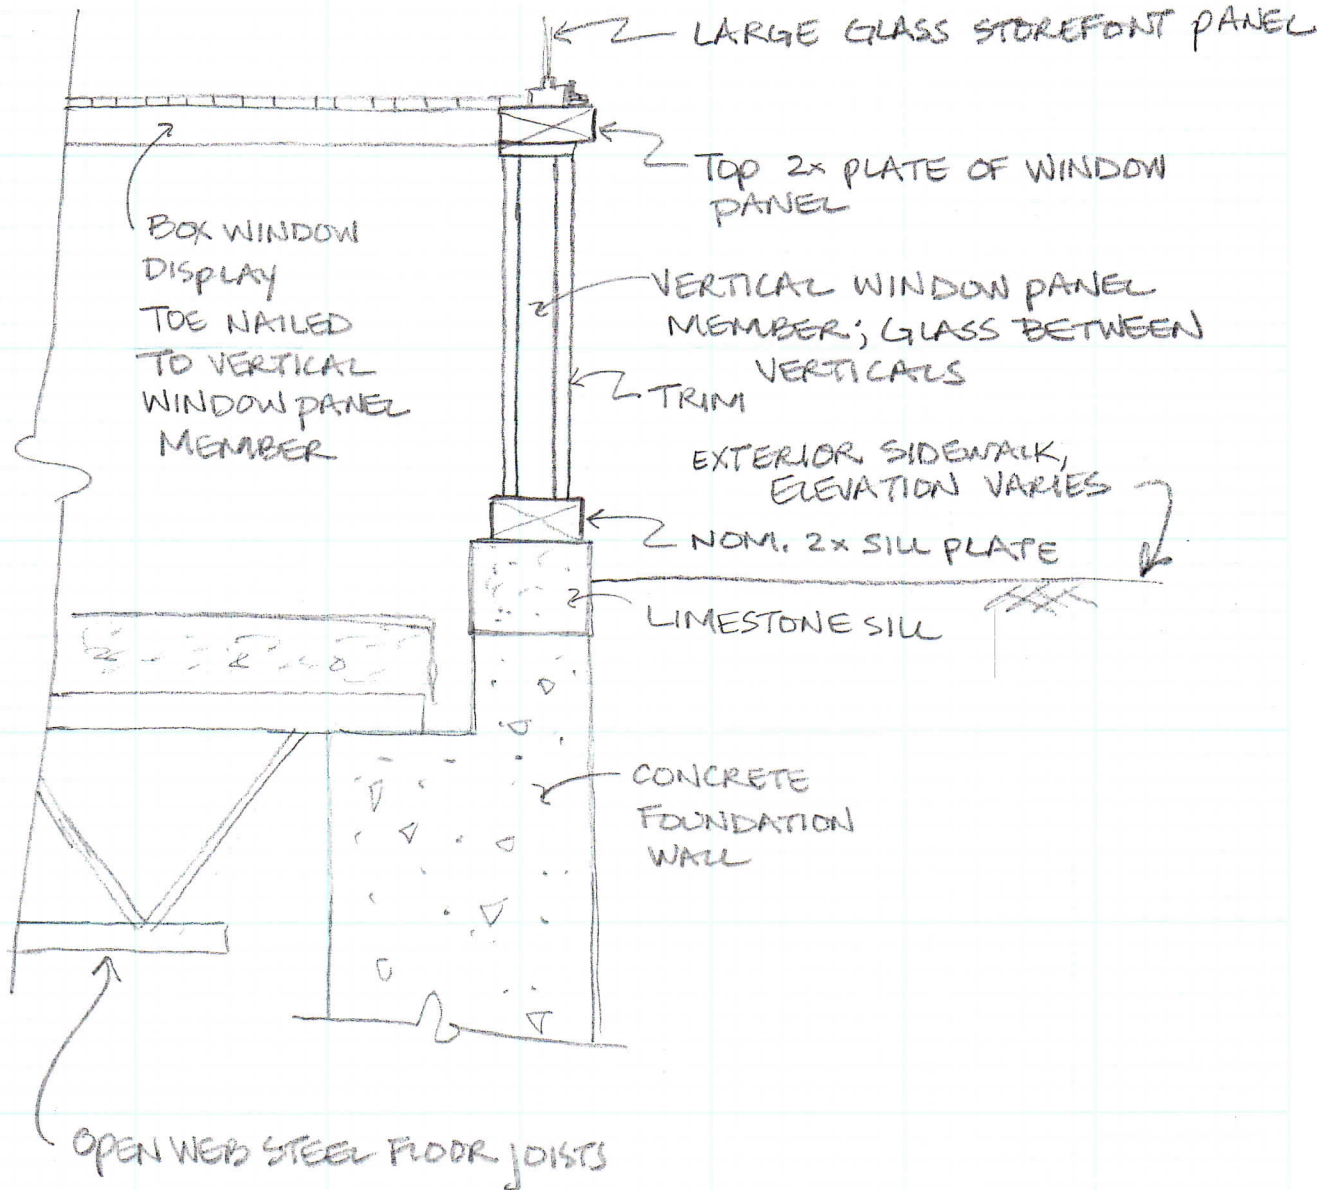
TYPICAL CROSS SECTION THRU BASEMENT WINDOWS

Along the north side of the building, the bottom members (the nom. 2x sill plate) of the wood framing below the large storefront glass panels has shifted outward toward the street significantly. Similar movements were observed elsewhere, but not to the extreme condition observed at the western most bay of the north elevation. I have attached a sketch of a cross section through this north wall that describes the existing construction of the windows. Construction along the west wall is similar, but the windows and stone sill are bearing on a steel beam as the basement extends further west below the sidewalk above. The elevation of the exterior sidewalk varies slightly around the perimeter of the building, but is relatively close to the bottom members of the wood window frames (less than 6" at most).

I suspect the nominal 2x sill plates at the bottom of the window framing are deteriorating from their close exposure to grade and thus snow and other moisture sources. The panel with the extreme lean may also be deteriorating due to its proximity to the radiator hidden in the wood display box at this window bay. Unfortunately, direct access to the structural bottom plates of the window framing could not be obtained during my site visit to confirm the deterioration of the wood. When probed from the exterior, there were several locations where a screw driver tip could penetrate the wood sill up to 3/8 of an inch.

The window framing is supported on the nom. 2x sill plate up to the lintel above. The top 2x plate above the smaller basement windows spans between the vertical window panel members that then bear on the nominal 2x sill plates. Should the sill plates fail, the vertical members will settle or shift as well, removing support for the top 2x plate that directly supports the large glass storefront panels.

Regardless, though, rebuilding of the window frames is recommended, especially where the frames have shifted significantly. Considering the proximity to final grade on the exterior, I recommend the frames be rebuilt with treated lumber or other non-deteriorating material. Profiles and sizes of members can be matched to meet any historic district requirements. Use of the treated wood may be problematic if the treated wood is in any contact with any existing steel (at building columns? near joists or beams? fasteners for existing framing?) as the treated wood will corrode the steel. Painting of the treated wood would be required regularly (annually?) as well. Window frames are now available in other materials that may service this area of the building in a more economical manner and still provide the historic profiles desired. I refer you to Quinn Evans Architects and your window supplier to determine the best solution that will fit your needs.
