# ANN ARBOR HISTORIC DISTRICT COMMISSION

## Staff Report

**ADDRESS:** 549 S First Street Application Number HDC24-0095

# **549 S 1ST STREET - SIDING, TRIM AND PORCH RESTORATION AND REPLACEMENT**

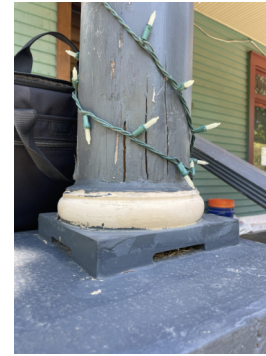
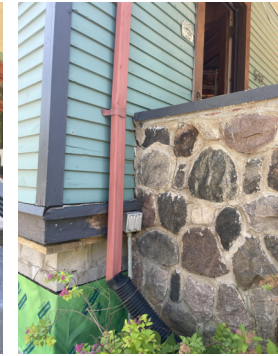
DRY ROT AND SPLITTING -  
REPLACE

HOLES @ COLUMN TOPS, TYP.

"BLISTERING" ON FACE OF BOARDS  
BENEATH PORCH, TYP.

DRY-ROT, SPLITTING, SCREWED  
THROUGH FACES -  
REPLACE

BOTTOM "BELT" TRIM AND  
BEVELED TRIM FULL OF  
PENETRATION, HOLES, NOT  
HISTORIC TREATED LUMBER -  
REPLACE W/ BORAL - TYP.

SIDING DRY ROT AND SPLITTING -  
REPLACE

SPLIT BOARD -  
REPLACE

SPLIT BOARDS -  
REPLACE

DRY-ROT AT COLUMN BOTTOMS, TYP. -  
REPLACE

SPLIT BOARDS BEYOND -  
REPLACE

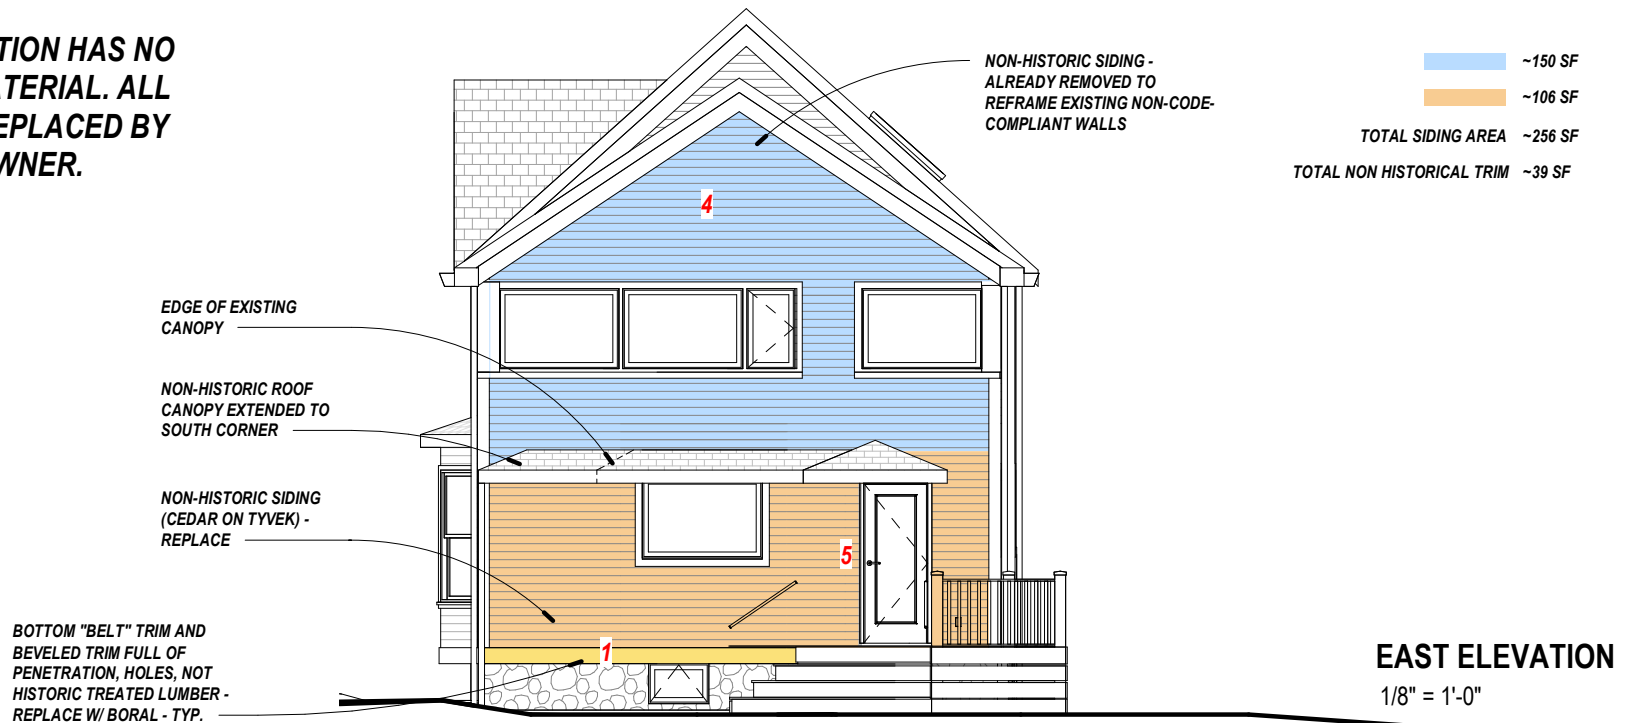
**EAST ELEVATION HAS NO HISTORIC MATERIAL. ALL HAS BEEN REPLACED BY PREVIOUS OWNER.**

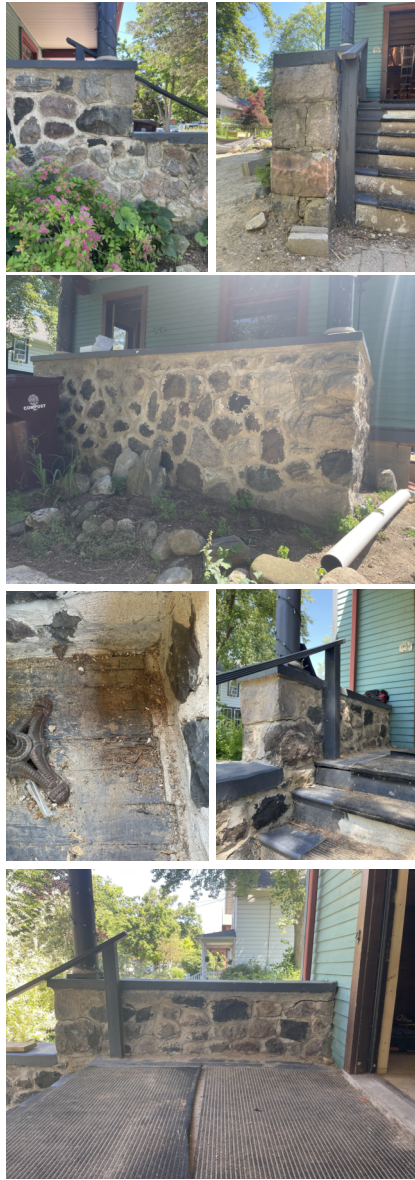
SOME 1X3 T+G  
PORCH FLOOR  
BOARDS ARE  
DRY ROTTED
