## **415 West Washington Historic Structure Assessment**

415 West Washington, Ann Arbor, MI 48103

Final Report August 29, 2013

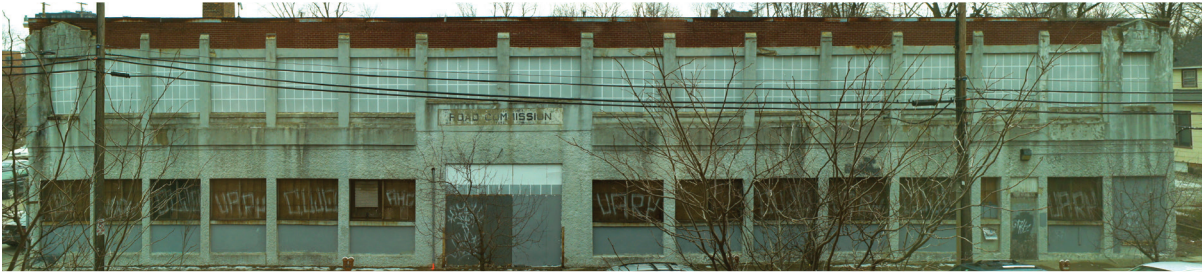
North facade facing Washington street in 2013 (photo is a distortion corrected panorama).

the brick parapet is concrete. It is now partially covered with rusting galvanized steel copings. Large expanses of steel framed glazing fill the remaining space. (The City has covered the glazed steel sash with plywood security panels painted to simulate steel sash.) The lower floor windows have been covered with wire mesh for many years.

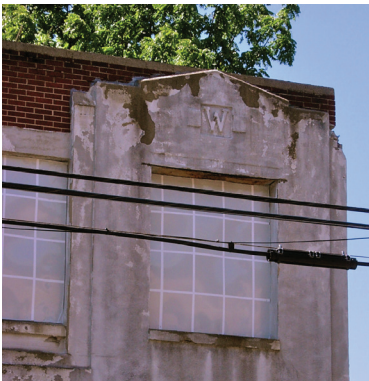
West facade: Art deco parapet with the block "W."

The facade is divided into multiple bays with concrete columns approximately 10 feet on center. The original one-story garage had 12 bays. The 1925 remodeling replaced two of those bays with one large central overhead door. The second floor was being built at this time along with the two story west (right) four bays. The construction joints can be seen here and cracks are evident at this location.

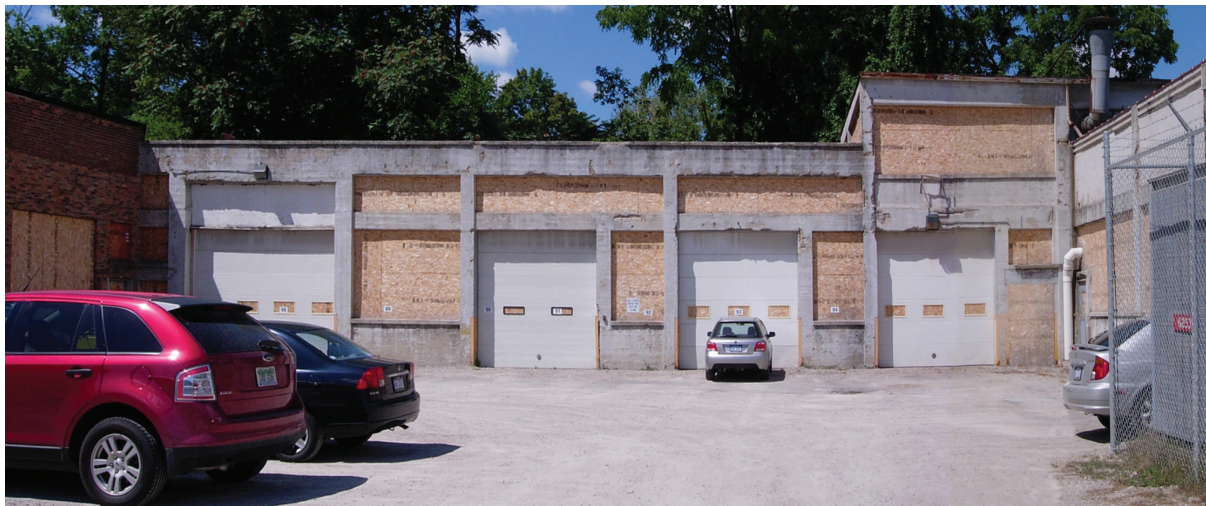
2012 photo of the 1928 addition showing the steel sash covered with OSB board for security.

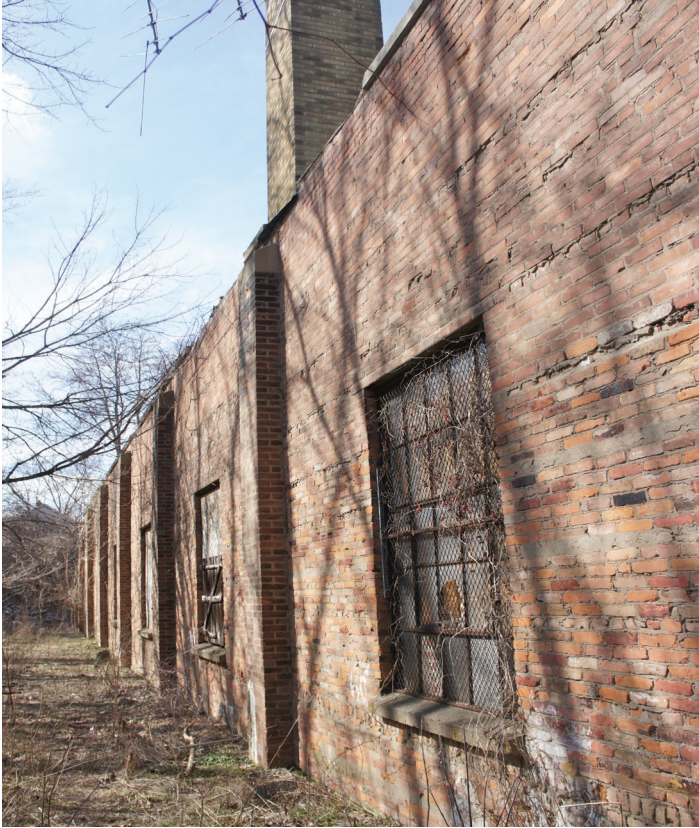
Rear of CWA brick garage

The walls are in reasonably good condition, however, some brick faces have spalled off quite badly in certain courses on the south sides and locations near the ground. The brick on the rear south wall which was out of sight is extremely crudely laid, perhaps by the unskilled laborers practicing. The walls are capped with a cast concrete coping which has been covered with roofing materials in an attempt to waterproof the parapets. This may have been done to prevent water from entering the walls and further deteriorating the brick.

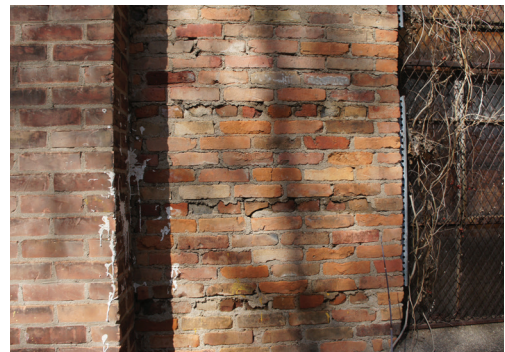
Rear of CWA brick garage. The reclaimed brick masonry on the wall to the right is very poorly laid. The bond courses are recessed and do not match the plane of the face layers. Joints vary greatly in width and are not struck. Note the contrast on the left where the pilaster is of new harder brick with flush struck joints and even coursing.

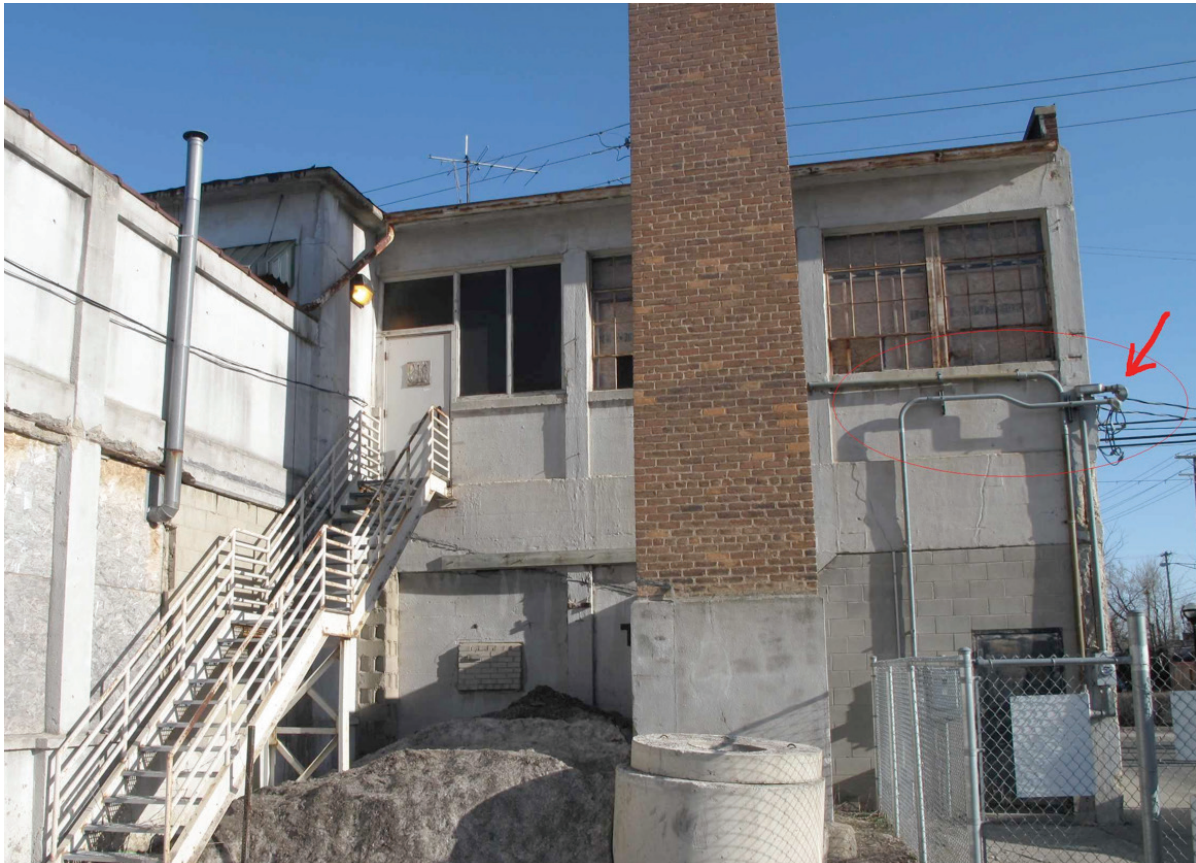
Picture E1: Existing electrical service at corner of buildings A & B

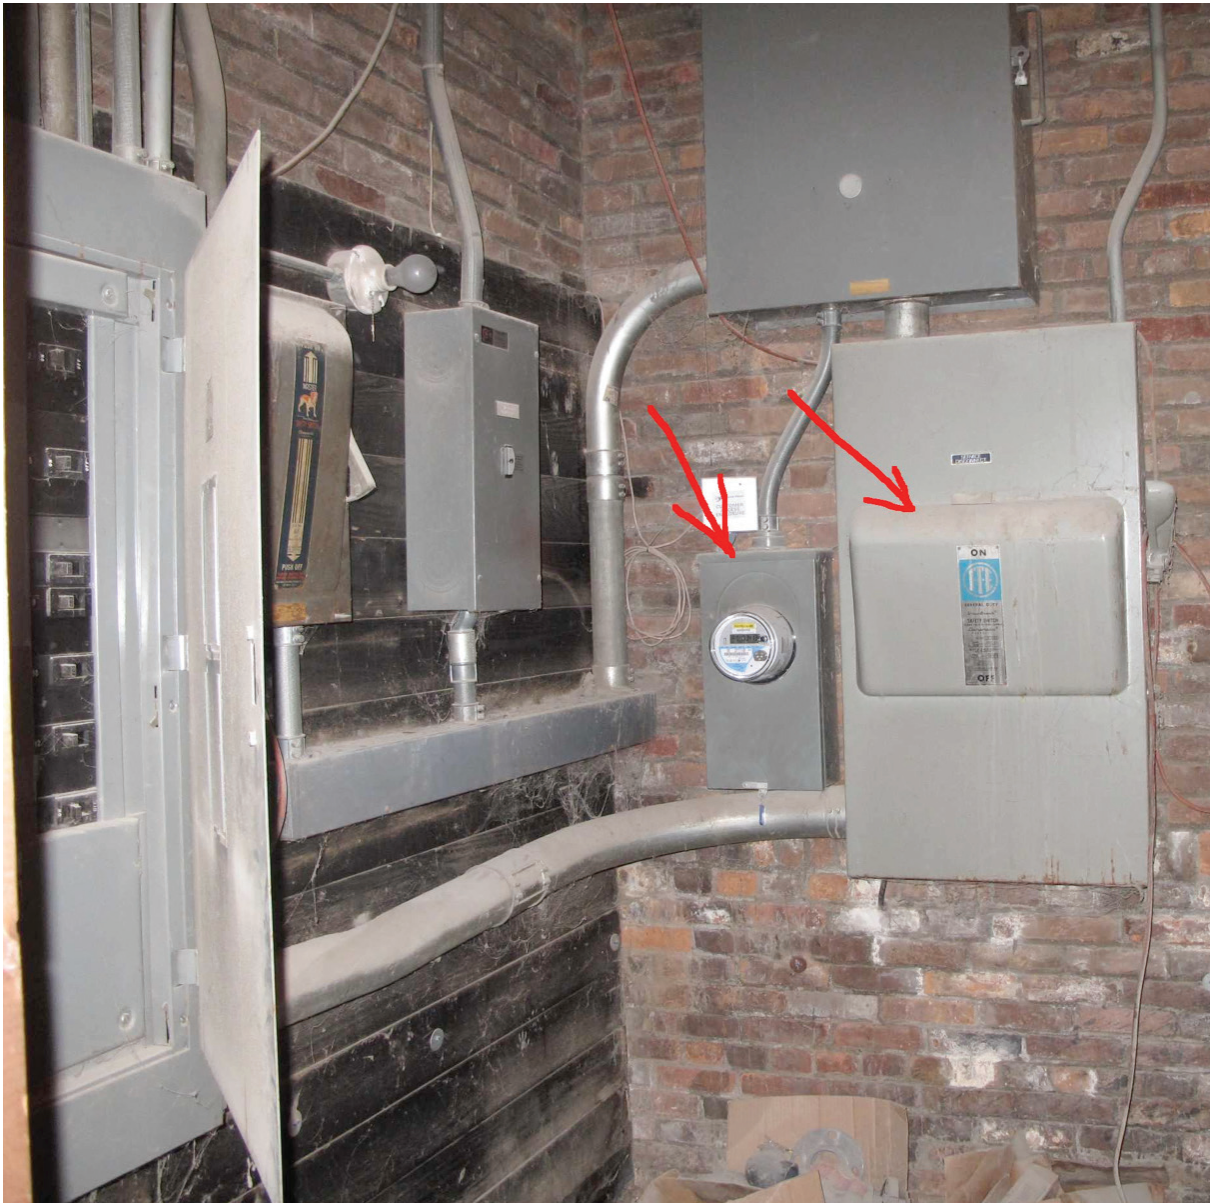
Picture E2: Existing electrical service at building D

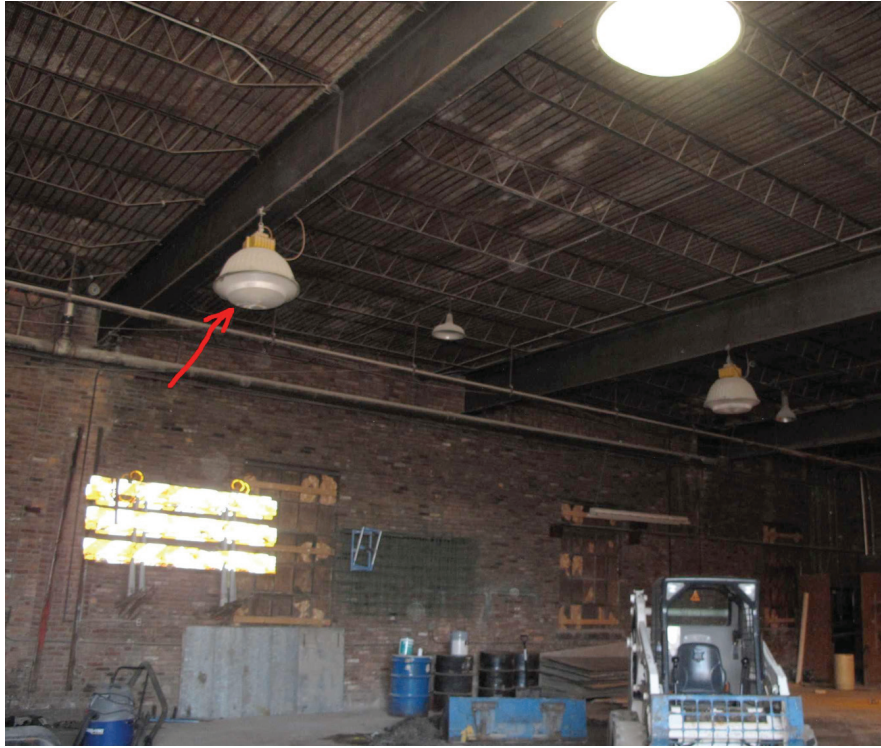
Picture E3: Existing lighting  
**Condition Evaluation**

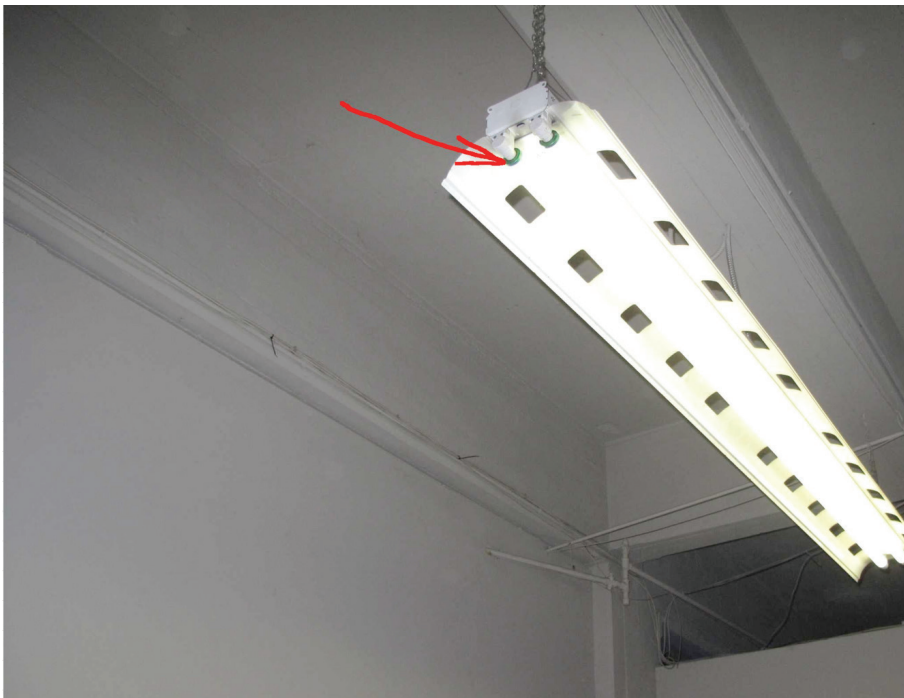
Picture E3: Existing lighting

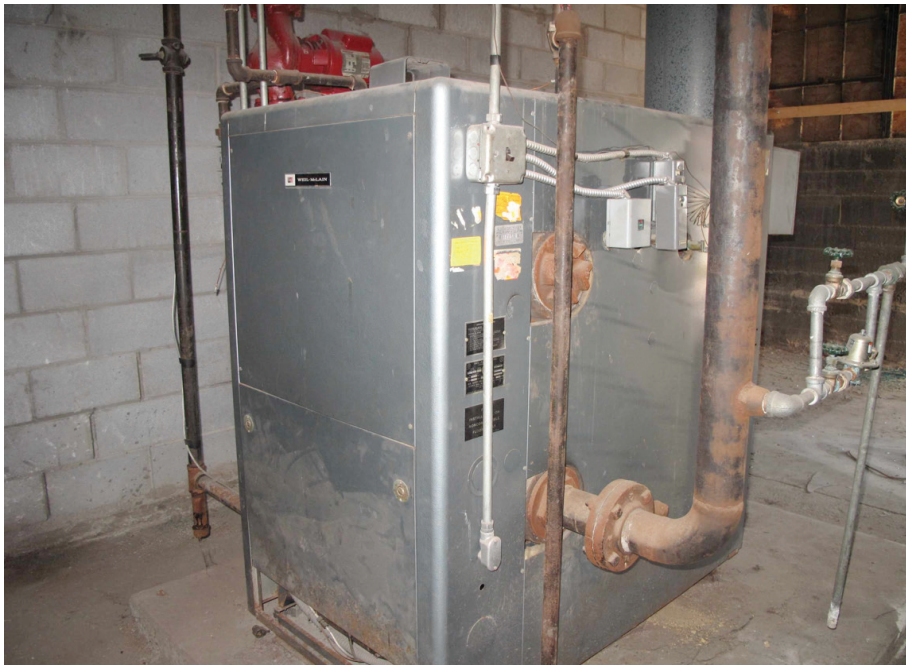
Picture M1: Existing boiler to be demolished

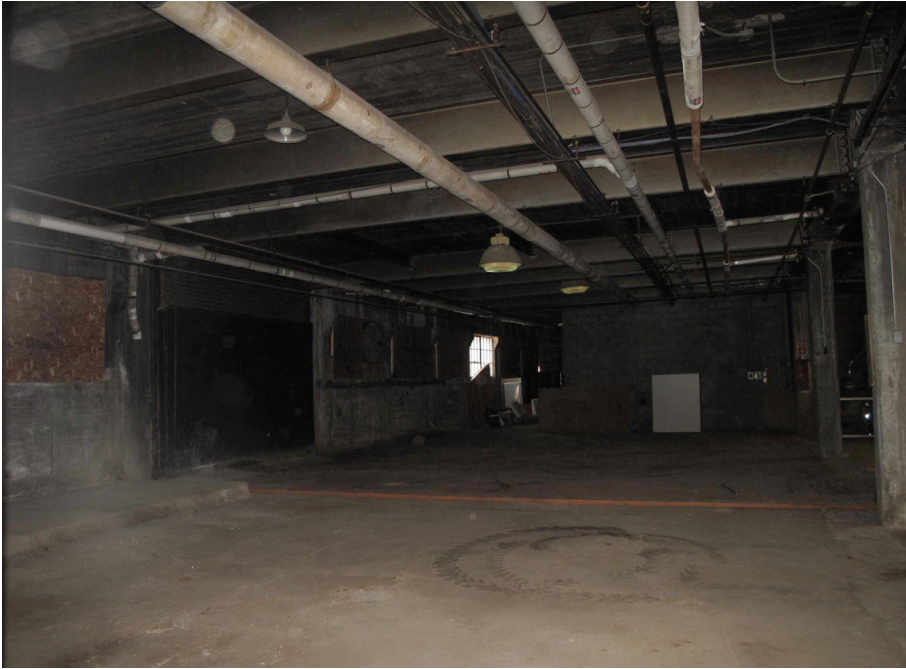
Picture M2: Existing piping to be demolished

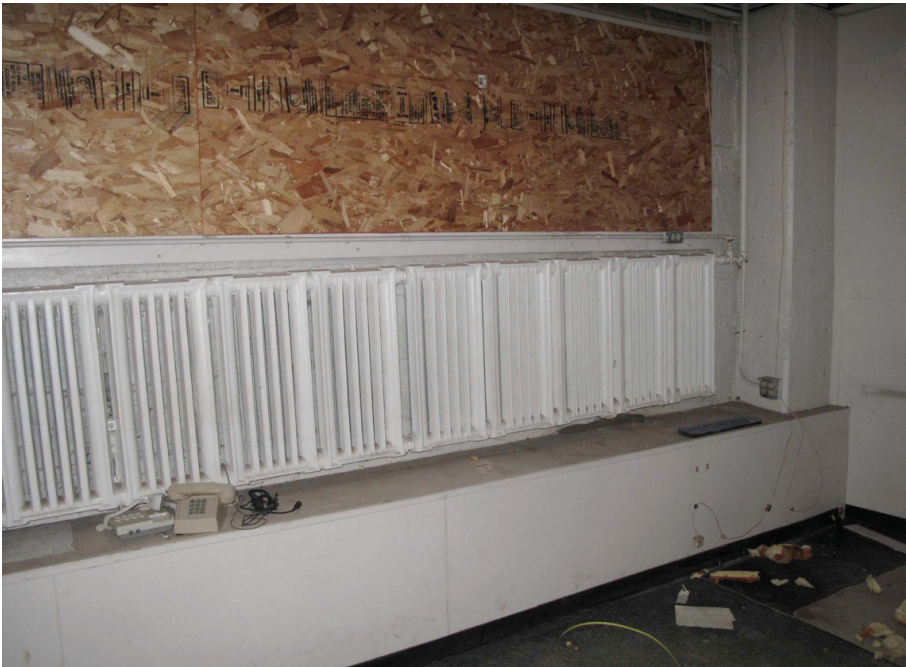
Picture M3: Existing radiators to be demolished
