ROAD SAFETY AUDIT

JACKSON AVENUE

ANN ARBOR, MI

DATE: OCTOBER 2025

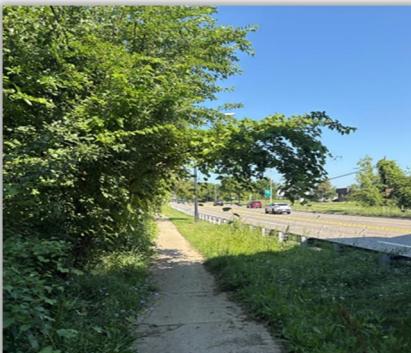
Foliage and Branches Along Sidewalk

- Vegetation was observed to be encroaching onto the sidewalk on the south side of Jackson Avenue
- Roadway Geometrics and Signing
 - Missing guidance sign for eastbound to westbound crossover, east of Wagner

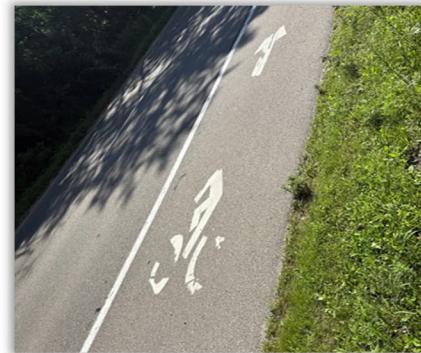
Worn Bike Lane Pavement Marking

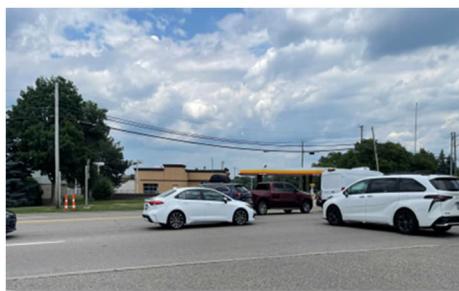
Vehicle Turning Left from Westgate Plaza

- Vehicles making left-turns from the shopping complex, near misses were observed
 - Vehicles were not looking for pedestrians for the eastbound right-turning movement from Jackson Avenue to Stadium Road

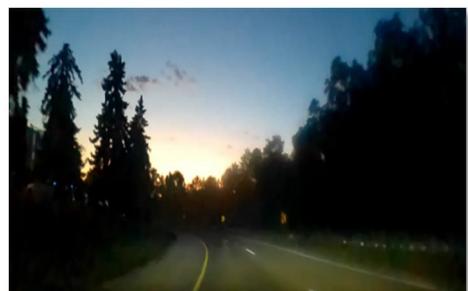
Nighttime Lighting along Westbound Jackson Ave Curve

- Buses were observed causing extensive queues on eastbound Jackson Avenue, extending back to the westbound I-94 off ramp
 - Speeding vehicles through the curve along the westbound Jackson Avenue curve approaching Wagner Road resulting in over tracking through the turn and possibly endangering bicyclists or pedestrians in the shoulder.

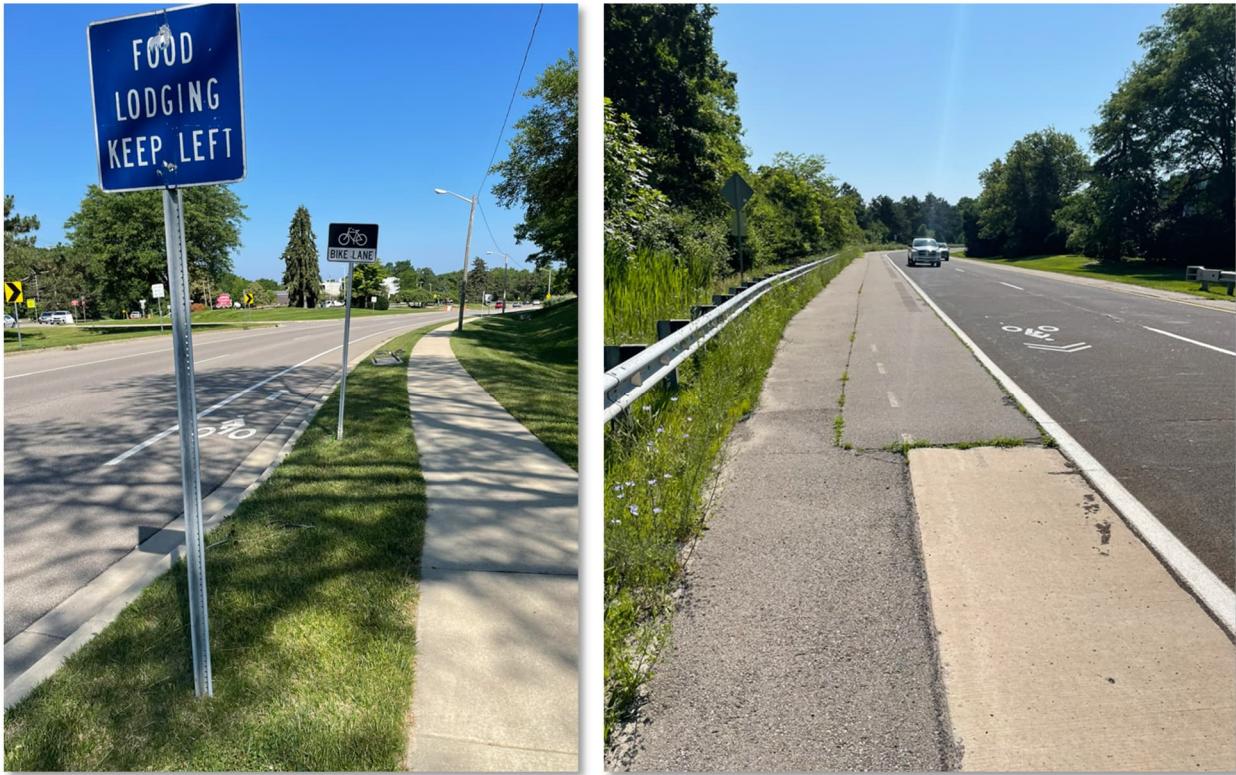
Figure 18 - Westbound Jackson Avenue Bike Lane Signage

Lack of consistent signage and markings for the bike lane adjacent to westbound Jackson, west of the interchange. There is also no formal entryway for the bikes to enter the bike lane from the sidewalk. The bike lane sign is also blocked by an informational sign. Vehicles were observed travelling at high speeds through the sharrows section. Figure 18 shows some of the bike signage along the corridor.

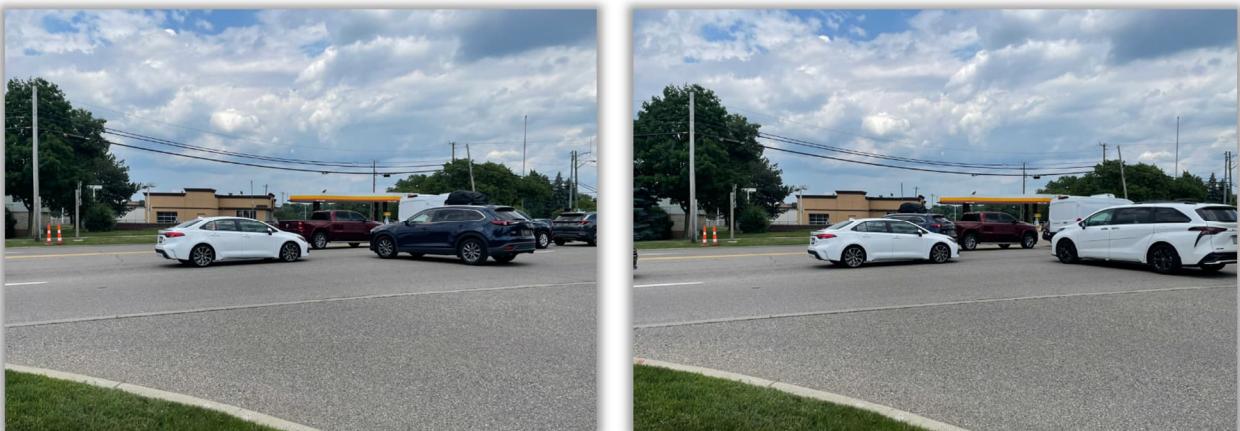
Figure 25 - Left-turning vehicles from the plaza

Access management is an issue near the Westgate shopping plaza, west of Maple, where several cars were observed forcing their way through queues. This scenario was observed just before and during the PM peak hour as vehicles attempted to complete the left-turn movement by crossing as many as five lanes of traffic from the eastern driveway at Westgate shopping plaza. The shopping plaza which is south of Jackson Avenue has two driveways allowing left turns onto Jackson Avenue which increases conflict points with through traffic and pedestrians on sidewalks. The team observed a few hazardous maneuvers and frustrated horn blowing as left-turning vehicles attempted to access westbound Jackson Avenue during the evening peak hour. Turning vehicles have very limited or no line of sight for the westbound vehicles when eastbound queues are present and these through vehicles cannot see the turning vehicles which increases the potential for crashes or other near-miss incidents. There were instances where vehicles were observed driving in the opposing lane of traffic in an attempt to make left turns as the two way left-turn lane was backed up beyond the driveways. Examples of some observed left-turning maneuvers from the east driveway are shown in Figure 25.

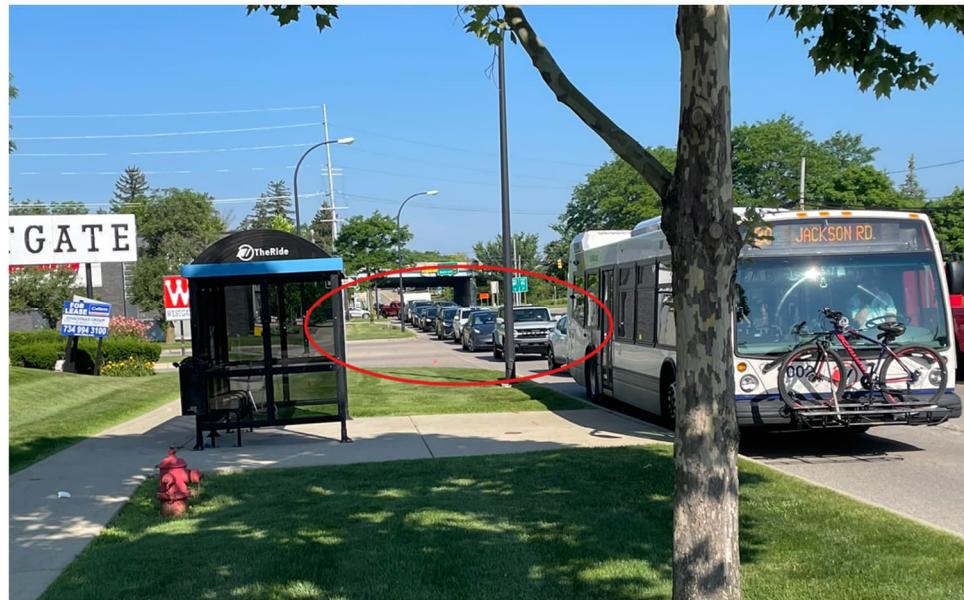
Figure 27 - Queueing at Eastbound Bus Stop

Buses were observed causing extensive queues on eastbound Jackson, extending back to the westbound I-94 Off Ramp as shown in Figure 27. At various times the audit team noticed that buses stop for extended periods at this bus stop and given that rear-end crashes are the most frequent type of crash along this corridor, queuing may contribute to the issue. While the audit team was observing the evening peak hour, they observed a rear-end crash occurring just east of the bus stop.

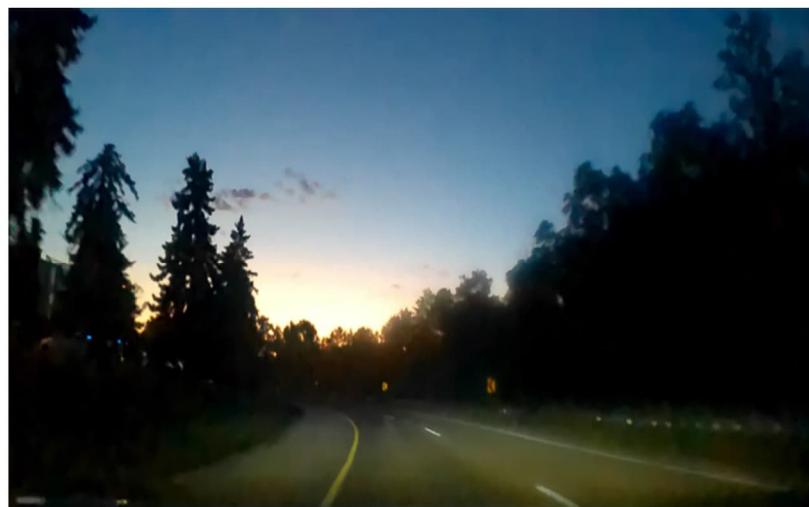
Figure 28 - Curve Nighttime Lighting

Going west towards Wagner Road, Jackson Avenue splits into two one-way roadways and the westbound roadway is curved. The audit team noticed that vehicles speed through this curved area, which also has a narrow shoulder designated for bicycle traffic. The high speeds could result in vehicles over tracking through this region as well as encroaching on the bike lane. The observations also highlighted that there is no roadway lighting provided for westbound Jackson, west of the interchange. There are also minimal ambient sources of light available with minimal development in this section as shown in Figure 28 taken during evening observations.

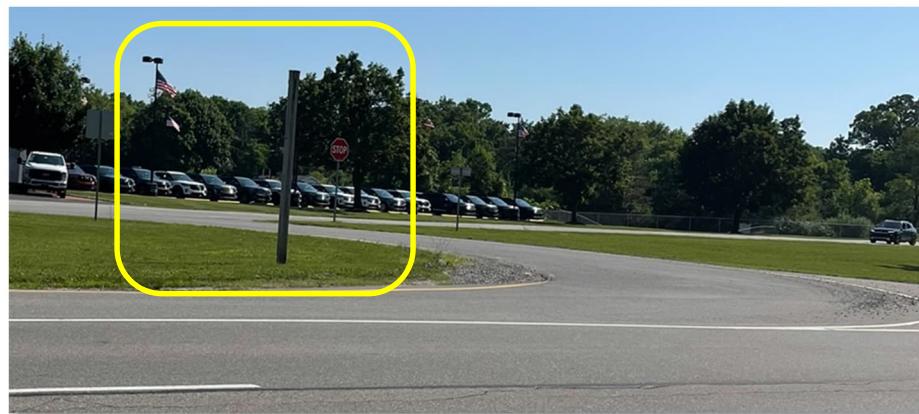
Figure 29 - Eastbound to Westbound Turnaround with Missing Signage

The eastbound to westbound sign for the turnaround east of Wagner is missing as shown in Figure 29, which may cause driver confusion. This is a quick fix that could also provide another indication of the roadside due to retro reflectivity.

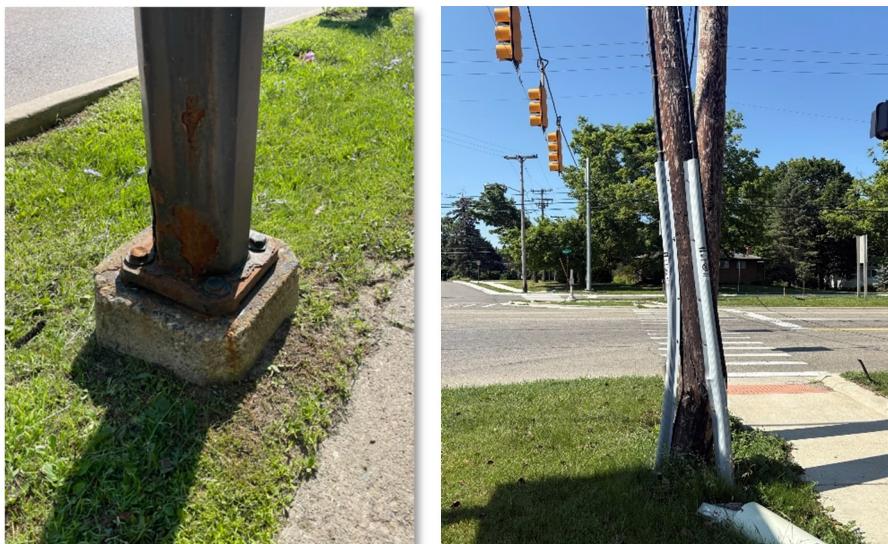
Figure 33 - Observed Pole Foundation Condition

Some light poles were observed as rusted with foundations showing cracks which could potentially cause a safety issue if the pole is subject to inclement weather or contacted, causing it to fall on the sidewalk or in the roadway. The picture on the right shows a cracked utility pole which was leaning significantly at the Highlake Road intersection. Some of the observations are highlighted in Figure 33.
