**ANN ARBOR HISTORIC DISTRICT COMMISSION**

**Staff Report**

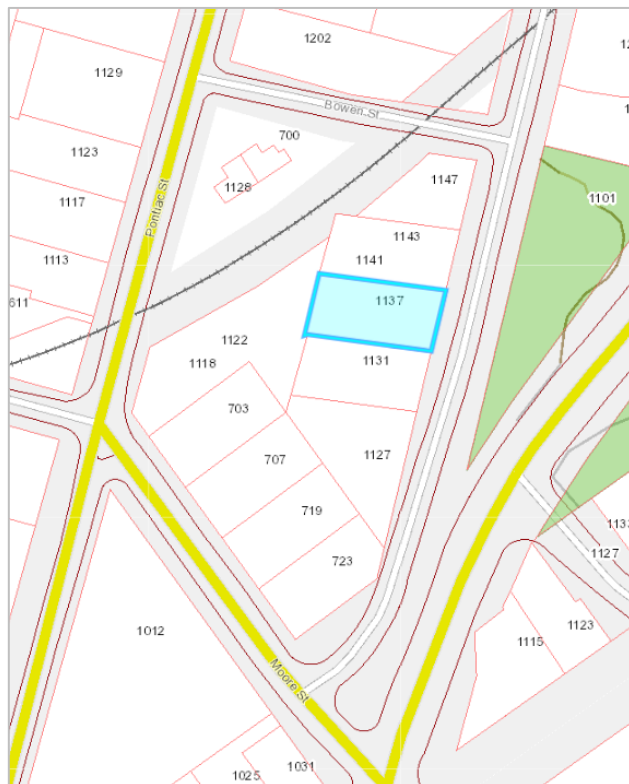
**APPLICABLE REGULATIONS:****From the Secretary of the Interior's Standards for Rehabilitation:**

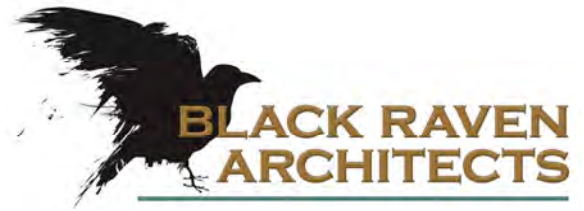
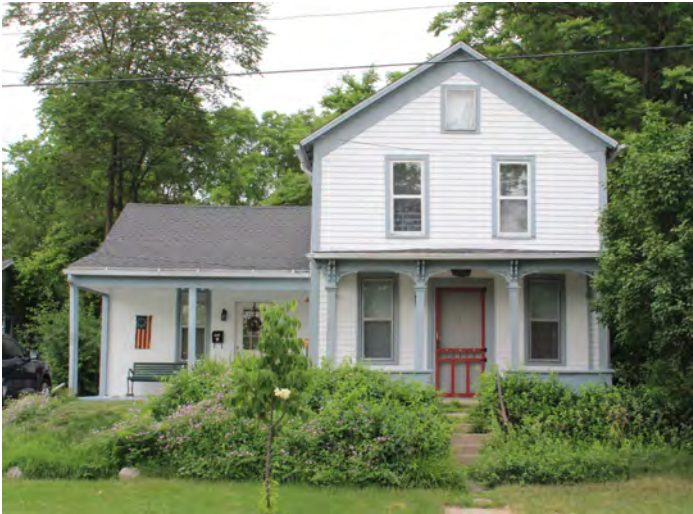
ADDENDA TO HDC APPLICATION

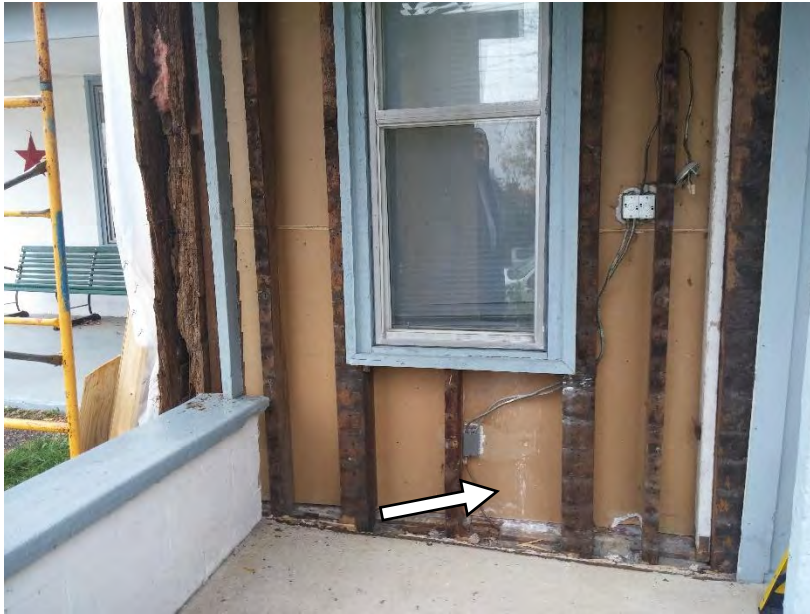
*Figure 1. Exterior cladding removed in 2016 exposing wood framing of east wall of home. Arrow is pointing to water staining on the backside of the gypsum board interior finish.*

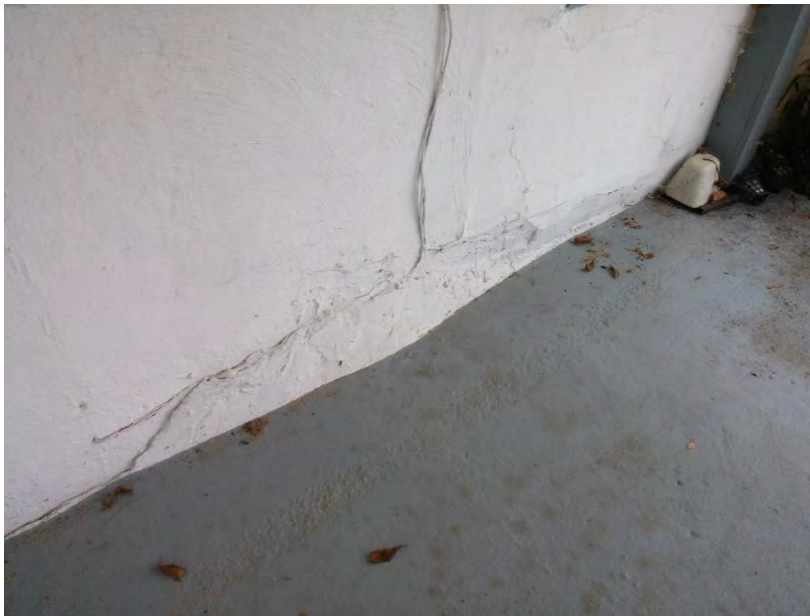
*Figure 2. Bulging of exterior stucco finish along adjacent wall to east wall of home.*

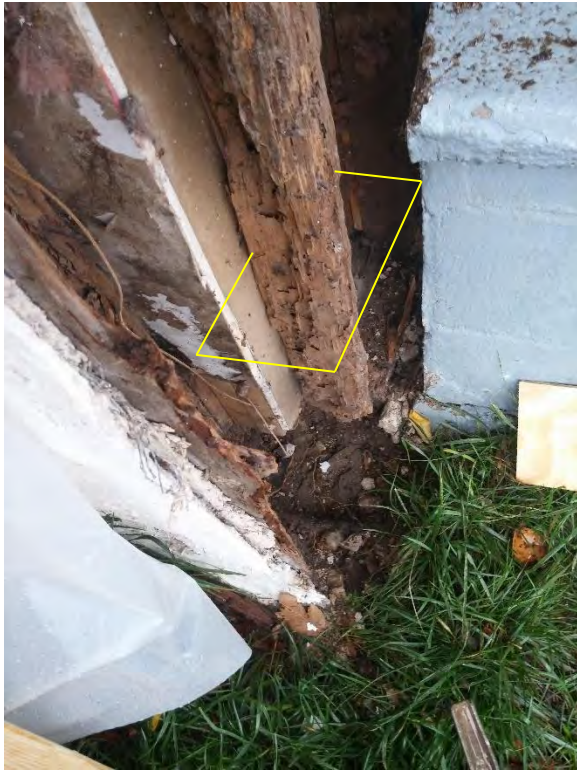
*Figure 5. Decayed timber corner column; yellow lines indicate approximate original section size.*

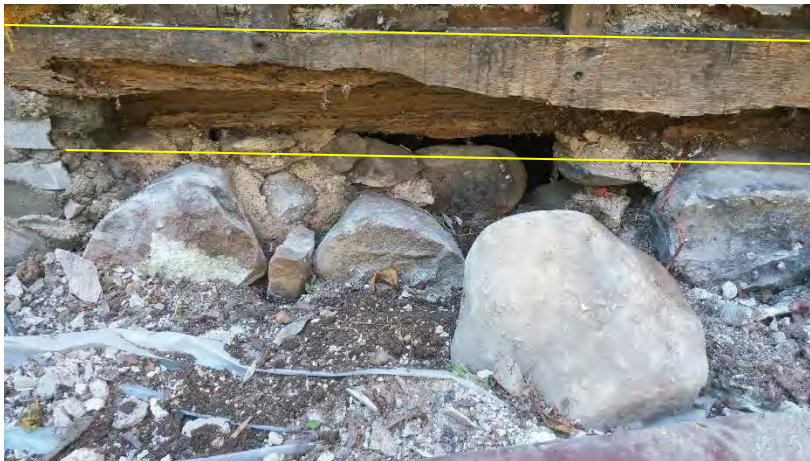
*Figure 6. Loose stone and missing mortar of stone foundation. Decayed summer beam atop stone foundation. Yellow lines indicate approximate original section depth.*

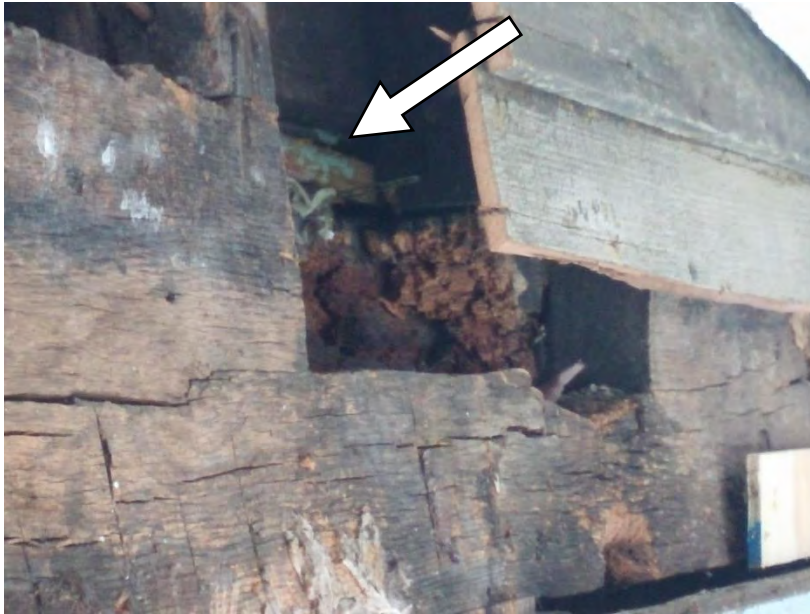
*Figure 7. Decay of second floor perimeter timber beam. Arrow pointing to edge of second floor decking.*

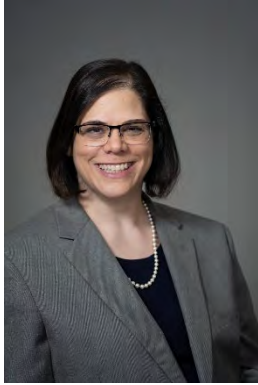
**BRENDA RIGDON, AIA, LEED BD+C**  
Principal, Black Raven Architects  
137 N. Main Street  
Adrian, Michigan 49221  
brenda@blackravenarchitects.com  
734.717.2753

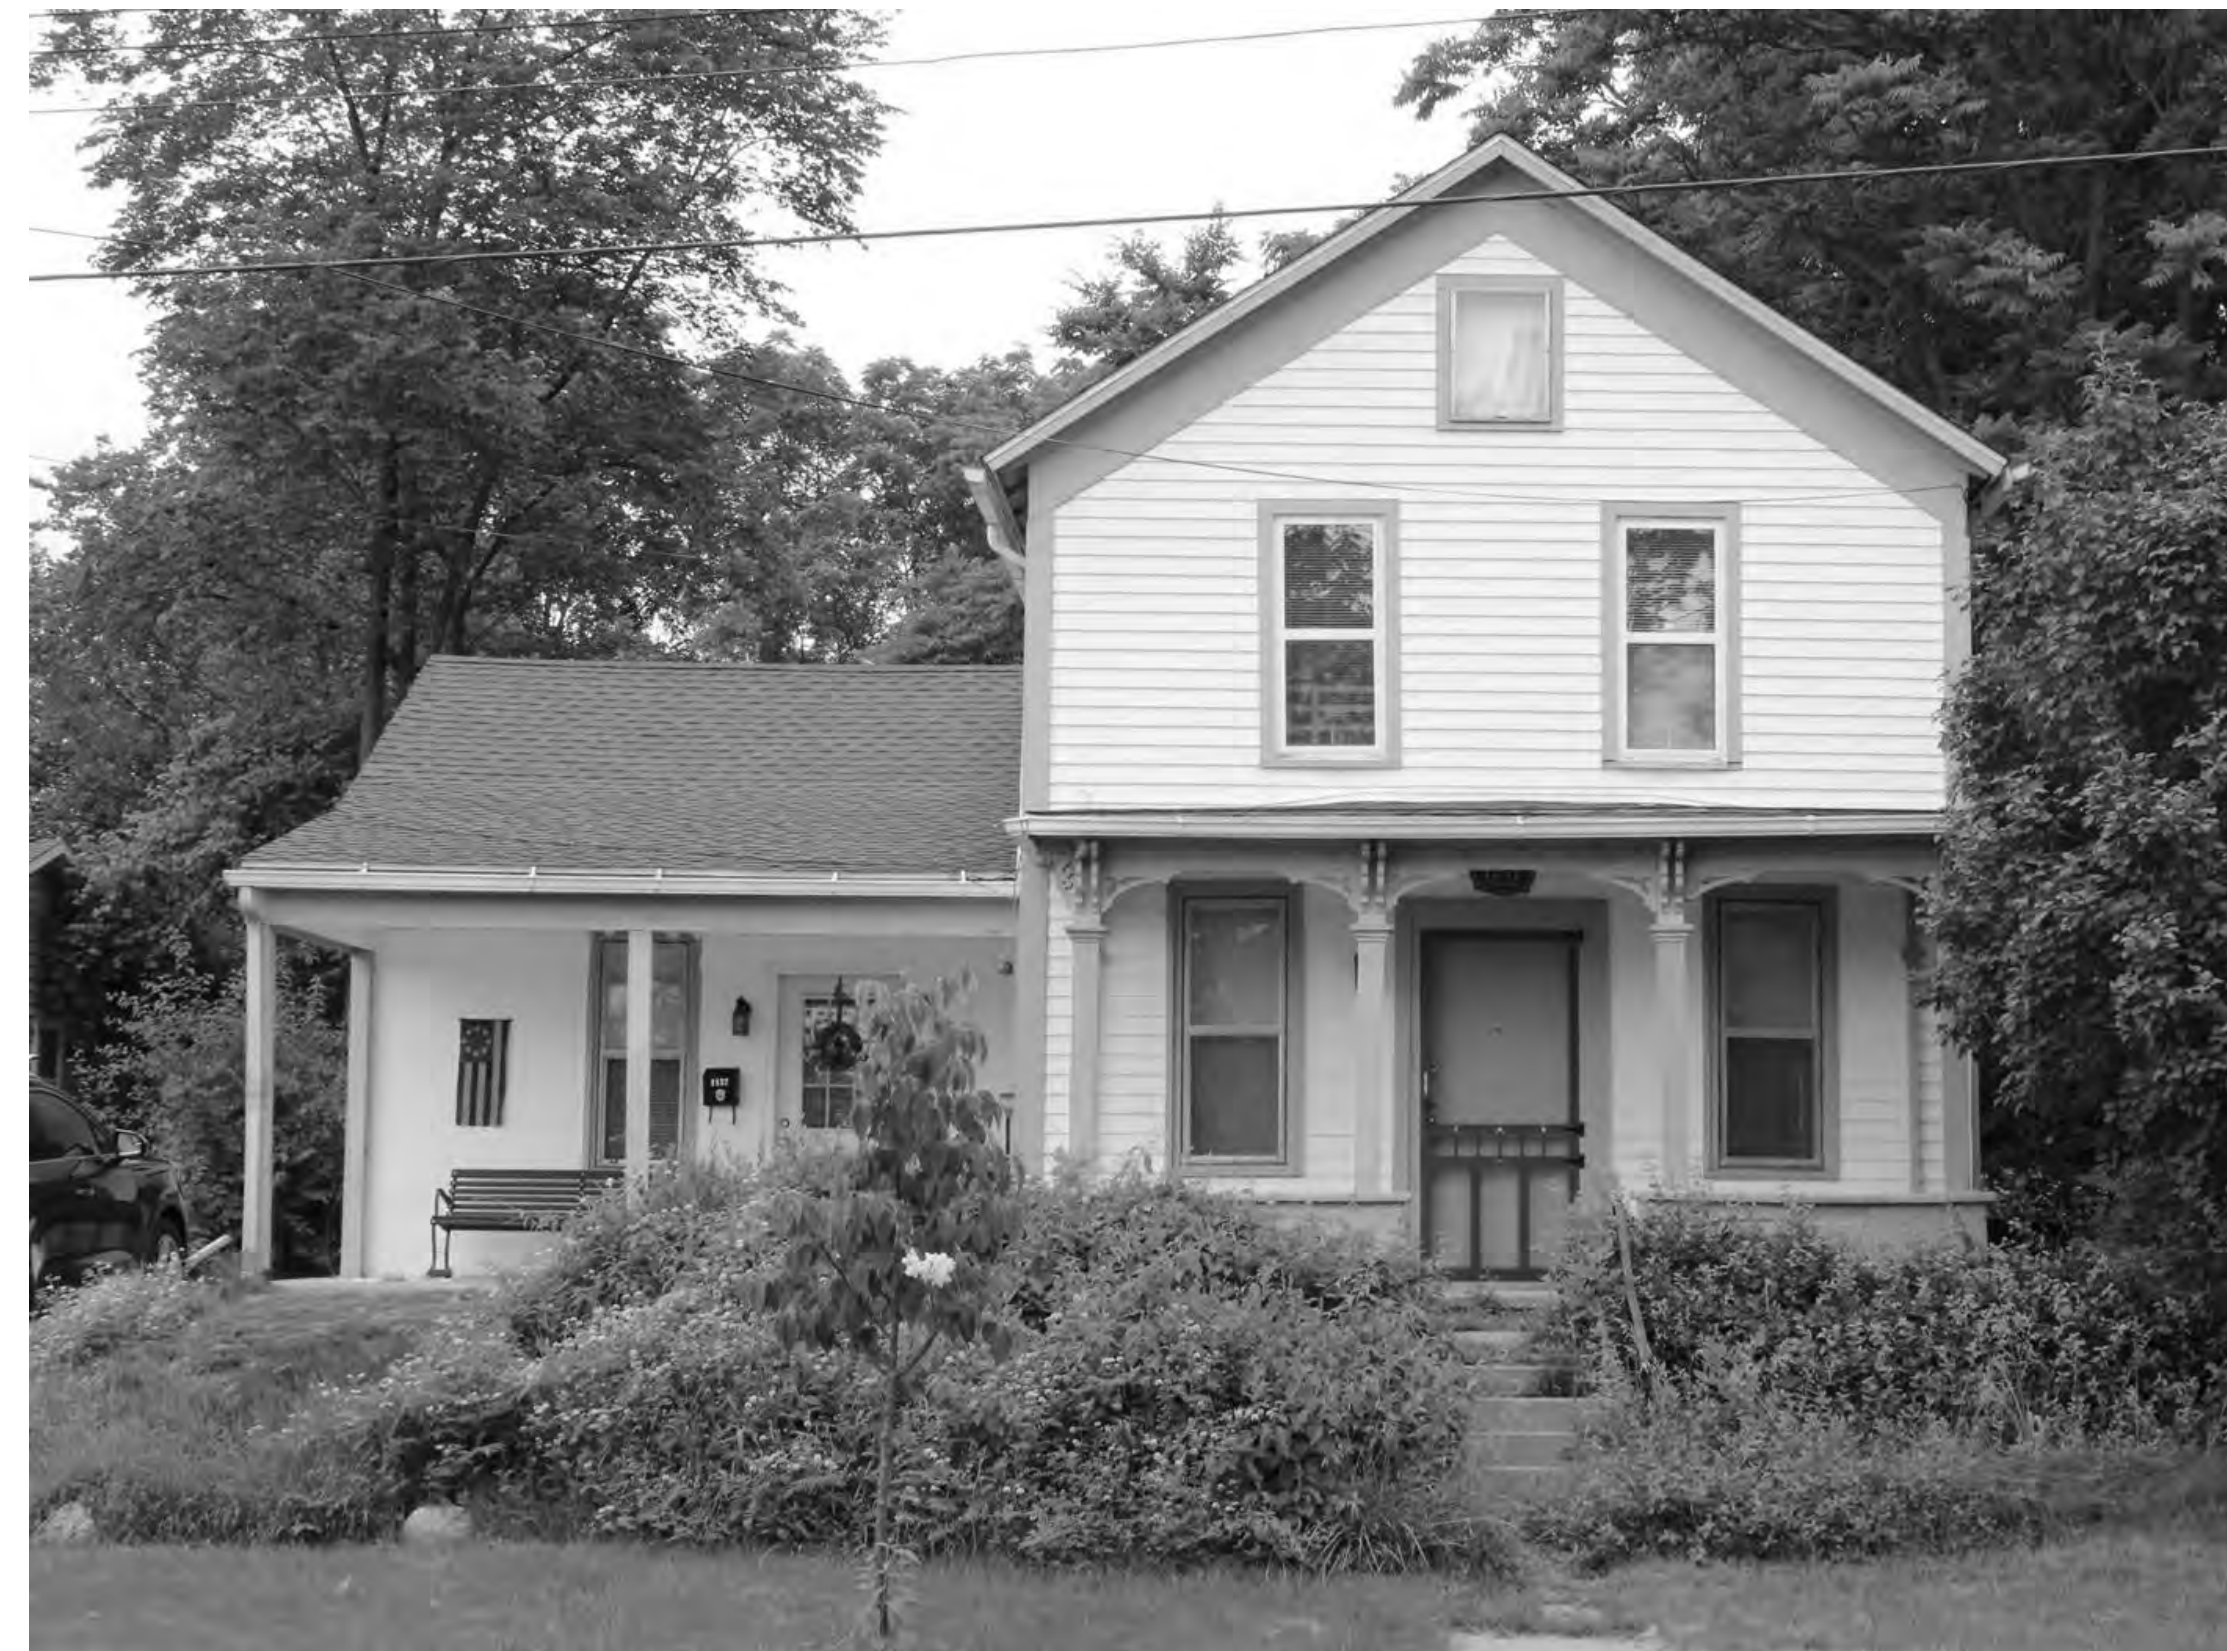
- REPAIR OR REPLACE THE FOUNDATION AS NEEDED FOR SOLID BEARING OF NEW WALLS.
- INSTALL NEW INSULATED STUD WALLS AT THE EXTERIOR TO ENCLOSE THE BUILDING. THE INTERIOR WALL FINISH WILL BE GYPSUM BOARD.
- INSTALL NEW OR SALVAGED DOORS AND WINDOWS AT THE PREVIOUS LOCATIONS.
- INSTALL NEW EXTERIOR CLAPBOARD SIDING MATCHING THE EXPOSURE OF THE HISTORIC SIDING.
- INSTALL NEW FLOOR FRAMING AND FINISHES.
- INSTALL A NEW CONCRETE SLAB FOR THE NORTH PORCH.
- RECONSTRUCT THE NORTH PORCH WITH NEW COLUMNS, ROOF, AND DECORATIVE TRIM.
- USE THE ORIGINAL PORCH BRACKETS TO RECREATE THE PROFILE FOR THE NEW BRACKETS.
- PRIME AND PAINT ALL NEW WOOD.
- REPOINT THE EXPOSED INTERIOR BASEMENT WALLS.

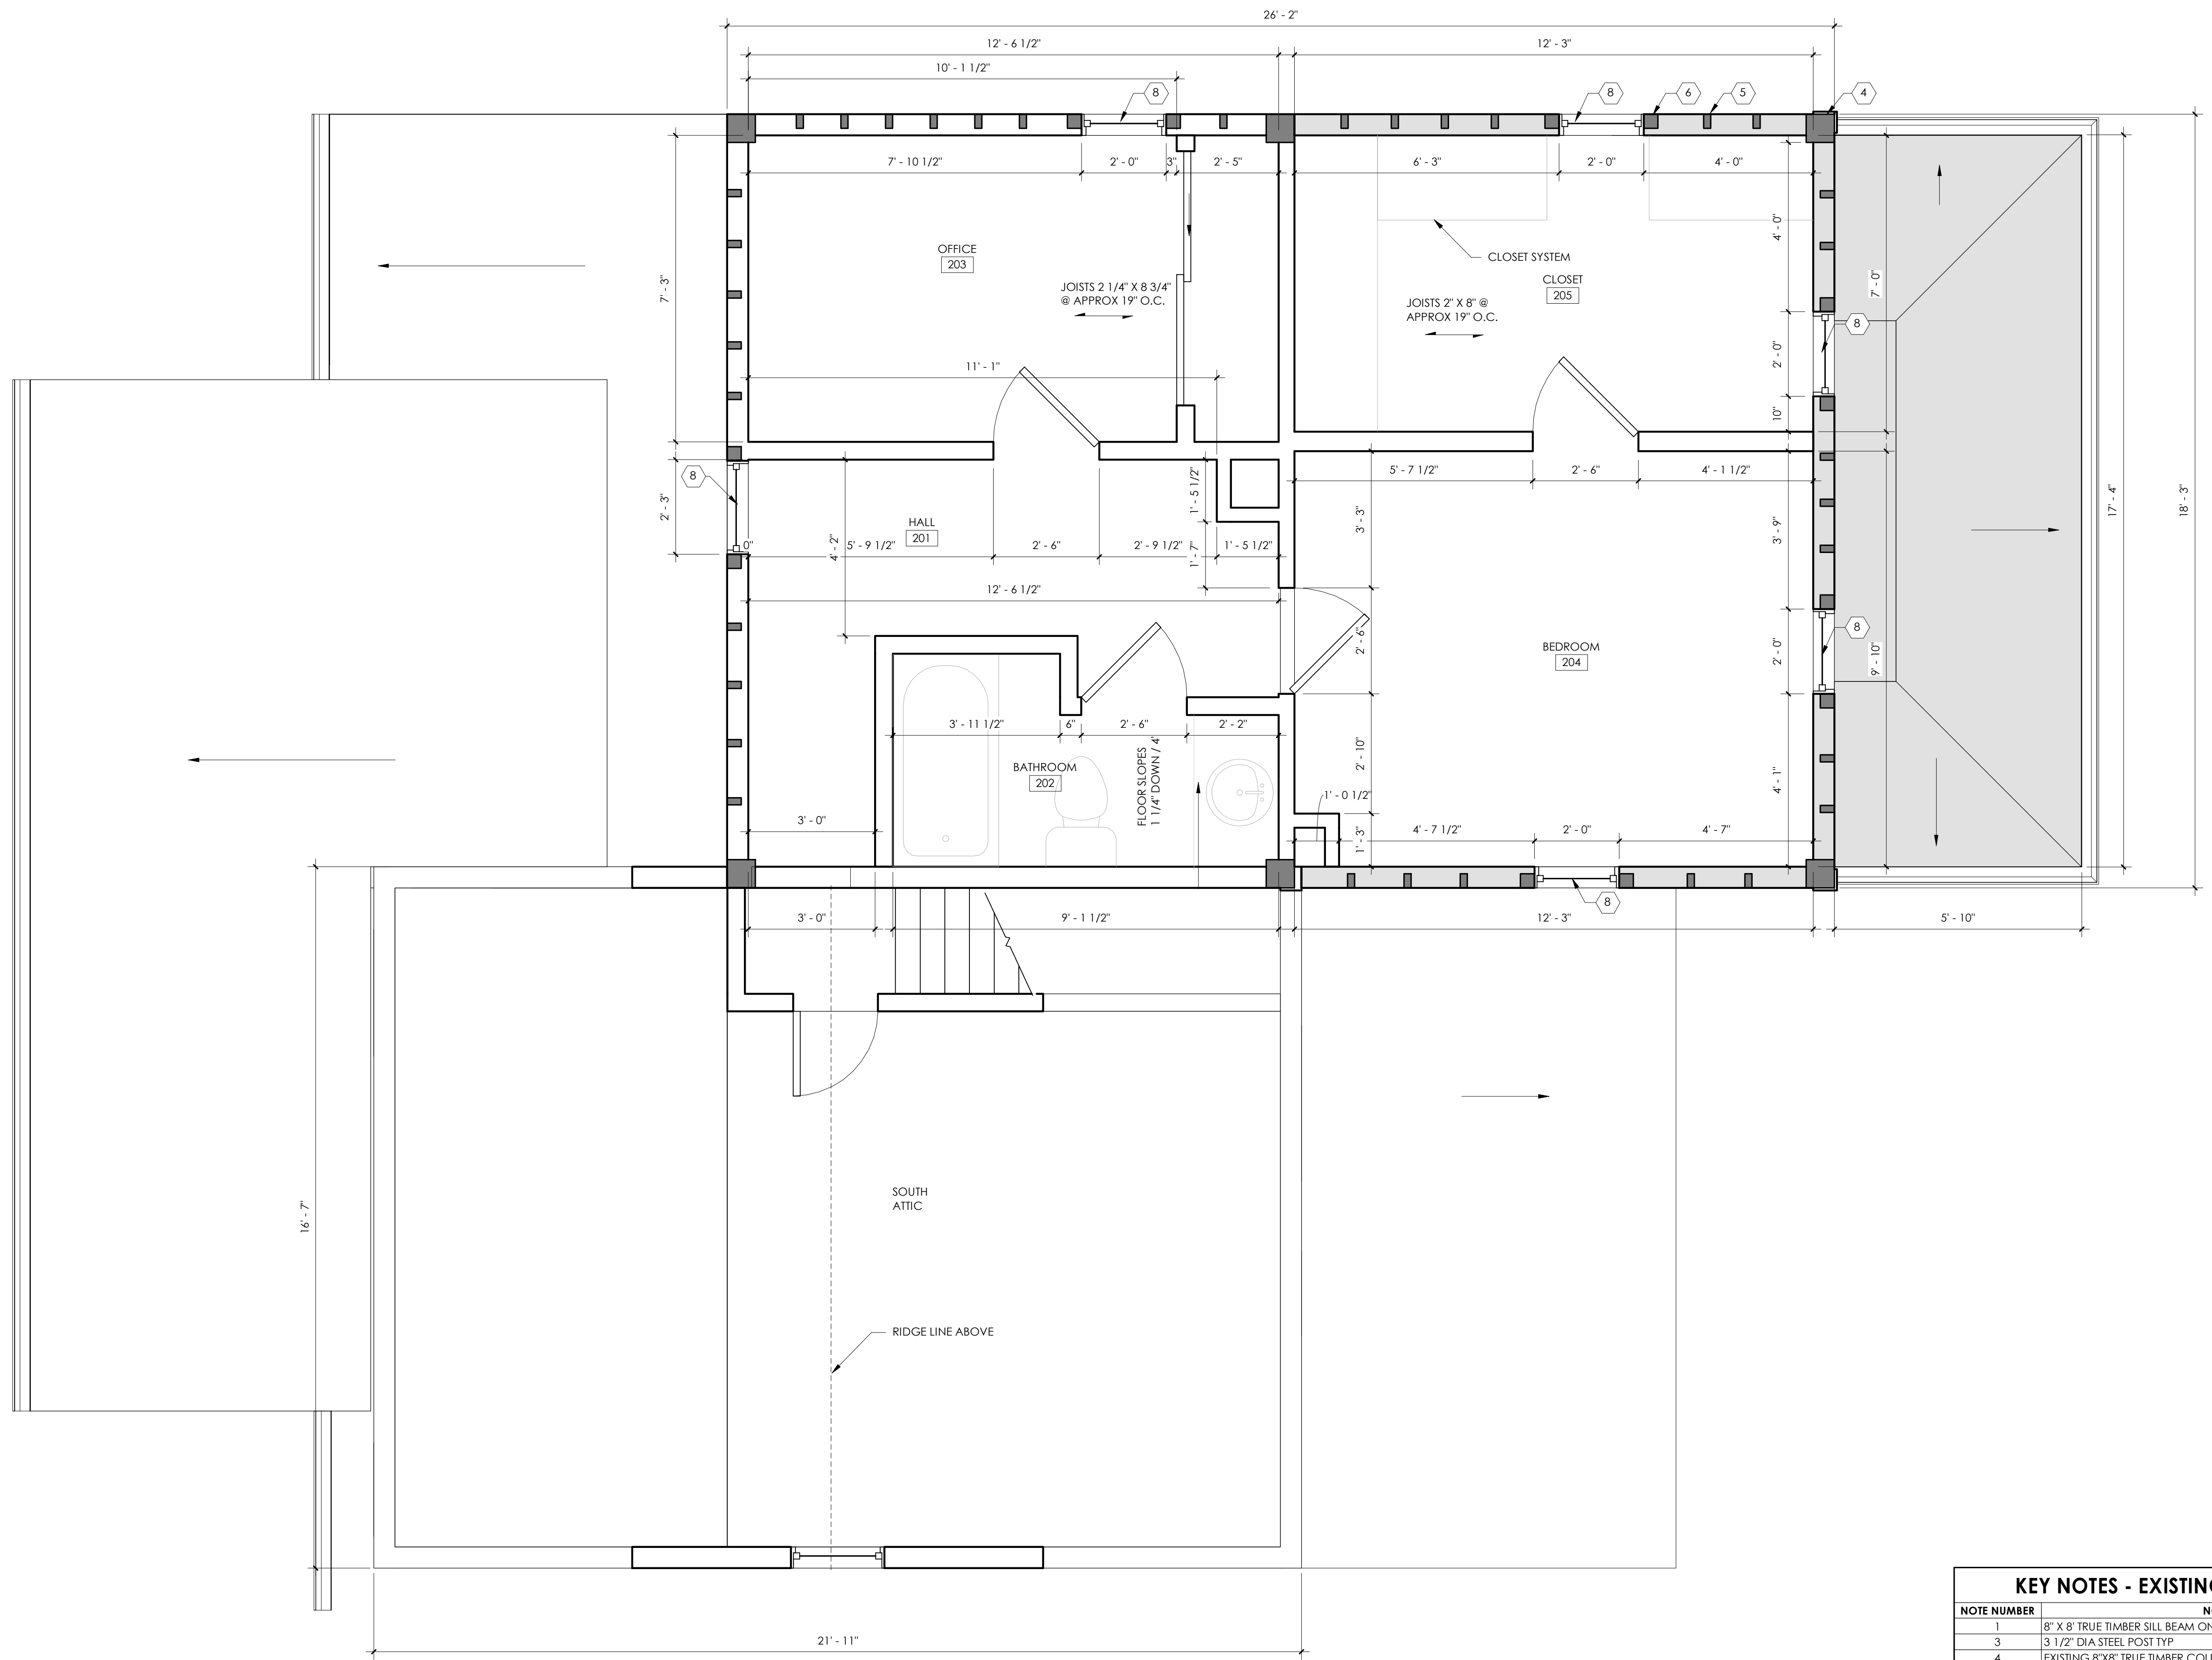
**EXISTING FIRST FLOOR PLAN**  
1/2" = 1'-0"

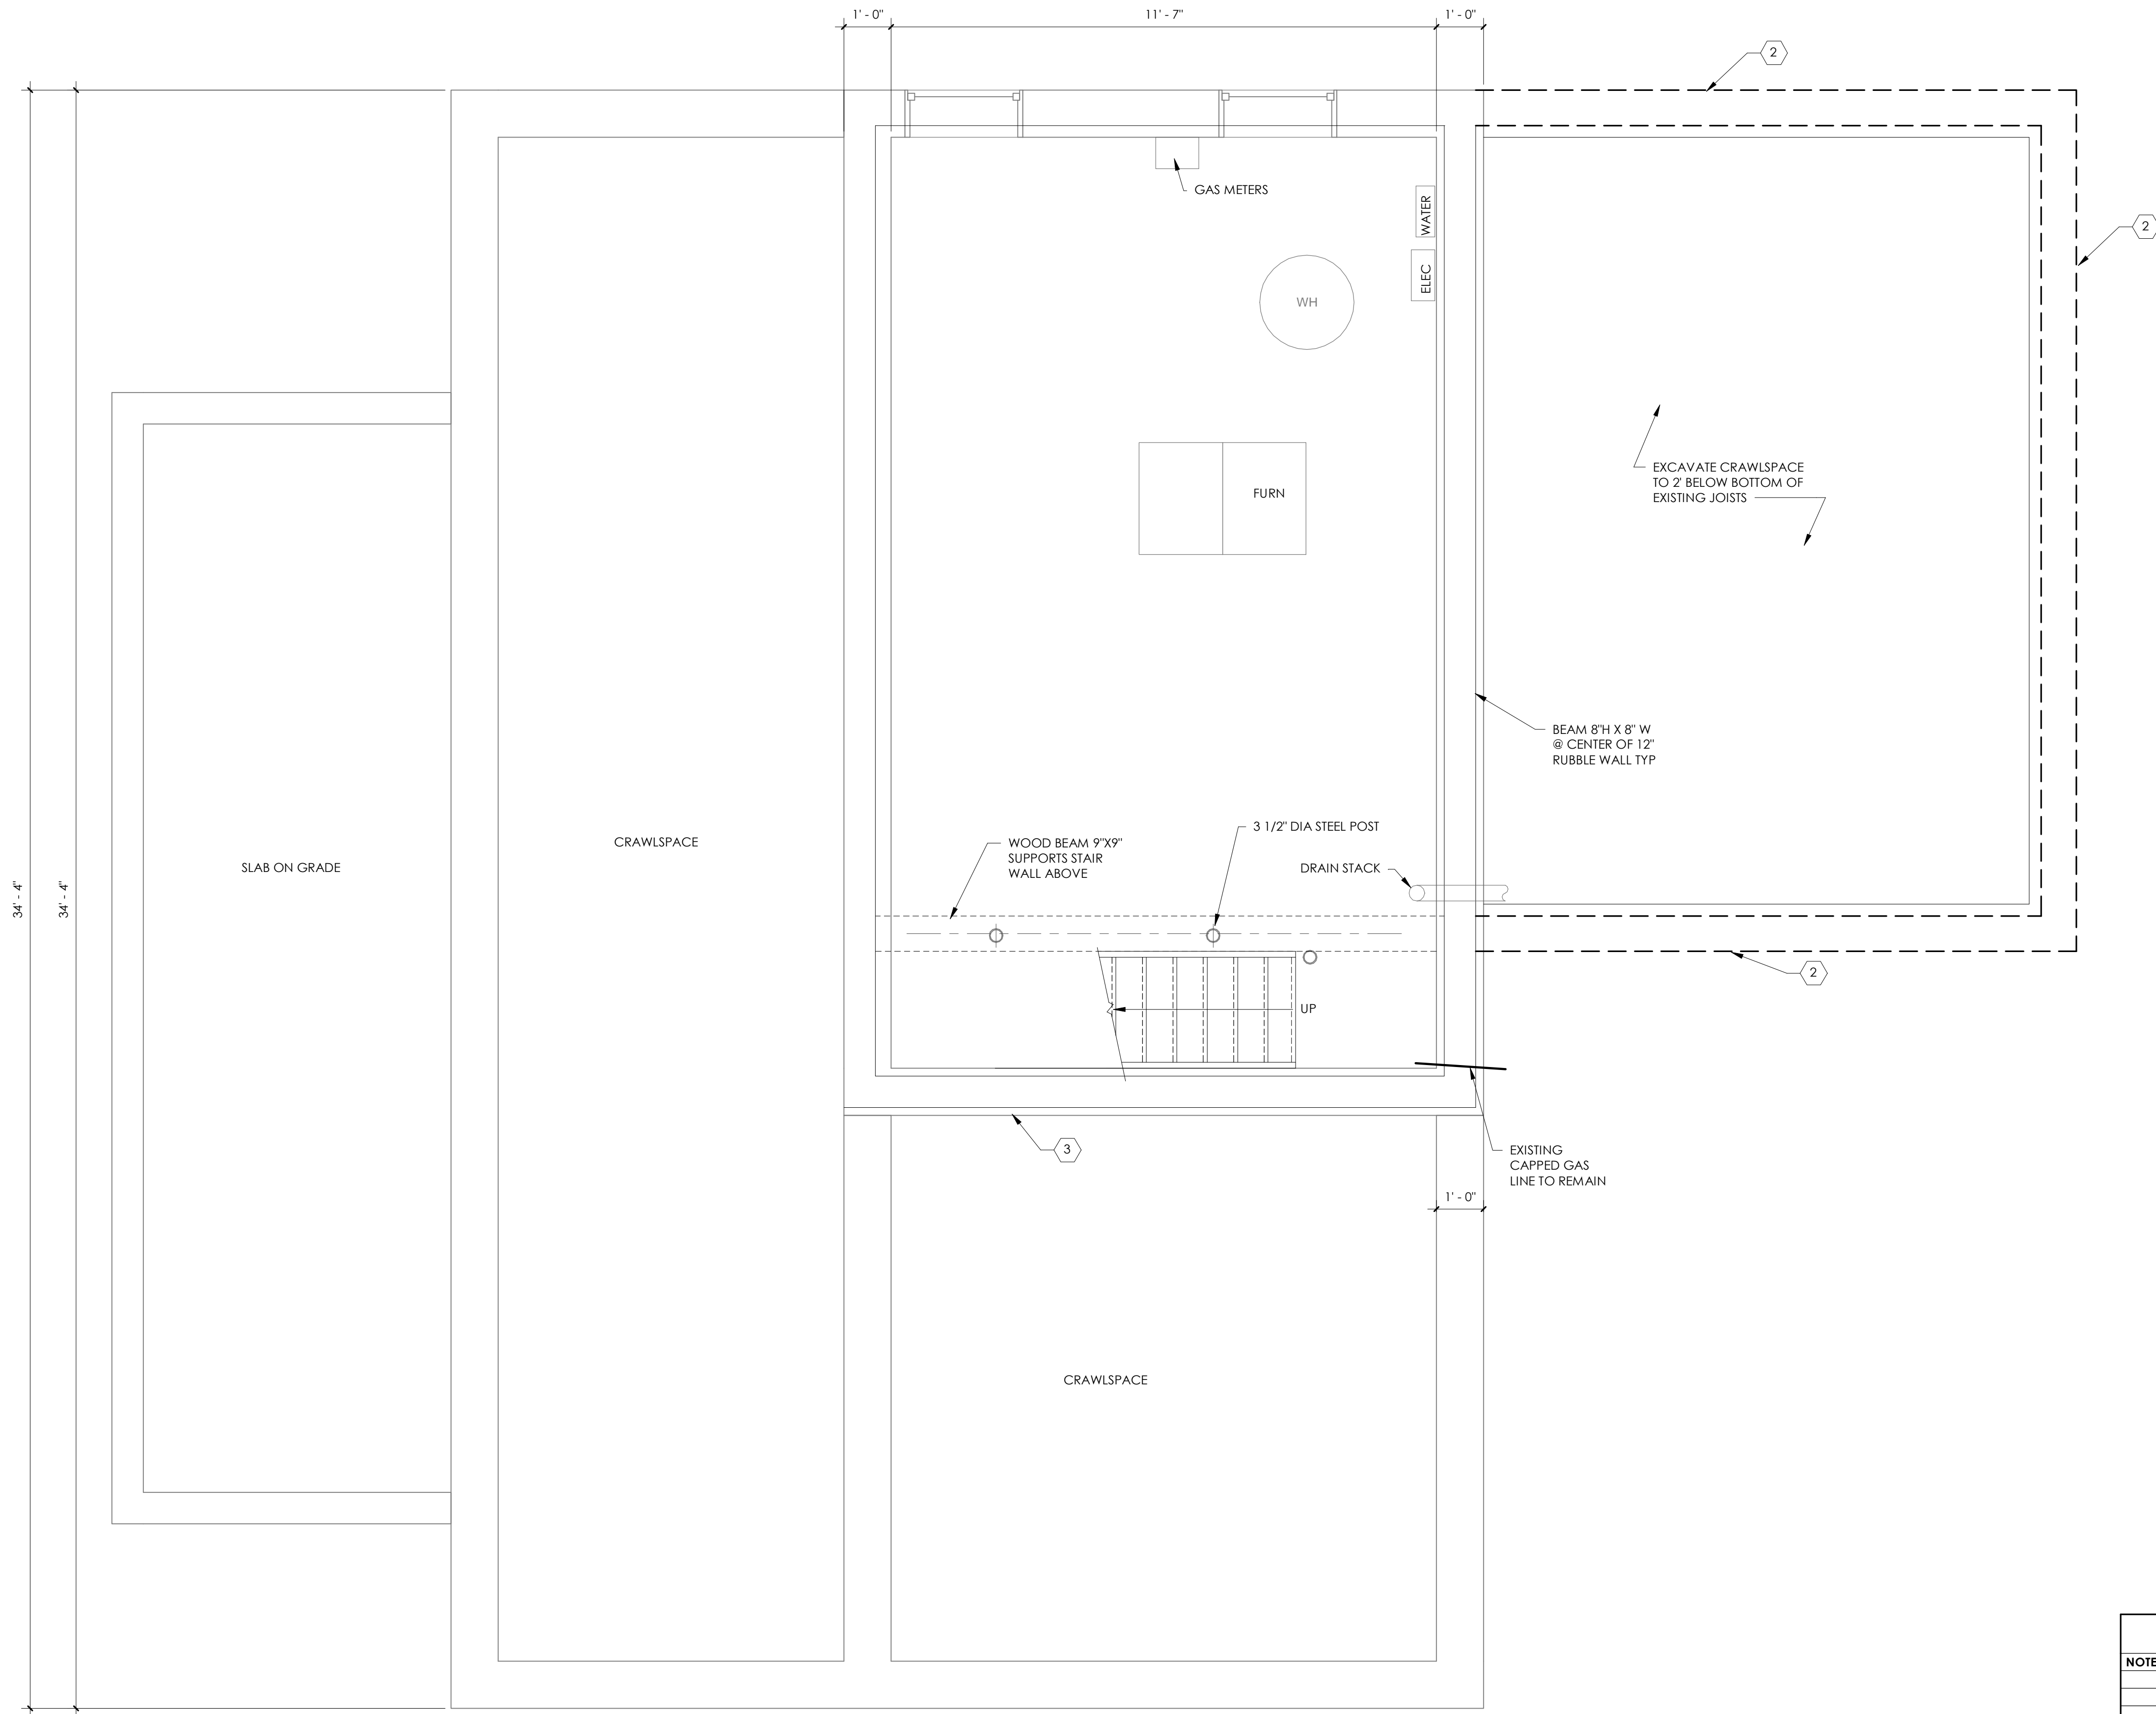
**SECOND FLOOR EXISTING FLOOR PLAN**  
 1/2" = 1'-0"

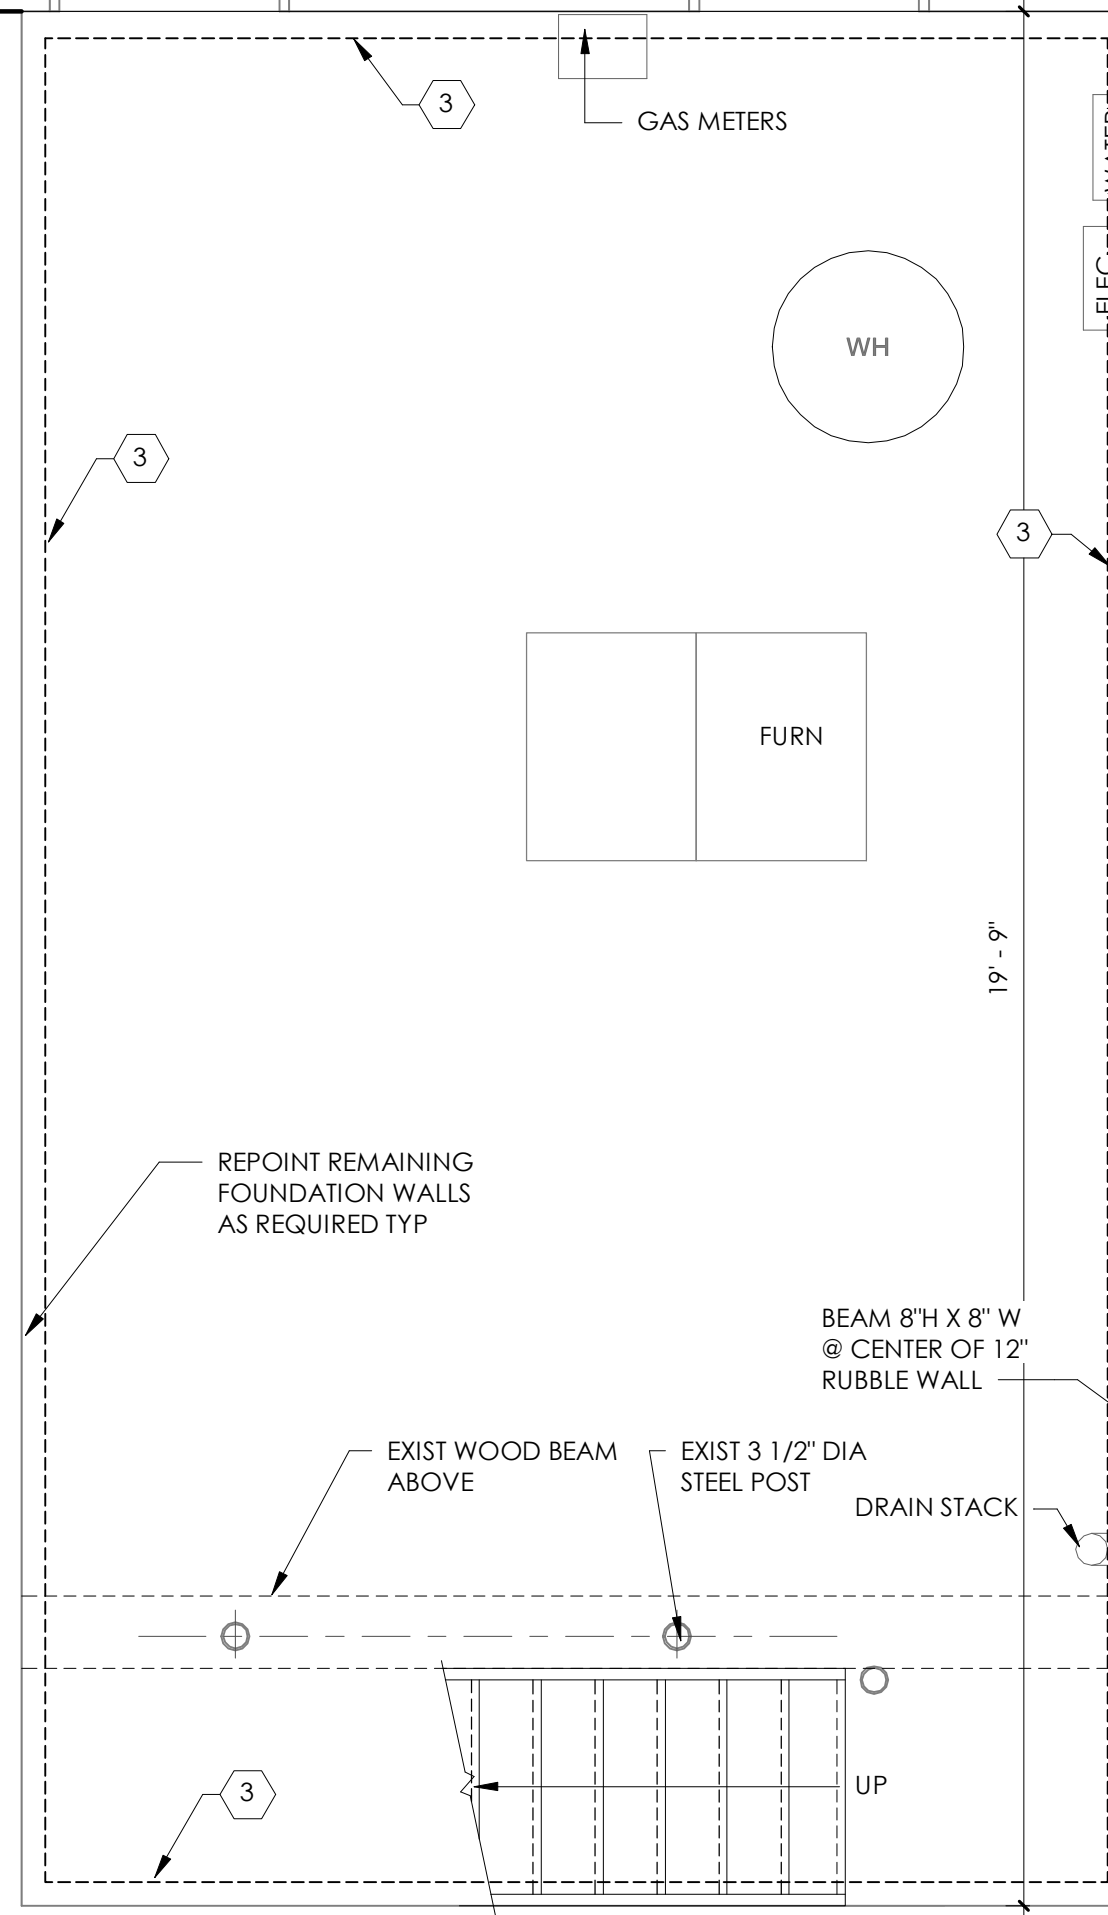
REPOINT REMAINING FOUNDATION WALLS AS REQUIRED TYP

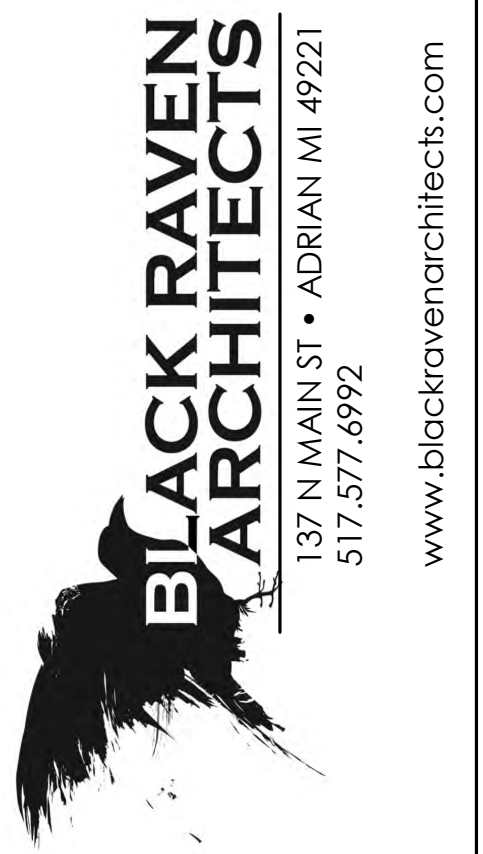
SEALED BY:  
**NOT FOR CONSTRUCTION**

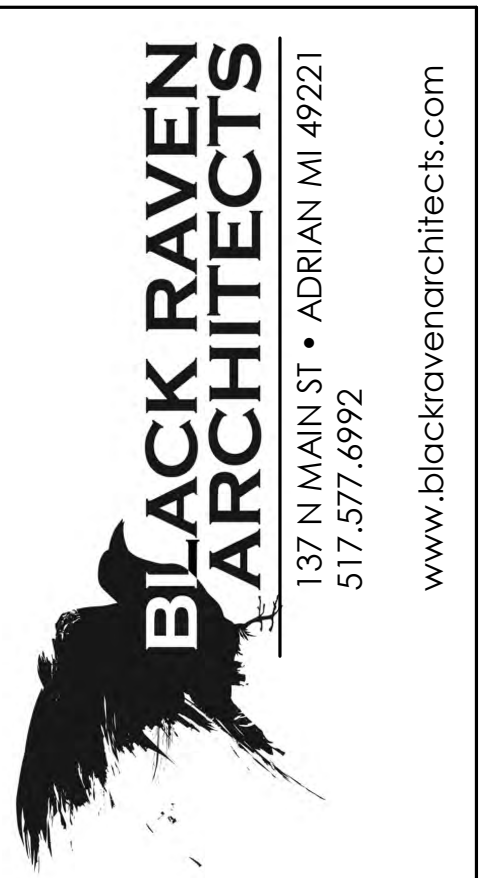
**NOT FOR CONSTRUCTION**
