## ANN ARBOR HISTORIC DISTRICT COMMISSION

### Staff Report

**ADDRESS:** 216 N State Street, Application Number HDC21-035

## INSPECTION REPORT OLD GARAGE 216 N. STATE ANN ARBOR, MICHIGAN

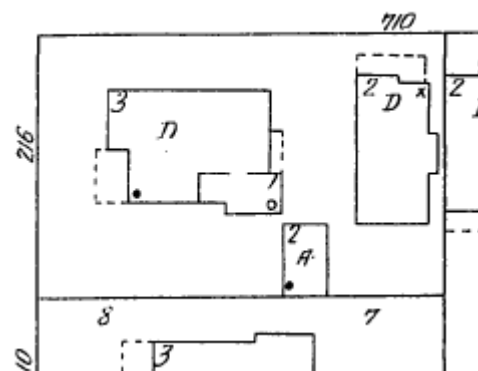
3. The garage is shown on the 1925 Sanborn Fire Insurance Map at right, which indicates a two-story automobile garage in the same footprint as the existing. It does not change on the 1931 or 1948 Sanborn. The garage was not present in 1916.

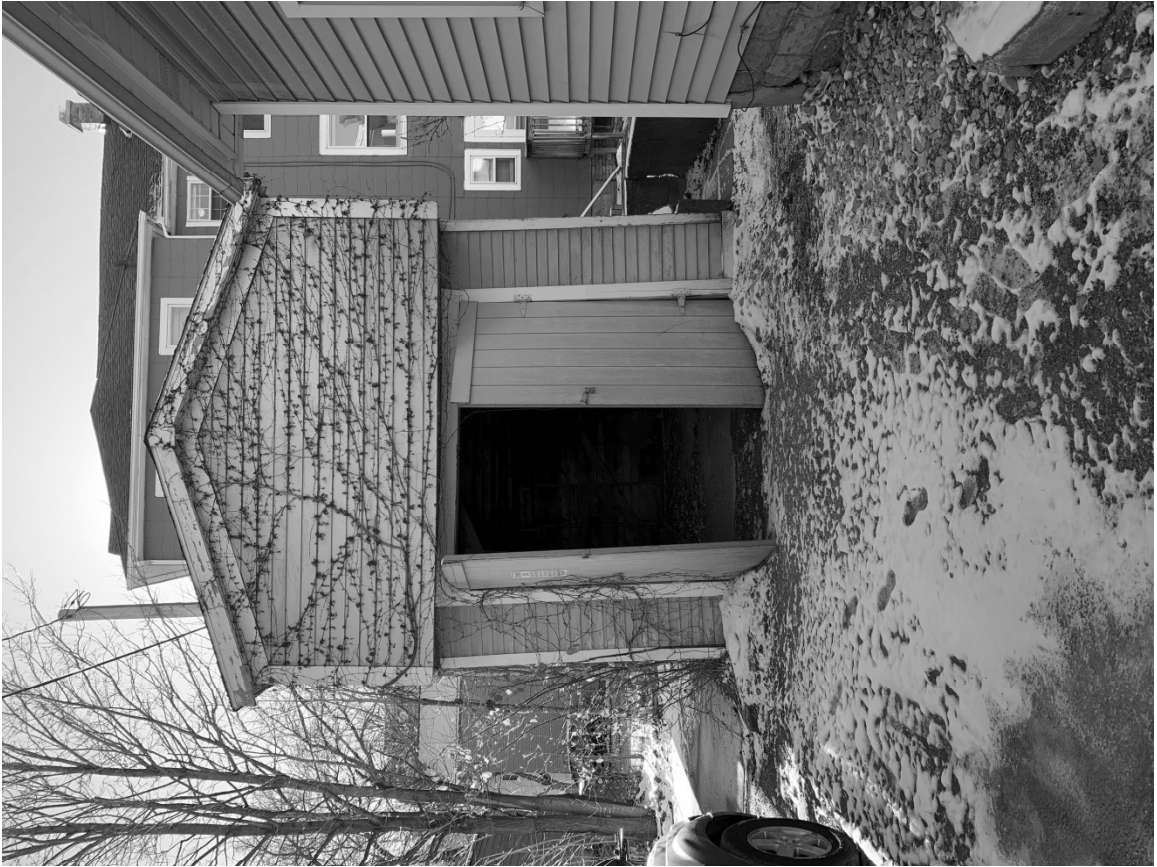
**PHOTO #1 – NORTH ELEVATION**

- 1) The building has a distinct lean to the east (visible in photo #1), as its resistance to wind load is insufficient.
- 2) Rotting of studs at base of wall (see photos #5-7). In more than a few instances, the degree of rotting is complete; there is zero connection/load transfer between the stud and foundation.
- 3) Discontinuous studs (see photos #8-9). Some of the wall studs consist of discontinuous and/or spliced studs. It is difficult to “splice” wood and obtain the required strength (the splices will create a “hinge”, greatly impairing the ability to the stud to act as a structural member).
- 4) Deteriorated joists/decking (see photos #10-12). A number of joists and some of the decking has been repeatedly exposed to moisture (roof leaking), and has deteriorated as a result. The loss of strength can be seen in the excessive bowing.

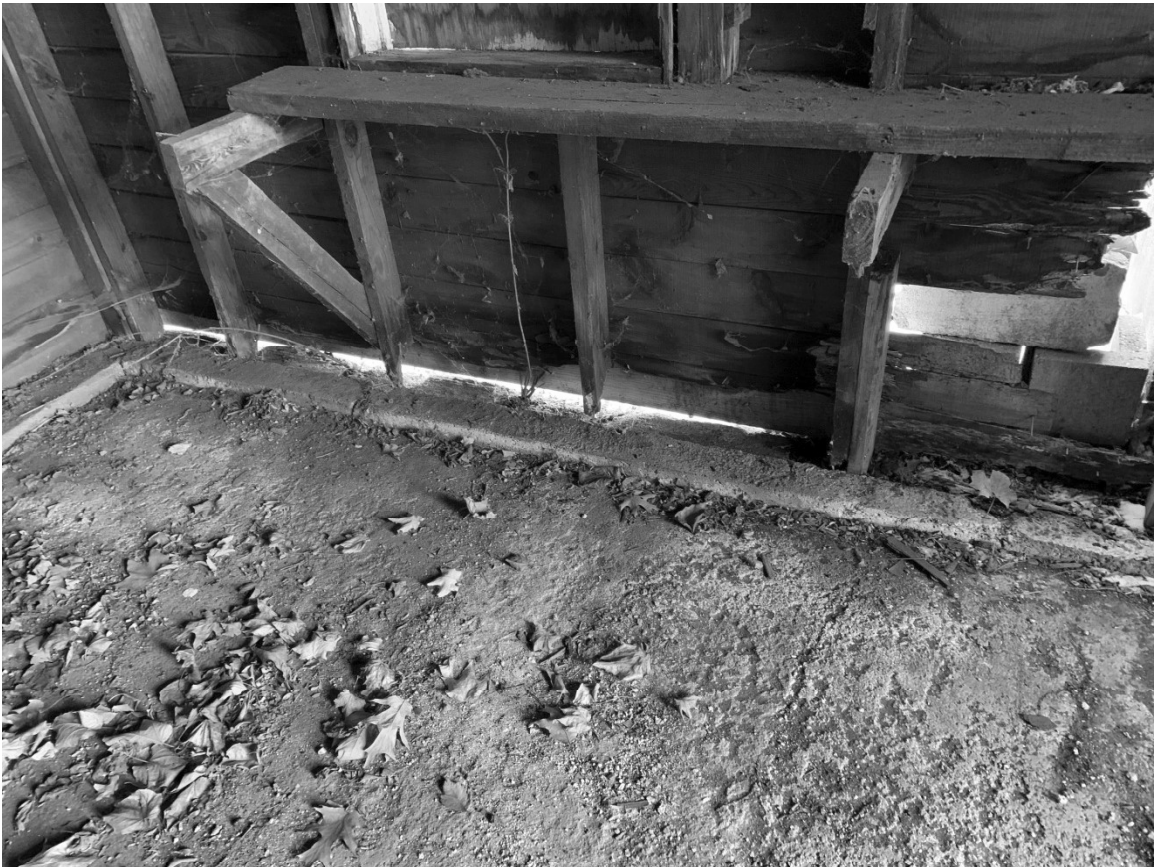
**PHOTO #5 – ROTTED STUDS @ BASE**

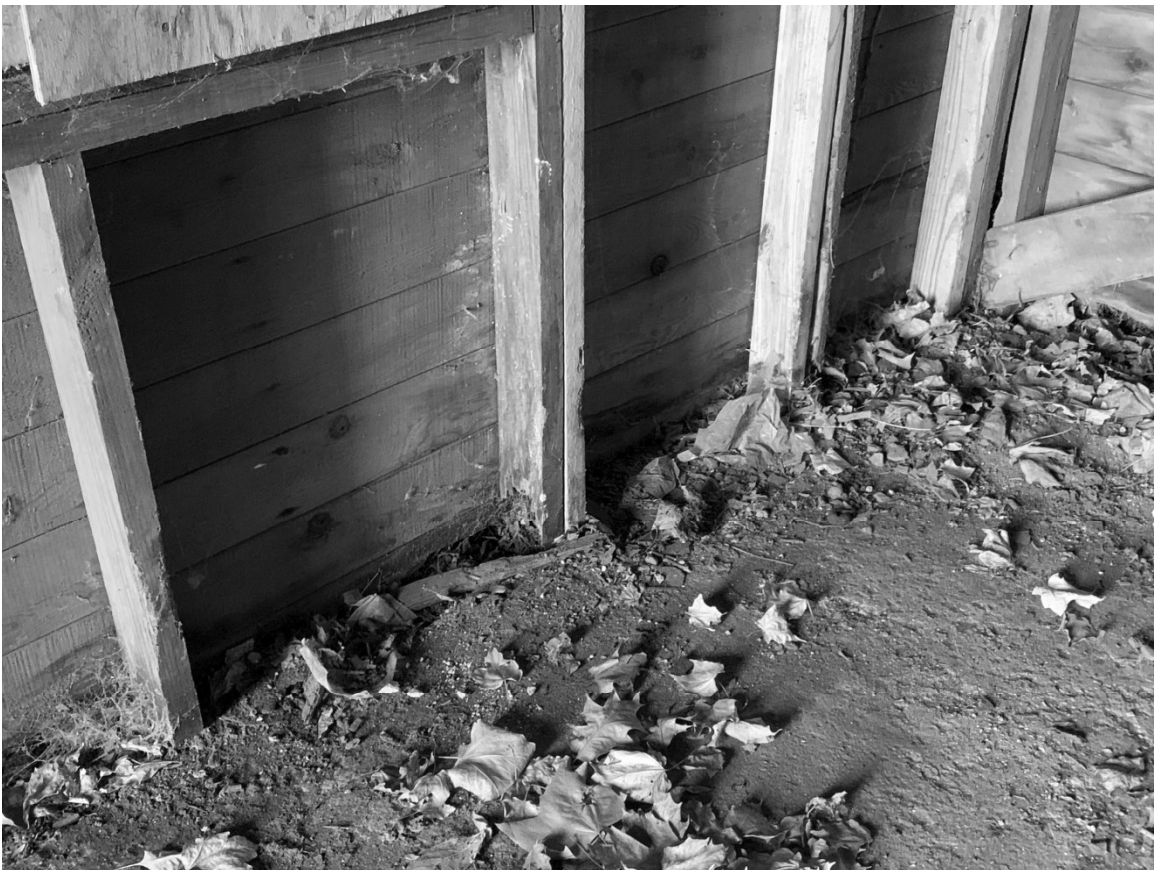
**PHOTO #6 – ROTTED STUDS @ BASE**

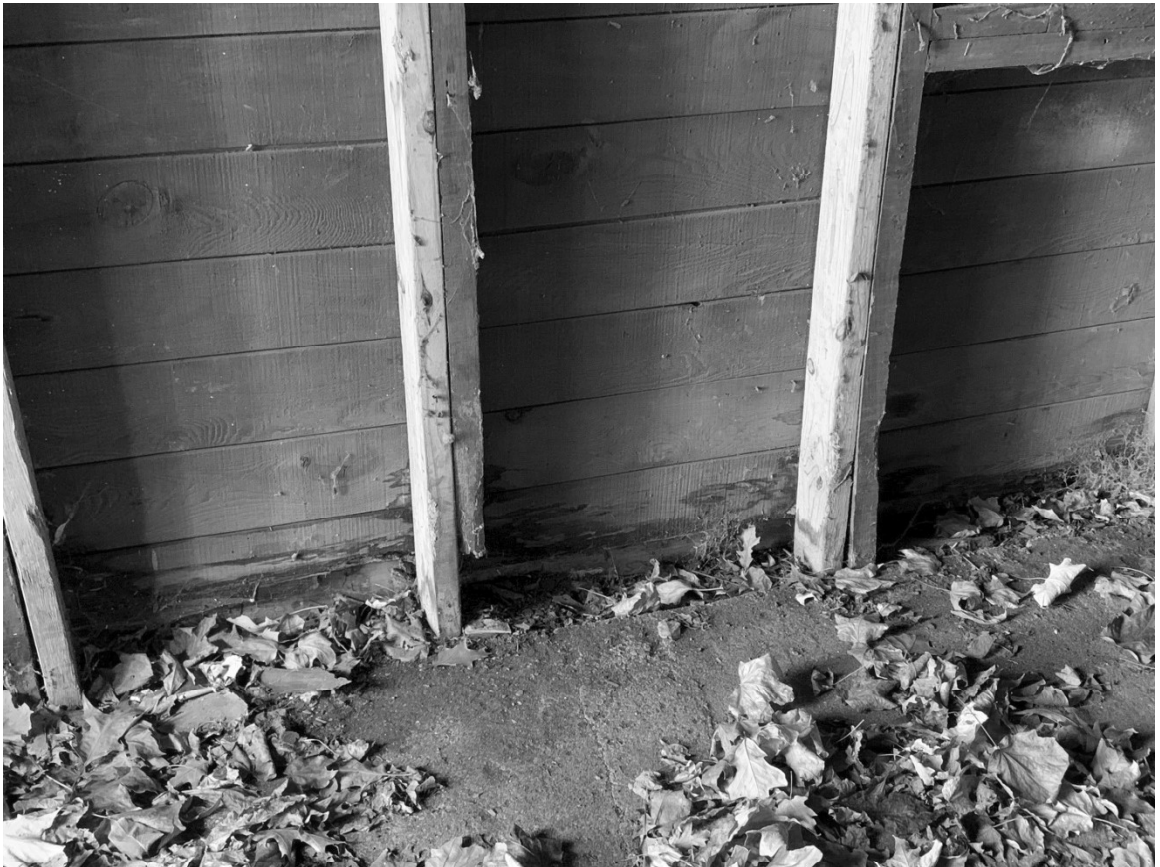
**PHOTO #7 – ROTTED STUDS @ BASE**

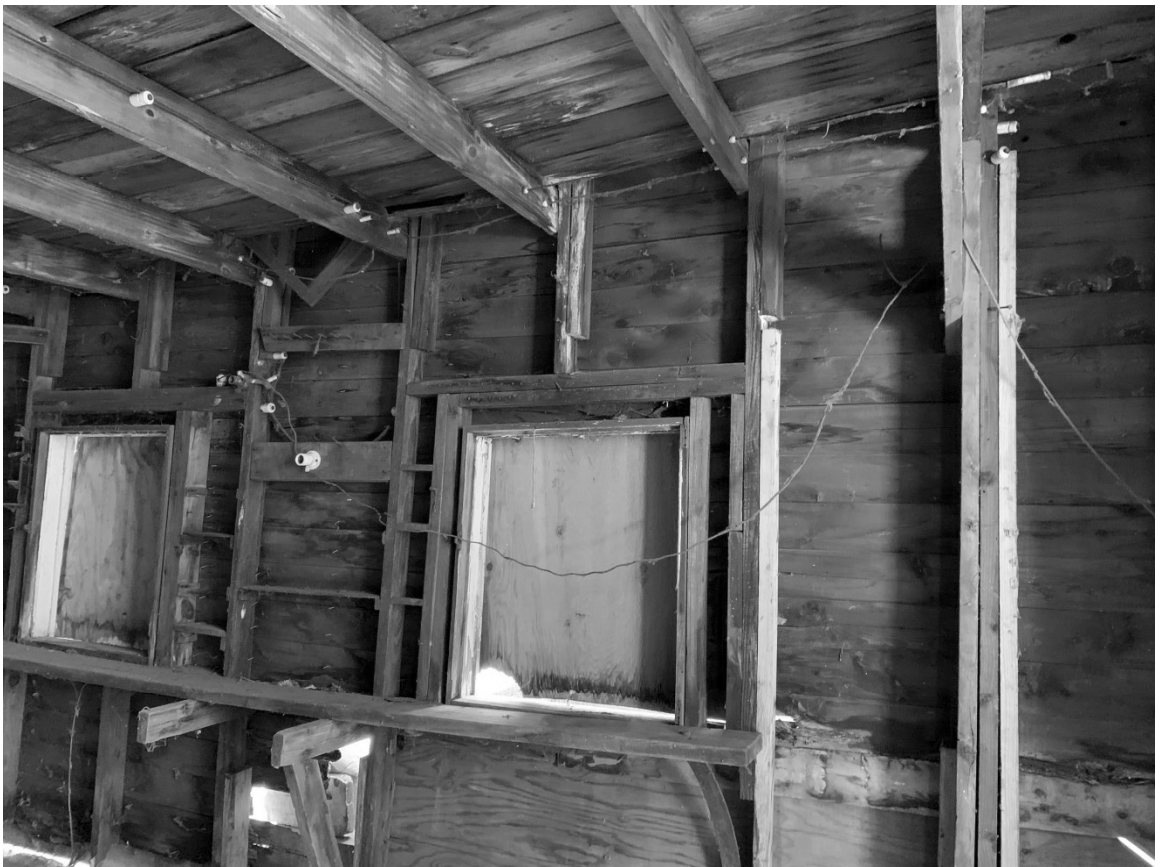
**PHOTO #8 – DISCONTINUOUS STUDS**

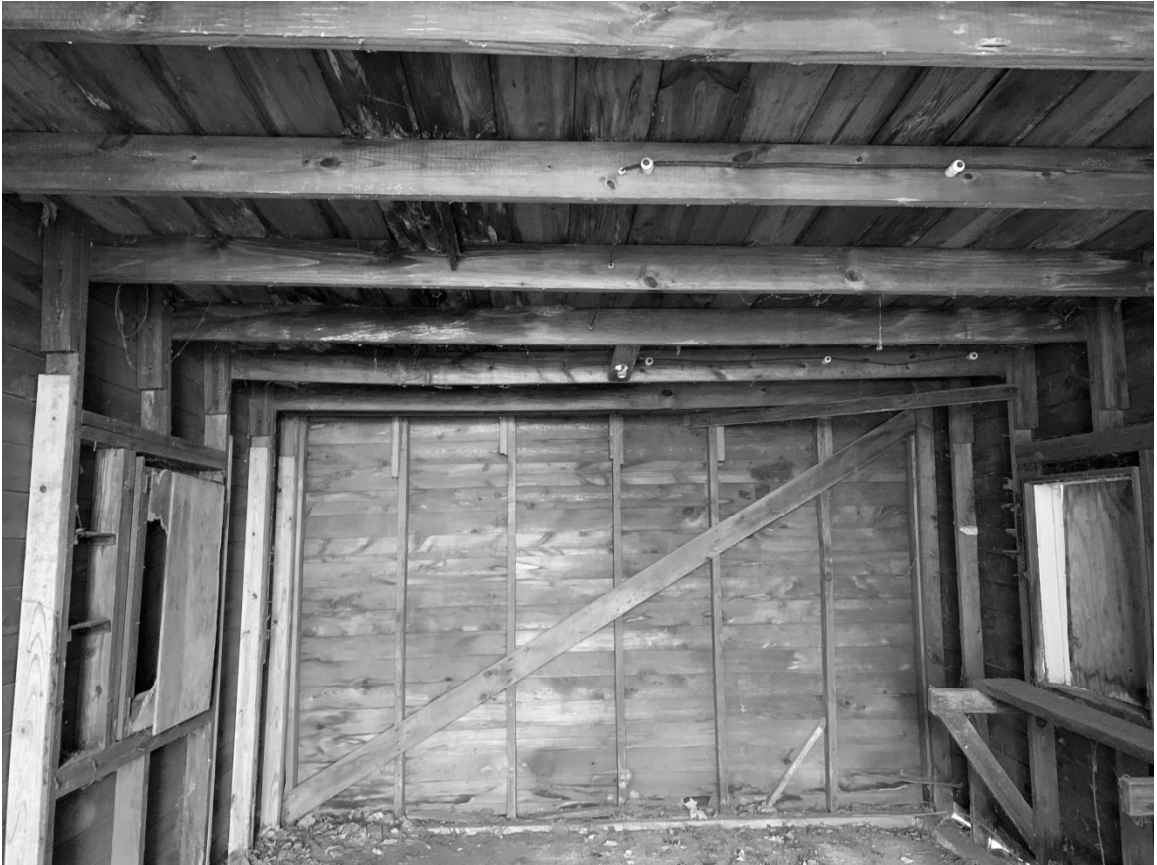
**PHOTO #9 – DISCONTINUOUS STUDS**

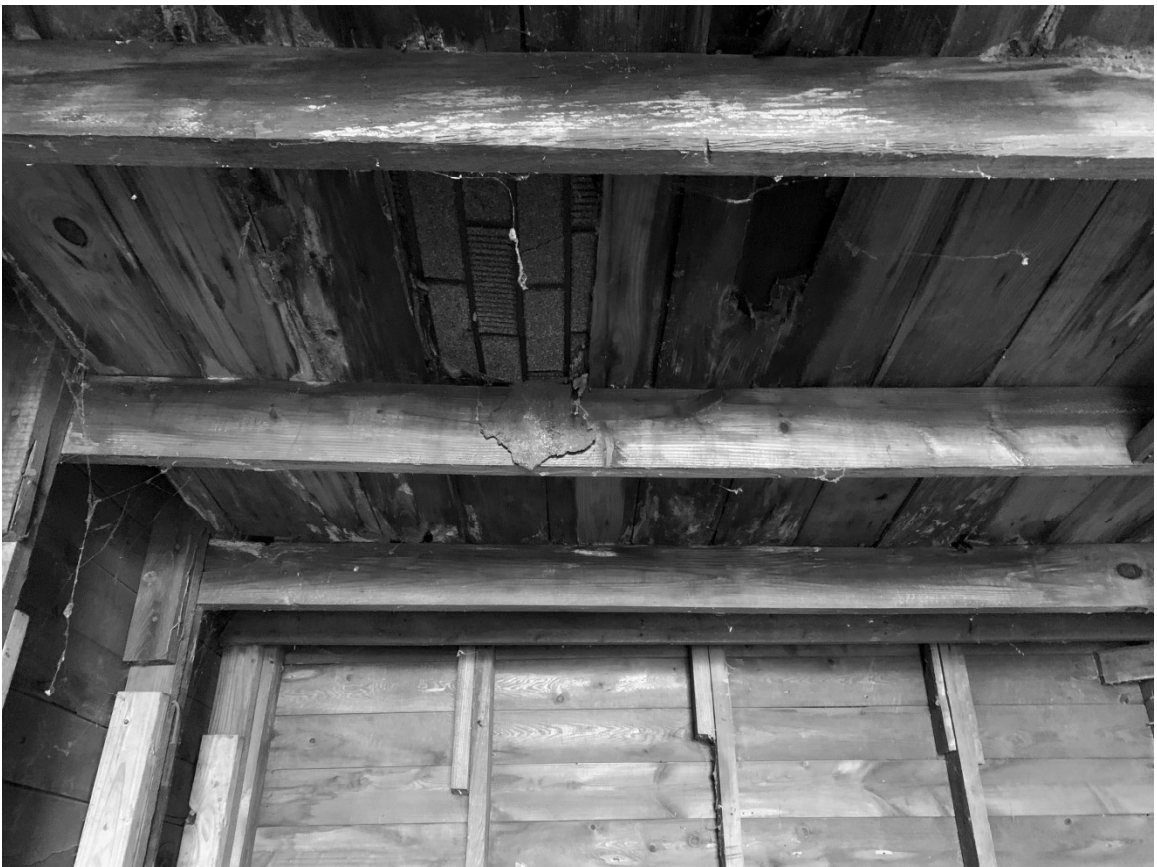
**PHOTO #10 – DETERIORATED JOISTS/DECKING**

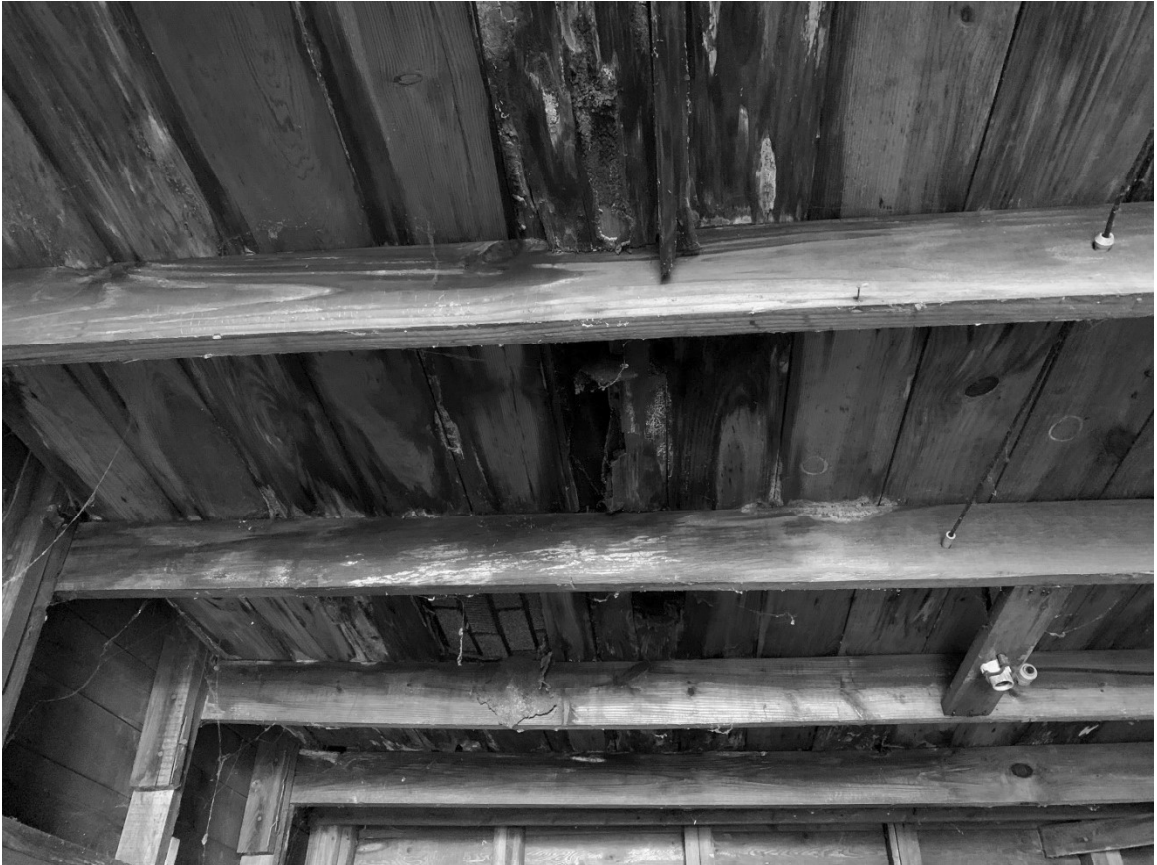
**PHOTO #11 – DETERIORATED JOISTS/DECKING**

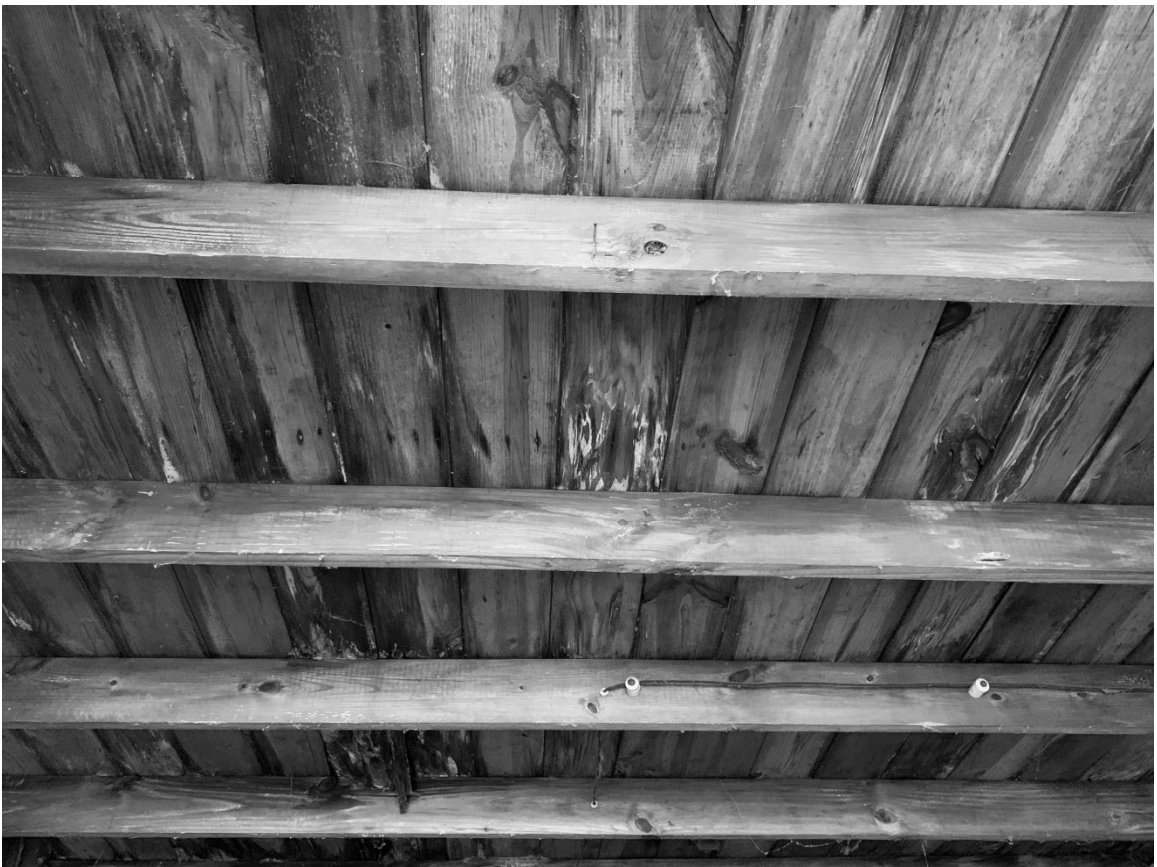
**PHOTO #12 – DETERIORATED JOISTS/DECKING**
