STRUCTURAL EVALUATION REPORT

Chimney at 415 W. Washington Ann Arbor, Michigan

DNCE Project No. : 18-1339

Date Submitted: November 20, 2018

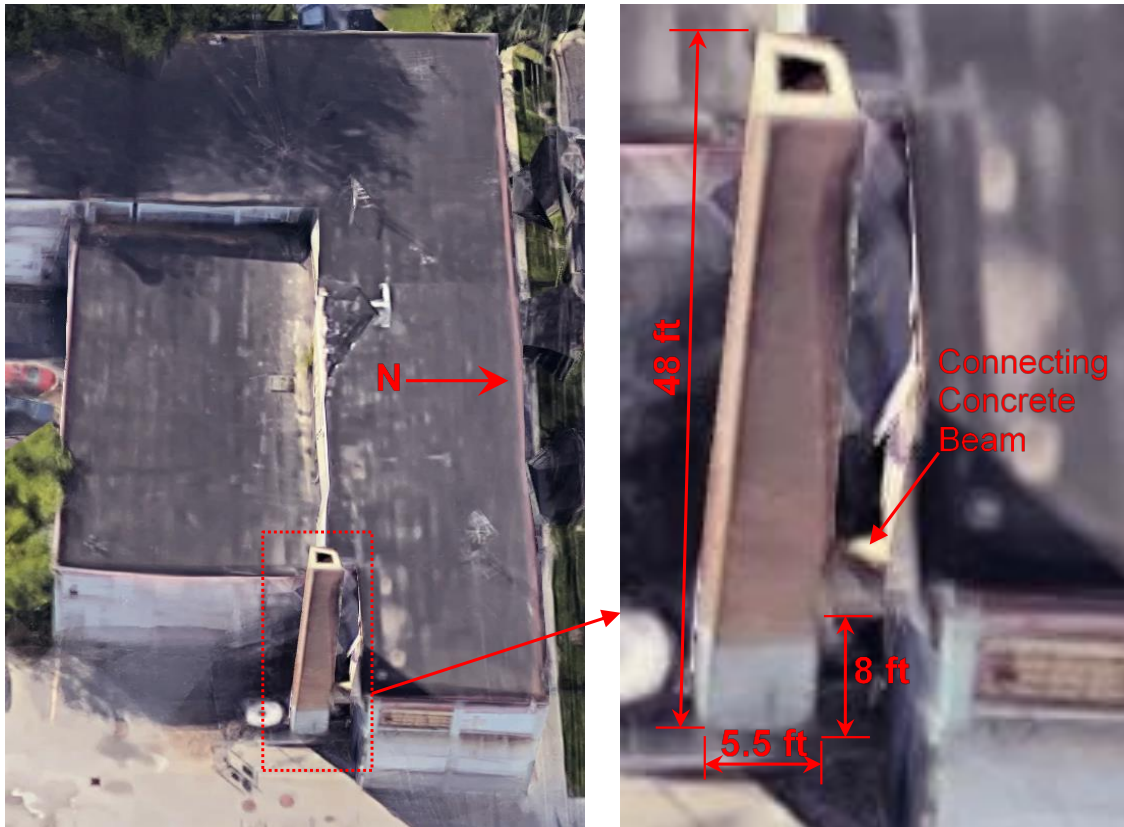
Figure 1. Chimney configuration and attachment to adjacent building.

The chimney is approximately 48 ft tall with plan dimensions of approximately 5.5 ft x 5.5 ft, constructed from clay bricks and supported on a reinforced concrete base (Figure 1). The concrete base of the chimney is connected to the adjacent building through a concrete beam that is approximately 6 ft long, 2.75 ft x 2.75 ft in section, and 8 ft above ground level. There is also a 7 ft high masonry wall connecting the chimney (at the north-west corner) to the adjacent building wall (Photoset 3). Due to the lack of Existing Structural Drawings and the visual nature of the inspection, the chimney foundation layout is assumed to be isolated from the adjacent building foundation.

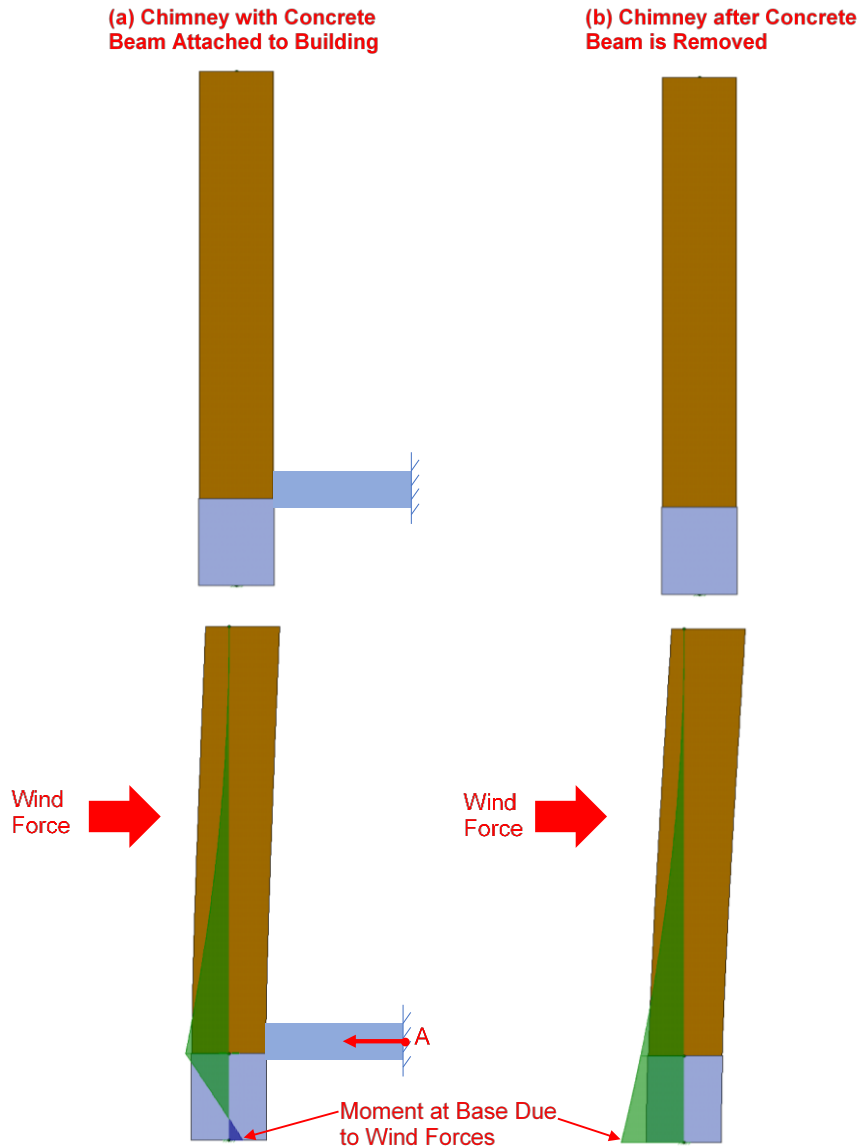
Figure 2. Concrete beam attachment to chimney and the adjacent building.

In order to examine the effect of removing the existing concrete beam (flue) connecting the chimney to the adjacent building, two models for the chimney structure have been analyzed (Figure 2). In both models, distributed lateral wind forces along the entire height of the chimney structure were applied in the north-south direction. The first model (a) is based on the existing conditions, while the second model (b) is based on the scenario where the beam is completely removed and the chimney is acting as a “stand-alone” structure. As shown in Figure 2, the resulted flexural moment at the base of the chimney after removing the beam (case b) became much larger, compared to the case where the beam is connected to the chimney, by approximately 4 times. However, this difference in the moment at the bottom is based on the assumption that the connecting beam is supporting the chimney in the horizontal direction, 8 ft above ground, and transferring lateral forces from the chimney to the existing building frame (presented by the reaction at point A).

Since no structural connection between the concrete beam and the existing building frame was visible, it is assumed that the beam was not designed as a main lateral support member to the chimney structure. Therefore, removing this beam should not affect the lateral stability of the chimney as a stand-alone structure, assuming that the chimney is supported on an isolated foundation. Thus, if the final decision is to keep the chimney, isolating the chimney foundation against vibration and soil movement during demolition and construction is highly recommended. Temporary shoring is advised during demolition of the adjacent building, and until the new construction is completed.

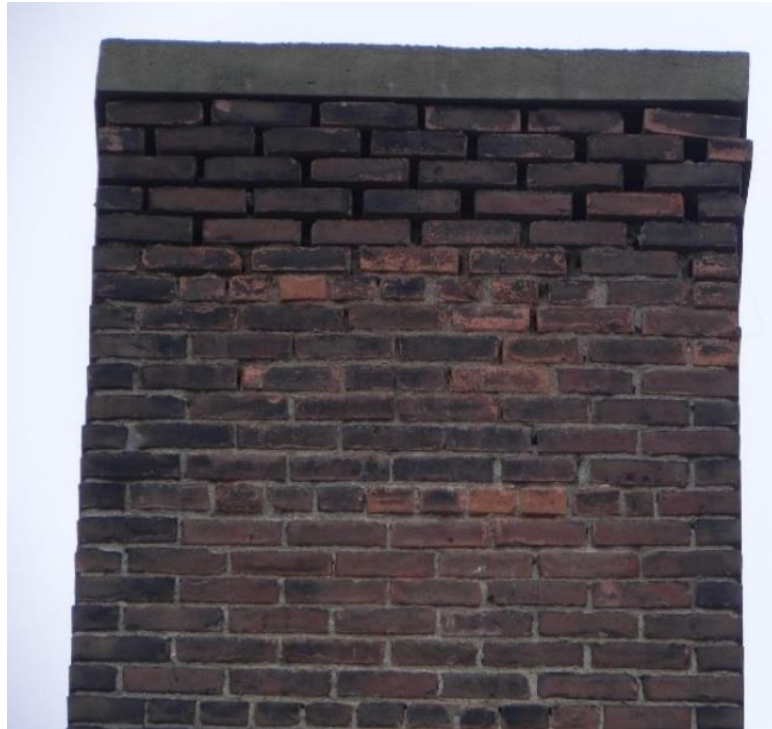
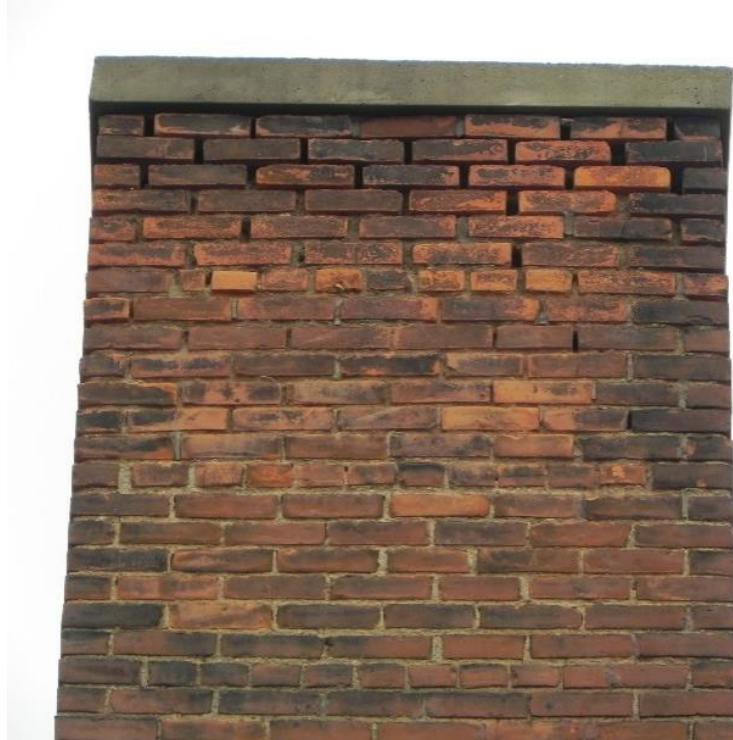
Chimney Top

- Loose bricks and lack of mortar between bricks at top of chimney (Photoset 1).
- The concrete base of the chimney has vertical cracks at the south side, east and west sides (Photoset 2).
- Major crack in bricks extending from the west to the south side of the chimney, above the concrete base (Photoset 3).
- Cracks in the concrete beam (Photoset 4).
- Sever horizontal crack in the existing building concrete frame near the beam attachment point (Photoset 4).

Photoset 1: Loose bricks and lack of mortar joints at top of chimney.

In general, the chimney structure is in a fair to good condition. There are no signs of settlement of the existing chimney base, but a few areas of cracking and loose brick as listed above (section 4.0). However, it should be noted that these areas require major repairs to be made acceptable by current building code requirements. It is recommended to repoint loose brick with new mortar, especially at the top of the chimney, as soon as possible to avoid further deterioration that could potentially become severe and risk falling.

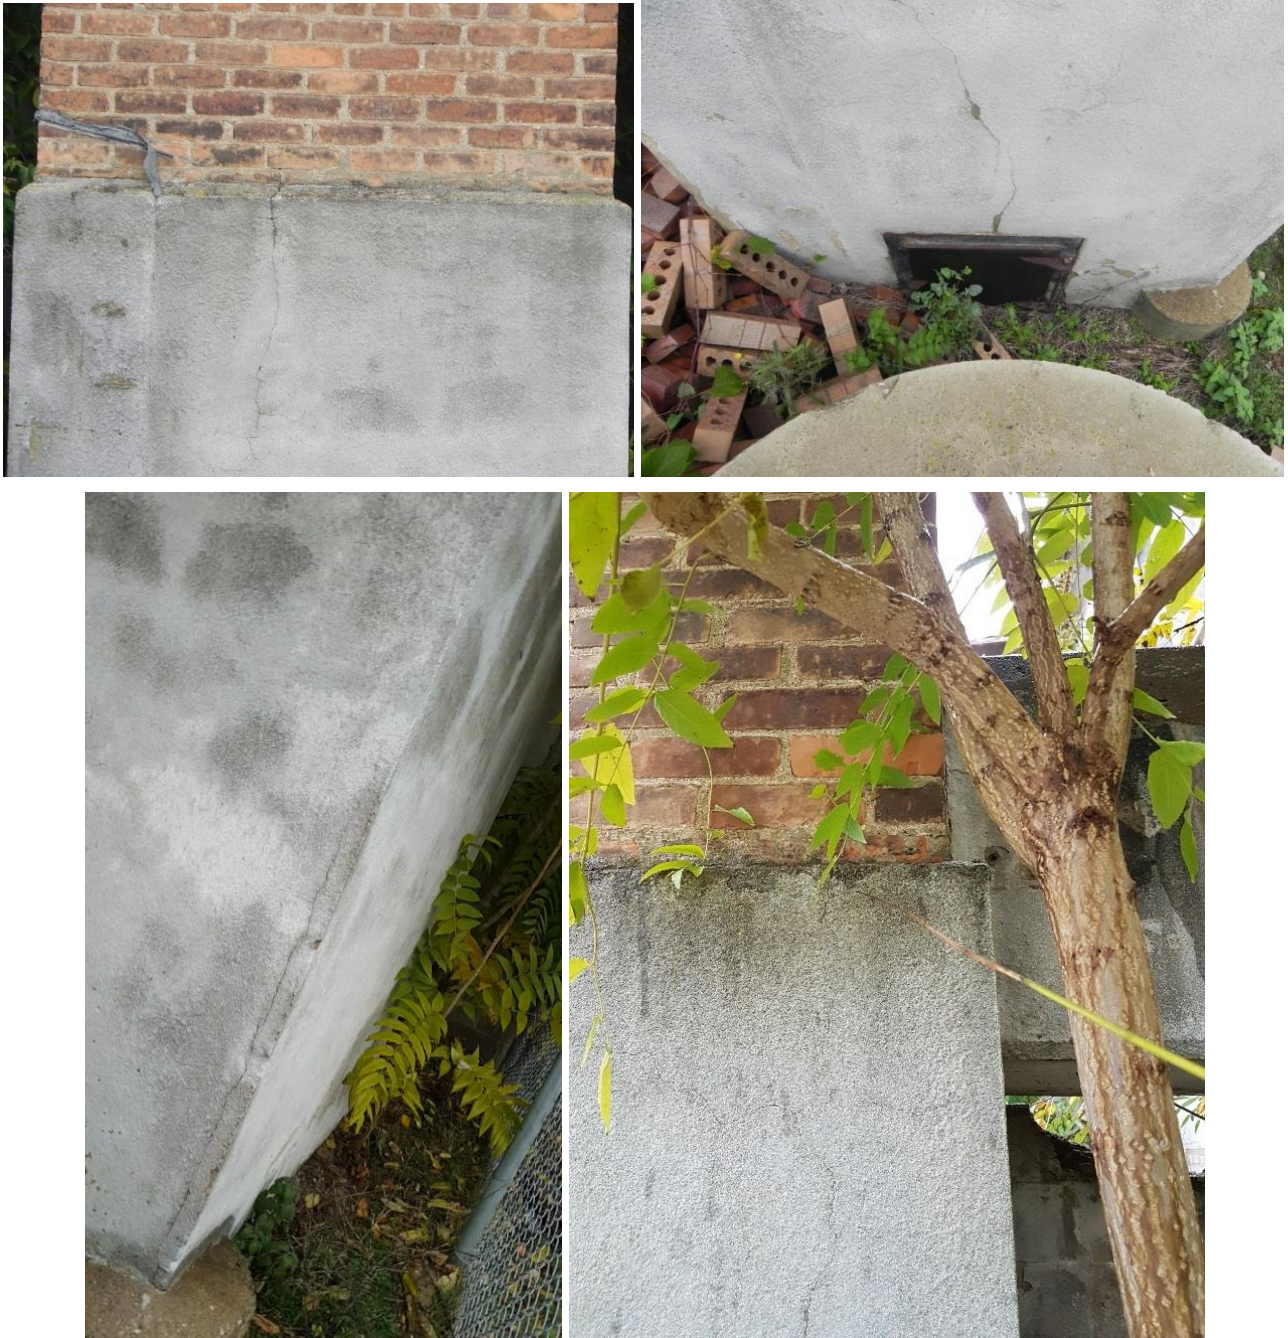
Chimney Base

Photoset 2: Major vertical cracks along the south and east sides of the base.

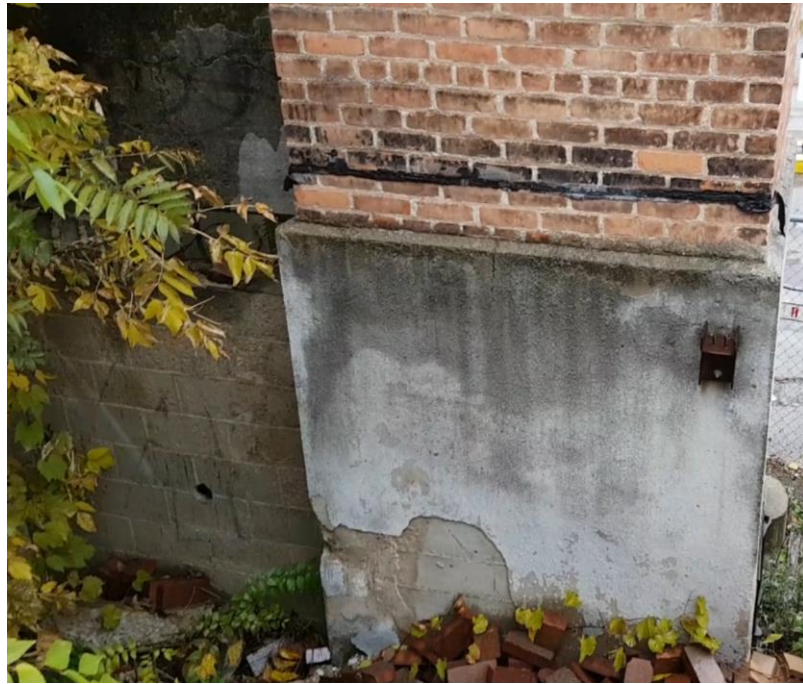
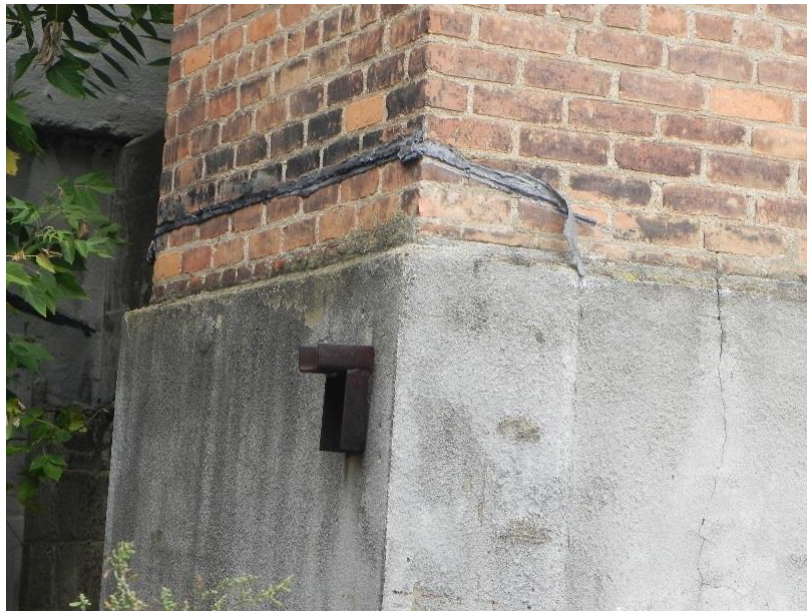
Photoset 3: Major horizontal cracks in brick above the concrete base along south and west sides.

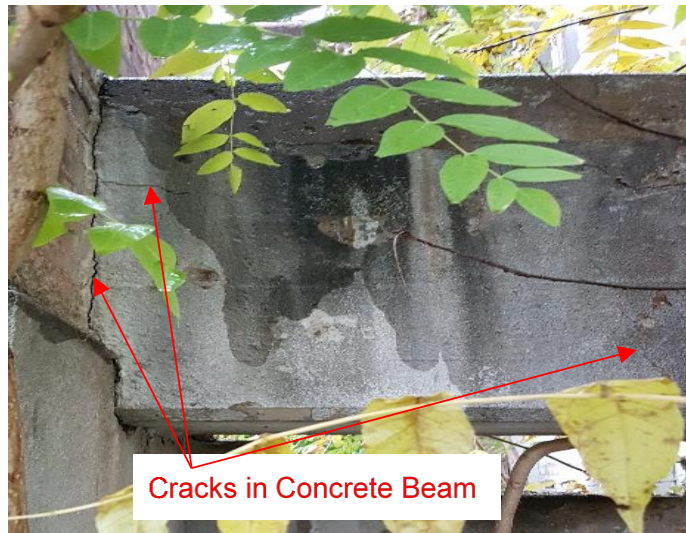
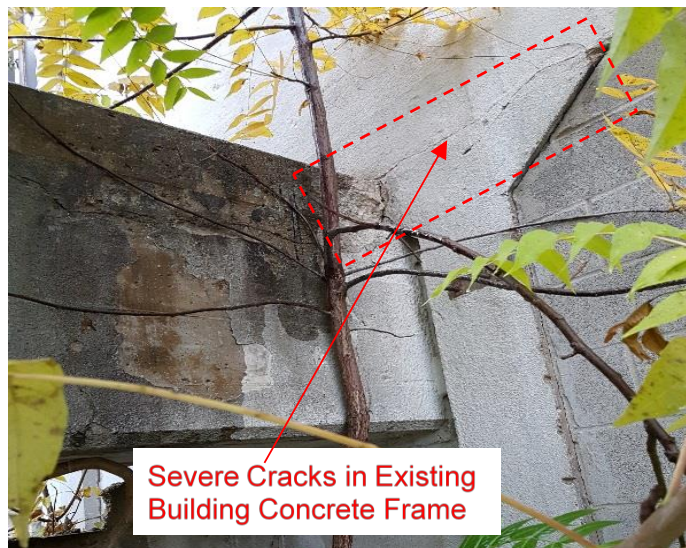
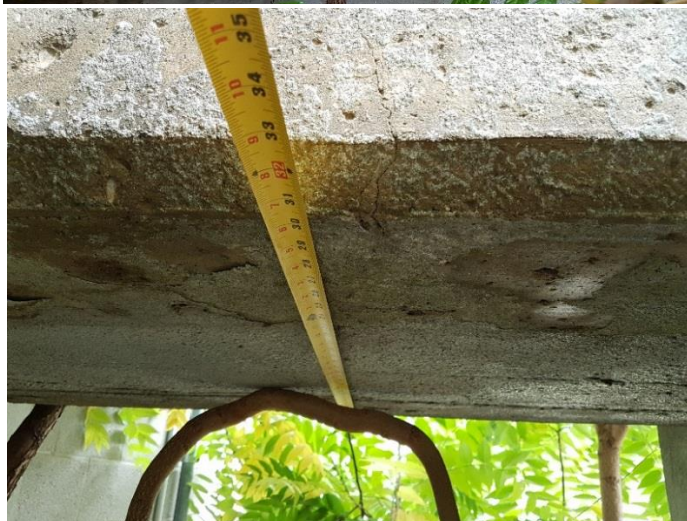
Connecting Concrete Beam

Photoset 4: Cracks in concrete beam and the adjacent building frame.

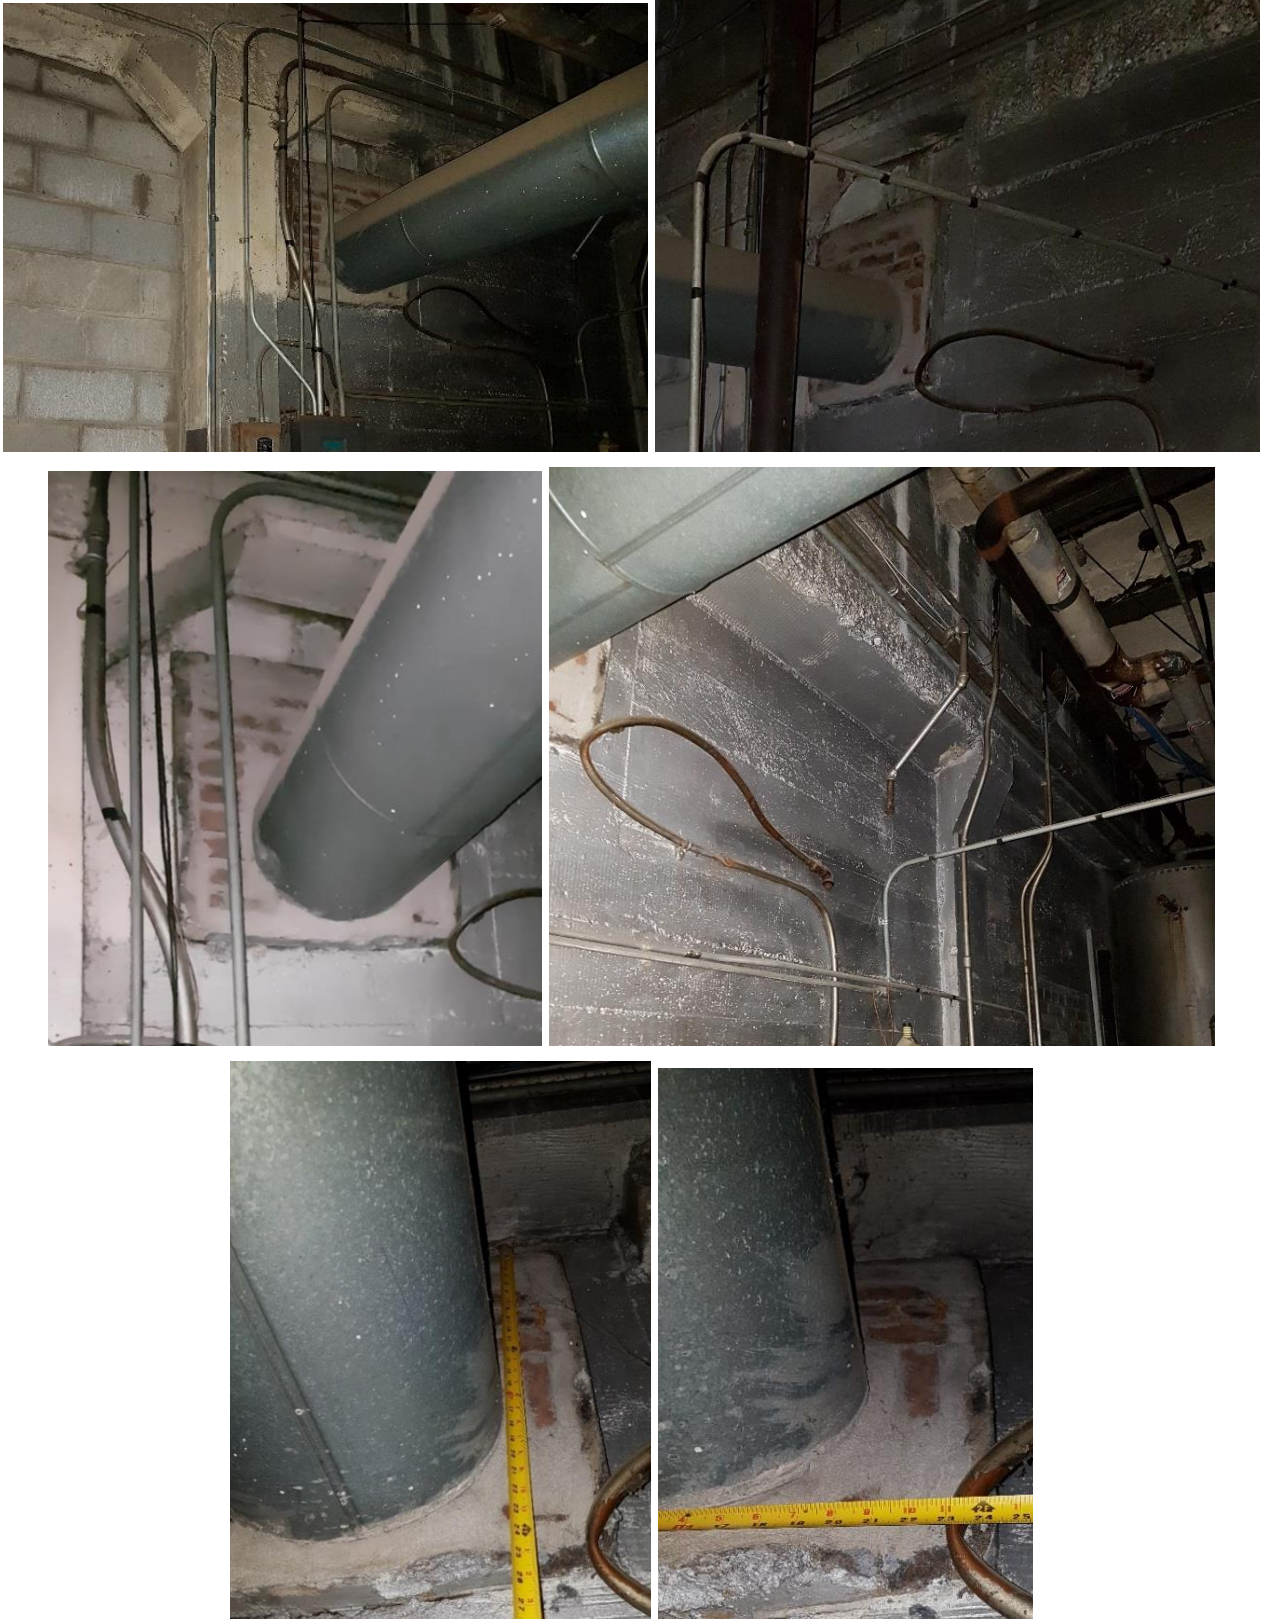
Furthermore, the analysis results showed significant lateral forces at point A, and thus for such large lateral force to be supported at that point, the beam must be connected to the building frame. This connection to the building frame was not visible from the inside of the building as shown in Photoset 5 where the beam is mainly passing through and supported by the existing wall, but not attached to the frame above.

Photoset 5: Extension of the concrete beam end to the inside of the adjacent building.
