## Storm Water Outfall Erosion Repairs at Huron Pkwy. & Hubbard

#### Exhibit - A

1. **Project Scope** – Repair existing 18" and 84" storm water outfalls located at the southeast corner of Huron Pkwy. & Hubbard Rd. intersection.

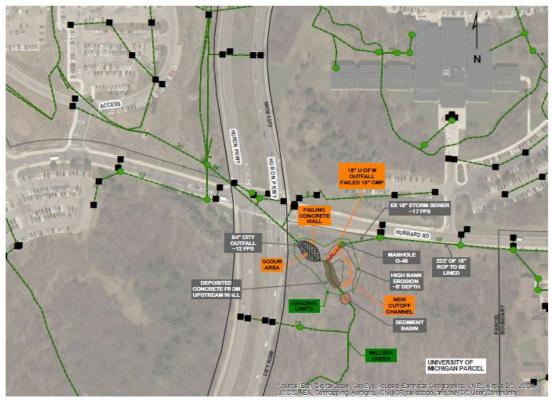
**Existing Conditions**

- 18" U-M storm water outfall
  - Serves a catchment area of about 24 acres mostly owned by U-M
  - o Failed manhole structure O-46
  - o Dislocated and rusted CMP outlet pipe
  - High velocity discharge
  - o Eroded channel
- 84" City storm water outfall
  - a. Serves a catchment area of about 750 acres owned by combination of City, U-M and privately owned residential & commercial land use
  - Scouring at the headwall
  - Undermining of foundation
  - o High velocity discharge
  - Concrete pipe joint separation

- 18" U-M storm water outfall
  - Option A Repair manhole O-46, install new drop structure and outlet pipe
  - Option B Replace manhole O-46 with a new drop structure, new outlet pipe (Recommended)
- 84" City storm water outfall
  - o Option C Riprap basin and cross vanes
  - Option D Riprap basin and cross vanes with live tree staking (Recommended)
- Common items for both outfall repairs
  - o Temporary sediment basin
  - o Gravel access drive from Huron Pkwy.
  - o ROW permit for access, staging & laydown
  - o Traffic control for lane closure and sidewalk closure on Huron Pkwy.
  - T&E species investigation
  - o EGLE permit JPA
