ANN ARBOR HISTORIC DISTRICT COMMISSION

Staff Report

ADDRESS: 200 East Washington Street, Application Number HDC14-027

DISTRICT: Main Street Historic District

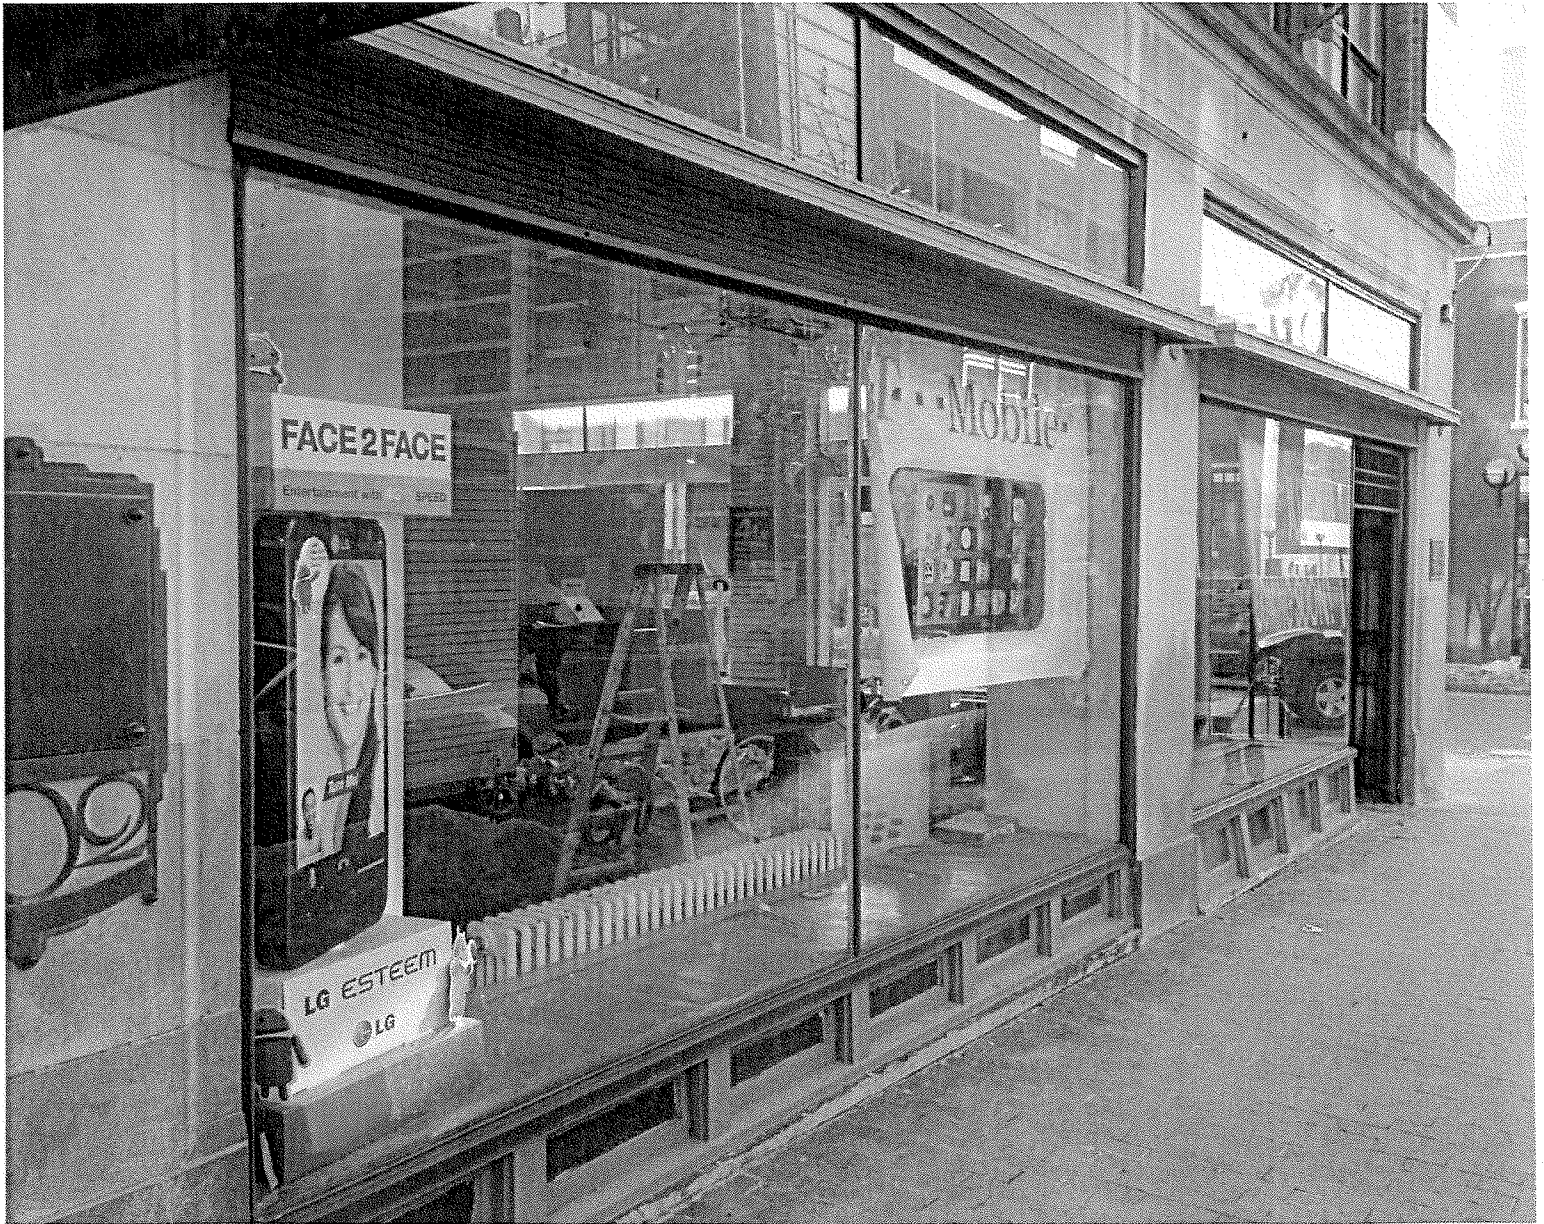
Existing windows are large 8' X 10' Plate Glass Windows, in a 2" x 6" wooden base structure which sits on a limestone base. There is rusted steel, glass stops between panes, outer edges and, top edges. Wooden structure is breaking down and the western set of windows exists in a dangerous condition.

200 Washington – existing structure. Note structural instability close to the entryway.

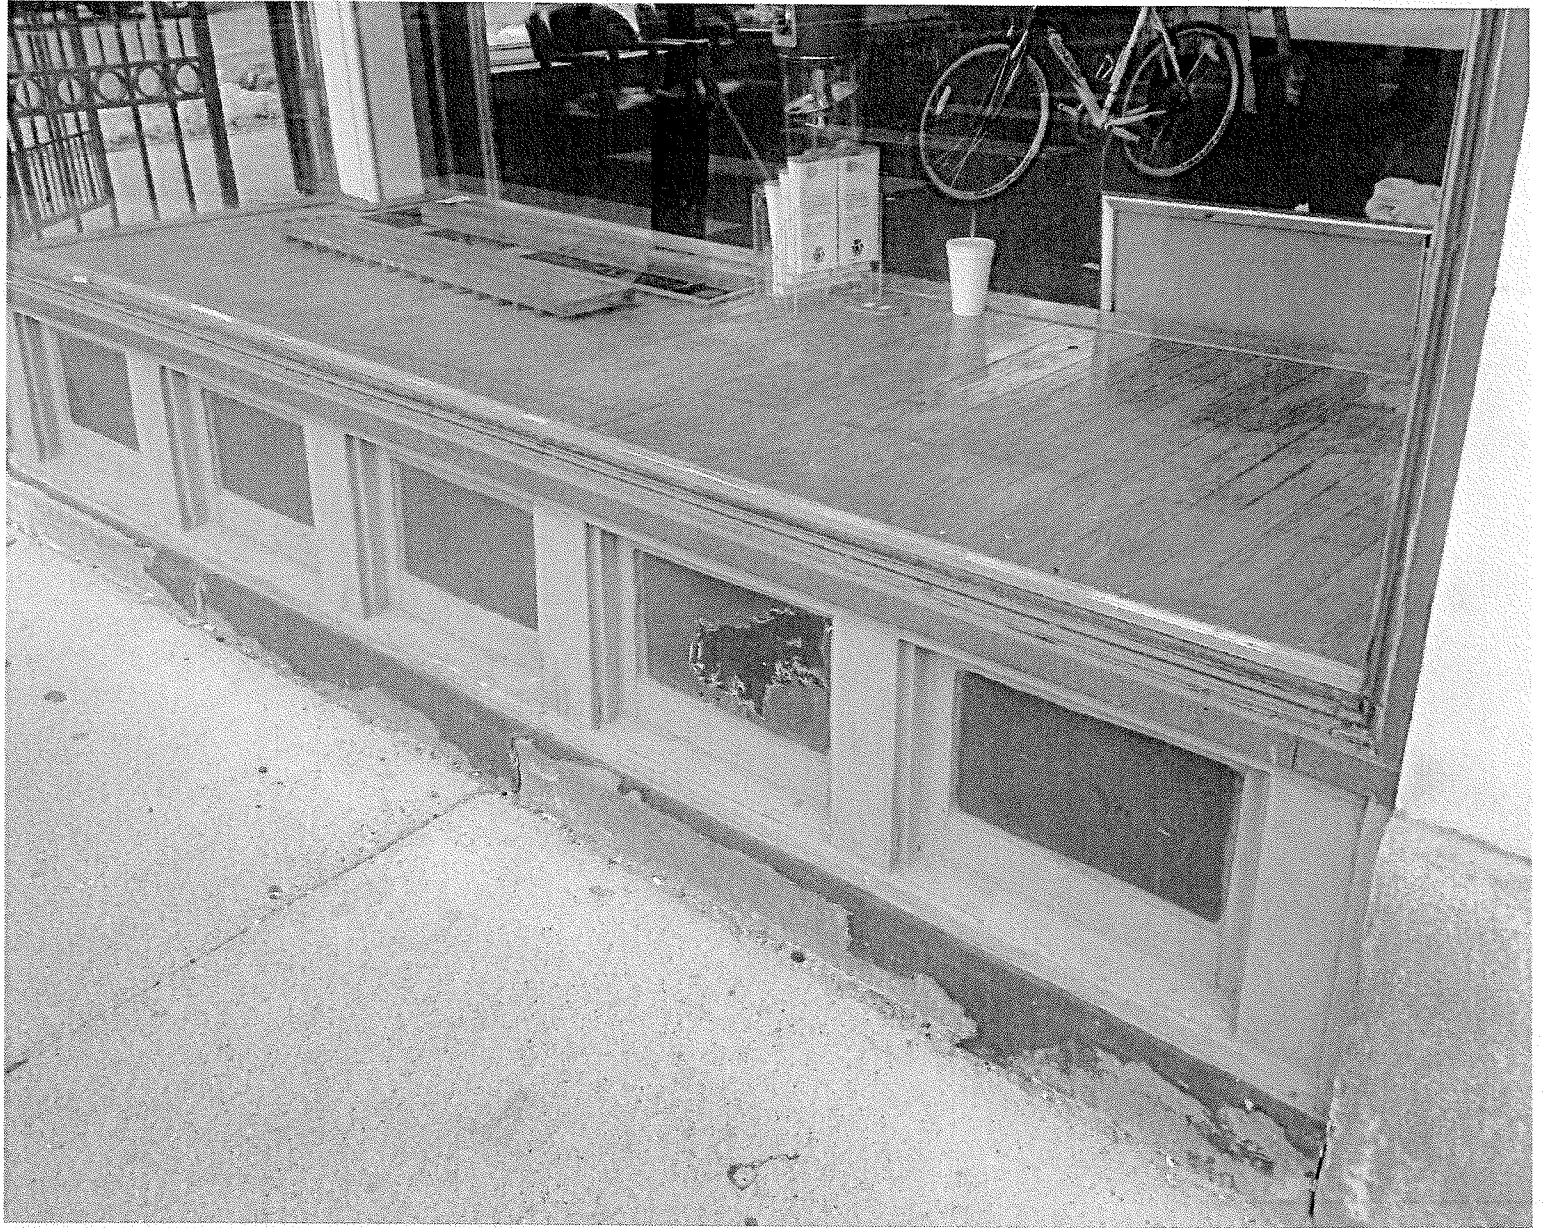
200 Washington – the Fourth Street side of corner retail space – structural damage

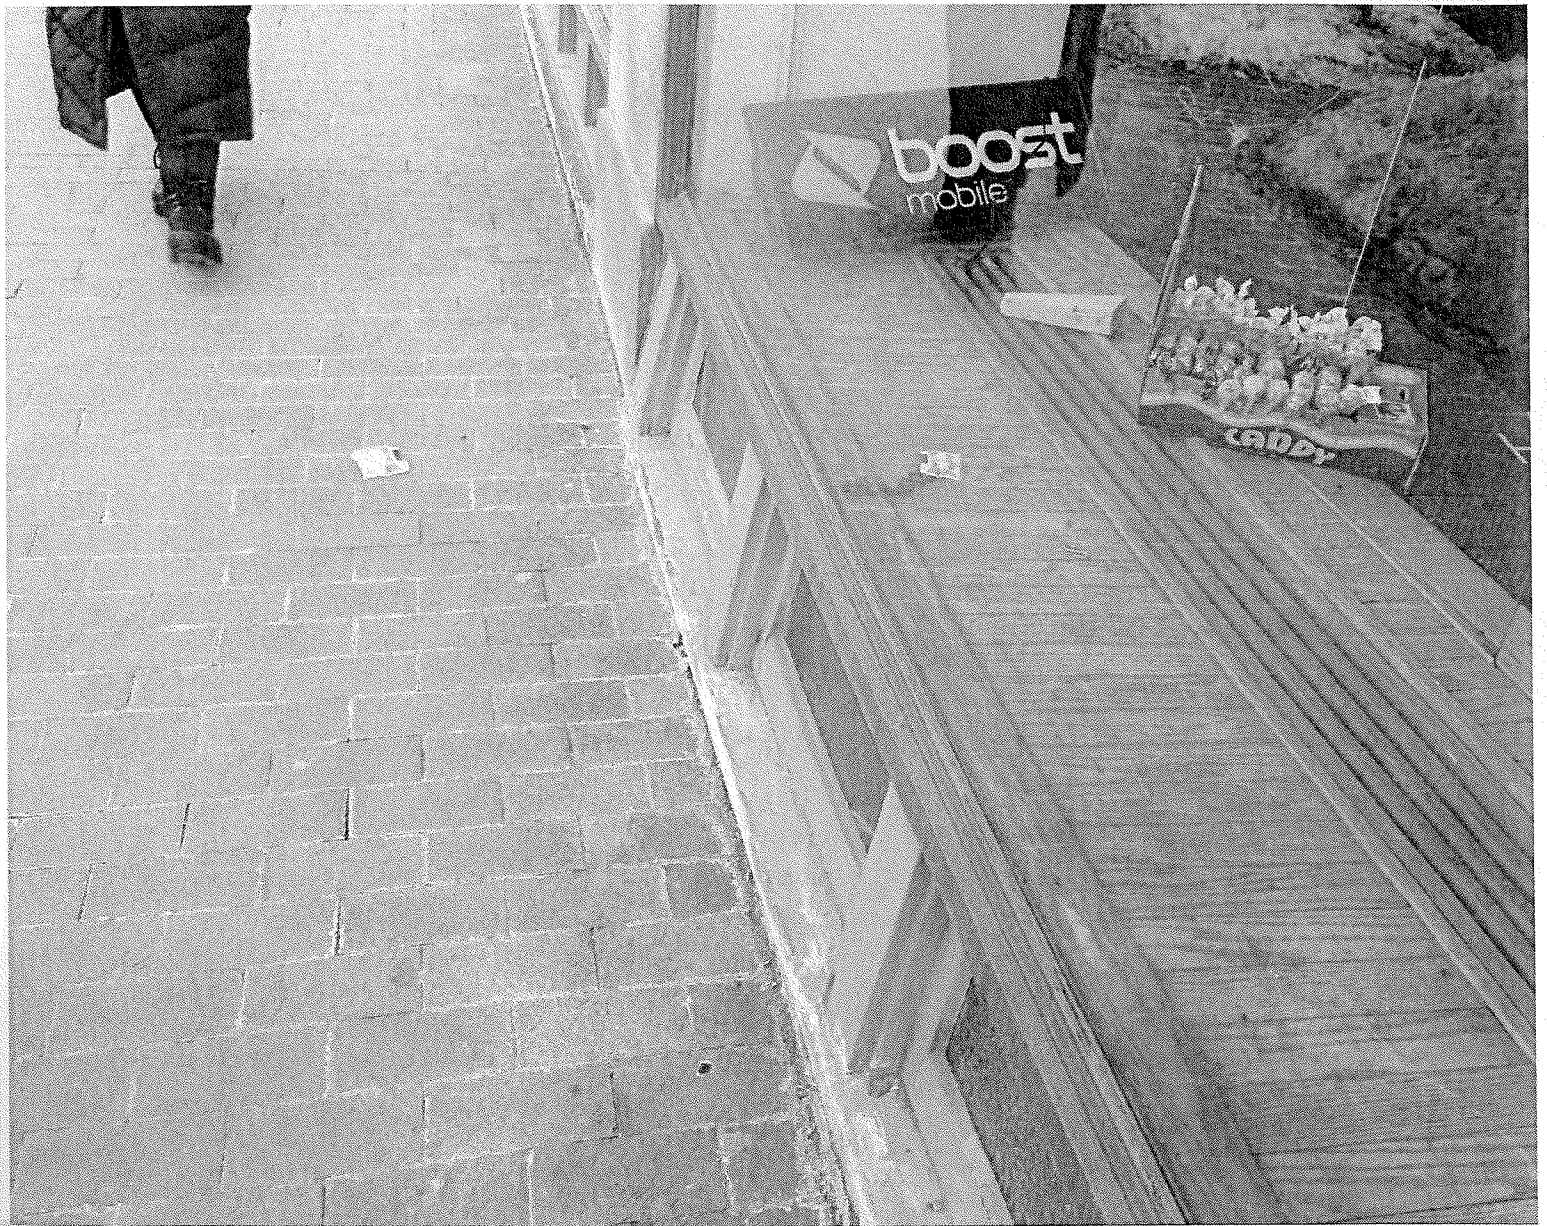
3. Parts of the metal window framing have rusted away completely. The building manager told staff that the wood beams dividing the windows from the transoms are also heavily deteriorated. The wood kickplates, which rest on a limestone base, have shifted as a result of construction in the street, and show some signs of visible deterioration.

200 Washington – close up of structural instability.

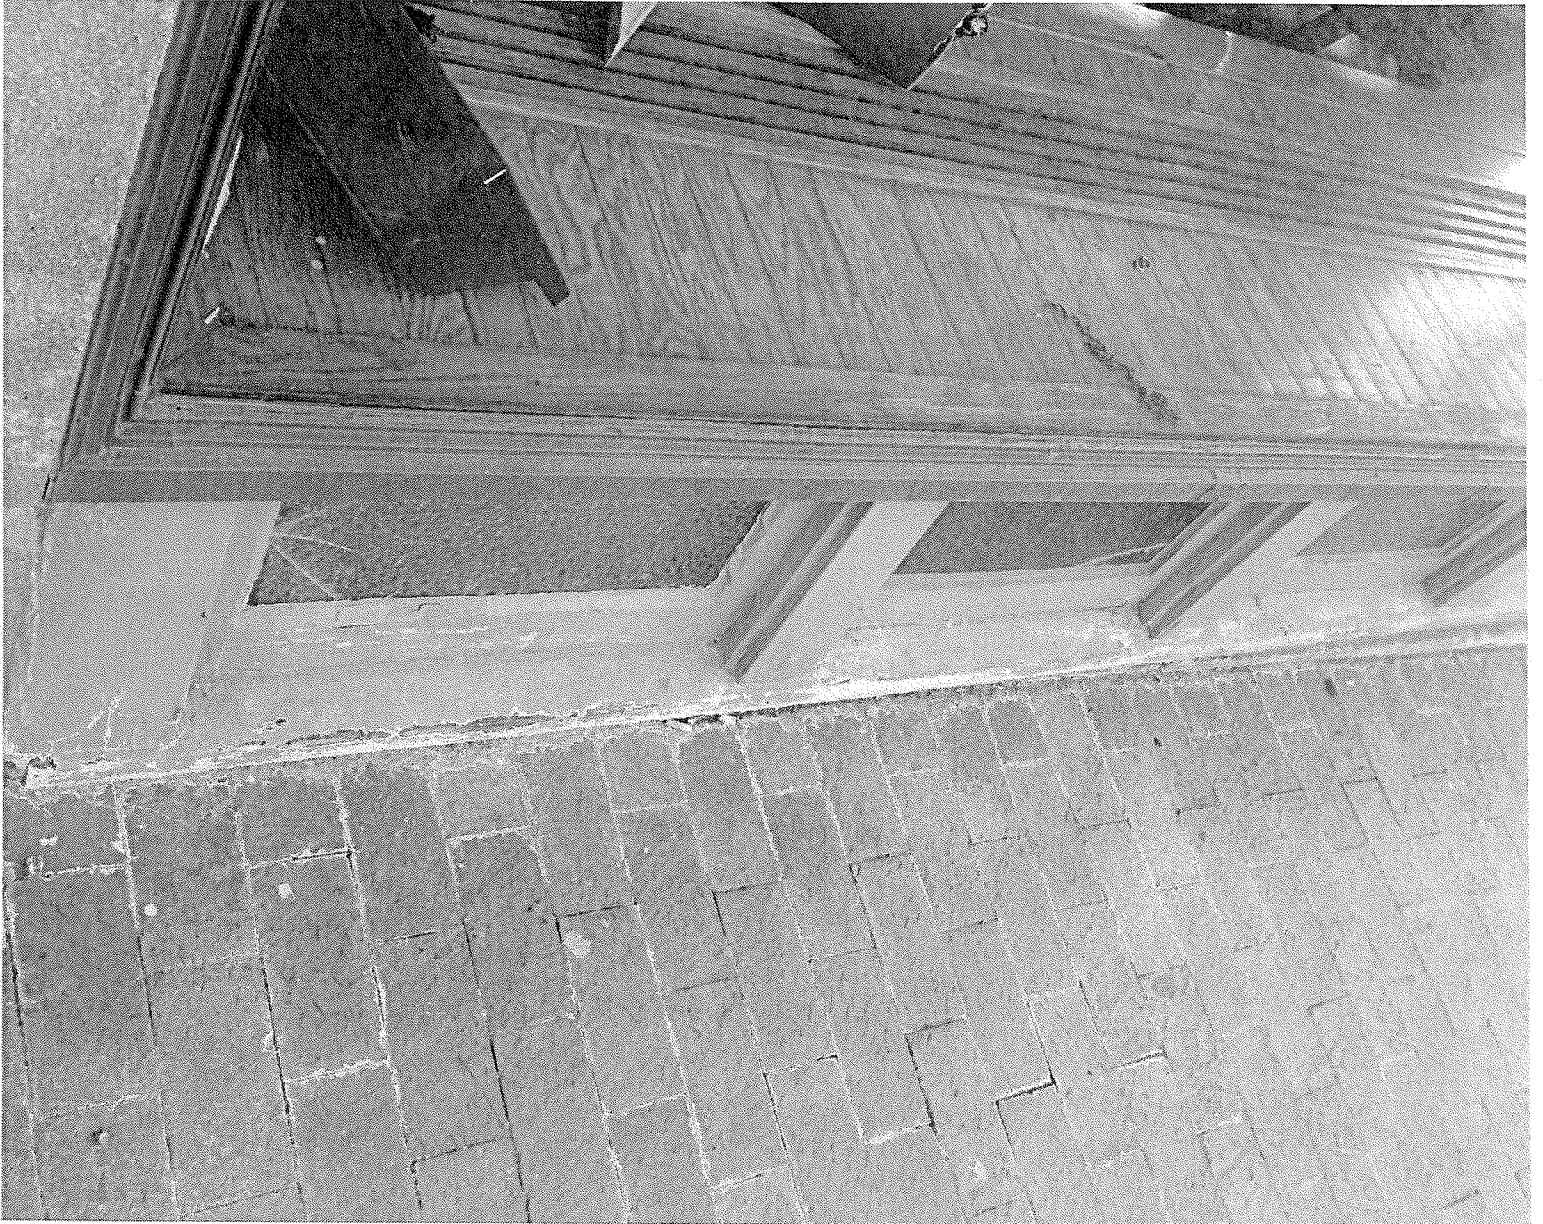
200 Washington – close up of structural damage.

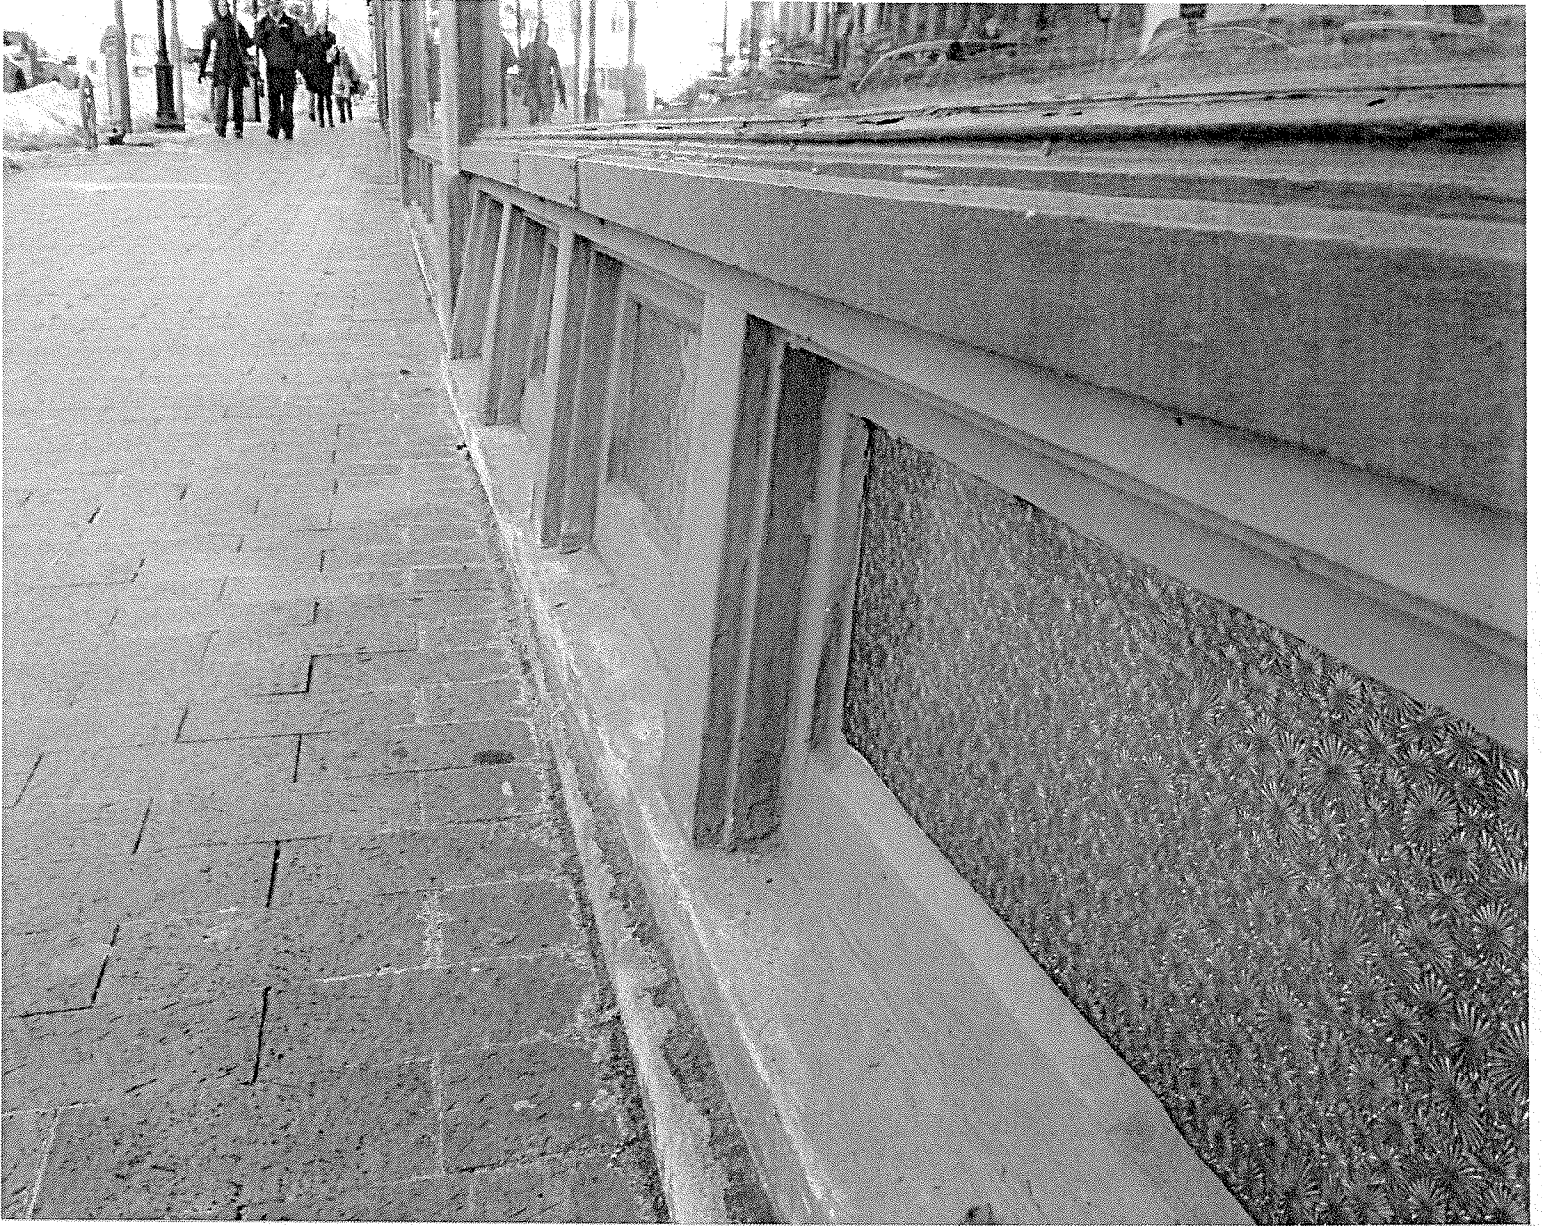
200 Washington – close up of structural damage.
