ANN ARBOR HISTORIC DISTRICT COMMISSION

Staff Report

ADDRESS: 1435 Broadway Street, Application Number HDC17-247

REPORT DATE: December 14, 2017

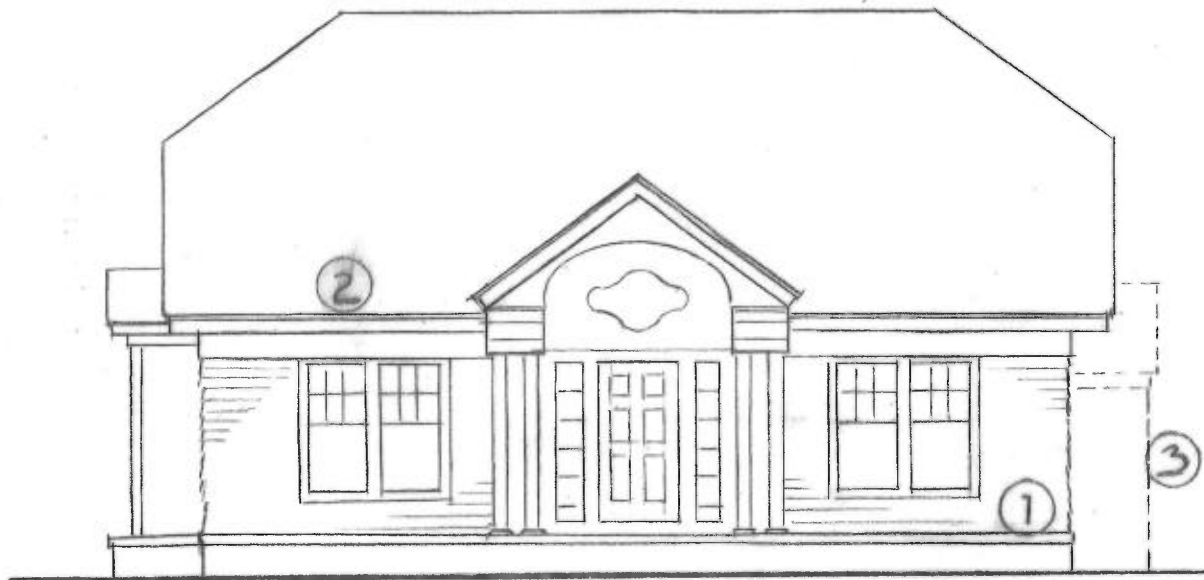
FRONT ELEVATION scale $\frac{1}{8}''=1'-0''$

- ① The front concrete porch is failing both in its foundation and concrete slab. This work will involve removing the porch columns and supporting the existing porch roof from the front wall. Then remove the concrete porch including the foundation. Replace with a new 42" trench footing, two courses of concrete block, and a new 4" concrete slab. Refinish the columns including new bases and re-install under porch roof.

- ③ The structure at the right side of this elevation is an addition that provides protection and enclosure for a basement entrance. That structure is built in the required side setback and makes this a non-conforming property. The structure is to be removed completely and a drain is to be added to the stair-well.

The work to be done to the front elevation is generally to restore it to its original glory.

All windows, door, and sidelights are to be repaired as necessary, scraped, re-glazed as required, and refinished.

There are four spots where the existing soffit needs repair. Make the repairs with beaded ceiling board matching the existing, and paint to match.

The entire house will receive a complete exterior paint job including scraping the entire house, caulking where required, repairing siding and trim where required, and two coats of white.

- ② Install new gutters on eaves over the front porch, with downspouts at each end of the porch. Gutters and downspouts to be old style galvanized half-round gutters with round downspouts.

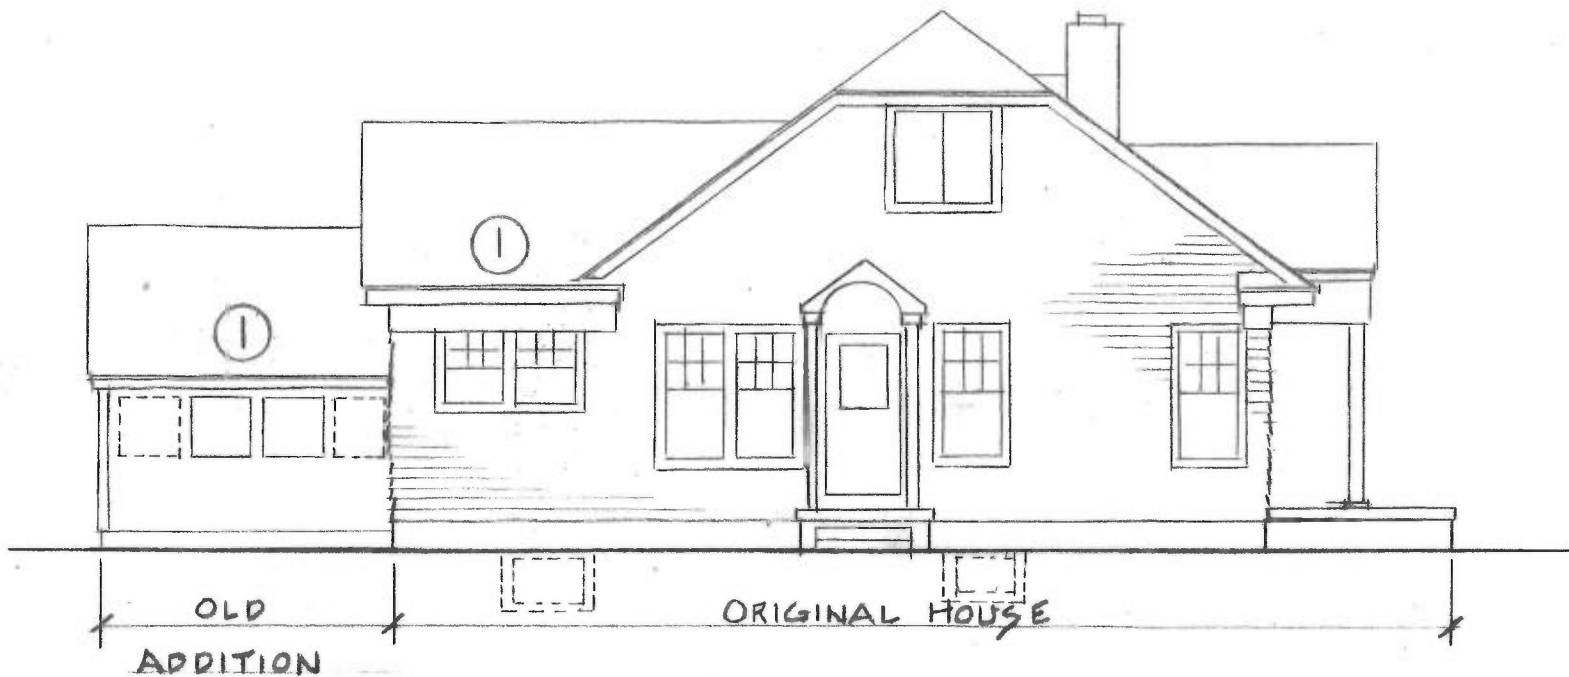
LEFT SIDE ELEVATION scale $\frac{1}{8}''=1'-0''$

The "Original House" portion of this elevation follows the same theme as the Front Elevation. All windows and doors are to be repaired and refinished. The porch columns and roof are to be straightened and made plumb. The entire elevation is to be painted. The area wells and windows into the basement are to be cleaned out and repaired and painted.

The "Old Addition" portion of this elevation was previously an unheated sun-porch. This structure is to be saved and re-purposed as a laundry and mud room. The work here requires all of the windows and doors of the sun-porch to be removed. There will be two new fixed windows installed on this elevation, while the remaining wall will be insulated and new wood clapboard siding will be installed matching the siding on the original house.

- ① New gutters and downspouts will be added on the eave over the kitchen windows and on the eave of the "Old Addition".

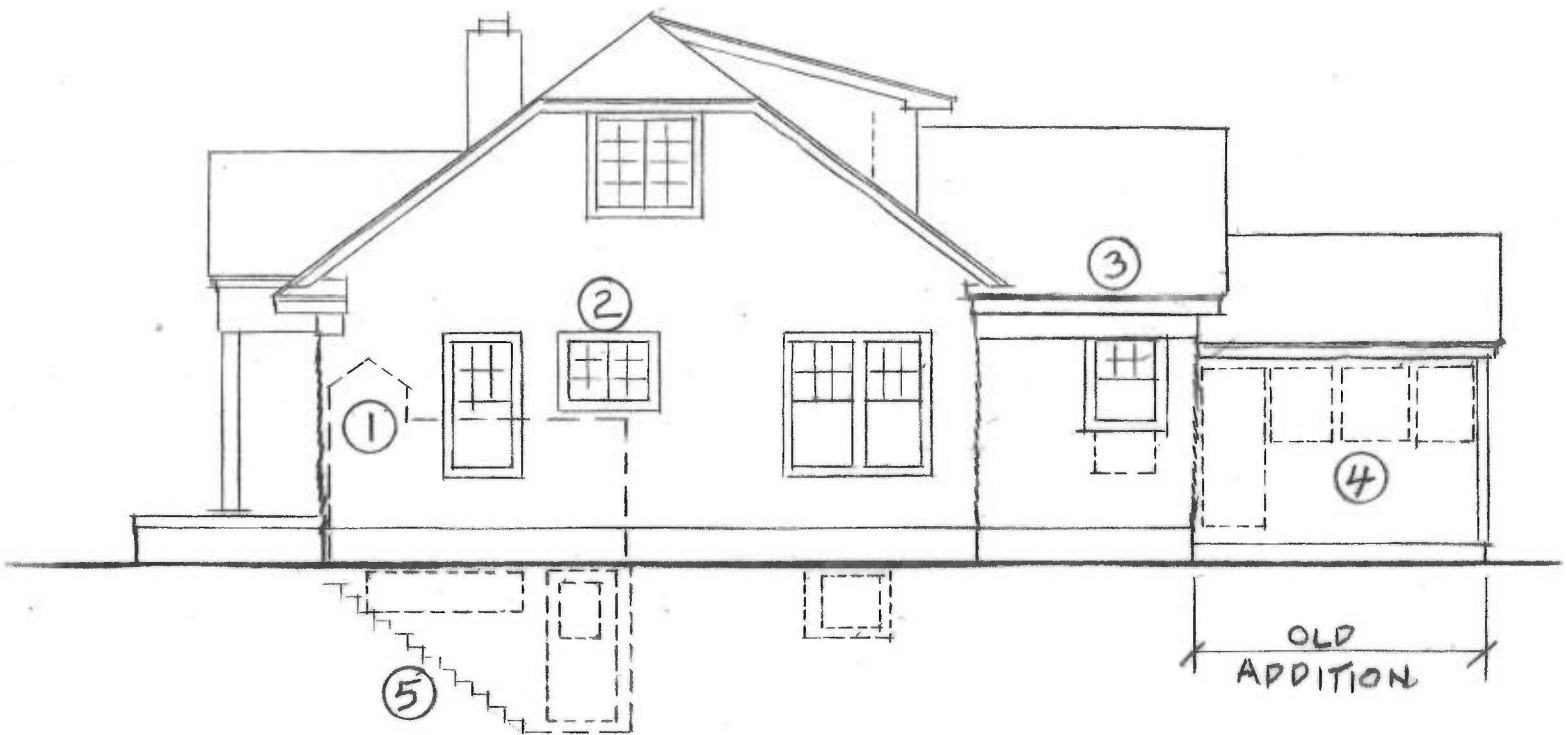
RIGHT SIDE ELEVATION scale $\frac{1}{8}''=1'-0''$

- As described on the Front Elevation, the structure on the left side of this elevation is to be removed completely. This is the structure that encloses the window and door to the basement. The existing window that is partially covered by the unwanted structure will be restored and refinished to match all the other existing windows.

- There is a window to be added to this elevation to give light to a bathroom. The window to be used is the window that is being removed from an area-well on the rear elevation of the house. This window is to be repaired and refinished to match all existing windows.

- The full height window on this side of the kitchen, is being removed and replaced with a shorter window that is currently in the bathroom on the rear elevation. This window matches the dimensions of the windows on the opposite side of the kitchen (see left side elevation) and will work above the countertop of the kitchen.

- The windows and door in the "Old Addition" portion of this elevation are to be removed and framed-in, and the entire wall will receive new wood clapboard siding to match the original house.

- A new fixed window and insulated door are to be installed in the existing openings going into the basement.

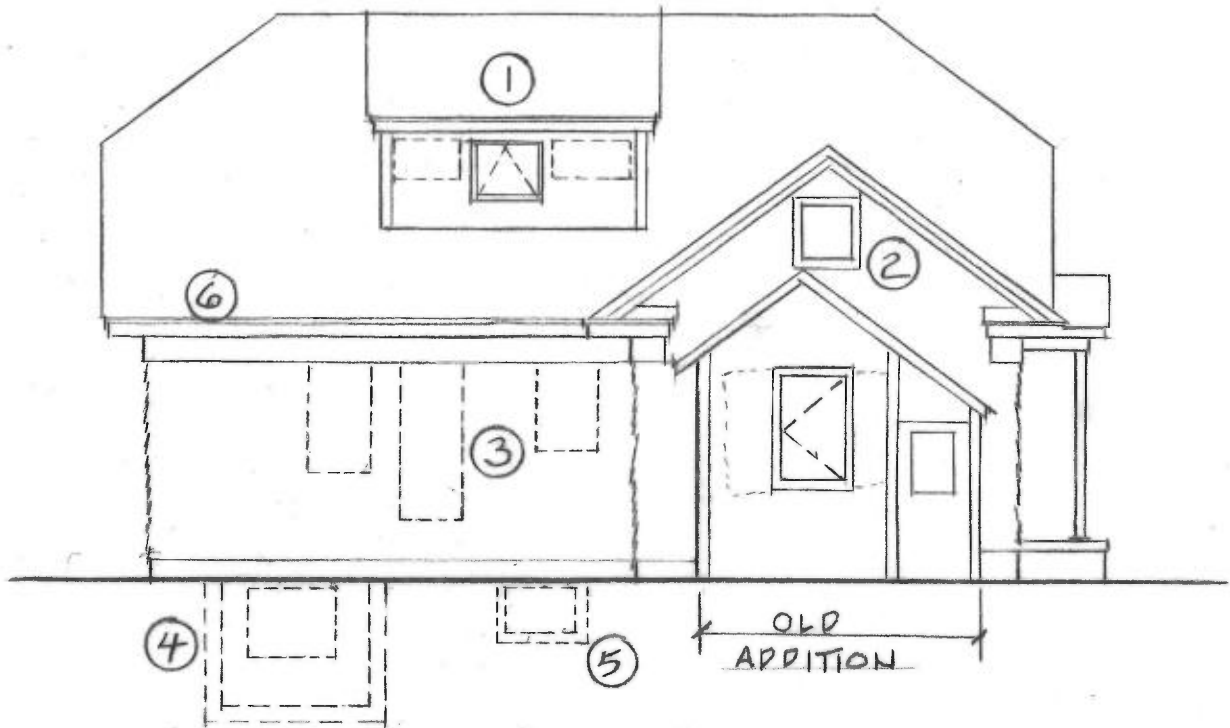
REAR ELEVATION scale $\frac{1}{8}''=1'-0''$

- ⑤ The southerly area-well is to have the window removed (it is very decayed) and replaced with glass block fit into the existing foundation wall.
- As previously described, the "Old Addition" will have all of it's windows and doors removed and framed-in. A new wood casement window and an insulated door will be installed as shown on this elevation.

- ① The dormer for the second floor showing on the rear roof will be extended rearward by 2'-4" in order to properly fit the second floor bath. The three existing windows are severely decayed and will be removed from the existing dormer and replaced by a single new wood awning window with insulated glass.

- ② Existing gable window to remain.
- ③ The two existing windows and the door are to be removed, framed-in and resided to match. The window coming out of the existing bath is to be reused in the kitchen as shown on the Right Side Elevation. The taller window will be used for parts to repair other windows in the house as many windows are the same size.

- ④ The northerly area-well and window are to be removed to make room for a larger egressable area-well (escape well). This window is to be re-used in the bathroom as shown on the Right Side Elevation.

- ⑥ New gutter and downspout to be installed on the eave of the original house on the left half of this elevation.

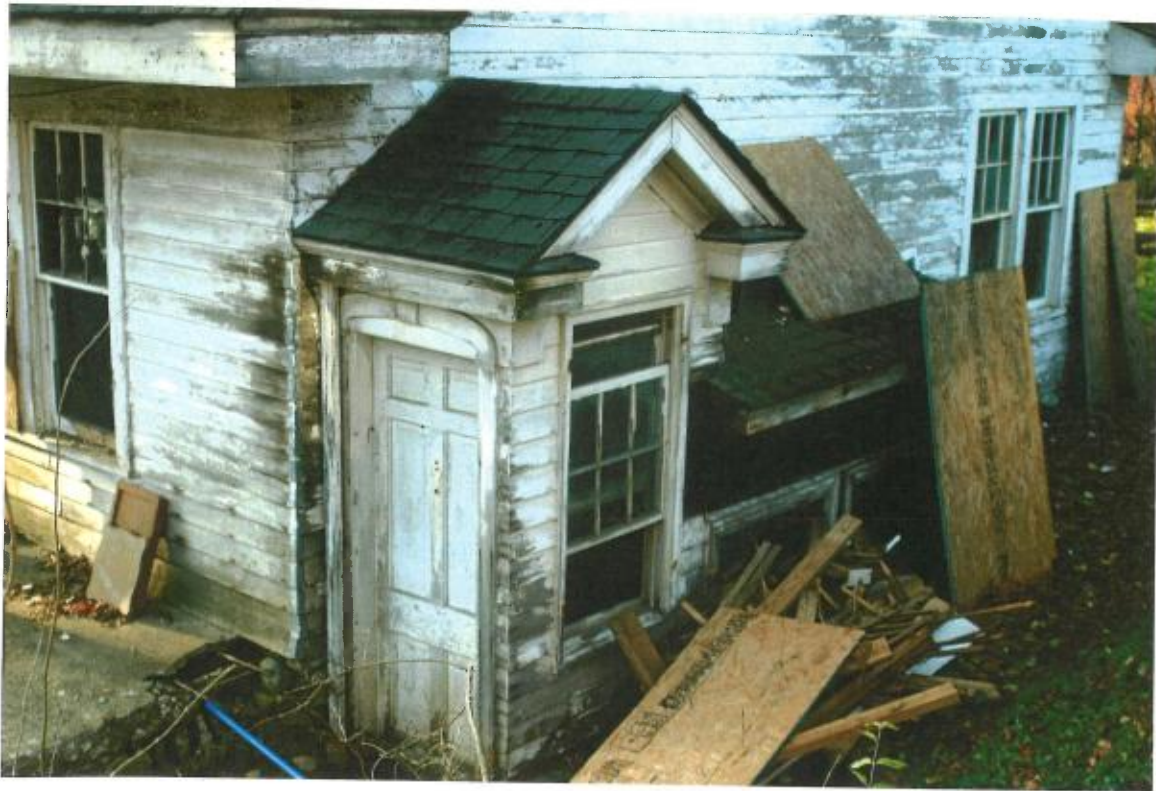
EXISTING STRUCTURE FRONT RIGHT CORNER OF HOUSE

3. *Exterior stair enclosure:* At some point, a part of the basement was converted to an apartment. A door and enlarged window were cut into the north (or right, when facing the front) basement wall below grade in a well. The well was covered with a small addition, whose roof bisects the outside of a window on the first floor. The part of the addition that faces the street was nicely trimmed out to match the front entry, but staff does not believe the work is from the period of significance. See application photo of “existing structure front right corner of house”.

This structure was added to the house sometime after the house was built. The structure provides enclosure for a basement entrance. The structure was built in the required setback from the side property line making this property non-conforming to Ann Arbor codes. The structure also covers half of one of the original windows. In our proposal, this structure is to be removed completely. The covered window will be repaired and repainted. There will be a new wood window and insulated door set into the existing openings in the basement wall.

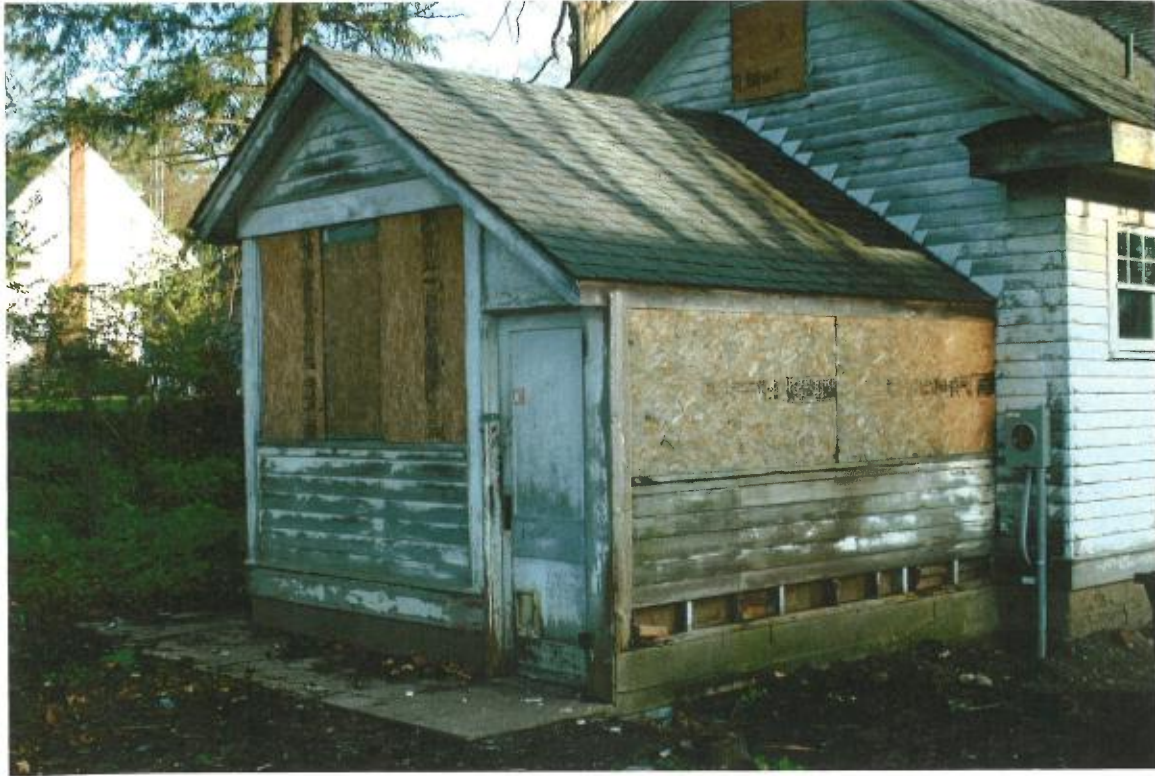
THE OLD ADDITION

4. *Sunroom addition:* This does not appear on 1947 aerial photos. It currently has only storm windows or nothing in the openings. Most of the windows would be infilled, three would have new wood windows installed in existing openings, and a new steel door with a single light would be installed facing the backyard. The entire addition is proposed to be resided with new wood clapboard siding to match the main house. Since the sunroom does not imitate the style or trim details of the original house, staff feels that wood lap siding will not cause confusion about whether this addition is new or old. See application photo of “the old addition” and photos #6.

This is an old sun-porch addition built sometime after the main house. Most of the windows are decayed or broken. The siding is in worse shape than anything on the main house. The sunporch is wrapped in windows and doors so there is no wall space and almost no function. Our plan is to remove the windows and doors and re-purpose the addition as a laundry room and mud room. Three new wood windows and an insulated entry door will be installed as described in the elevation studies.

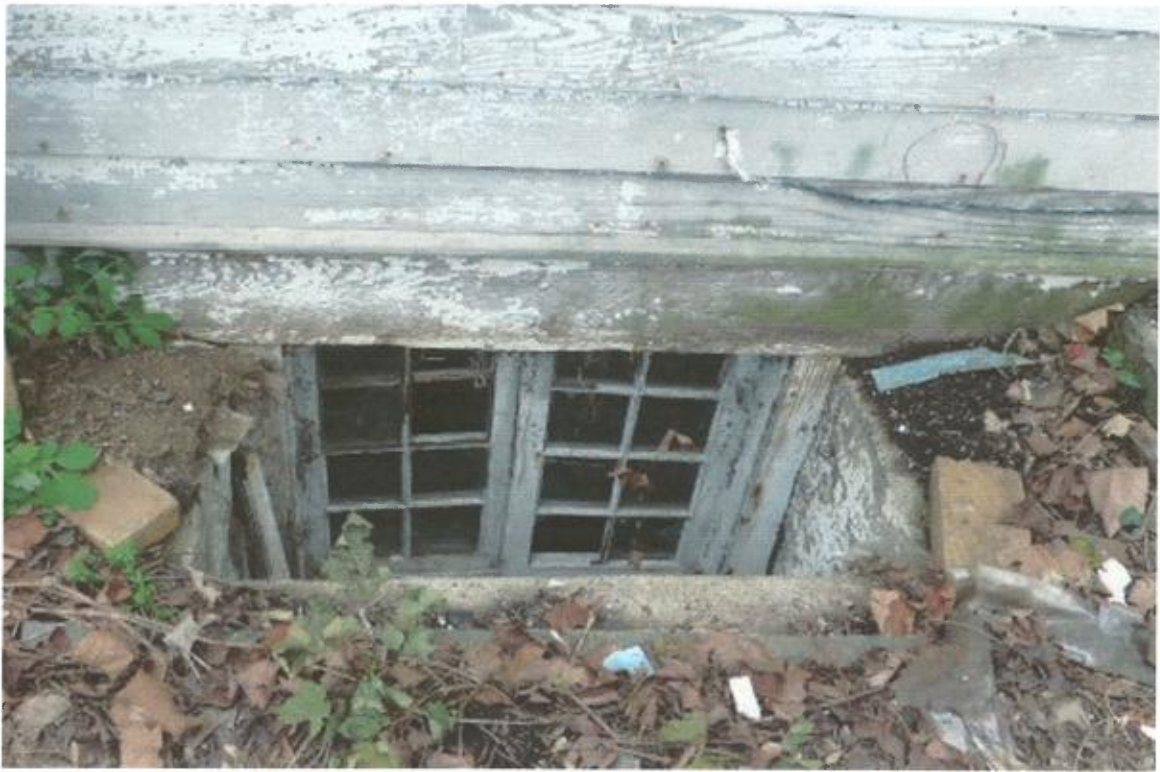
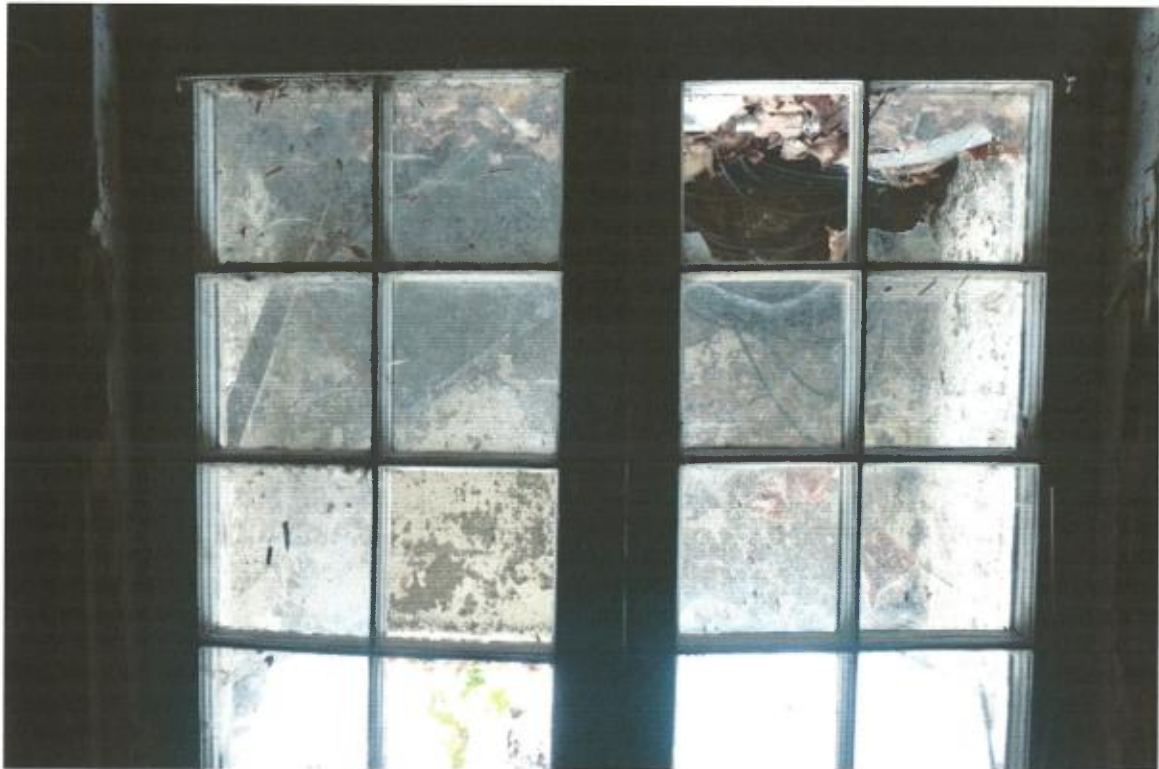
5. *Move basement window:* The basement window (marked #1 on the attachments) on the rear of the house is an 8-light double casement. This window is proposed to be removed, rehabilitated and installed on the first floor of the north/right side of the house, in a new bathroom. Moving windows is not addressed in the SOI guidelines or the Ann Arbor Historic District Guidelines. Generally, cutting in new windows on character-defining elevations is discouraged. The Commission may want to consider that the window is original to the house, and the style is distinct but compatible, and the north side of the house is visible but not prominent. The basement window opening would be converted to an egress window, which requires a larger well than the one there now. If the Commission does not approve the relocation of this window, the well could be made larger and the window appears to be big enough to be used for egress as it is (though the exact measurements are unknown).

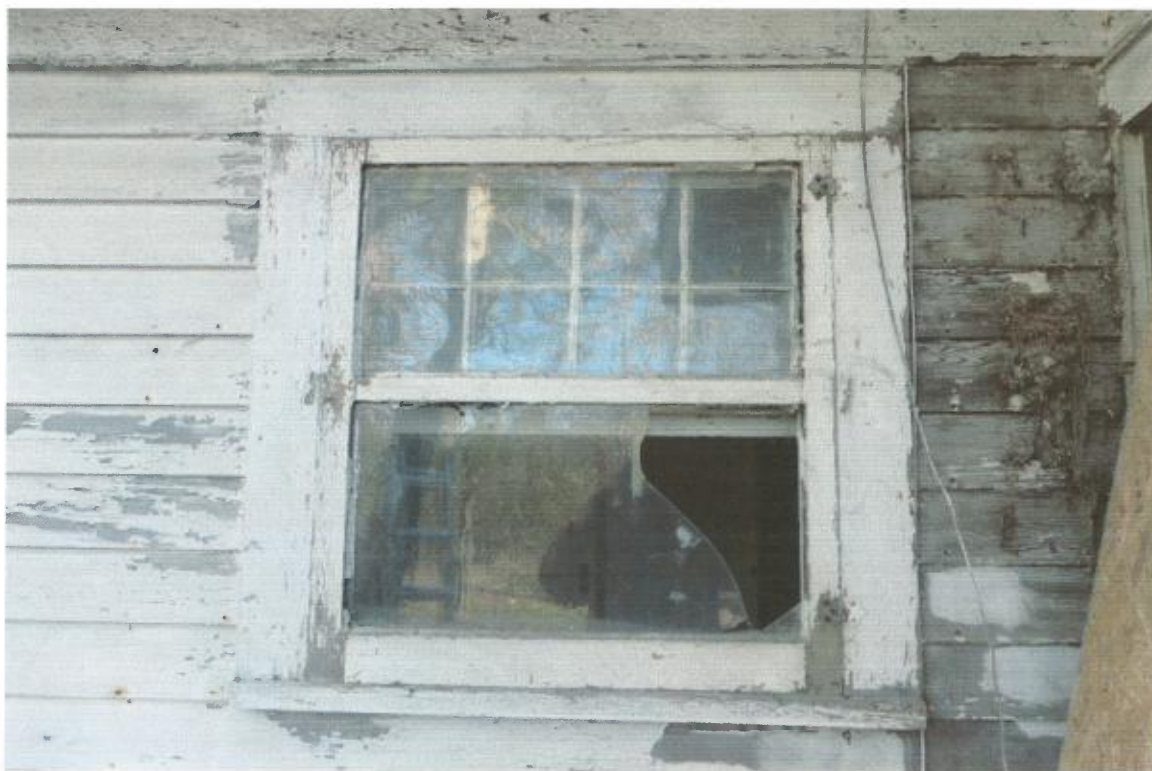
6. *Move rear window to kitchen, also rear:* The same rationale should be applied to this window (photo #2 of the attachments). It is currently on the back of the house, and the new floorplan puts it inside a closet. It is proposed to be moved nearby, where it would replace a taller window in the kitchen. While leaving it where it is would be most appropriate, since both windows are on a not-visible rear wall, staff does not object to this work.

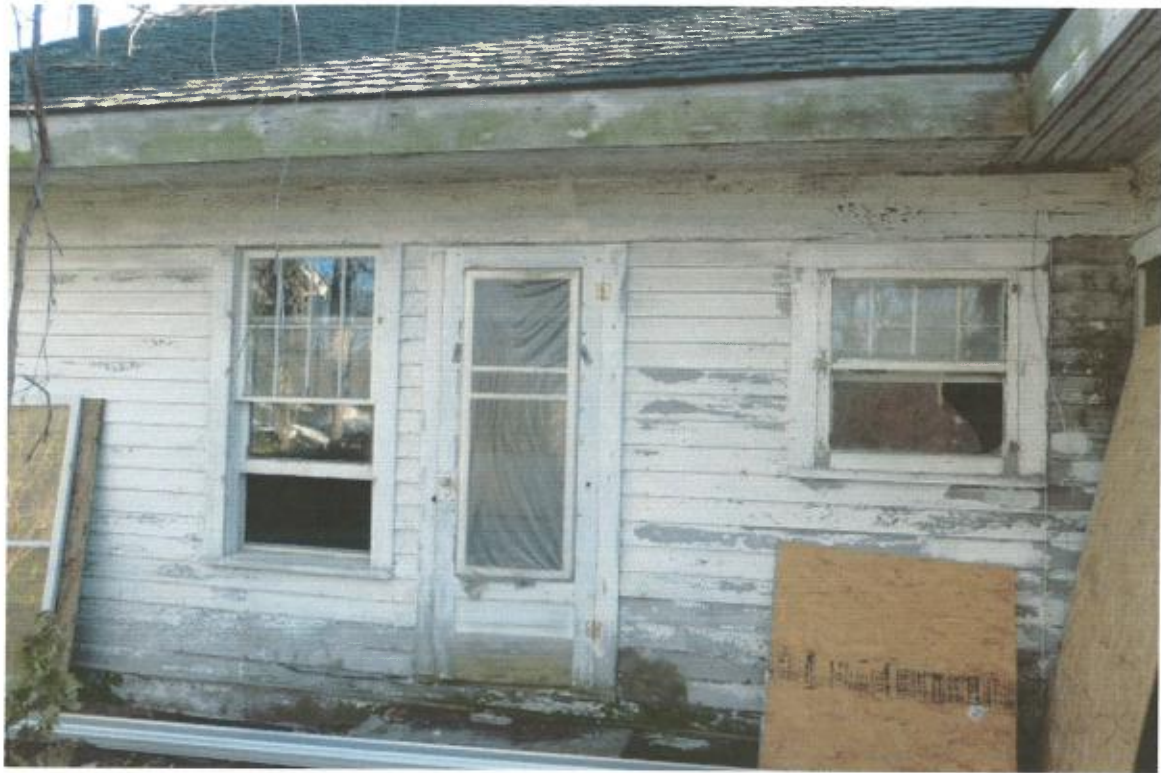
#3

8. *Rear elevation infill*: Two windows and a door are proposed to be infilled on the rear wall of the house (photo #3). One of those windows would be moved (see above), and another would be used to repair an important front elevation window that has no sashes. Since the work is on the back of the house and both windows would remain on the structure in new locations, staff is not opposed to this work. In addition, a small basement window is proposed to be infilled with glass block. The window is not significant, and staff feels the work is appropriate.

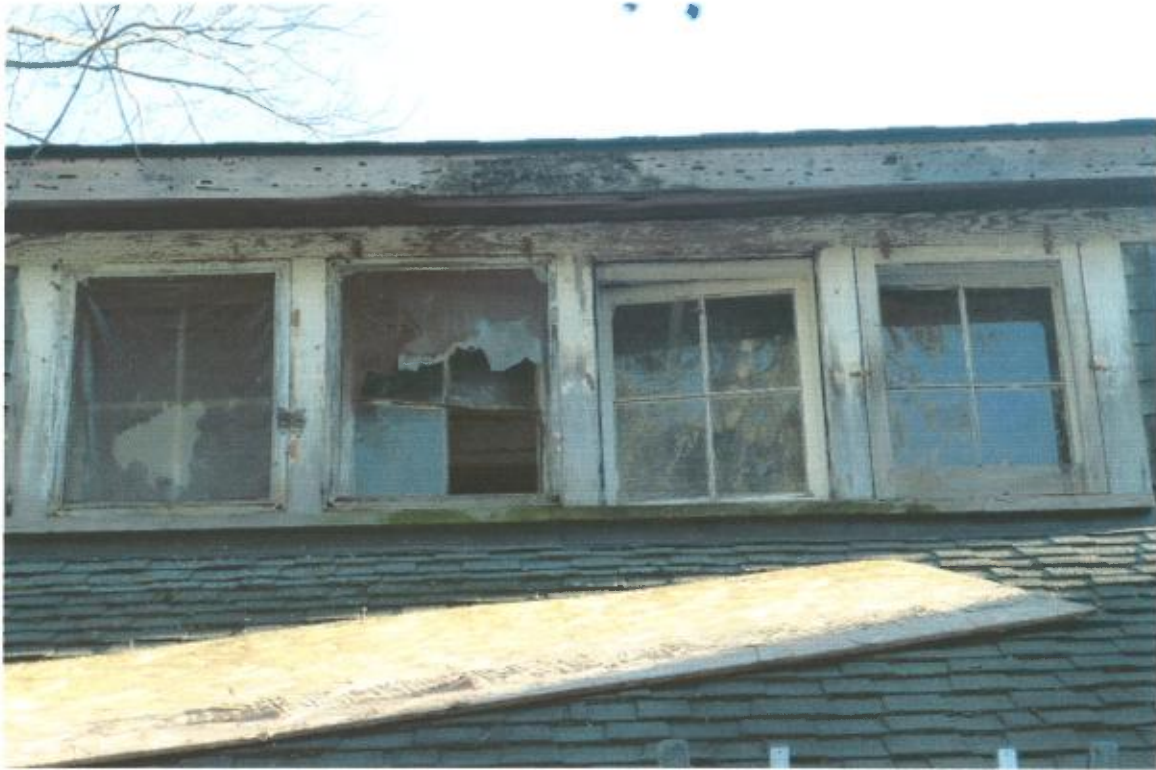
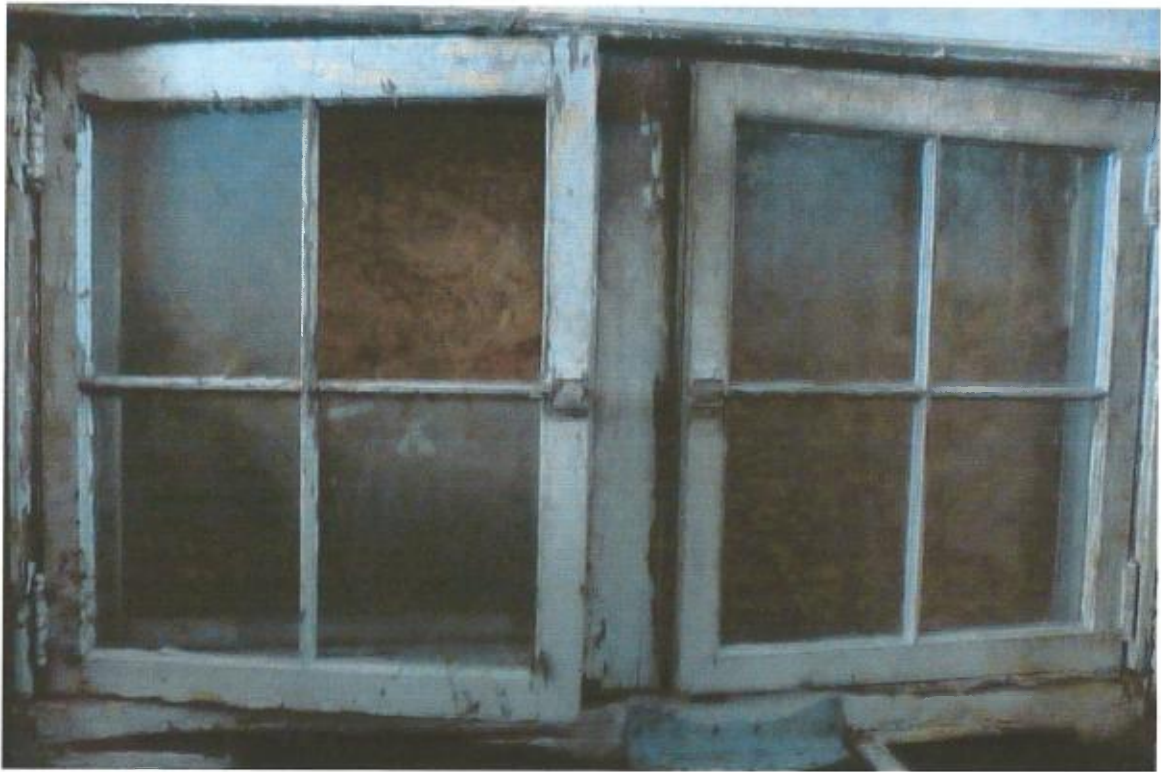
#5

7. The upstairs dormer facing the rear would be expanded 2’ 4” further back. (See photos #5.) This would allow enough space for a bathroom upstairs. Two bedrooms upstairs already have egressable window openings. The expanded dormer would have a single window instead of the four small four-light ones there now, which are extremely

deteriorated. Since those windows would need to be replicated, staff prefers the new single window design, which is a telltale that “something was changed here”.
