MEMORANDUM

Re: Postponed Application for 504 High Street

Staff Report

ADDRESS: 504 High Street, Application Number HDC 14-020

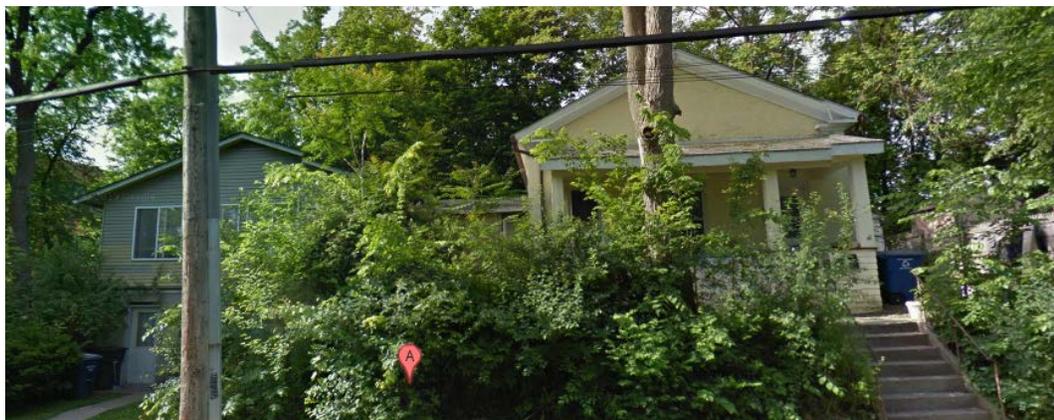
504 High (June 2011 Google maps photo)

BACKGROUND: This Classic Revival, one story rectangular painted brick residence is the 1854 Colored Baptist Church. It features a front gabled roof with returns, double-hung windows with shallow brick arches and stone sills, and a full front porch added after 1908 with a shingled base and short, square columns. Both the 1868 and 1872 City Directories list the Colored Baptist Church at this locations, and the 1854 and 1870 maps indicate Union Church here. The 1881 County History mentions a “flourishing African Baptist church with a house of worship in the 4th Ward”. By 1888, the first Sanborn map indicates that a new Colored Baptist Chhurch was being built on North Fifth Avenue at Beakes. The Centennial History of the congregation, the Second Baptist Church, says that a Rev. Lewis organized the first congregation in 1865 in a “frame dwelling”. The High Street building, however, is a solid brick structure. A large wing on the Elizabeth Street side was added when the house became a day care center in the 1970s. (From the Old Fourth Ward study committee report)
