ANN ARBOR HISTORIC DISTRICT COMMISSION APPLICATION

Address of Property: 317 S. STATE STREET
Historic District: _____
Name of Property Owner (If different than the applicant):
HOGARTH MANAGEMENT LLC.
Address of Property Owner: 115 DEPOT ST. ANN ARBOR, MI 48104
Daytime Phone and E-mail of Property Owner: 734-994-5050
Signature of Property Owner: [Signature] Date: 10/20/2012

Job Name: 317 S. State St.
Job Location: Ann Arbor, MI

Re: Site Review of Historic Steel Windows

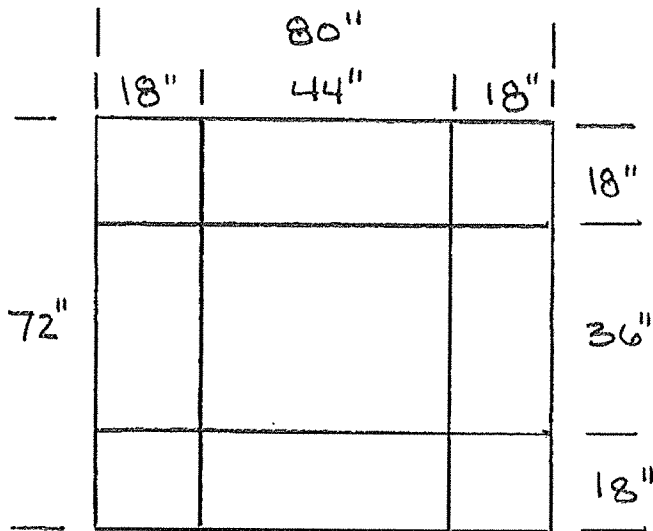
MK-C (6)

HORIZONTAL
TYPICAL

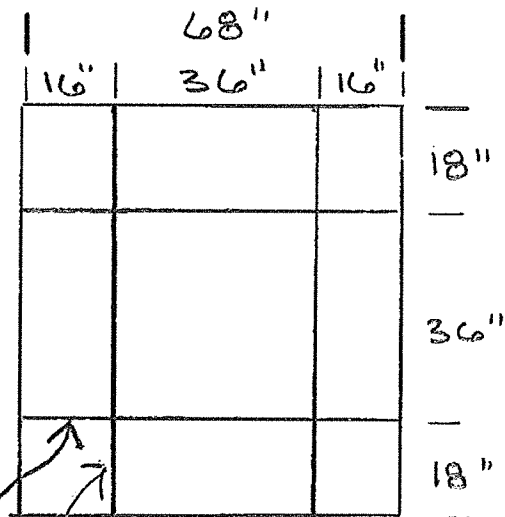
MK-D (3)

VERTICAL
TYPICAL
