## ANN ARBOR HISTORIC DISTRICT COMMISSION

### Staff Report

**ADDRESS:** 2781 Packard Road, Application Number HDC12-241

**APPLICATION:** The applicant seeks HDC approval to replace the cedar shake roof on the 1986 barn with imitation shakes.

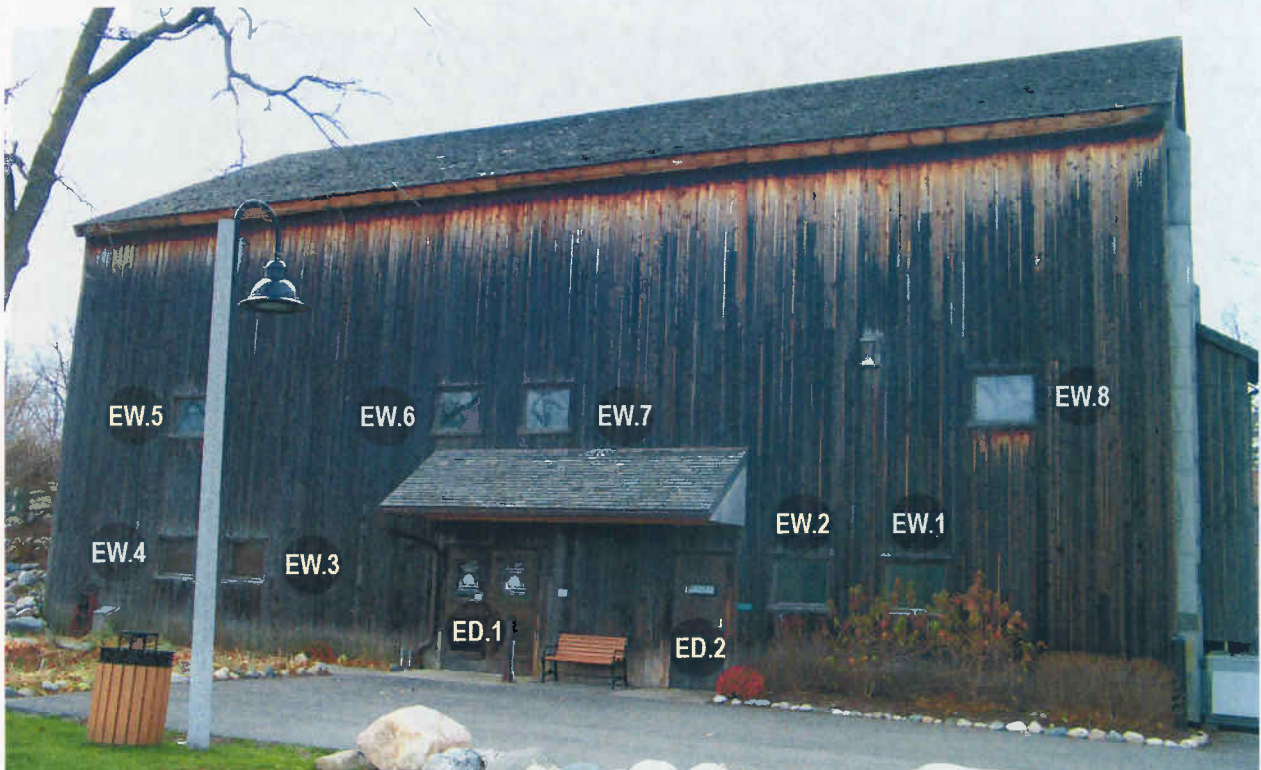
East Elevation

The wood clad East elevation is the main entry point to the Cobblestone Center. Two (2) glazed 3'-0" x 6'-8" hollow metal entry doors (skinned with wood) are situated at the midpoint in the elevation and provide access to the main level Orientation area. A single 3'-0" x 6'-8" hollow metal door and frame (skinned in wood) sits adjacent to the North of the main entrance, the doors are covered with a cedar shingled shed canopy with gutter and downspout situated at the South of the canopy. A hose and water spigot is situated on the south end of the elevation. Four (4) windows are located on the main level and 4 on the upper level. The windows are a cranked-awning aluminum clad wood unit with insulated glass and trimmed in wood. There is no eaves trough or downspout at the main building fascia.

- Numerous pieces of siding have cupped and pulled away from the waferboard sheathing, exposing the felt to the weather and UV deterioration.
- Deterioration, splitting and rot have occurred in the siding – particularly bad at base of building
- Moisture readings range from 9.7% to 11.2% 2'-0" above grade
- Moisture readings range from 10.9% to 29.2% below 2'-0" above grade
- Fascia & soffit appear to be in good condition
- Soil and landscape mulch are placed against the base of the siding allowing moisture to penetrate siding and cause further deterioration.

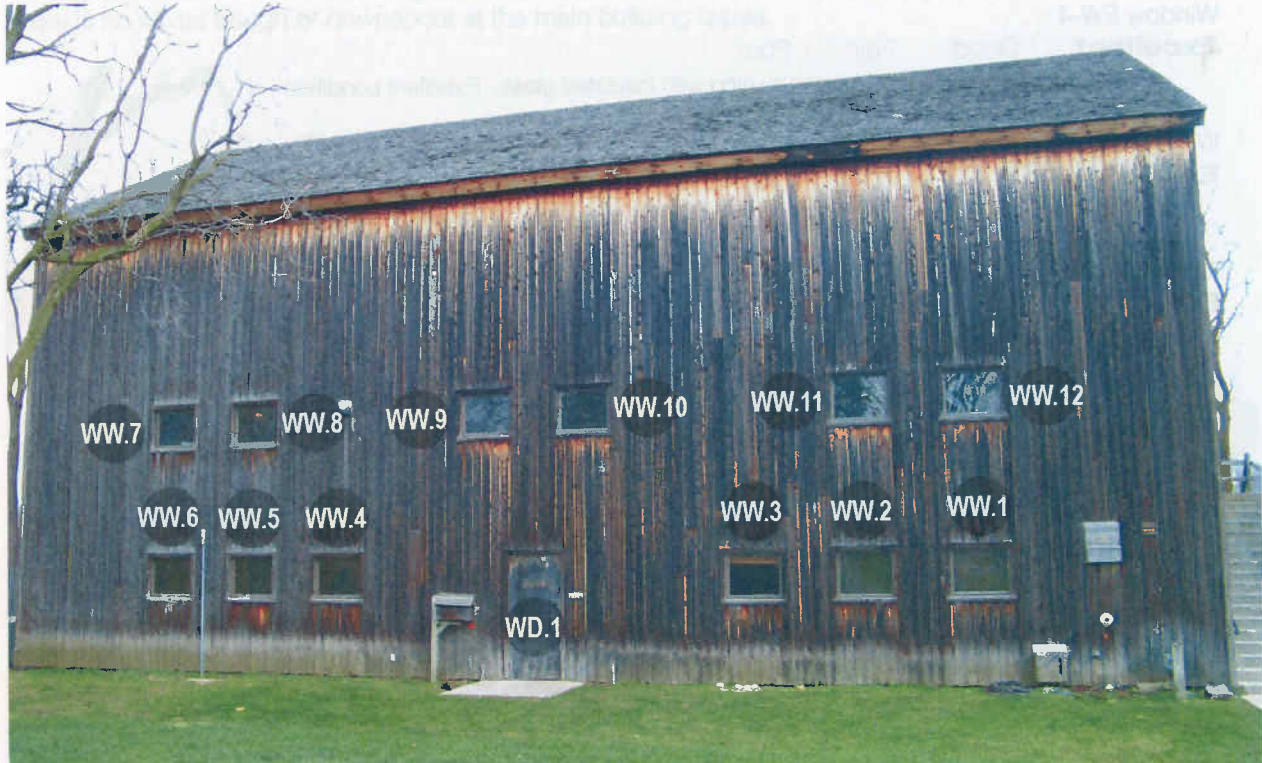
West Elevation

The wood clad West elevation fronts the interior backyard of the Cobblestone Farm House. A single 3'-0" x 6'-8" hollow metal door and frame (skinned in wood) entry is situated at the midpoint in the elevation and provides a secondary means of access to the main level Orientation area. A hose and water spigot are situated on the south end of the elevation. Six (6) windows are located on the main level and six (6) on the upper level. The windows are a cranked-awning aluminum clad wood unit with insulated glass and trimmed in wood. There is no gutters or downspout on the main gable roof fascia.

- Numerous pieces of siding have cupped and pulled away from the waferboard sheathing, exposing the felt to the weather and UV deterioration.
- Deterioration, splitting and rot have occurred in the siding – particularly bad at base of building
- Moisture readings range from 9.7% to 11.2% 2'-0" above grade
- Moisture readings range from 10.9% to 29.2% below 2'-0" above grade
- Fascia & soffit appear to be in good condition
- Some deterioration of the stress panel waferboard at the base of the wall is evident along the entire length of the elevation.

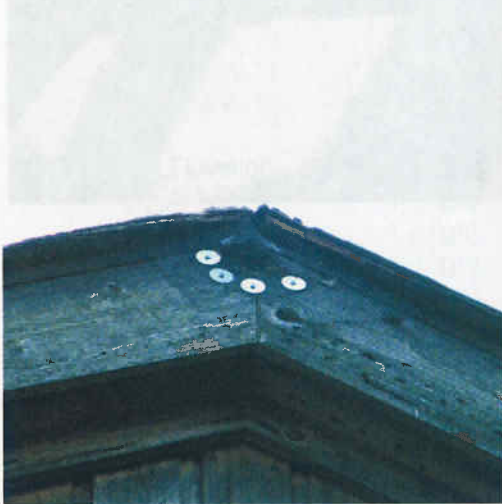
Roof Gable Detail

The gabled roof of the Cobblestone Center is finished with a Western Red Cedar shingle. The original drawings from Riverbend Timber Framing Inc. call for the shingles to be laid over 1x2 sleepers over an 8 3/8" stress-skin roof panel. Whether or not the 1x2 sleepers were installed was not able to be verified through visual observation. The small 6" soffit on the gable end and 1x12 fascia board is exposed and weathered.

- Evidence of splitting and loss of shingles as well as cupping and warping of shingle indicating the possibility of inadequate air flow beneath the shingle.
- Deterioration is evident in large sections of the roof
- Roof replacement is recommended or alternative treatment strategies below
- Trim at North and South gable ends of roof is deteriorating.
- Signs of wear at exposed wood fascia and soffit.
