Ann Arbor City Council Regular Session: January 6, 2014
Email Redactions List Pursuant to Council Resolution R-09-386

INTRODUCTION:	
Scope and Objective of Report	1
Methodology	1
Report Team	1
Facility Assessment	
Background Statement	2
Existing Building Plan	3
Flood Assessment	4-5
Building Systems	
Exterior Facade:	
Building 1	6-13
Building 2	14-19
Interior:	
Building 1	20-23
Building 2	24-27
Roof:	
Existing Roof Systems	28-29
Building 1 & Building 2	30-33
Electrical Assessment	34-37
Mechanical Assessment	38
Structural Assessment	39
Hazardous Materials	40-41
Accessibility	42-43
Cost Analysis	
Proposals	
721 Gallery and Studios	44-45
Allen Creek Sustainability Center	46-47
721 N. Main Street Architectural Explorations	48-50

The overall goal of this report is to assess and evaluate the existing conditions of the Maintenance Garage structure at 721 N. Main Street; provide recommendations for the treatment and maintenance of the facility; determine related costs and phasing for these treatments; and propose suggestions for possible adaptive re-use potentials which the facility may be redeveloped for.

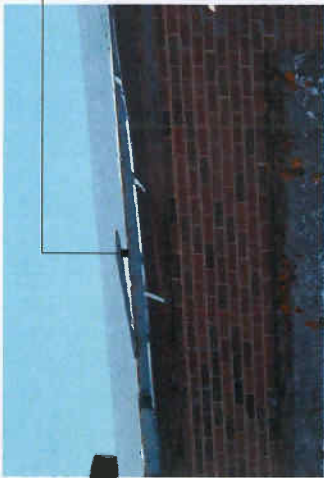
E1.1 The gutter has disconnected from hangers at many locations along the existing fascia. Several hangers have broken and fallen away from the building. The gutter is sagging and deteriorated in locations where water cannot drain.

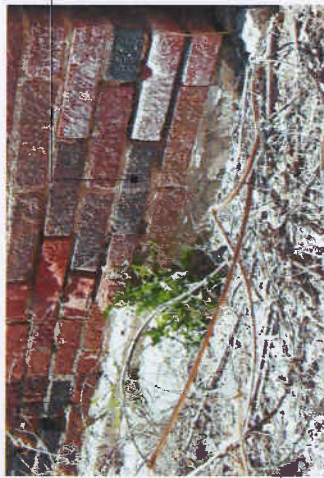
E1.2 The existing brick and mortar joints appear to be in poor condition in concentrated areas along the base of the building. In many areas the mortar has completely deteriorated and the brick has spalled, flaked and cracked away. In some areas the bricks have come completely loose and have exposed the inner wall cavity to both air and water infiltration.

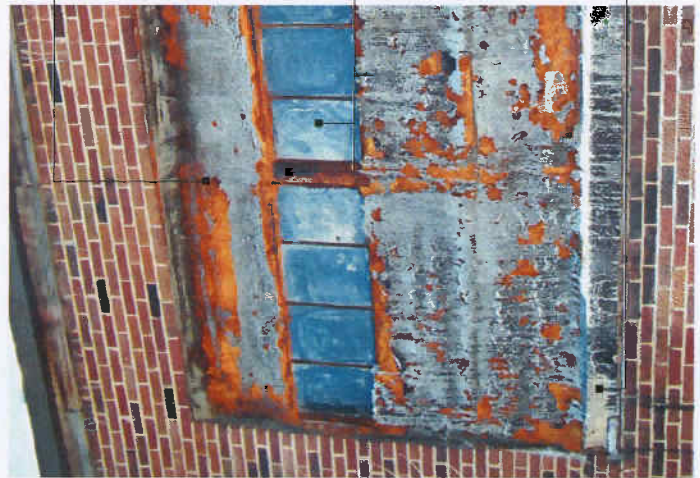
E1.3 Spray-on insulation has been applied to the existing steel sash windows, jamba, head and sill; bonding to the steel and glazing. The original fluid applied weather-resistant membrane has deteriorated exposing the spray-on insulation to the elements. Original application of the fluid applied membrane has left staining on the concrete window sills and adjacent face brick.

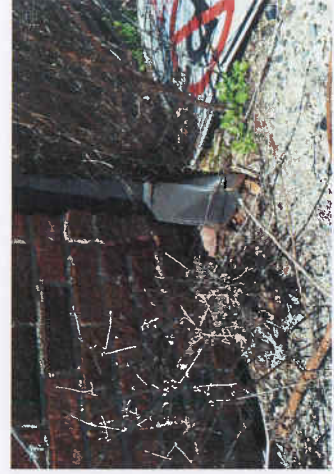
E1.7 Three of the four existing downspouts tie into conductors as part of the existing storm drainage system for the building. A single downspout at the SE corner of the building is disconnected and damaged and currently discharges onto the adjacent concrete paving. Overall the downspouts and conductors appear to be in fair condition with evidence of semi-recent maintenance.

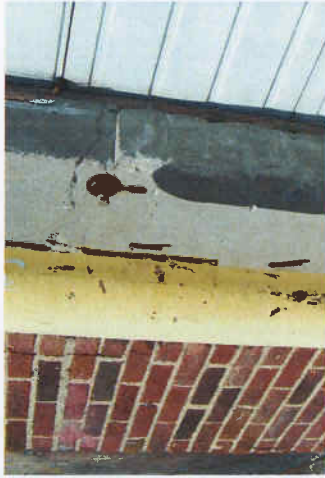
S1.2

Newer galvanized cap flashing has been applied over the brick parapet wall on the west end of the South Elevation. An open joint between the fascia and South Elevation parapet wall was observed. The wood fascia board is in poor condition and is displaying signs of severe rot and deterioration. Mortar has completely deteriorated in some areas of the parapet wall and the brick has spalled and cracked in many locations.

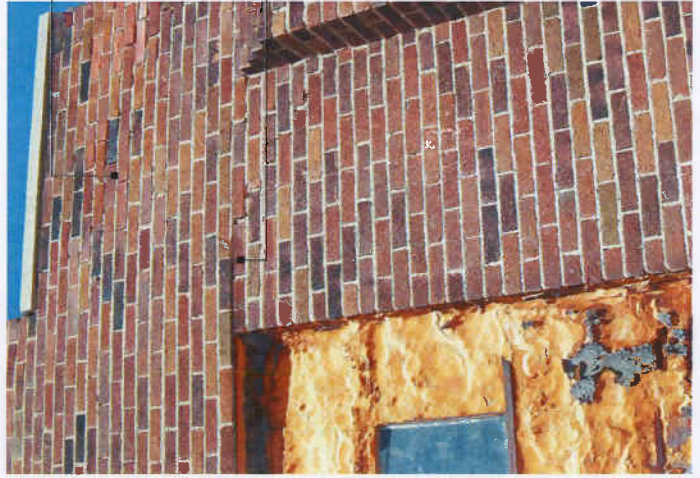
S1.3

Diagonal stepped-cracking in the brick wall between the window head and brick pilaster was noted as well. In general Building 1 is lacking adequate control and expansion joints to accommodate thermal movement of the brick facade. Coupled with issues of water infiltration, the thermal expansion of the brick has caused significant damage to the facade.

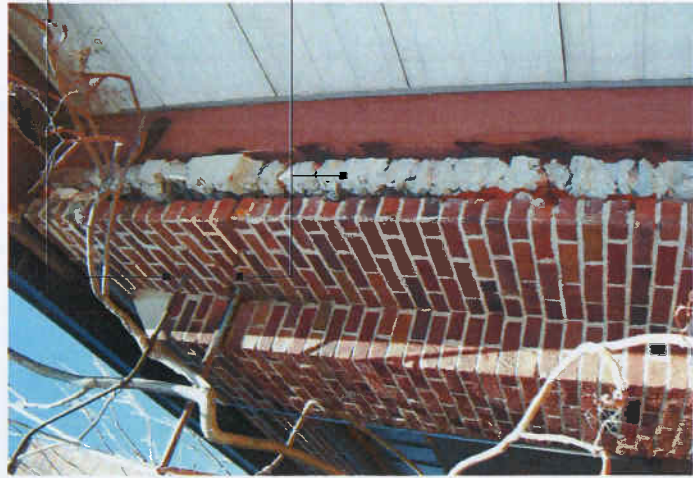
W1.3
The existing brick and mortar joints appear to be in poor condition. In many areas the mortar has completely deteriorated and the brick has spalled and cracked away. The brick facade is penetrated by pipes and conduit with no joint sealant around the perimeter of the opening.

Diagonal stepped-cracking in the brick wall between the overhead door and adjacent brick pilaster was observed. A jamb plate which once connected to the steel structural support of the overhead door and sealed along the edge of the brick has been removed exposing the interior wall cavity to air, water and bird infestation.

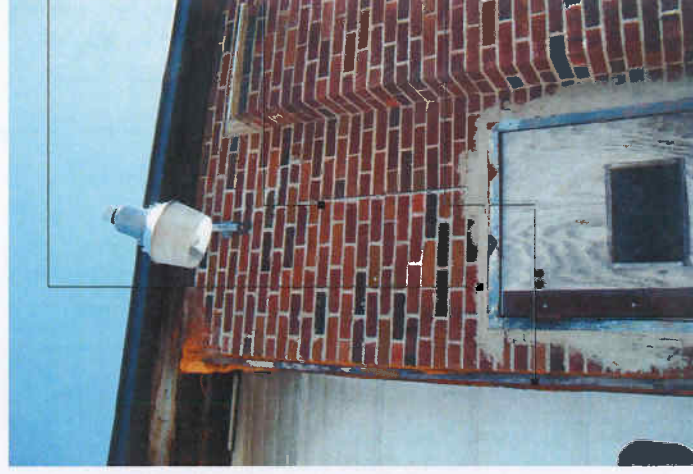
W1.6
It appears that the original brick was cut to create an opening for a steel frame and man-door. The joint at the perimeter of the frame and brick appears to have been patched with a grout mixture that extends beyond the joint to the adjacent brick facade.

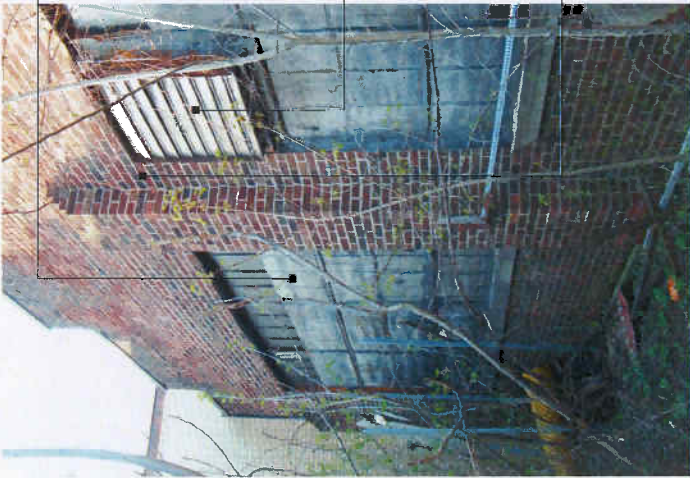
N1.1 Spray-on insulation has been applied to the existing steel sash windows, jambs, head and sill; bonding to the steel and glazing. The northern exposure, out-building and vegetation have protected the original fluid applied weather-resistant membrane, which remains relatively intact. Small sections of the spray on insulation are cut open and exposed.

The existing brick is in Poor-to-Fair condition. Some stepped cracking was observed at the window head. Unsealed drilled penetrations in the brick facade were observed.

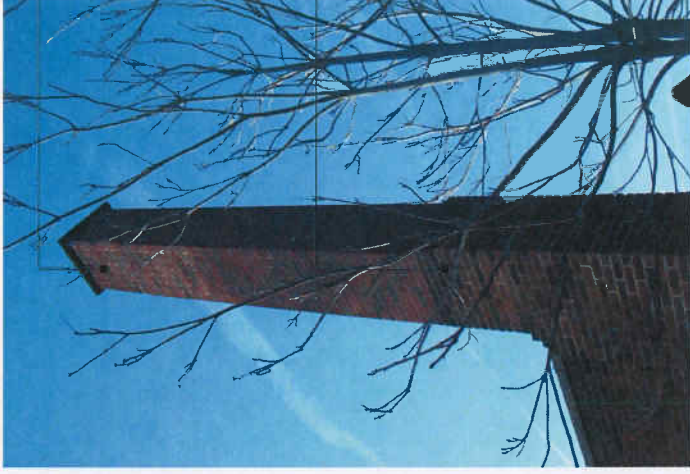
N1.2 It appears that the short chimney of the original structure was later expanded (possibly due to insufficient draft), increasing the overall height of chimney. The added brick appears to be in Fair condition with minimal wear and deterioration of the mortar joint. Aesthetically, the brick is a close match to the existing brick facade.

The existing brick and mortar joints below the expanded chimney are in Fair-to-Poor condition. The mortar has deteriorated moderately and section of the brick have spalled and flaked.

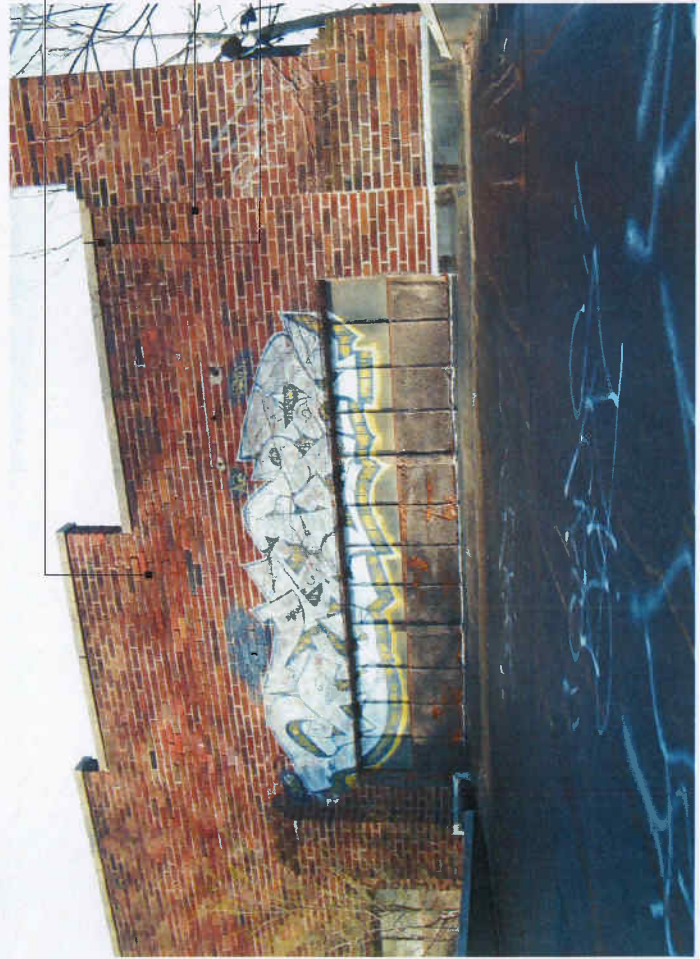
N1.3 The existing brick along the end of the parapet at the approximate location of the vaulted roof line is in poor condition. The mortar has completely deteriorated and sections of brick appear very loose and disconnected from the system. Root cause is likely water infiltration at the flashed joint between the parapet wall and roof.

Some ivy growth was noted along the North facade. The concrete coping at the parapet appears to have deteriorated creating an open joint condition between slabs of coping. This open joint would contribute to water infiltration along the parapet wall.

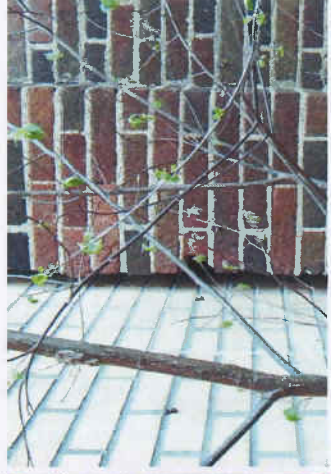
N1.4 The 1 1/2" wide expansion joint between Building 1 & Building 2 appears to be in fair condition. Set back 8" is a copper waterstop which is grouted in place along the continual length of the opening. Some deterioration of the existing brick at Building 1 was observed, as sections of the corner condition have crumbled and broken.

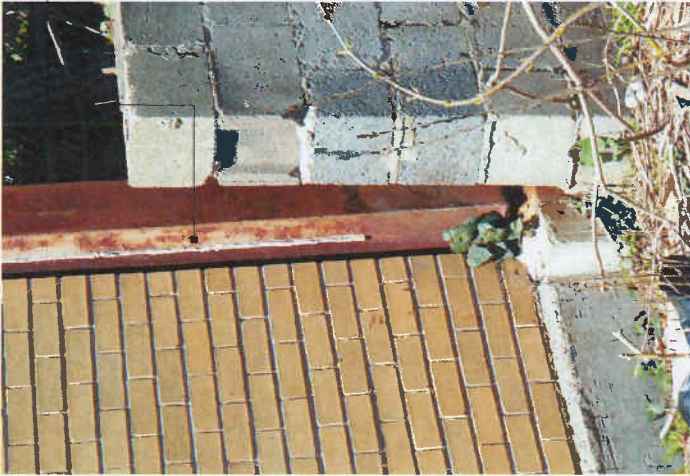
E2.1 Separation between the brick facade and steel column has occurred at NE corner of the building (see structural assessment for further evaluation). The resulting aperture between the brick and steel structure has caused separation of the joint sealant and exposed the internal cavity wall system to water, insect and air infiltration.

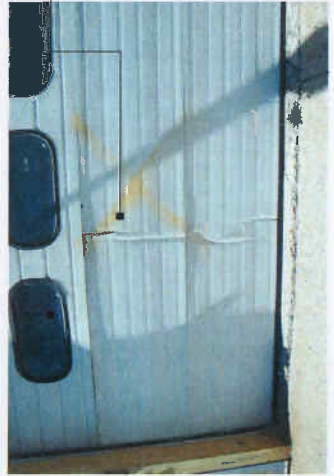
E2.3 Insulated face of the overhead door has been damaged in multiple locations. Weather stripping has broken away in many areas and the perimeter of the door has been breached by air and water infiltration. Adjacent key operator switch has been disconnected and signs of adjacent corrosion and deterioration were observed.

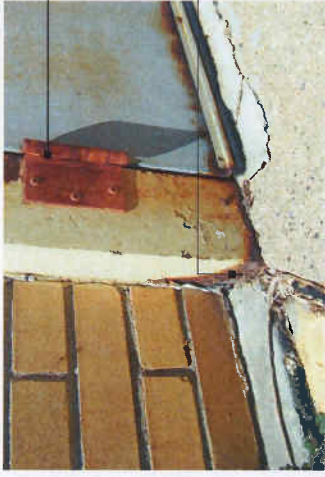
E2.4 Steel door and frame appear to be in Fair-to-Poor condition with moderate signs of corrosion at the base of the frame and the door. Hinges are completely corroded.

Steel column/frame is displaying signs of moderate corrosion at base condition.

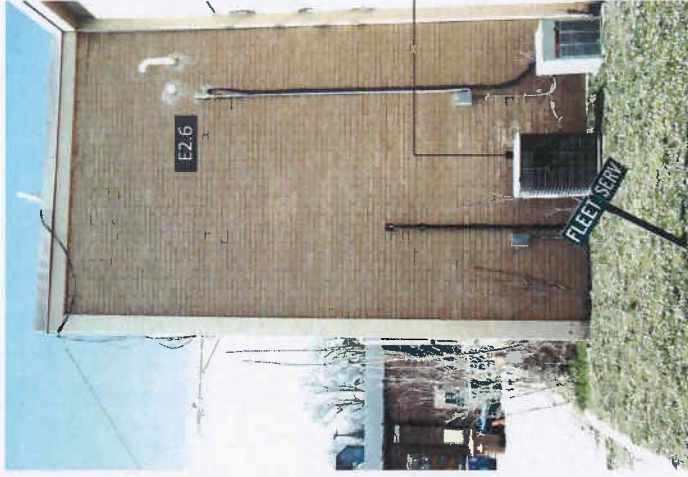
E2.5 Image of partial East Elevation at jog in South Elevation wall. Brick and grouted joints appear to be in good condition with some damage where the brick has been patched to accommodate the installation of mechanical/electrical conduits and PVC pipe vents for the ground mounted residential air conditioning units.

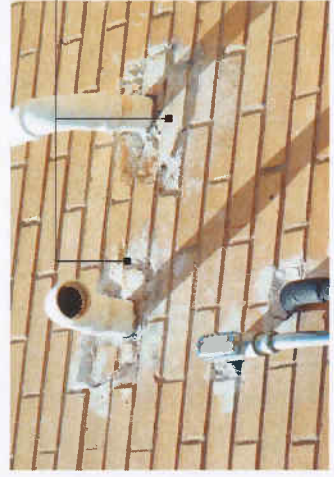
S2.6 Enlarged image of the damage done to the brick veneer to accommodate the installation of mechanical/electrical conduits and PVC pipe vents.

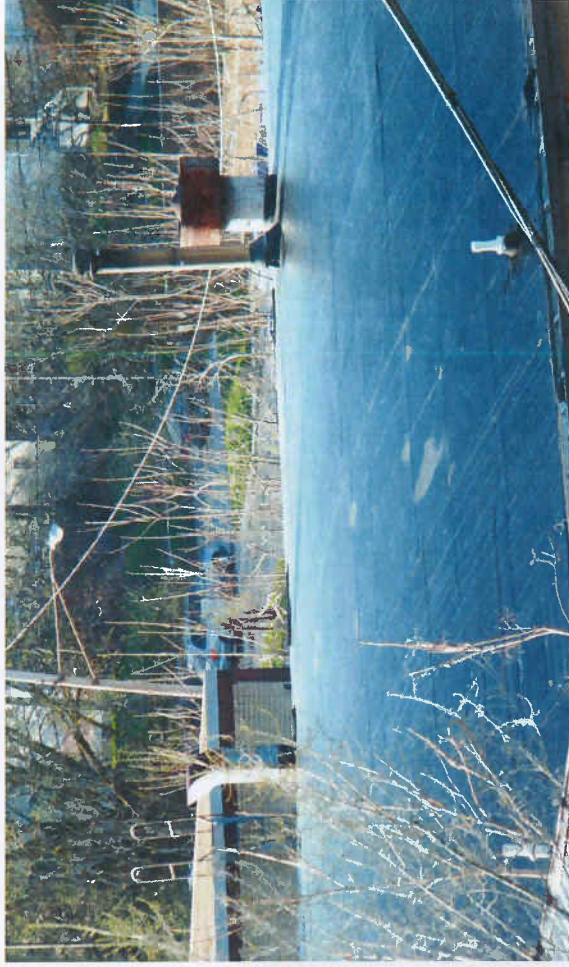
R1.1
View looking South of the Single-Ply membrane roof system installed over the Boiler Roof appendage on the North side of the building. The membrane appears to be in Good-to-Fair condition.

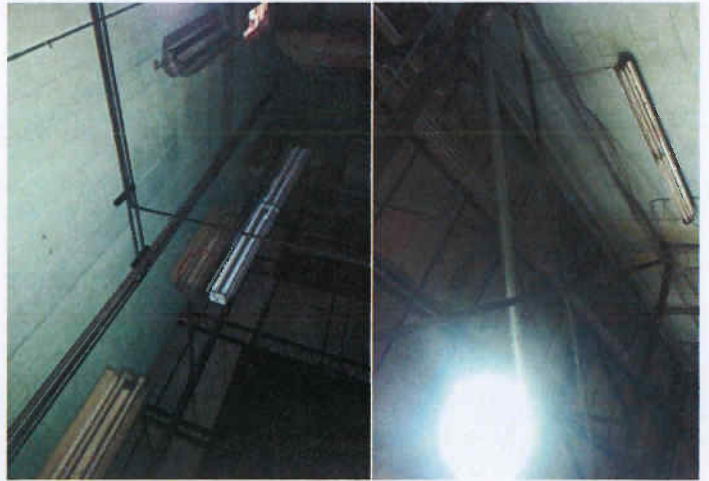
There is an existing paint booth in Building 2 that has not been in use for some time. There are existing fluorescent explosion proof lighting fixtures with T12 lamps in this area that are not in use, and have since been replaced with open strip fluorescent fixtures with T8 lamps.
