ANN ARBOR HISTORIC DISTRICT COMMISSION

Staff Report

ADDRESS: 317 South State Street, Application Number HDC12-219

REPORT DATE: December 6, 2012

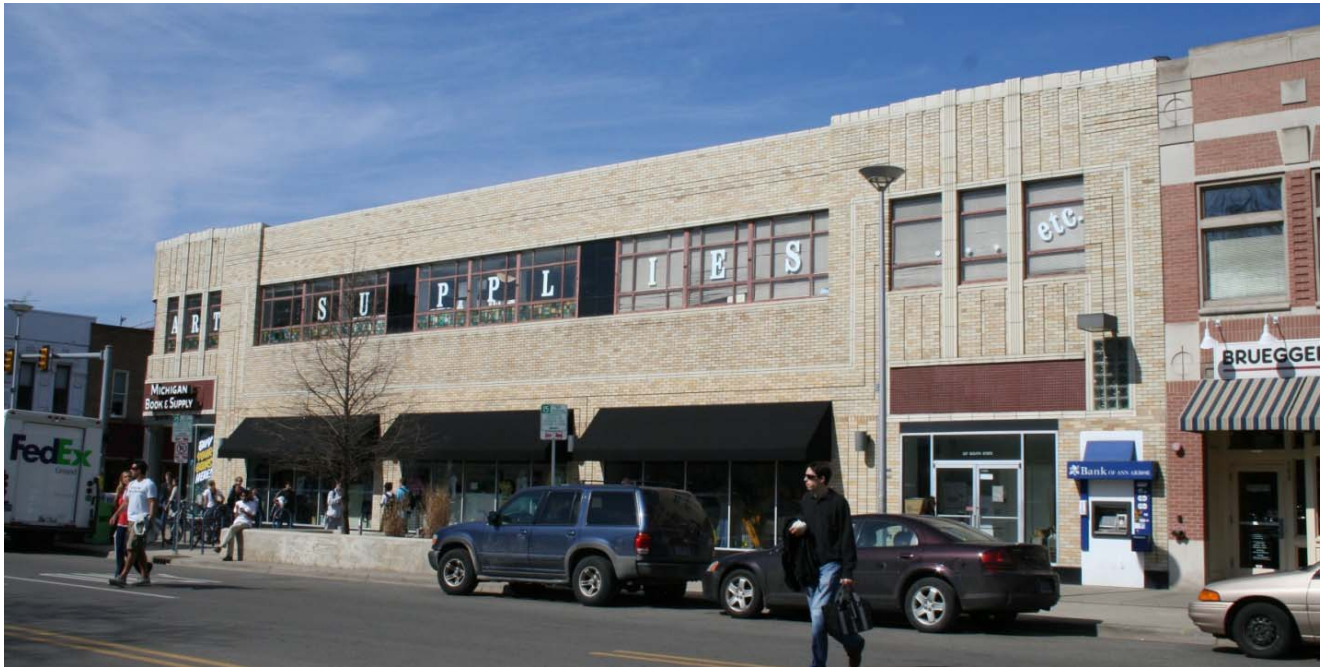
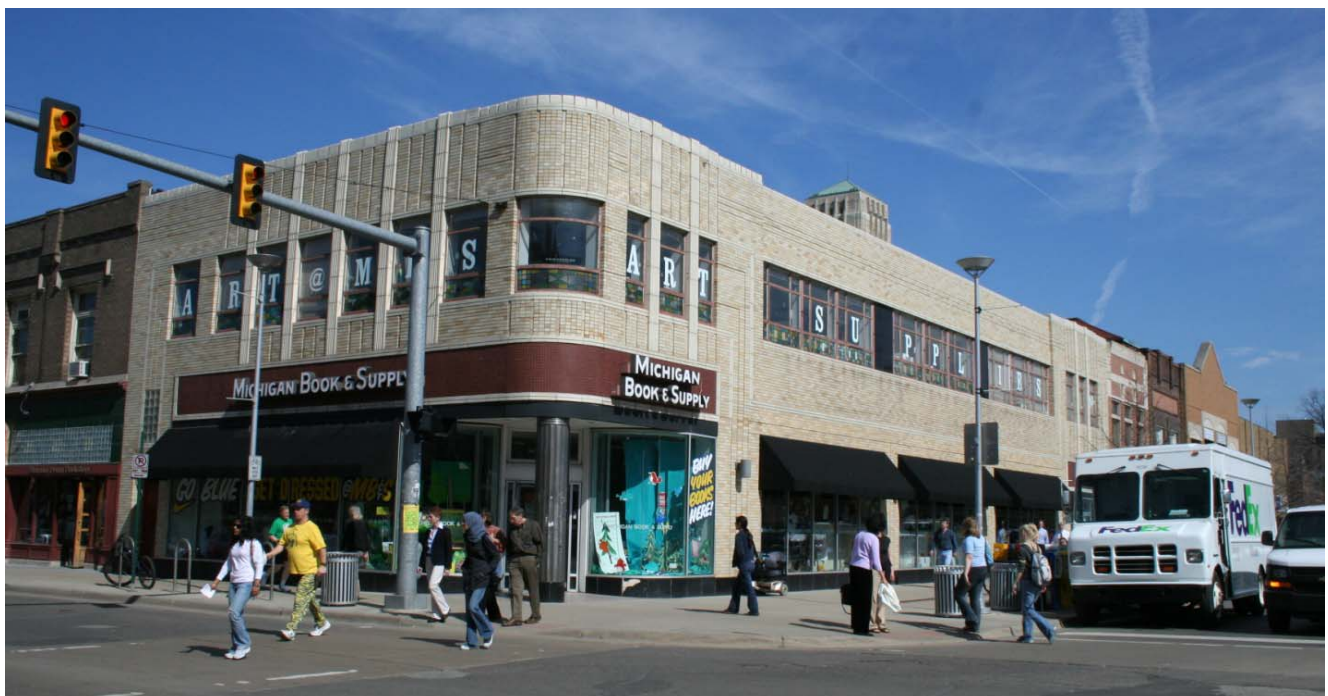
March 2007 photos (see application for additional window photos)

1. The steel windows proposed to be replaced are all on the second floor of the building. There are 14 single windows in two widths, each in three horizontal sections. There are 9 9-pane windows in a ribbon along the south elevation (facing North University). They are similar to the 14 single windows, with the addition of two vertical muntins on each window. The dimensions of each window type are given on the information sheet attached to the application. All windows except the corner were operable at one time, some with hoppers and some with pivots.
2. The muntins are applied to the interior and exterior of the glass. No interior spacer strip is proposed between the applied muntins because they are wide enough to shadow themselves. That is, someone looking up at the windows from the street will not be able to see daylight between the muntins because they are so wide.

6. The contractor provided a letter describing the condition of the windows. He recommends replacement of all windows except the corner curved window, which is not as deteriorated, probably because it has always been a fixed window.

7. After visiting the site and talking on the phone to the window contractor about the restoration prospects of these windows, staff believes that replication of the windows in aluminum is appropriate, with the exception of the curved corner window, which is not deteriorated beyond repair and should be restored.

I move that the Commission issue a certificate of appropriateness for the application at 317 South State Street, a contributing property in the State Street Historic District, to replace 21 of 22 steel windows with aluminum windows, as proposed, on the condition that the curved corner window is not replaced and is restored. The work as conditioned is compatible in exterior design, arrangement, texture, material and relationship to the rest of the building and the surrounding area and meets *The Secretary of the Interior's Standards for Rehabilitation and Guidelines for Rehabilitating Historic Buildings*, in particular standard 6 and the guidelines for windows.
