#### ANN ARBOR HISTORIC DISTRICT COMMISSION

### Staff Report

- ADDRESS: 614 South Ashley Street, Application Number HDC 13-125
- DISTRICT: Old West Side Historic District

**APPLICATION:** The applicant seeks after-the-fact HDC approval to replace four wood windows on the second floor with vinyl windows.

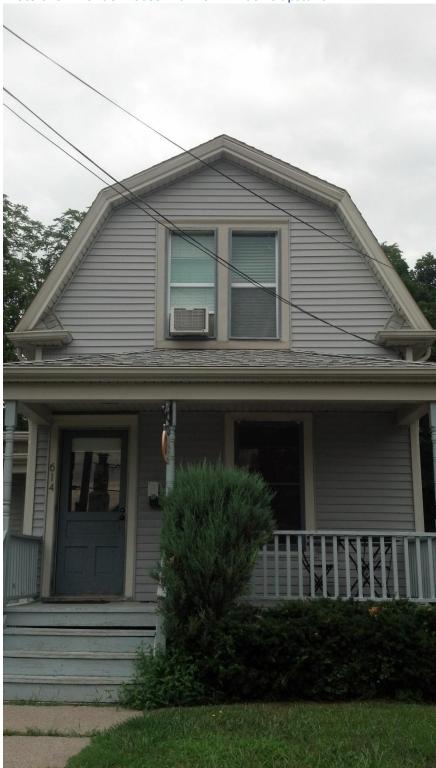
- 2. Per the applicant: Four wood windows on the second floor were replaced with vinyl windows. Two are on the front (east) façade, and two on the north façade. The replaced windows at one time were double-hung and had weights and pulleys, although those had been removed and the top sash fixed shut to convert them to single-hung windows. They matched the wood windows on other parts of the house that were not replaced. The presence of weights and pulleys indicates that it is extremely likely that the windows were installed during the period of significance for the historic district (i.e. pre-1942); visual inspection of remaining windows during the Review Committee visit will provide more information.

Photo 626 – front of house with new windows upstairs

- 4. In staff's opinion, the replacement of wood windows with vinyl ones does not qualify for a certificate of appropriateness. Since the wood windows removed from the house were discarded, reinstallation is not an option. Therefore, where wood windows previously existed, modifying the work by removing the vinyl windows and installing compatible wood windows that meet the *City of Ann Arbor Historic District Design Guidelines* is recommended by staff.

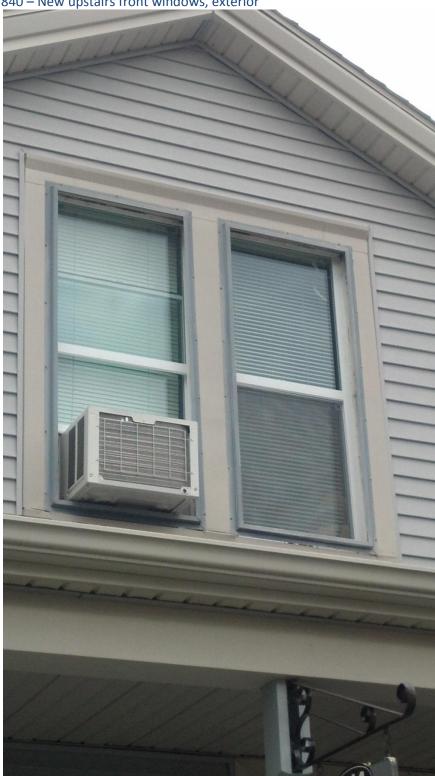
# 840 - New upstairs front windows, exterior

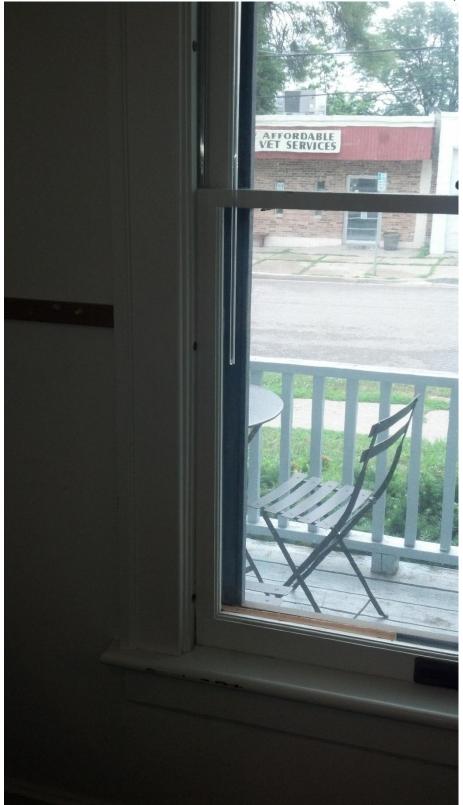
691 – First floor wood windows, interior, like the ones that were removed upstairs

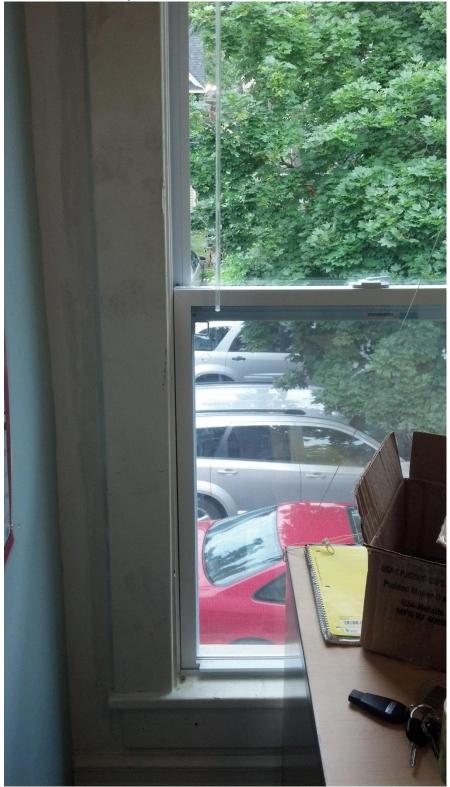
# 916 – New window upstairs, interior
