ANN ARBOR HISTORIC DISTRICT COMMISSION

Staff Report

ADDRESS: 423 West Liberty Street, Application Number HDC14-199

DISTRICT: Old West Side Historic District

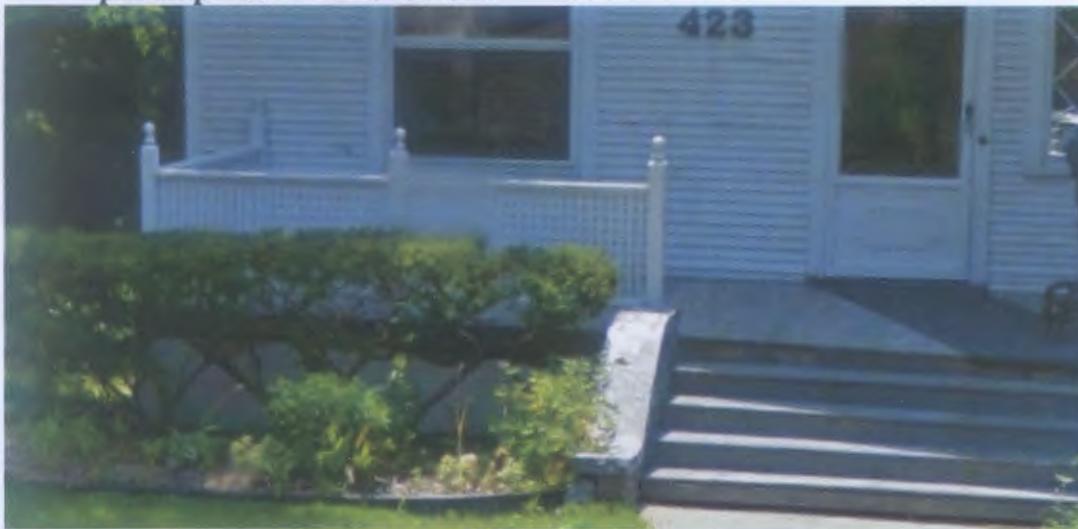
2. Provide a description of existing conditions. Prior to replacing the deck, the boards had rotted to the ~~point~~^{point} of being structurally unsound, and additionally developed a very significant amount of black mold on the bottom of the boards and into the basement. The porch contained no substructure and was at risk of collapsing anytime.

Wood porch prior to renovation

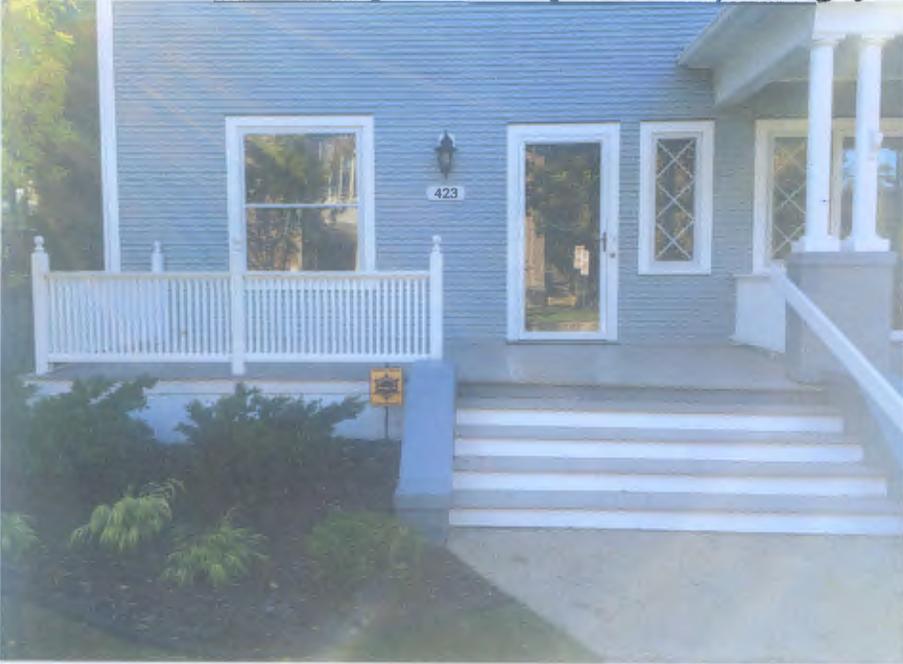
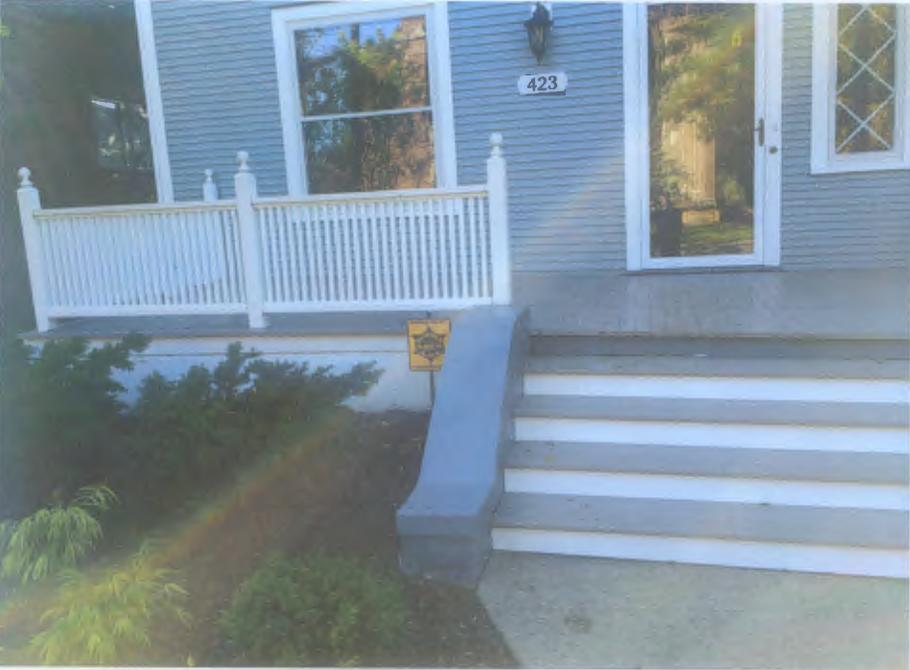
Porch after renovation - please note prior fence/railing system was kept

1. Provide a brief summary of proposed changes. Front porch at 423 W. Liberty was fully replaced with an Azek material deck of the same width and appearance. The pre-existing white wooden rail/fence system was kept to maintain the prior appearance of the porch from the street.

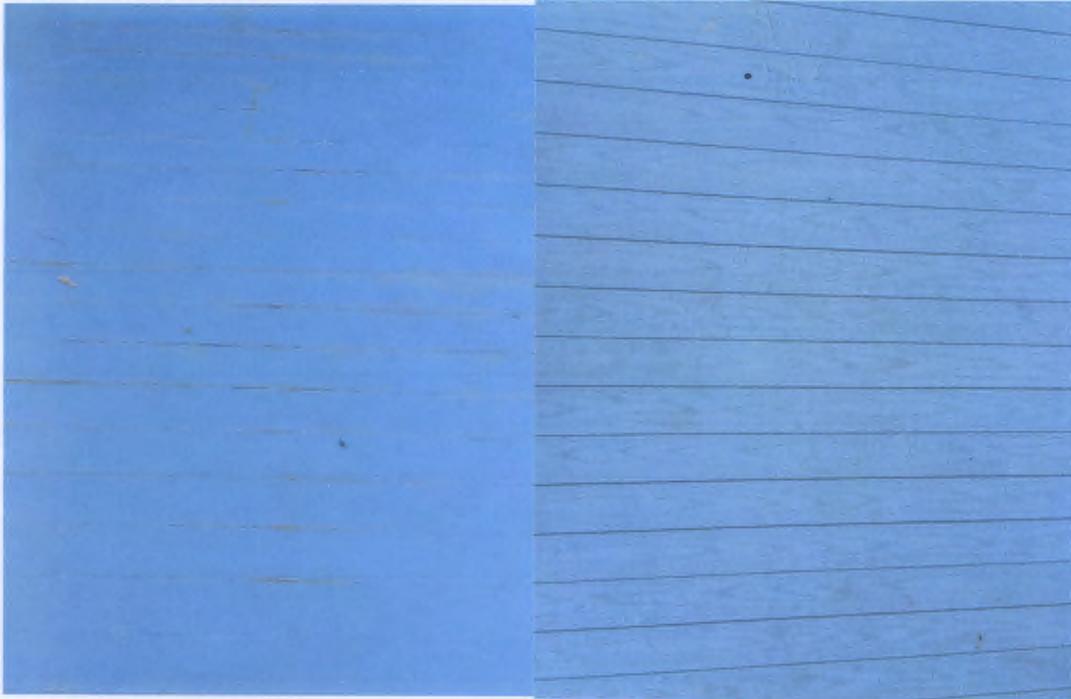
Width of the old porch boards and new Azek boards are the same

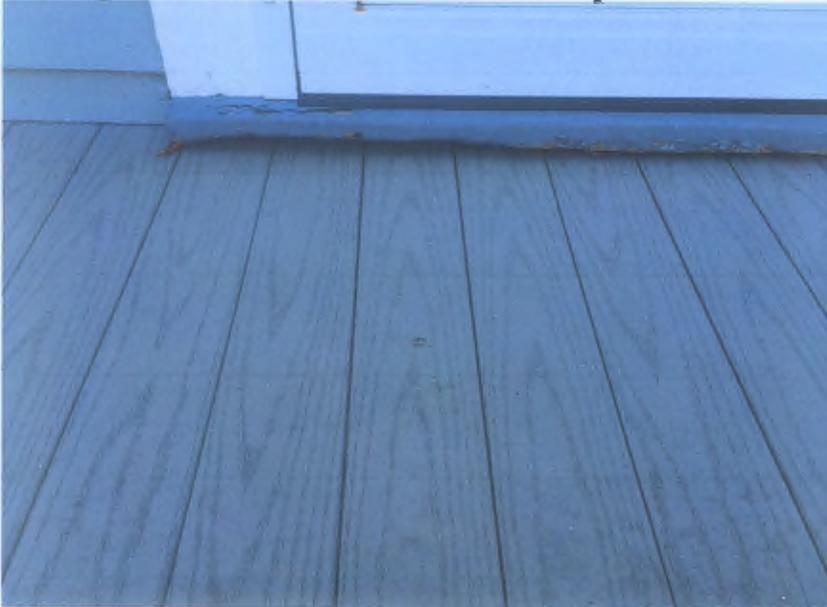
Rotting threshold board that was not replaced

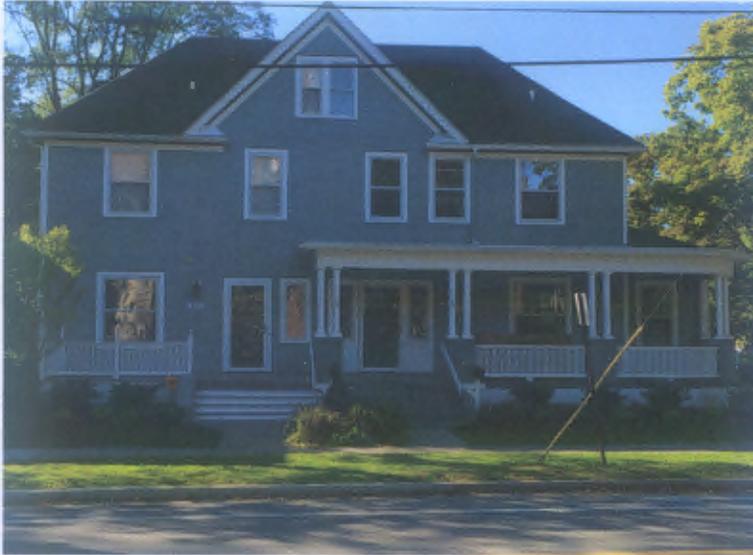
Exterior view (423 W. Liberty on the left) after the porch renovation. Due to keeping the old fence/railing, the exterior maintains the same appearance from street view as before
