ANN ARBOR HISTORIC DISTRICT COMMISSION**Staff Report****ADDRESS:** 1021 W Huron Street, Application Number HDC20-096**DISTRICT:** Old West Side Historic District**REPORT DATE:** August 9, 2020**REPORT PREPARED BY:** Jill Thacher, Historic Preservation Coordinator**REVIEW COMMITTEE DATE:** August 6, 2020**OWNER****APPLICANT**

APPLICATION: The applicant seeks HDC approval to modify the roofline of an existing garage, install three windows in a boarded garage bay, and install new fiber-cement siding and boral trim.

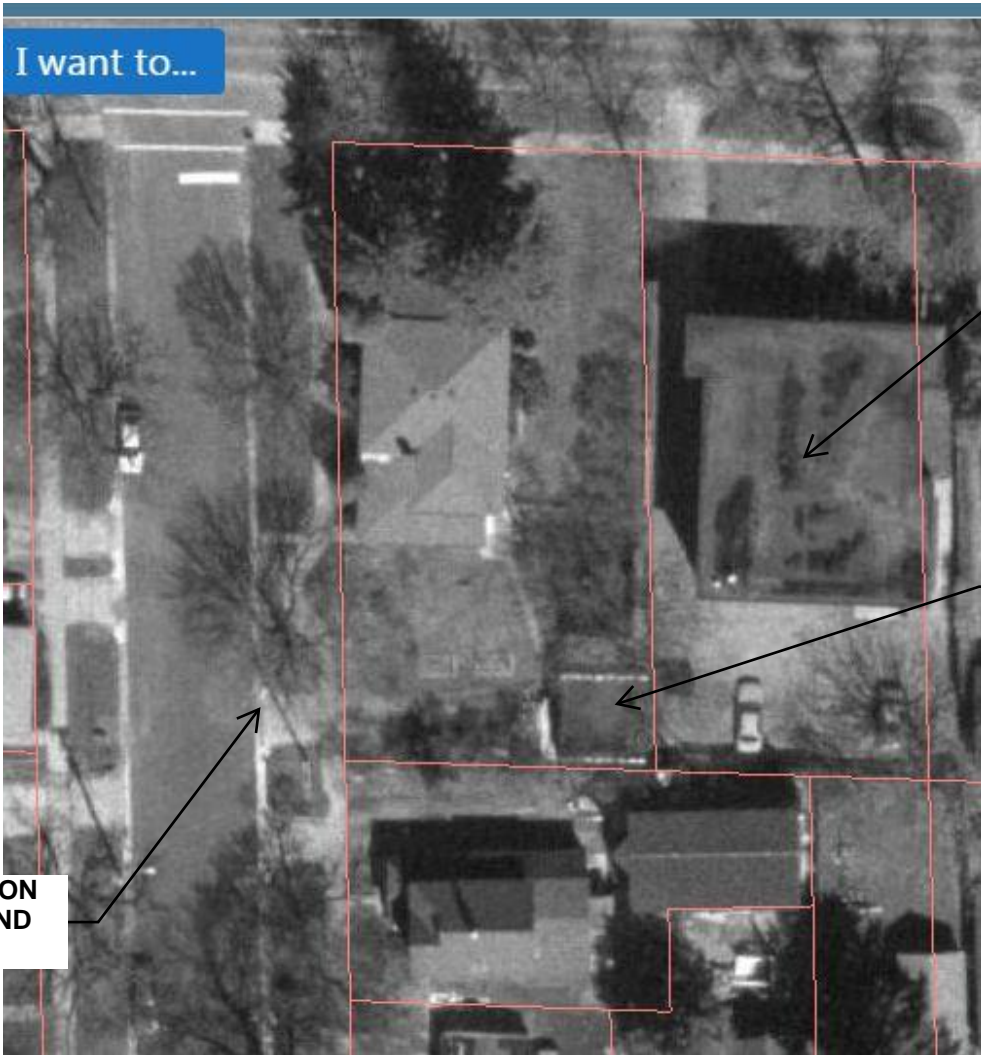
1997 AERIAL PHOTO

APARTMENT BUILDING
CONSTRUCTED EARLY
1960'S - MAY HAVE
ALTERED APPROACH TO
SHED

ROOF CONSTRUCTION
APPEARS TO HAVE
CHANGED AGAIN

CLEAR INDICATION
OF CURB CUT AND
DRIVEWAY

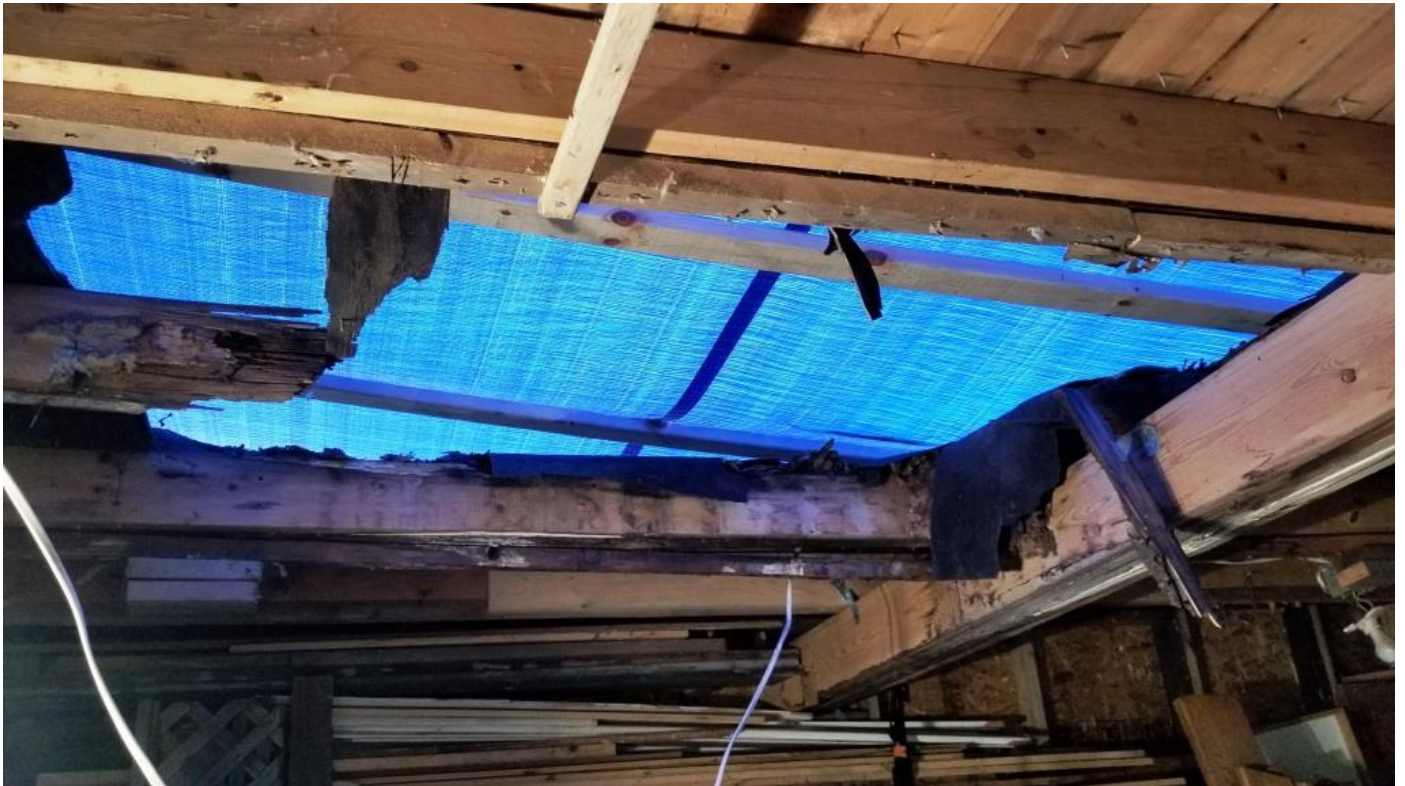
INTERIOR VIEW OF NORTH WALL

RECENT ROOF DAMAGE DUE TO ROT AT SHALLOW
SLOPED ROOF

ROOF JOISTS ARE OF
DIFFERENT AGES AND
DIMENSIONS

NOTE MULTIPLE TYPES
OF ROOF SHEATHING

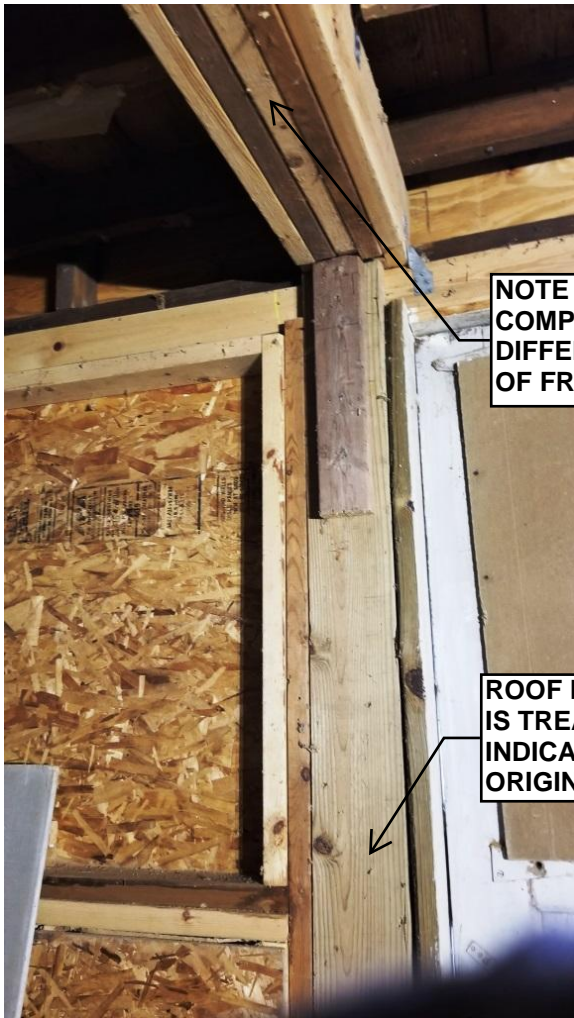
INTERIOR VIEW OF WEST WALL

NOTE ROOF BEAM IS
COMPOSED OF
DIFFERENT AGES/SIZES
OF FRAMING MEMBERS

ROOF BEAM SUPPORT
IS TREATED MEMBER -
INDICATING NOT
ORIGINAL

PLYWOOD USED AS
ROOF SHEATHING AT
MULTIPLE PLACES IN
LIEU OF 1 x 8'S

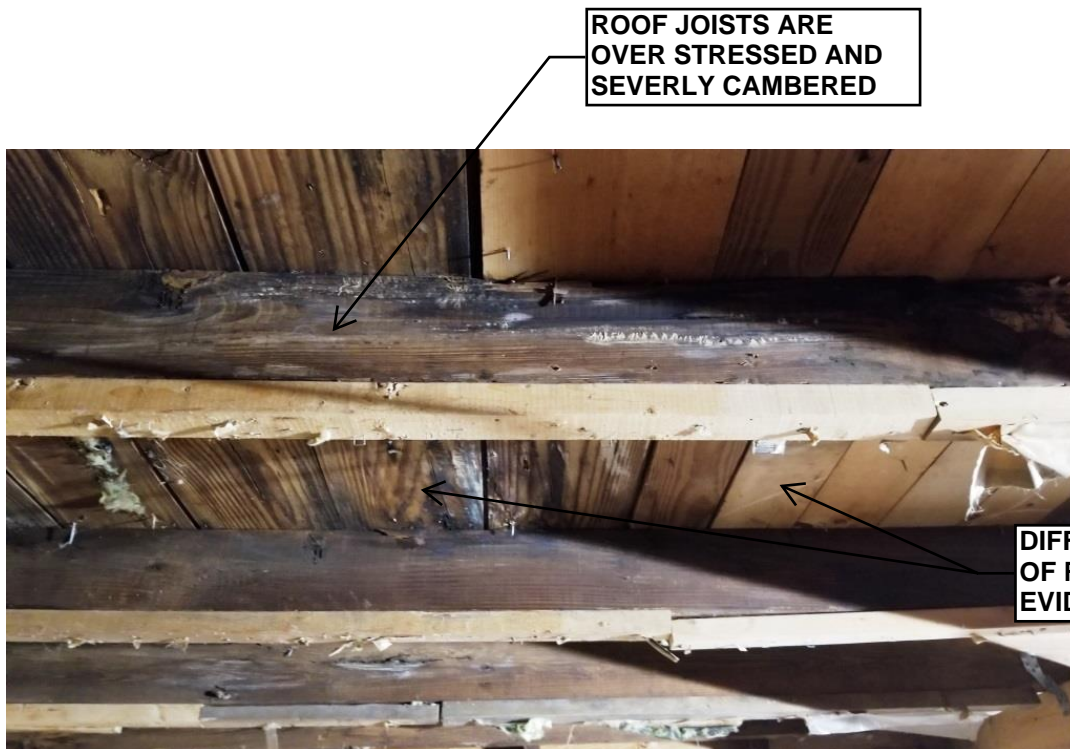
INTERIOR VIEW OF ROOF

ROOF JOISTS ARE
OVER STRESSED AND
SEVERLY CAMBERED

DIFFERENT TYPE/AGES
OF ROOF SHEATHING
EVIDENT

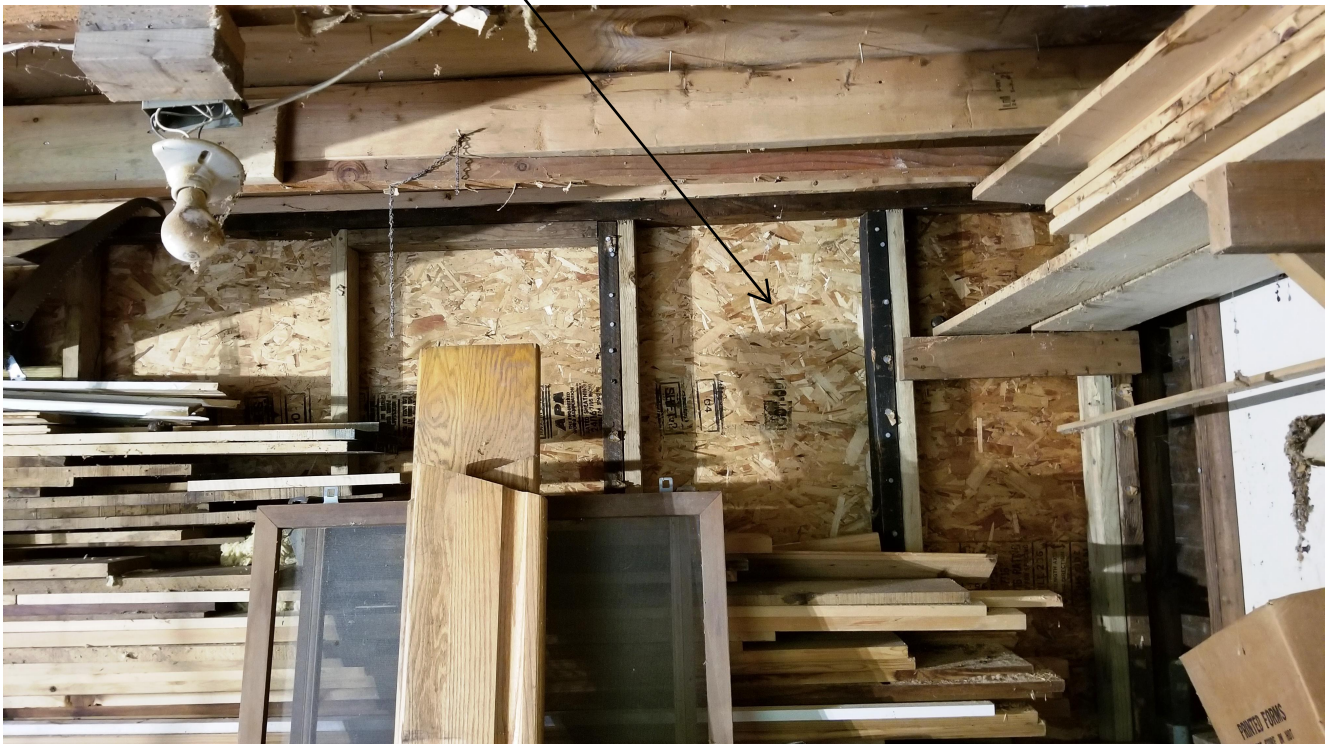
INTERIOR VIEW OF EAST WALL

NOTE EAST WALL IS OF
DIFFERENT
CONSTRUCTION: USE
OF OSB AND STUD
SPACING IS DIFFERENT

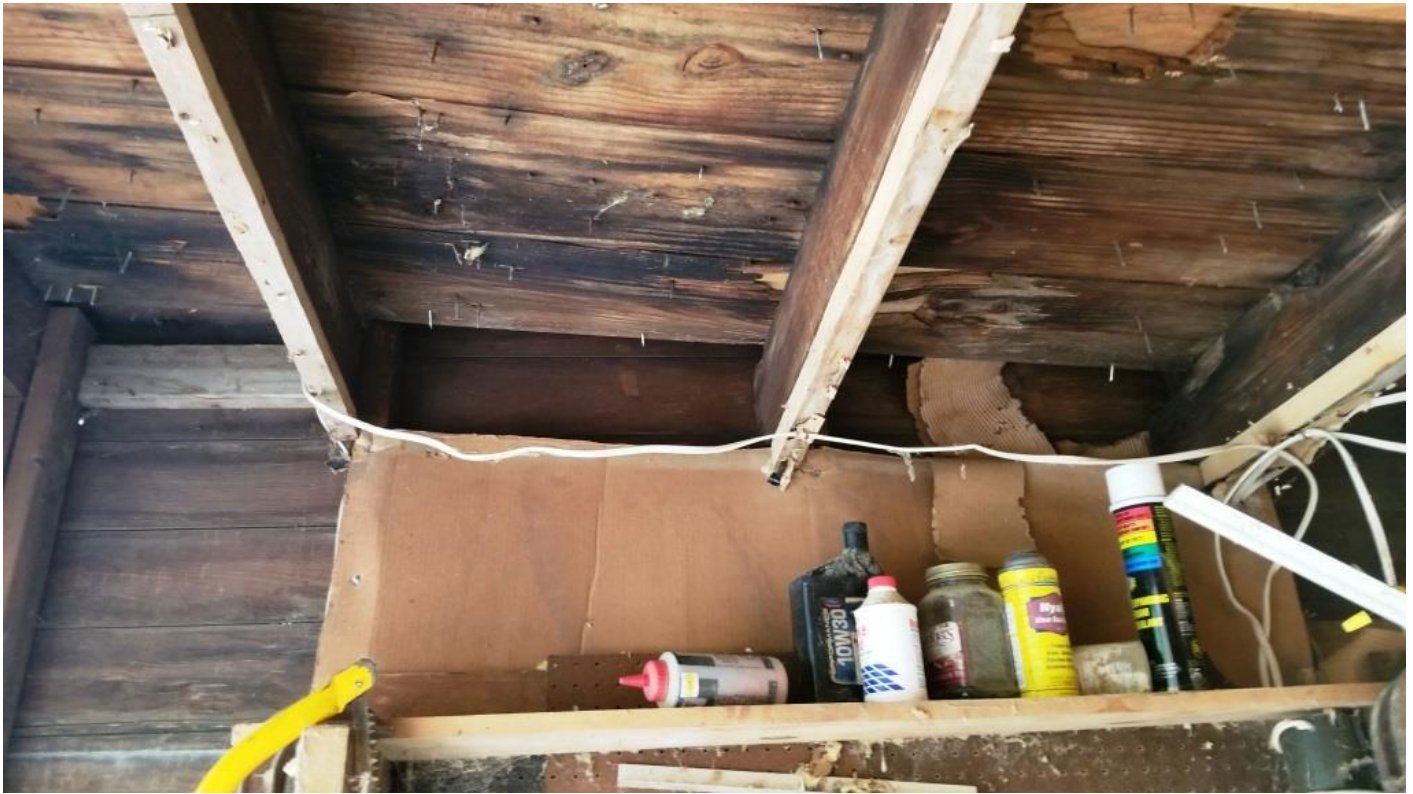
INTERIOR VIEW OF NORTH WALL

NOTE WALL
CONSTRUCTION IS
DIFFERENT: STUD AGE,
SPACING AND USE OF
OSB

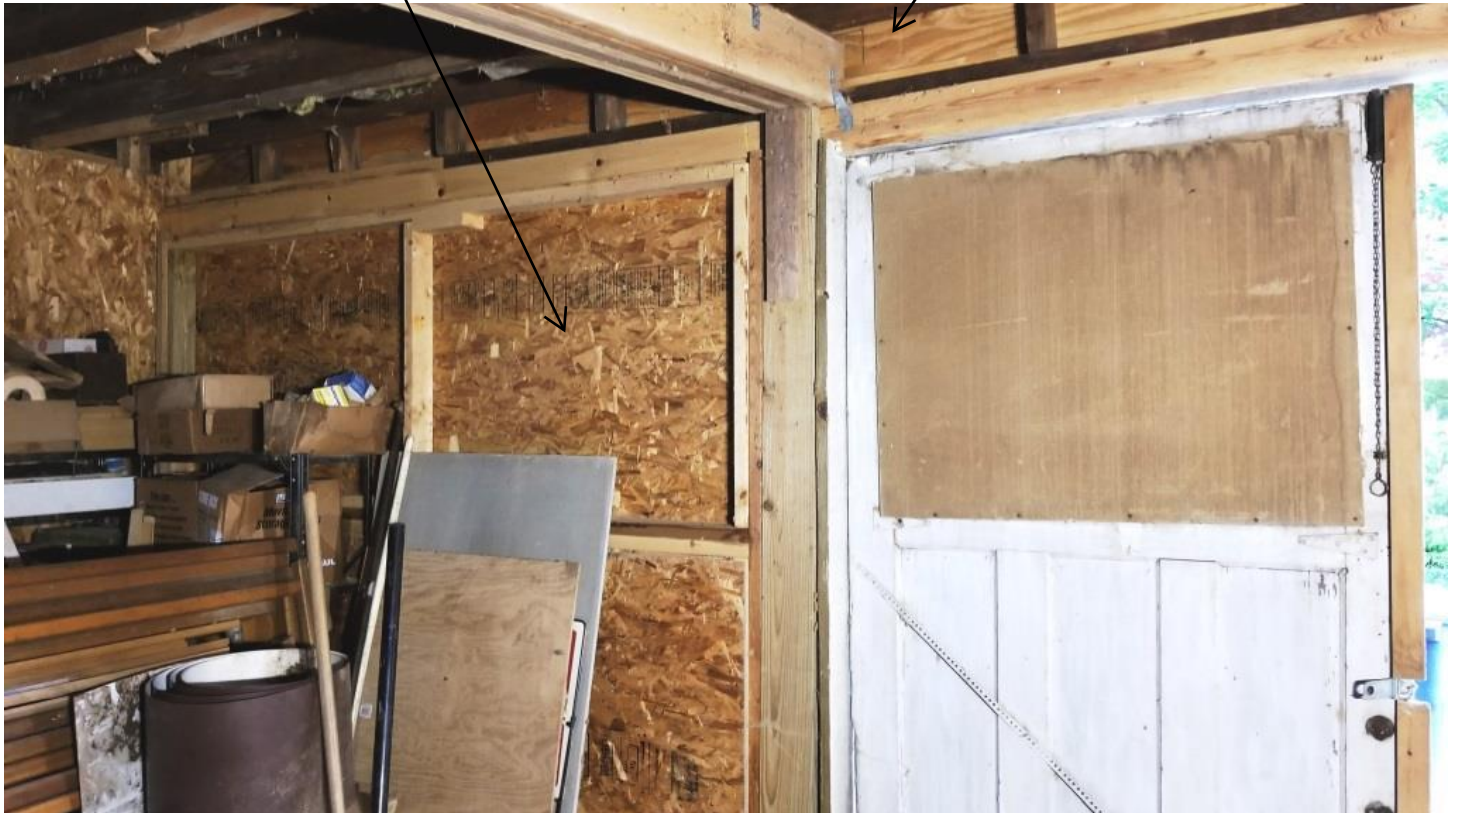
INTERIOR VIEW OF WEST WALL

NOTE WALL CONSTRUCTION IS
DIFFERENT: STUD SPACING,
USE OF PLYWOOD AT UPPER
PORTION OF WALL - THIS IS
DIFFERENT FROM OLDER
PORTIONS OF SHED STRUTURE
