ANN ARBOR HISTORIC DISTRICT COMMISSION

Staff Report

ADDRESS: 310 S Ashley, Application Number HDC21-037

DISTRICT: Main Street Historic District

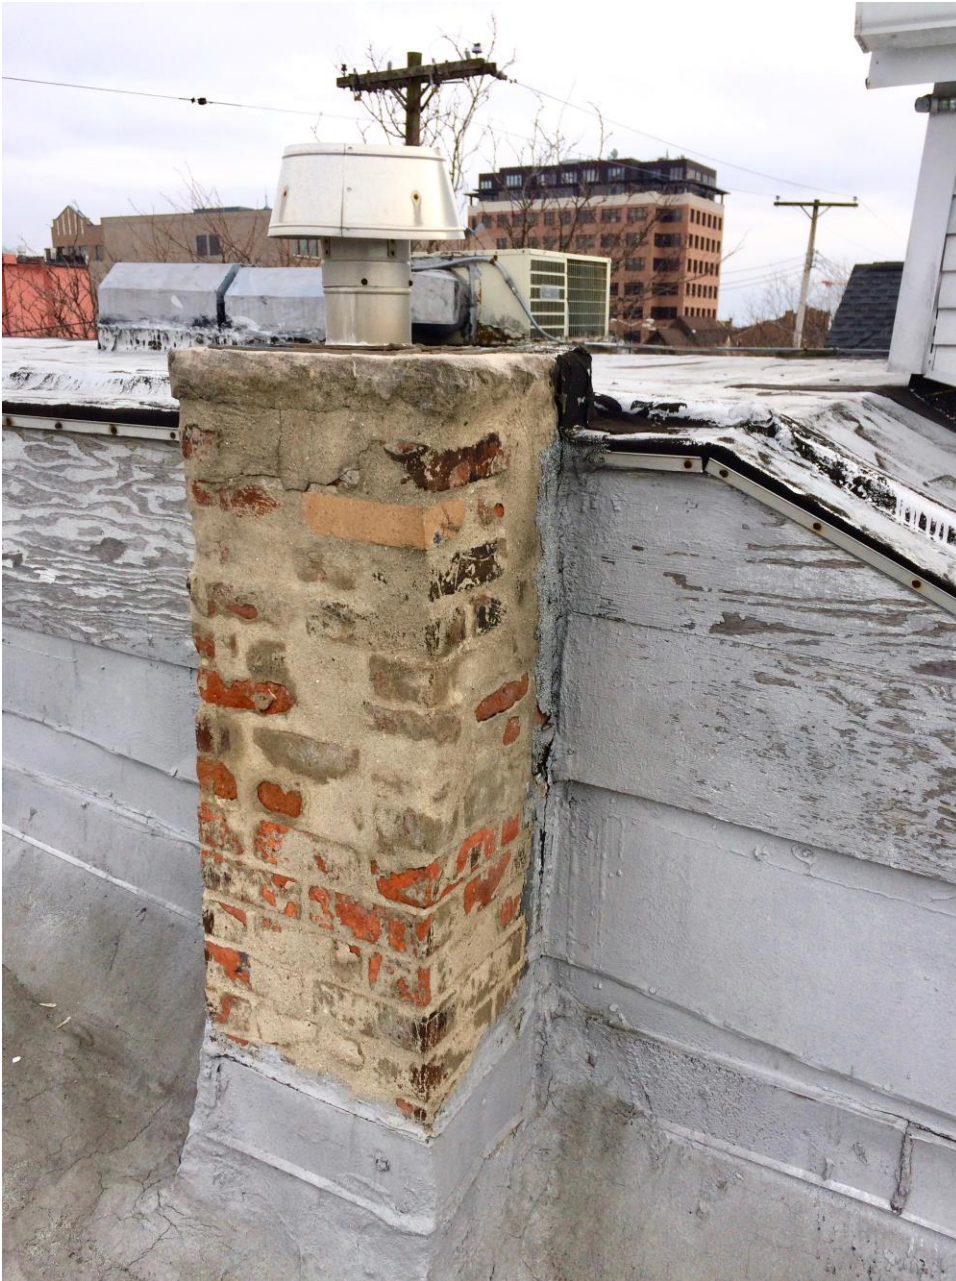
2. The bricks on the former chimney appear to be mostly common brick that matches the rest of the building. You can see a yellowish replacement brick near the top, and some of the other bricks are too coated with mortar to be able to identify their color. It is not an example of fine workmanship – there is nothing ornate or decorative about it. It is also not visible from any public right of way. The chimney was certainly old, however, and very likely from the period of significance (pre-1945).

310 S Ashley Chimney, photos courtesy of property owner
2018

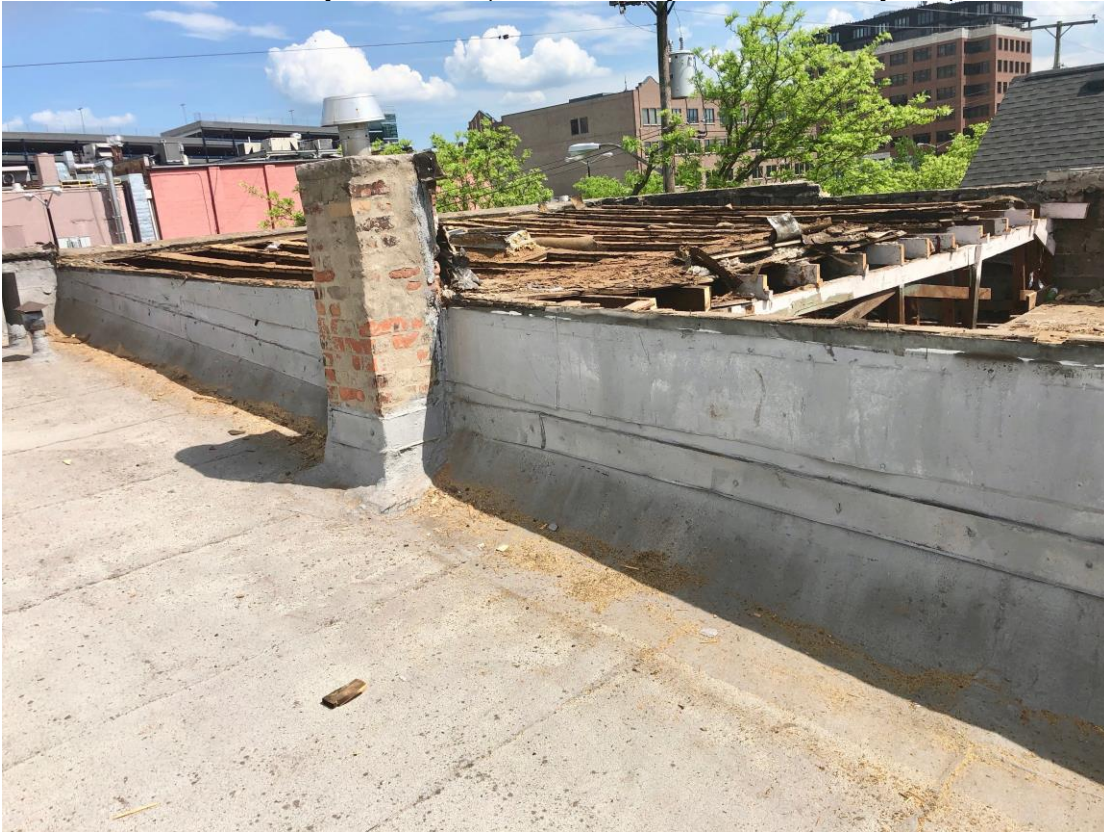
Received via email May 27, 2020 (312 S Ashley roof demo beyond)

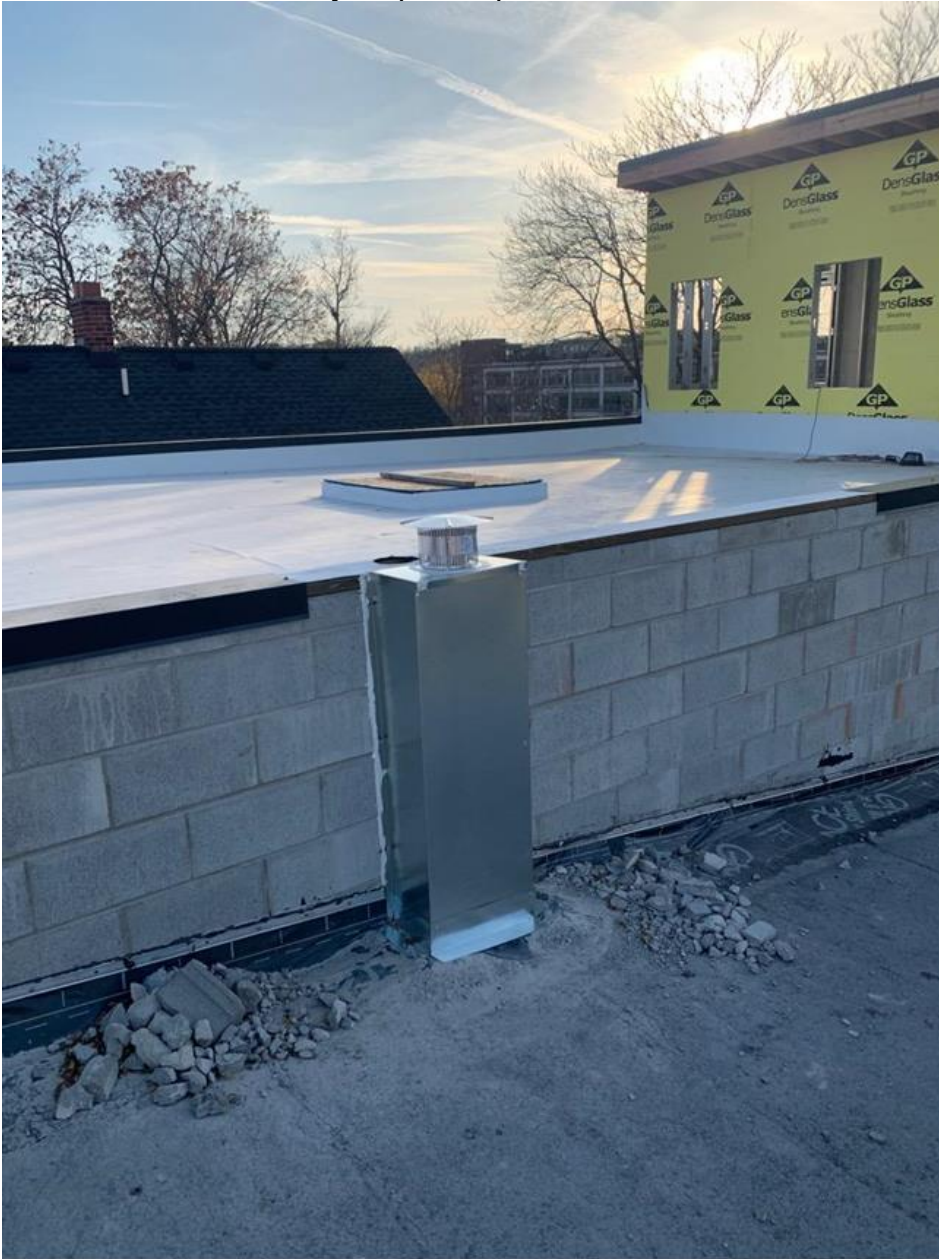
1. In February of 2020, the HDC approved work (HDC20-014) on the building at 312 S Ashley Street (formerly Nalli Music). Building permits were issued in August of 2020 and work commenced. In October 2020, the property owner informed staff that a brick chimney had been removed from the roof of 310 by the contractor working on 312 without authorization. It was eventually replaced with a metal duct (shown at end of report). The chimney vents the building's furnace.

December 21, 2020 City Inspector photo

I move that the Commission finds that the completed chimney work does not qualify for a certificate of appropriateness. The property owner shall restore the chimney to the condition the chimney was in before the inappropriate work or modify the work so that it qualifies for a certificate of appropriateness. The property owner is required to contact staff within 30 days to discuss a proposed remediation plan and timeline for completion.
