# **DOCUMENTATION and RECORDATION REPORT**

**439 South Division Street  
(Known locally as the Arthur Miller House)  
Ann Arbor, Michigan**

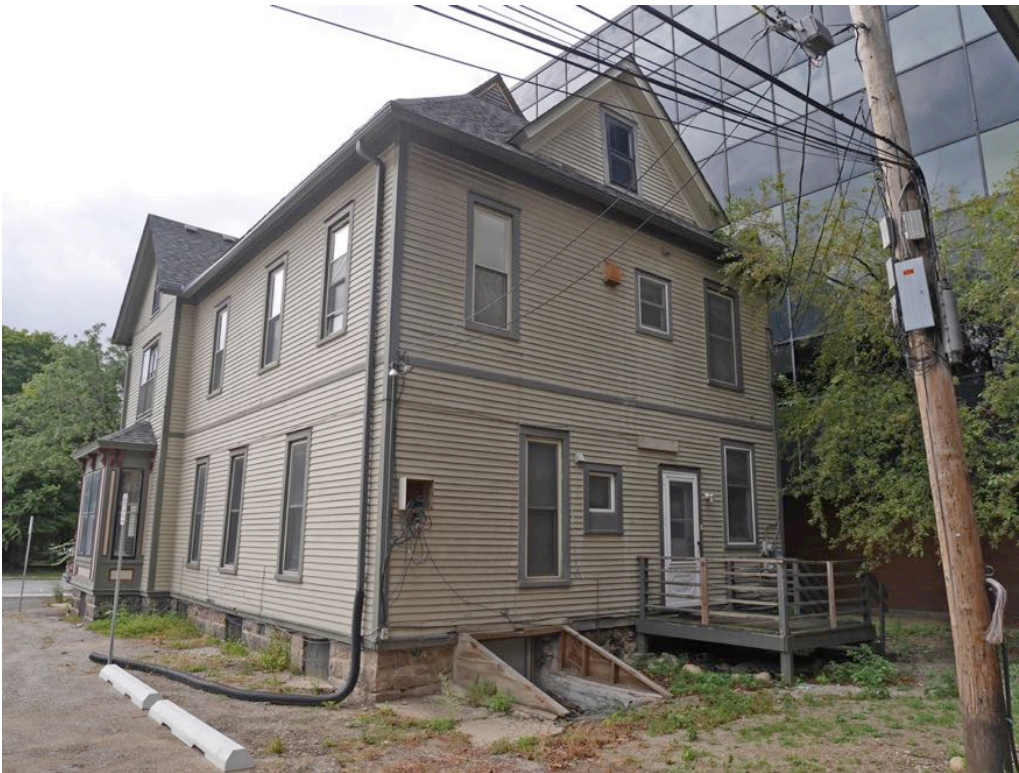
Photo No. 16 (image No. 44): East elevation is where most change has occurred. The original "back" door has been changed to a small window, and a new door added that leads into the modern kitchen. Cellar door cover is missing.
