ANN ARBOR HISTORIC DISTRICT COMMISSION

Staff Report

ADDRESS: 815 W Jefferson Street, Application Number HDC15-210

DISTRICT: Old West Side Historic District

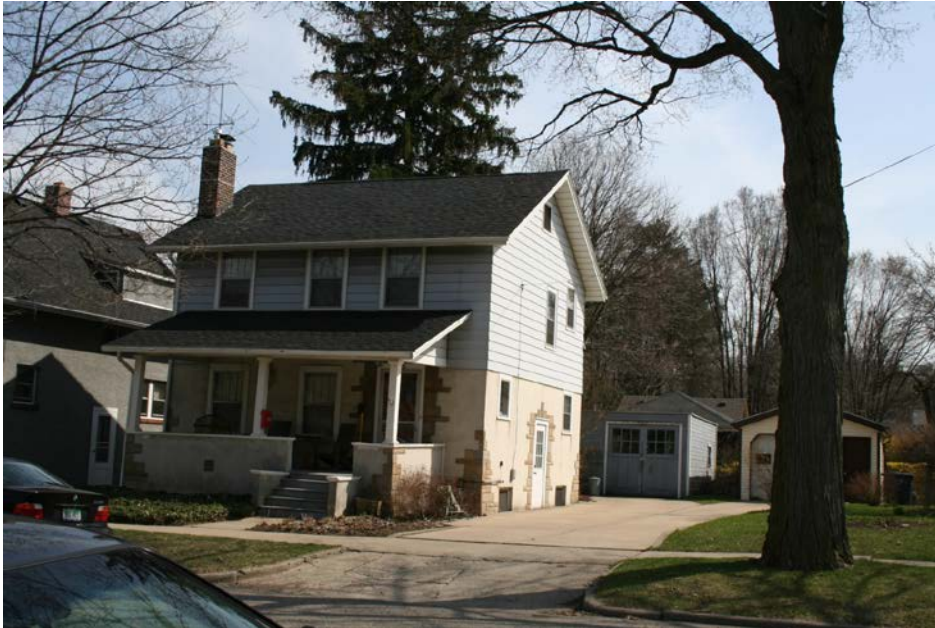
815 W Jefferson (2007 survey photo)

BACKGROUND: This two-story end-gable home was built in 1923 or 1924 and first occupied by William Wenger, and Wengers continued to live in the house until at least 1940. It features a full-width front porch, and its first-floor stucco with faux-exposed-brick around the openings is presumed to be original, and is unique to the Old West Side.

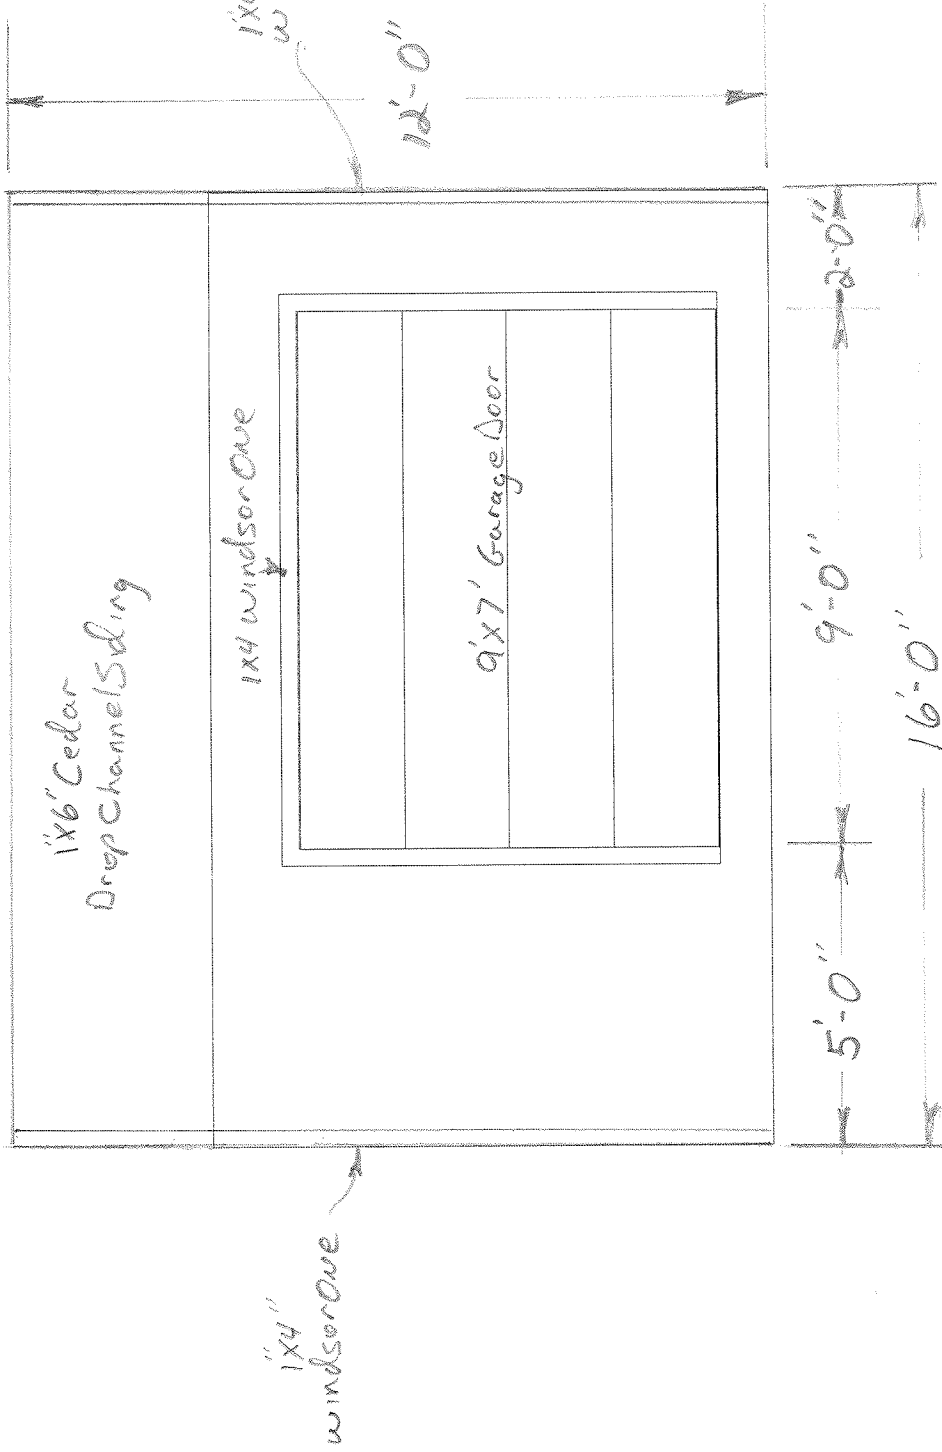
North Elevation
A-2

2. I would like to put a 3/12 gable roof on to eliminate the flat roof. Flat roofs are not very ideal with the environment we live in (heavy snow and rain). To keep the garage looking like the original I propose to build a false front to cover the front gable end (see drawing A-2).

4. The roof is too flat and needs to be pitched, and the new front parapet is less of a departure from the existing appearance than seeing a gable roof on the front of the building.
