ANN ARBOR HISTORIC DISTRICT COMMISSION

Staff Report

ADDRESS: 223 E Ann Street, Application Number HDC22-1097

DISTRICT: Old Fourth Ward Historic District

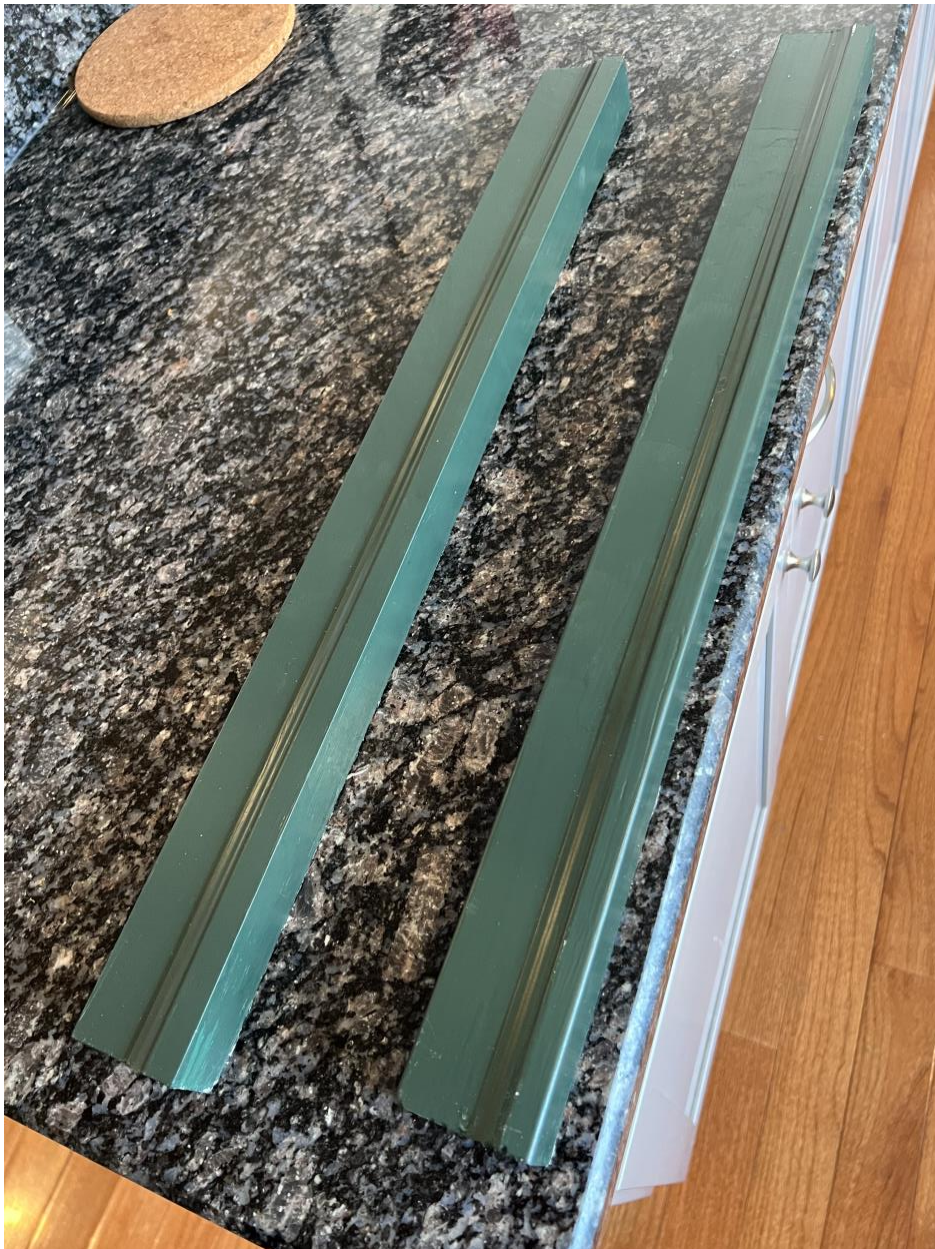
Here is a photo of the two materials. The trim piece on the left is the pine that is currently on the armory and rotting, and the trim piece on the right is PVC

We are proposing to replace the rotted pine with an identical Azek PVC which is the leading building material for this application and has gone through rigorous testing for longevity. This material is rated to last 30-50 years whereas pine is rated only for 20. I have attached the material spec sheets to the application. We will also be looking to install a window flashing waterproofing tape on the rough framing of the windows underneath the trim to maintain a waterproof and more airtight seal.

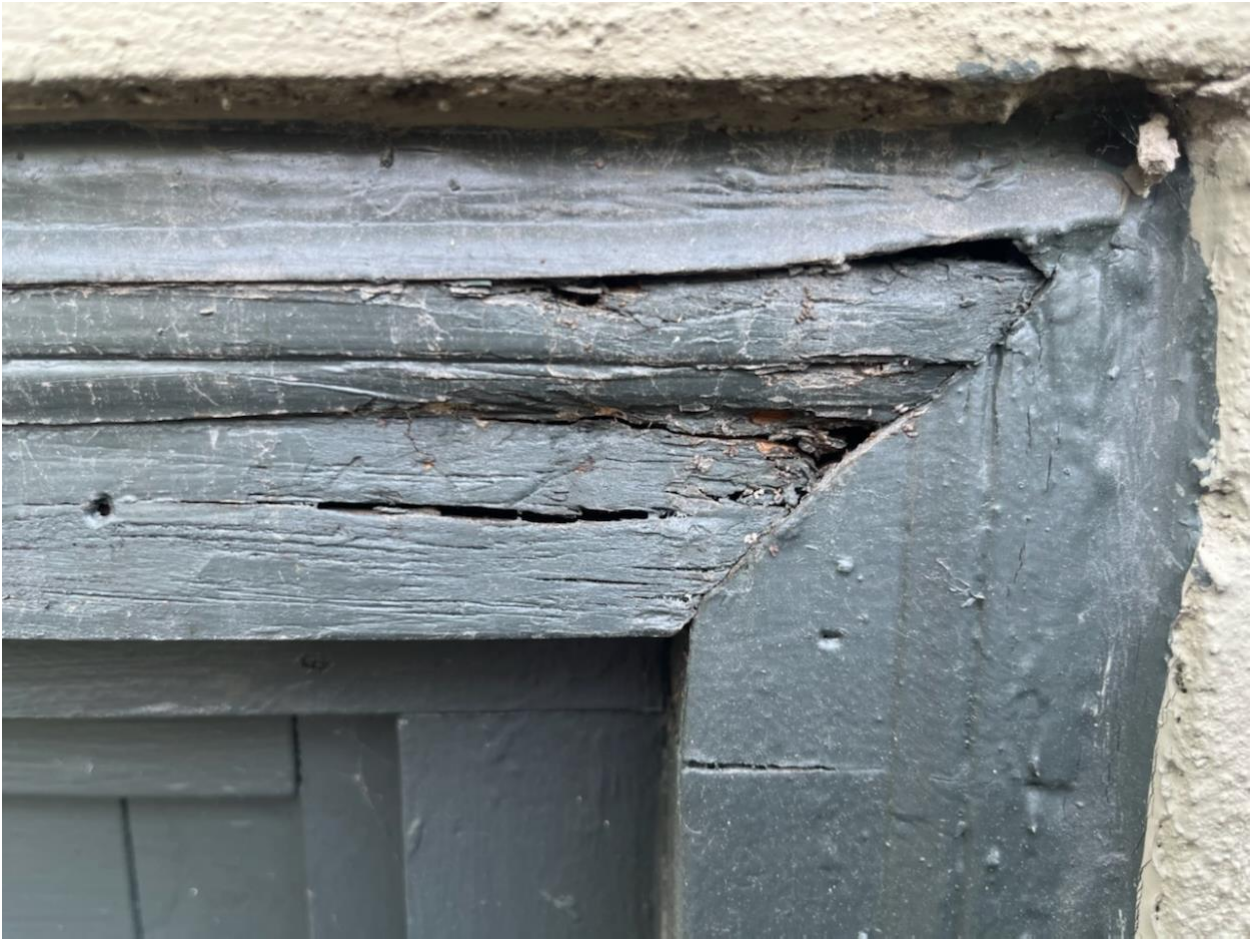
Example of Rotting Trim:

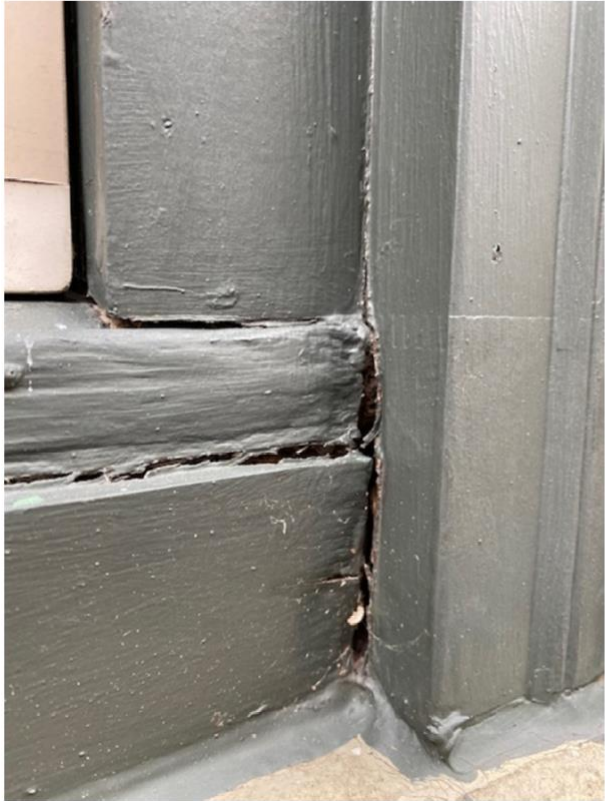
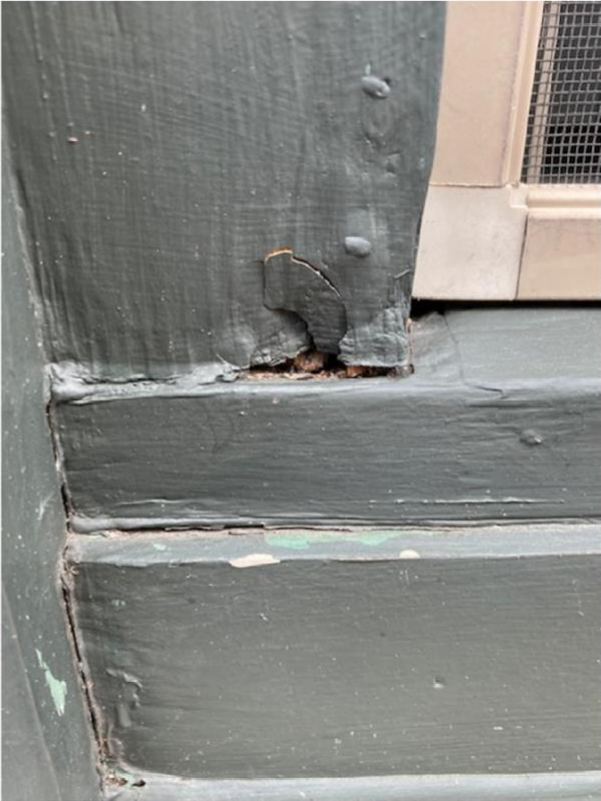
Example of rotting trim and sill with water leakage points:

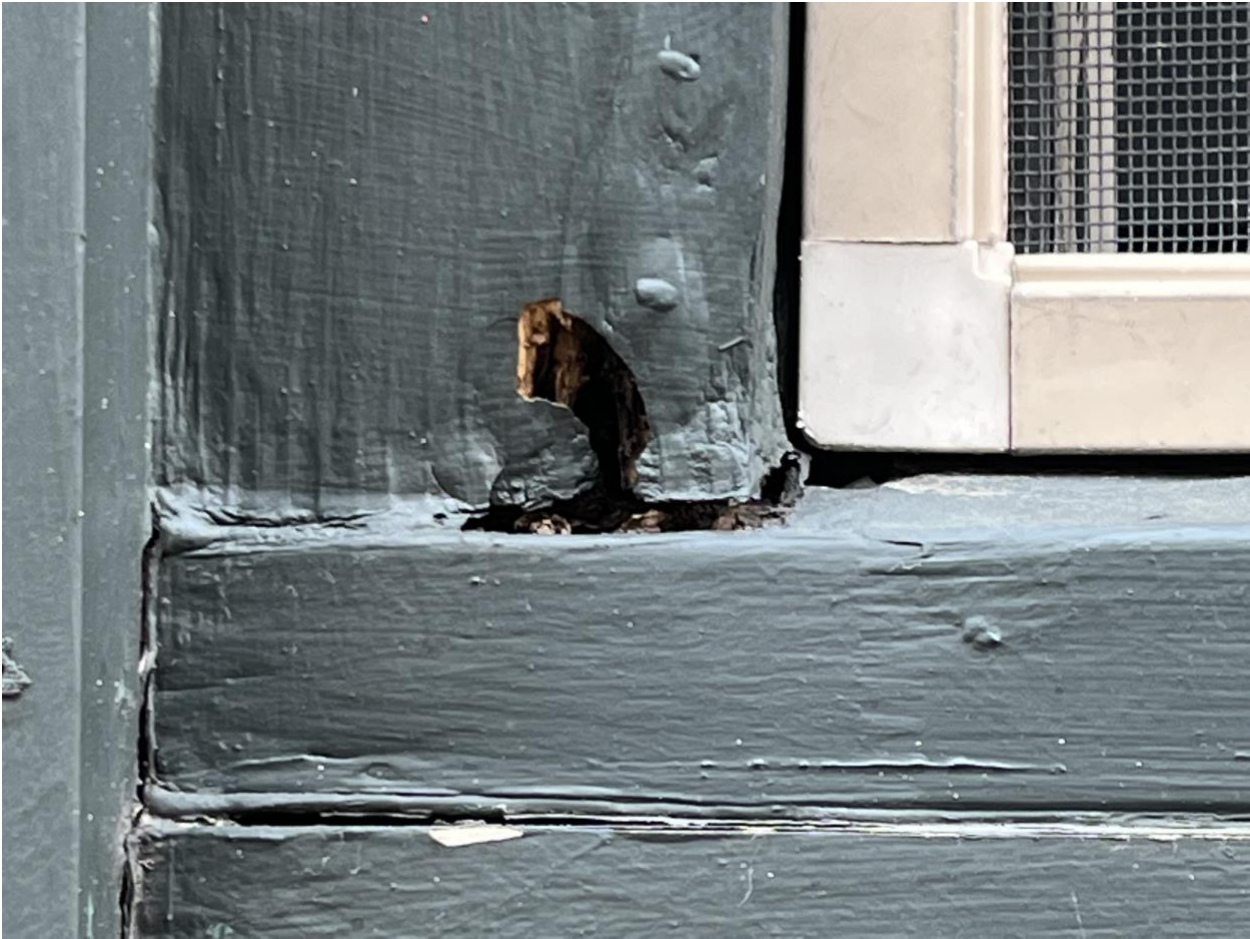
Example of rotting trim:

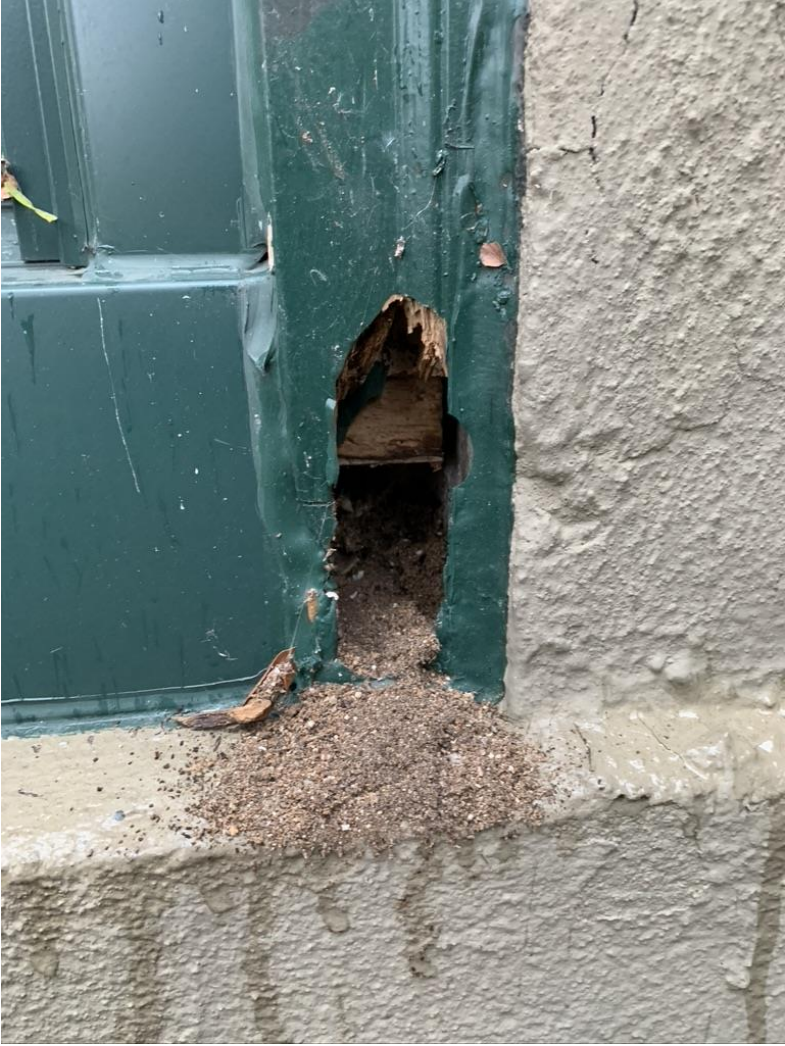
Example of rotten trim:

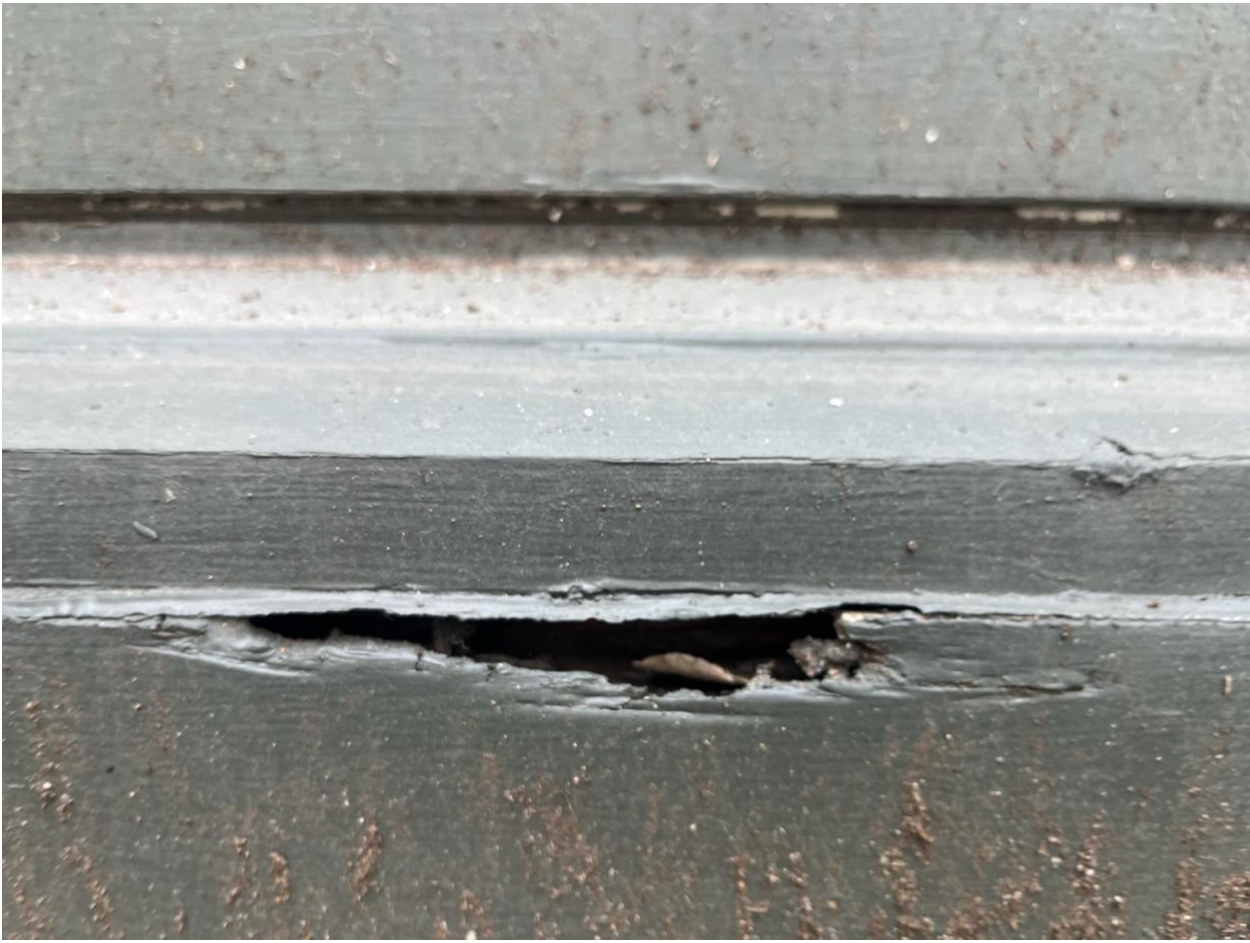
Example of Rotting Trim:
